PEACE RIVER REGIONAL DISTRICT

Rural Budgets Administration Committee Meeting Agenda

November 25, 2021, Immediately Following EADC
1981 Alaska Avenue, Dawson Creek, BC

**Facility Condition Assessment Report
Charlie Lake Fire Hall**

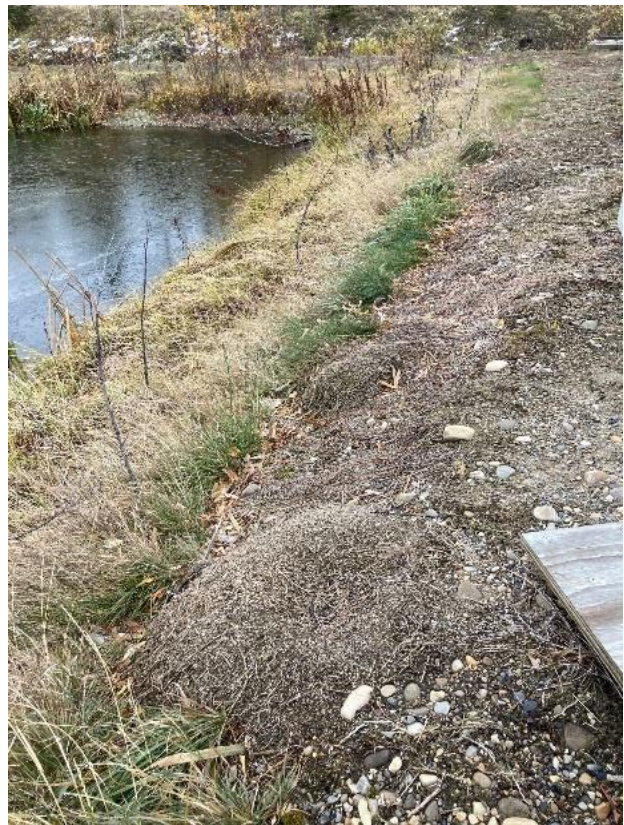
Numerous muskrats' burrows have been seen on the edges of the various lagoons and along the access roads. This is not causing any functional or structural problems at this time but should be monitored as the accumulation of these could cause the edges to become brittle and lead to the collapse of the roads especially between the cells 3 and 4 where the berm is already unstable and cannot allow heavy rolling equipment to access. Furthermore, this passage is not level and should be reconditioned.

Figure 2: Muskrats Burrows between cell 4 & 5

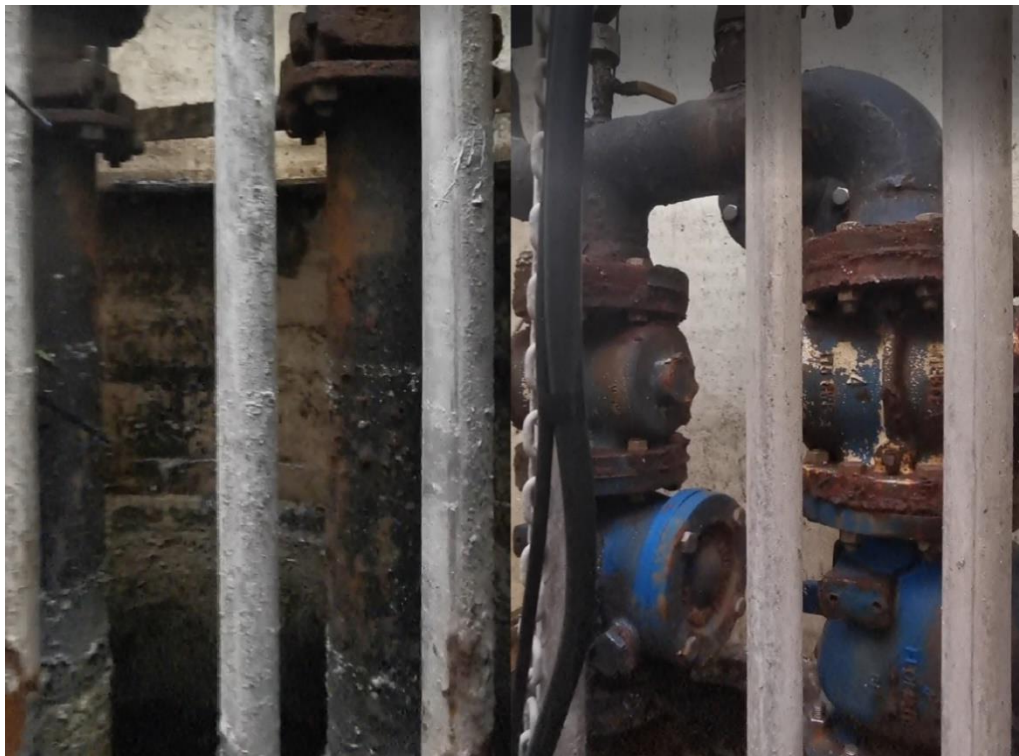
Figure 4: Rusted Pipes, Flanges, and Valves in the Wet Well

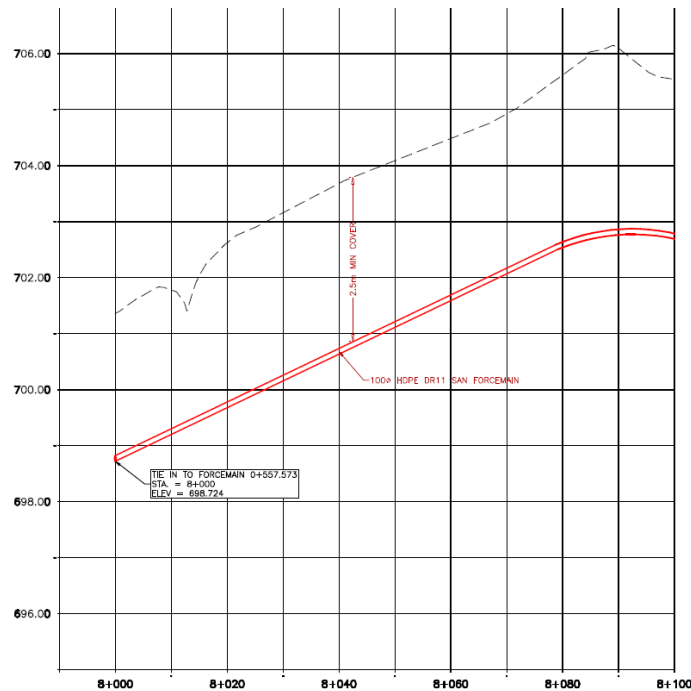
- i. Increased roughness inside pipe due to rust and spalling that causes higher flow restriction.
- ii. Sediment accumulated in the pipe that increases flow resistance and reduces flow area in the pipe (see [Section 3.4.2](#) for on-going maintenance on sewer pipe).
- iii. Wear on the impeller (although not reported by PRRD staff, this could still be a possibility).
- iv. A high point bend approximately 790m from the lift station ([Figure 8](#)) may allow some air to accumulate at the bend and restrict water flow.

Figure 6: A High Point Bend Section Downstream from the Lift Station

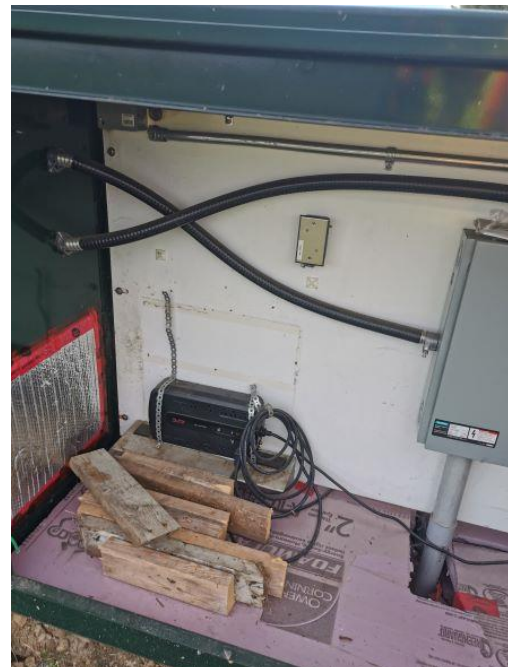
Figure 8: Residential Grade UPS

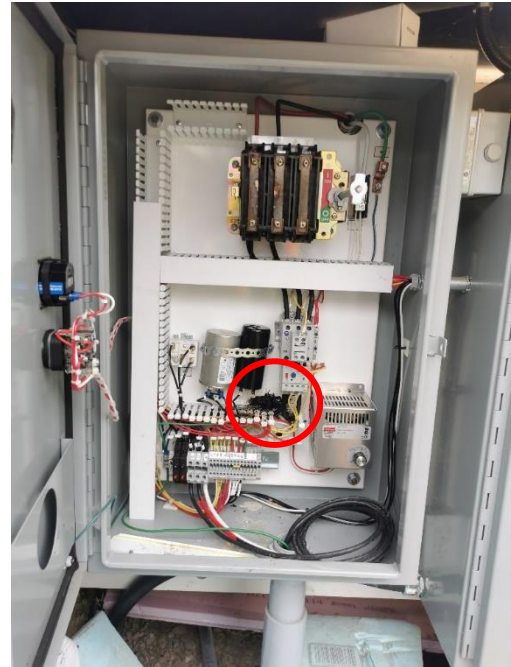
While reviewing the pictures of the electrical components inside the cabinet, McElhanney noticed at least one of the capacitors in each of the pump starter cabinets (total: 2 capacitors) appears to have experienced catastrophic failure and has been replaced (*Figure 9*), as indicated by the black burn mark circled in red in the photo. Based on the age of the facility and the capacitor failures already experienced, it is anticipated that another failure is likely. As the capacitors are installed directly into the starter cabinets, another catastrophic failure could cause other damage. A similar failure was noticed for the lift station in Chilton subdivision and may indicate a lighting strike occurred on one of the phases. A surge protector should be installed to avoid re-occurrence.

Figure 9: Capacitors Appear to Have Experienced Catastrophic Failure

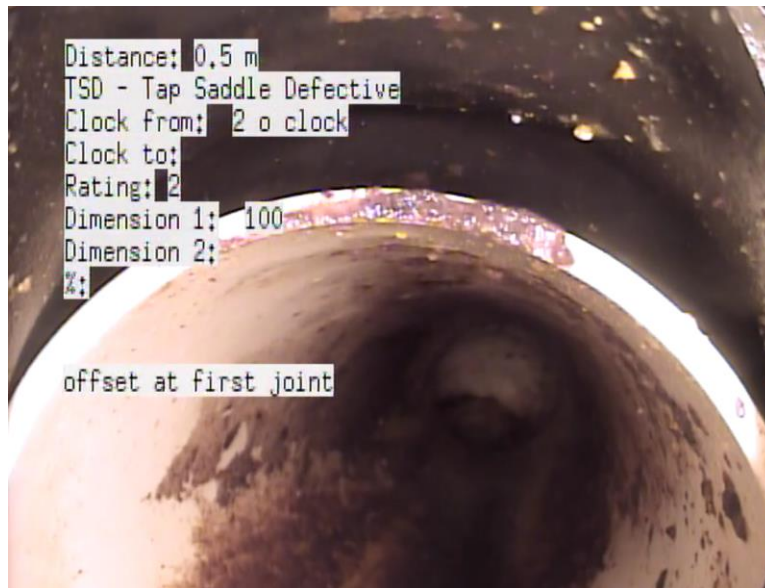
- SMH-01A to SMH-01B; 200mm HDPE: Pipe in fair condition, one instances of increased water level to approximately 50%, indicating sags in the pipe grade.
- SMH-01B to SMH-01C; 200mm HDPE: Pipe is in very good condition, no defects of note.
- SMH-01C to SMH-01D; 200mm HDPE: Pipe in fair condition, one instances of increased water level to approximately 30% near manhole SMH-01D, indicating sags in the pipe grade near the manhole. Services appear offset at their connections as seen in [Figure 10](#), but appear to be functioning.

Figure 10: Offset Connection for Service Between SMH-01C and SMH-01D

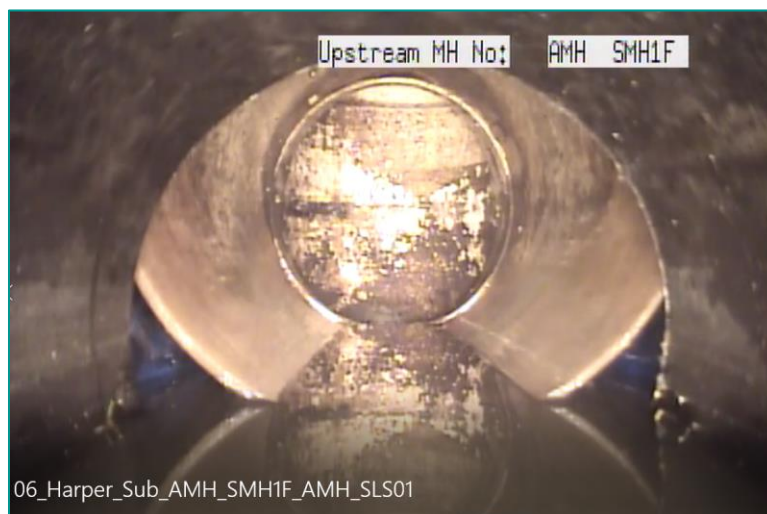
- SMH-01D to SMH-01E; 200mm HDPE: Pipe in fair condition, one instance of increased water level to approximately 30% near manhole SMH-01D, indicating sags in the pipe grade near the manhole.
- SMH-01E to SMH-01F; 200mm HDPE: Pipe in poor condition. One instance of underwater camera with pipe 80% full of water (with dry sections before and after) indicating large sags in the pipe grade. Several additional instances of water level reaching 50% of pipe diameter.
- SMH-01F to Lift Station; 200mm HDPE: Pipe in poor condition. While the structural condition of the pipe along the mainline is good, the pipe outfall to the lift station has a large offset joint as seen in [Figure 11](#). This offset joint constricts flow to the pump station and may result in reduced system capacity.

Figure 11: Offset Joint at Lift Station Outfall

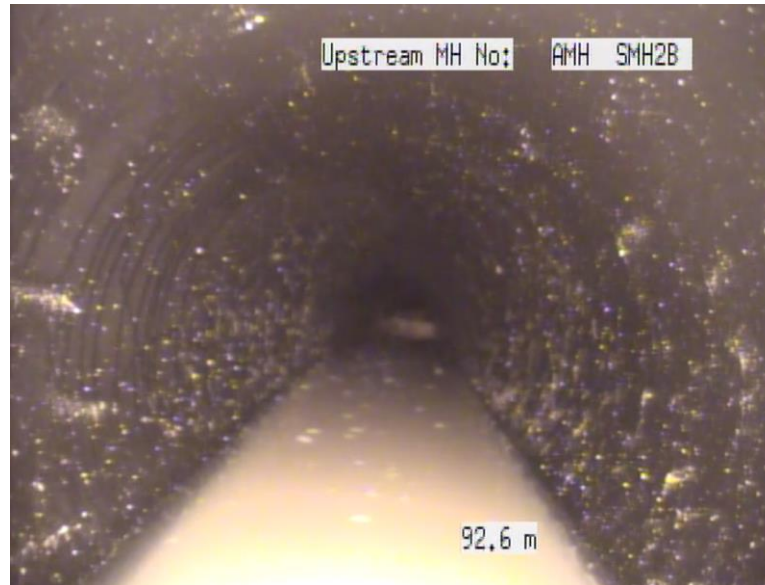
- SMH-02A to SMH-02B; 200mm HDPE: Pipe is in good condition, one instance of increased water level to approximately 30%, indicating minor sags in the pipe grade.
- SMH-02B to SMH-02C; 200mm HDPE: Pipe is in fair condition, one instance of underwater camera with pipe 80% full of water (with dry sections before and after) indicating large sag in the pipe grade with debris blocking the pipe as seen in *Figure 12*.

Figure 12: Gravel and Water Level Obstruction Caused by Pipe Sag Between SMH-02B and SMH-02C

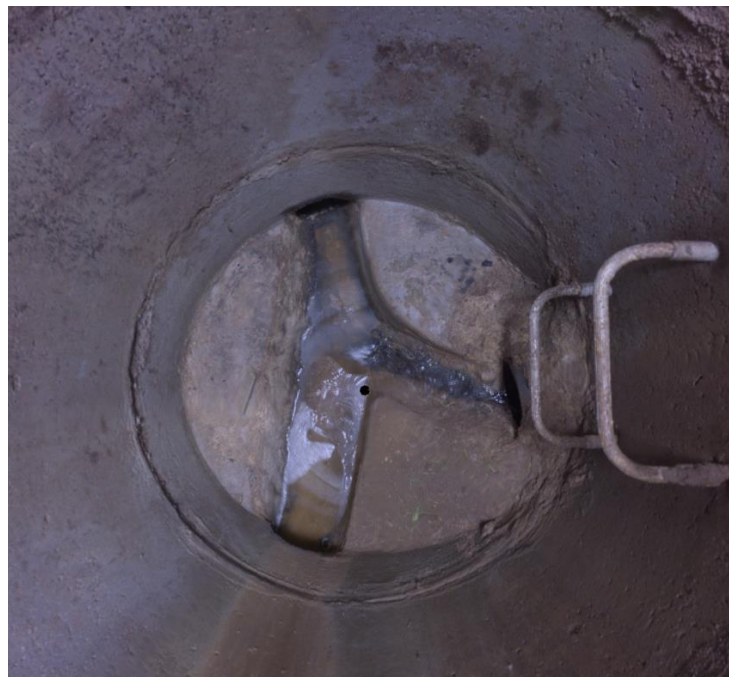
- SMH-01A, 1050mm concrete manhole: Manhole in good condition.
- SMH-01B, 1050mm concrete manhole: Manhole in good condition.
- SMH-01C, 1050mm concrete manhole: Manhole in good condition. Some minor infiltration staining.
- SMH-01D, 1050mm concrete manhole: Manhole in good condition. Some minor infiltration staining, and the pipe on either side of the manhole is sagging approximately 30% of pipe diameter.
- SMH-01E, 1050mm concrete manhole: Manhole in good condition. Some standing water at the time of survey in manhole channels.
- SMH-01F, 1050mm concrete manhole: Manhole in good condition. Some standing water at the time of survey in manhole channels as seen in [Figure 13](#).

Figure 13: Standing Water in Channels of SMH-01F (Final Manhole before Harper Lift Station).

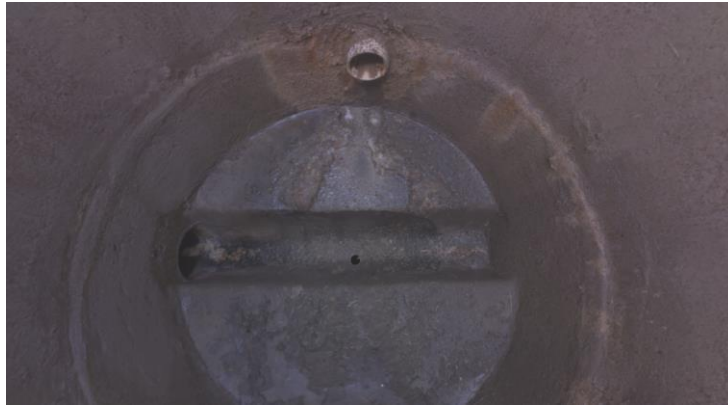
- SMH-02B, 1050mm concrete manhole: Manhole in good condition. Manhole has a service break-in set above the manhole benching without drop or ramp structure, as seen in Figure 14.

*Figure 14: Break in Service Connection to SMH-02B.
This service does not have a drop structure or benching to direct flows.*

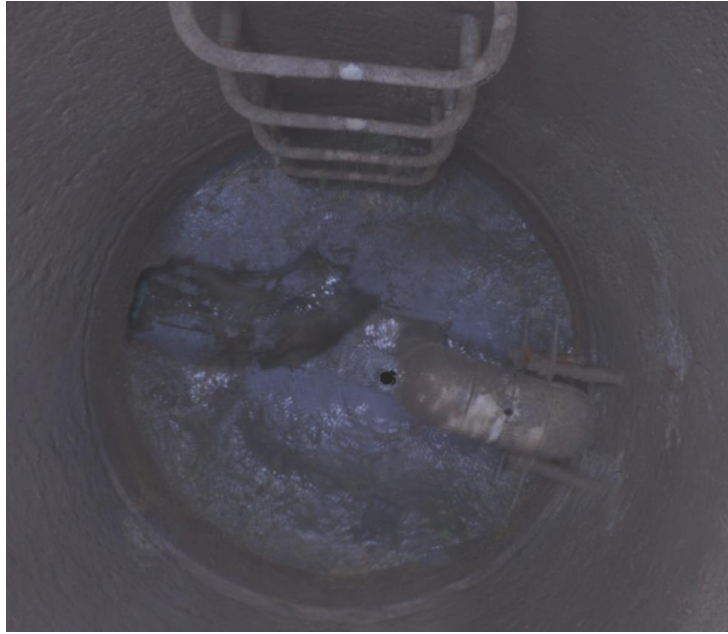
- SMH-03, 1050mm concrete manhole: Manhole in good condition. Drop structure from forcemain in good condition as seen in Figure 15, with restraints intact.

Figure 15: Drop Structure in Good Condition Based on Visual Inspection, with Restraints Intact. Rusting is present on the restraint hardware, but bolt threading and nut shape remain distinct and visible.

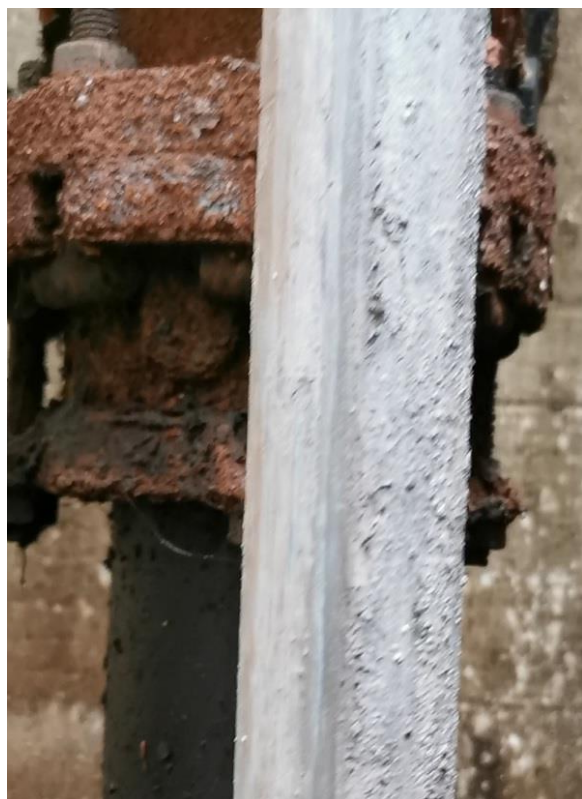
visible on the galvanized steel pipes and their flanges (*Figure 4*). The check valves, plug valves, and air release valve (*Figure 5*) within the wet well had no reported issues nor were any extraordinary observations reported by the staff.

Figure 4: Rusted Pipe and Flange in the Wet Well

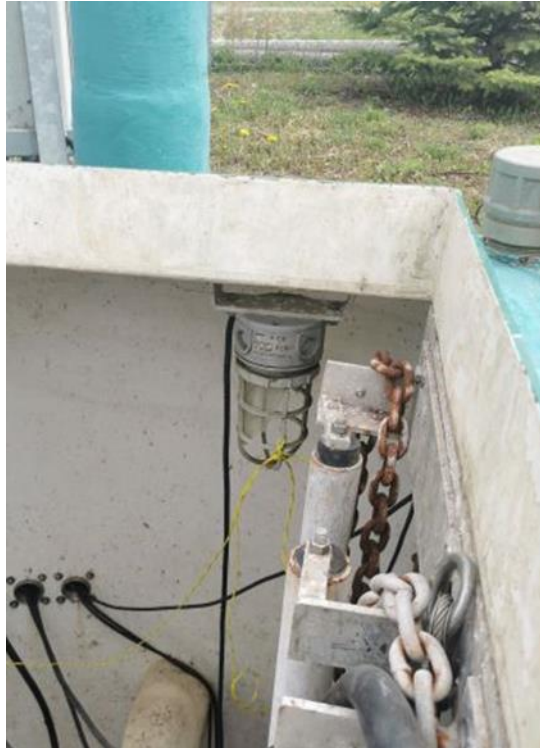
Figure 9: Damaged Explosion Proof Fixture (Light Bulb)

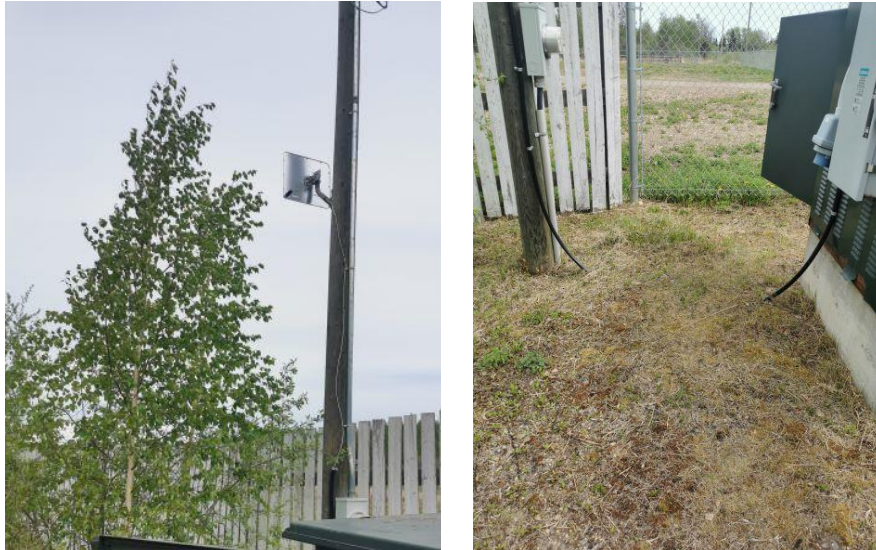
Figure 11: Antenna and Improperly Installed Cable

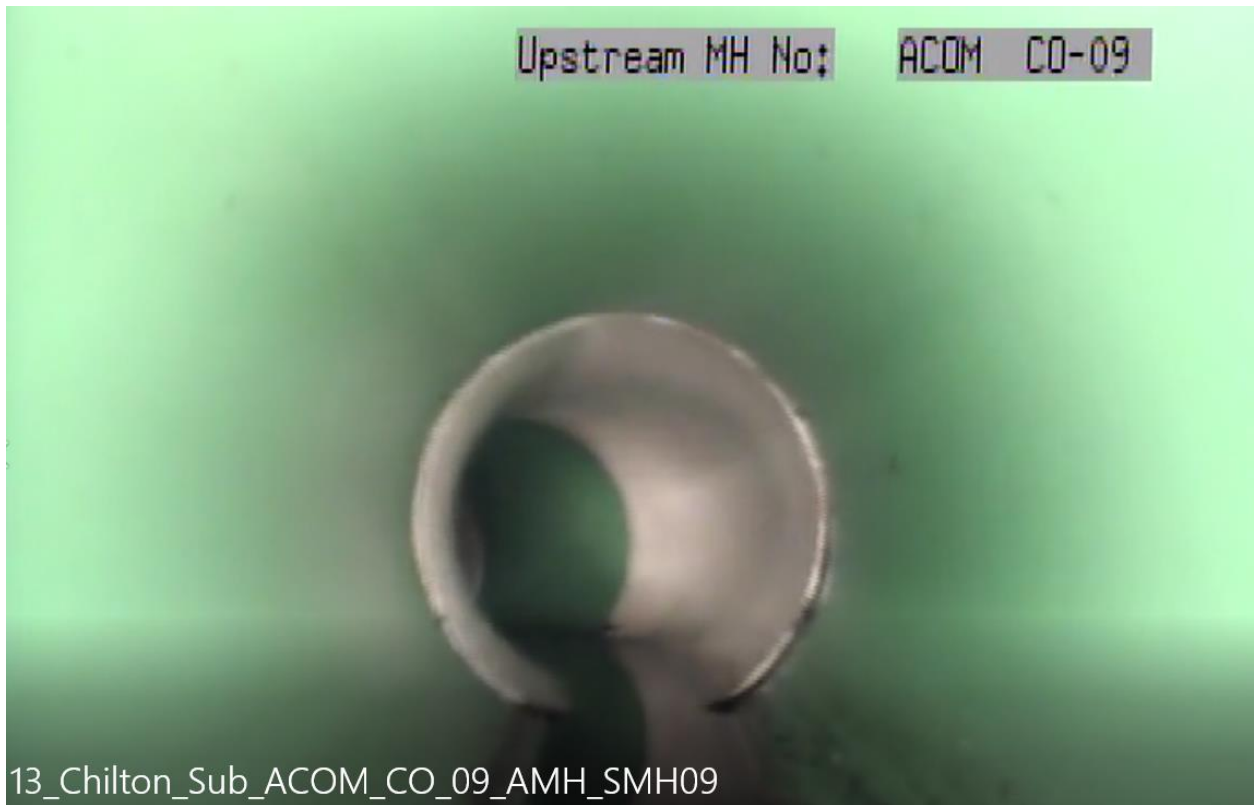
Figure 18: Bends in Pipe in Mainline Prevented CCTV Camera Survey

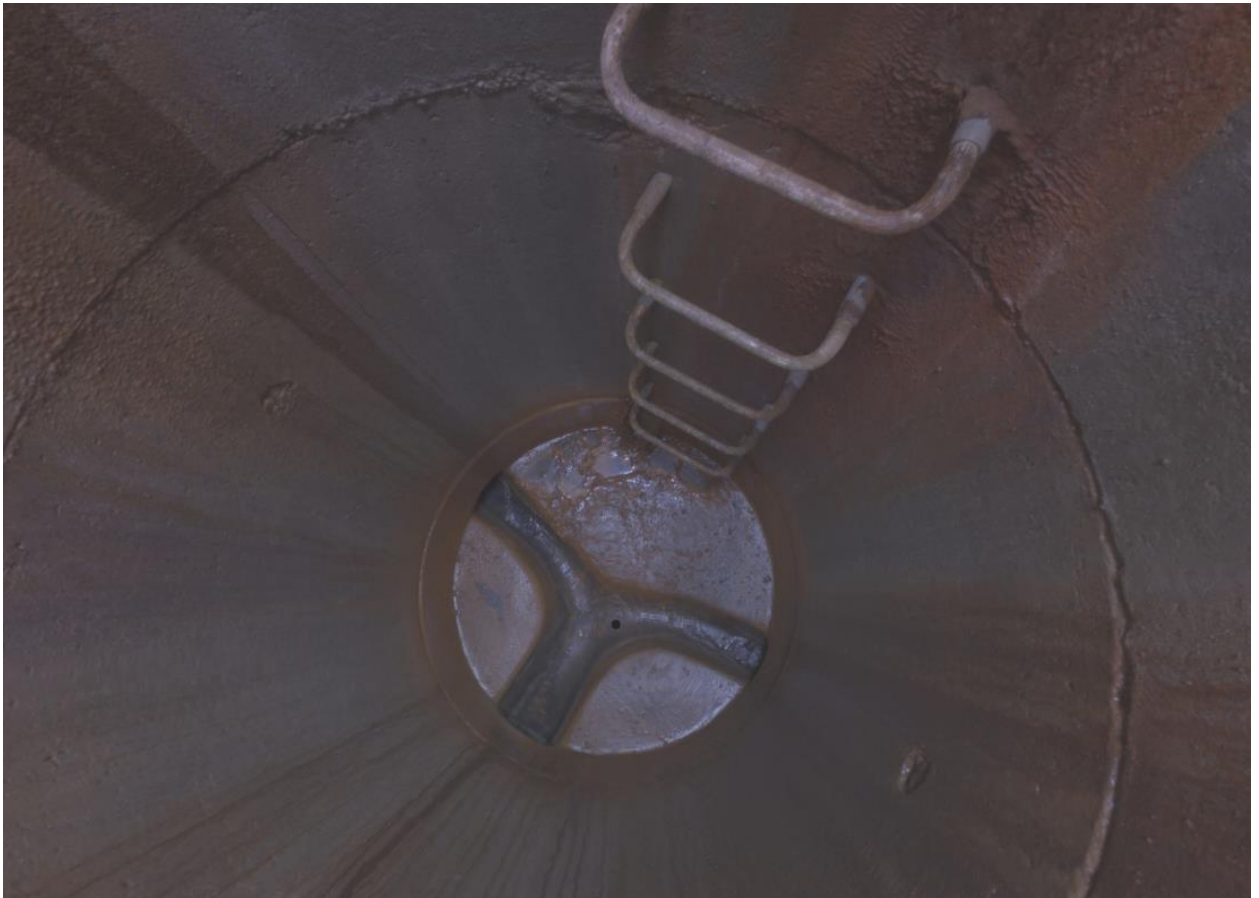
Figure 20: Some Minor Infiltration Staining and Encrustation in SMH-01

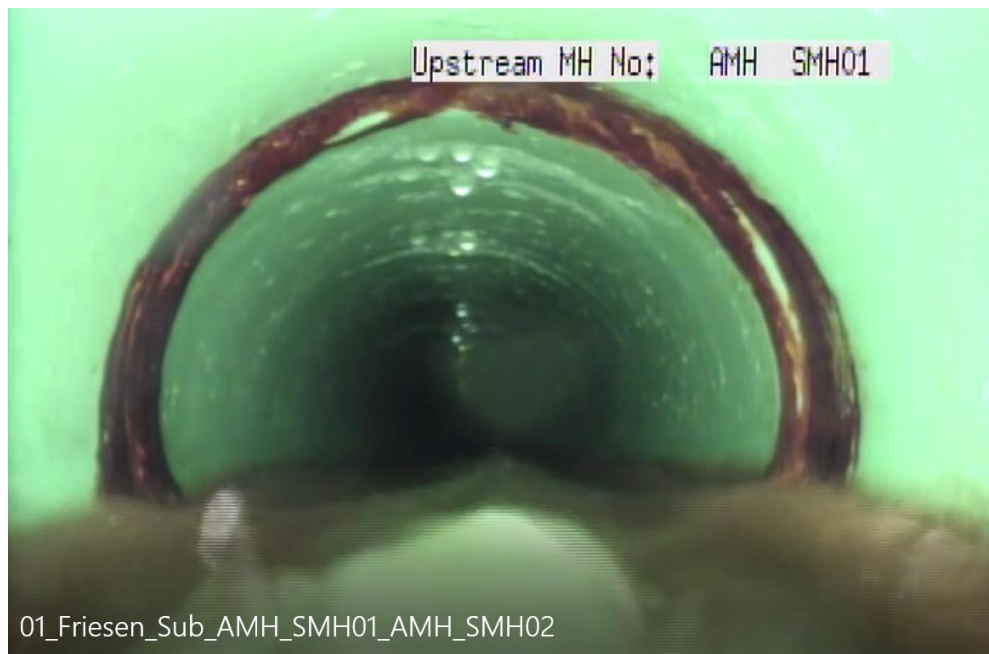
Figure 3: Circumferential Crack with Minor Infiltration
