PEACE RIVER REGIONAL DISTRICT

Electoral Area Directors Committee Meeting Agenda

Subject: North Peace Airport Subdivision Water and Sewer Condition Assessment

Condition Assessment Report

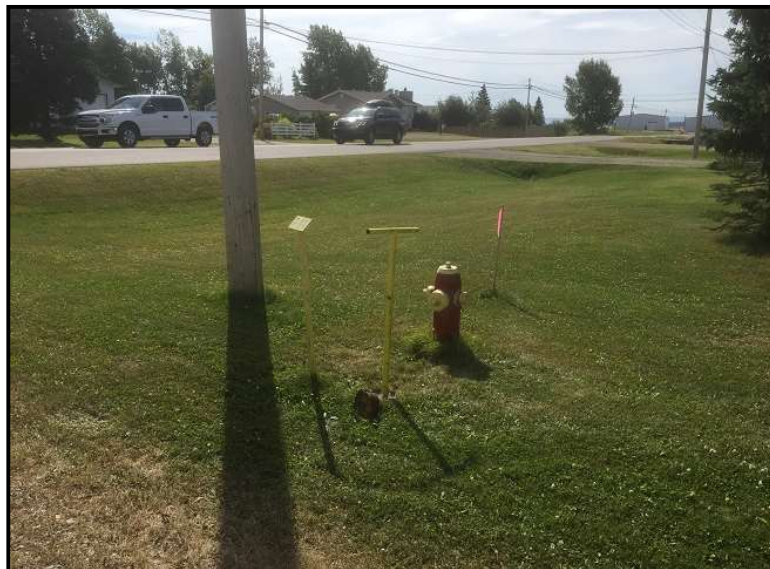
1. One (1) leak was located during the survey. This was a leak on a hydrant lead on the hydrant located outside 10330 257 Rd. Good leak noise was audible on the hydrant and on the secondary isolation valve. The valve itself was the likely source of the leak and maintenance is required as soon as possible.

All hydrants, hydrant isolation valves, all main line valves and any located service valves (curb-boxes) in the subdivision were sounded using an X-Mic ®. This is an electronic device similar to a microphone or a stethoscope with which a trained operator can detect leaks on a water pipe. One leak was located during the survey. This was a leak on a hydrant lead on the hydrant located outside 10330 257 Rd. (Figure 5.1). Good leak noise was audible on the hydrant and on the secondary isolation valve. When the isolation valve was operated, the leak noise increased and water began to surface in the valve box. This indicated that the valve itself was the likely source of the leak and maintenance is required as soon as possible.

Figure 5.1: Leak on hydrant located outside 10330 257 Road

These revealed an average of 16 l/h being fed into the system which is within the bounds of normal domestic usage. The repair of the remaining hydrant leak should reduce this further.

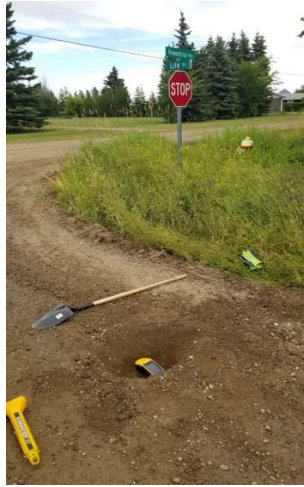
Figure 5.3: Inline Valve#3

Location: South of Lily-Rowantree

Notes: Buried 1 foot under gravel and raised back up while onsite. Valve stuck and could not be turned.

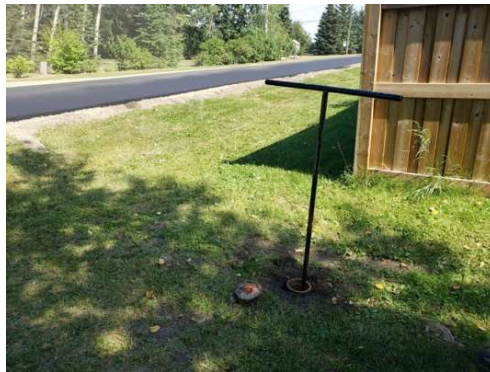
Figure 5.4: Inline Valve#4

Notes: Cap was stuck on and repaired onsite

Turn count: approximately 17.75 turns; fully closed and fully opened

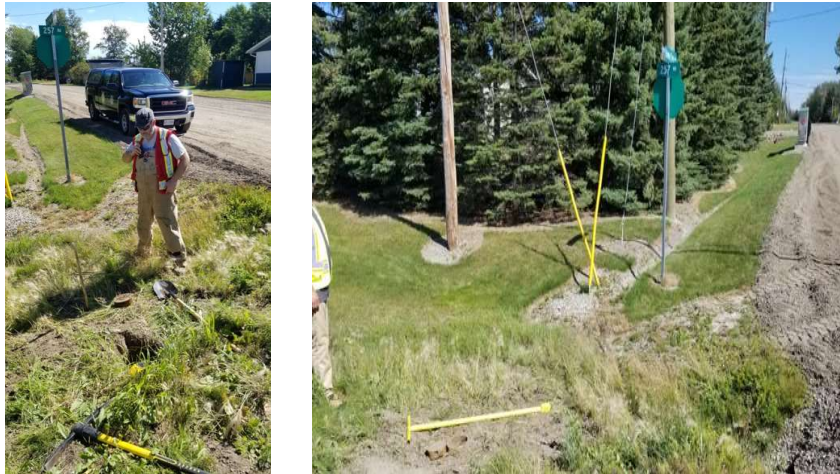
Figure 5.5: Inline Valve#5

Notes: Buried 1 foot in ditch; raised back up while onsite

Turn count: approximately 19.5 turns; fully closed and fully opened

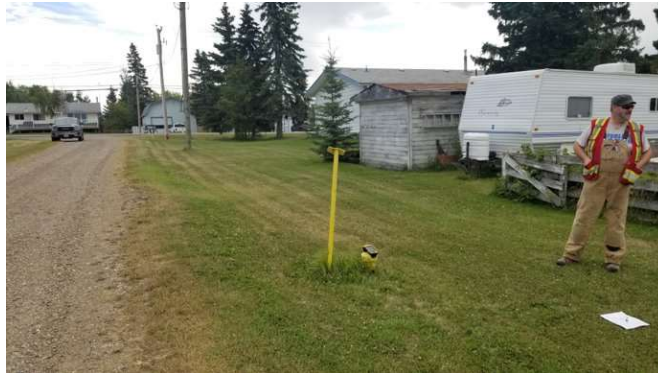
Figure 5.6: Inline Valve#6

Location: Off of gravel right of way, southeast of 257 road and Rowentree

Turn count: 20.25 turns; fully closed and fully opened

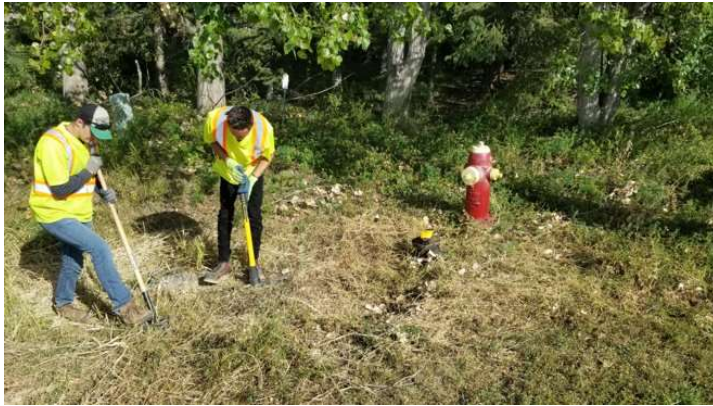
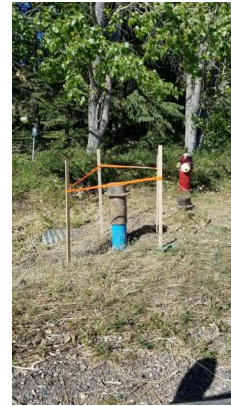
Figure 5.7: Inline Valve#7

Location: On 242 road (242 road – 257 road intersection)

Notes: Valve was buried, and casing broken; cleaned up and raised. Valve could not be exercised.

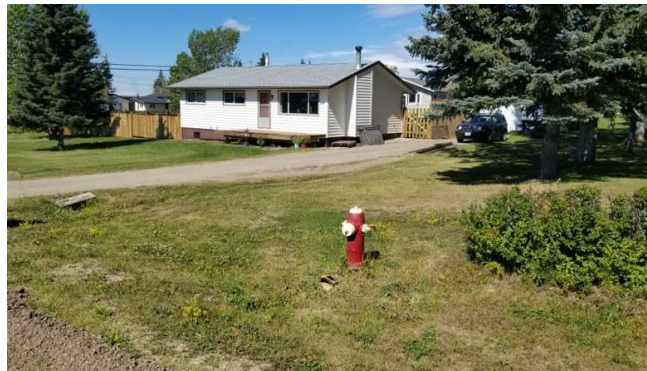
Figure 5.8: Hydrant A

Type: 6-inch isolation Gate Valve

Turn count: 19.5 turns; fully closed and fully opened

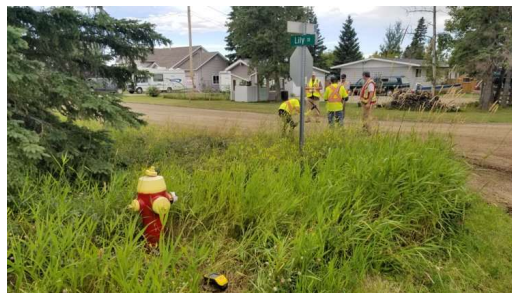
Figure 5.9: Hydrant B

Turn count: 20.25 turns; fully closed and fully opened

Notes: Keys stuck on extension

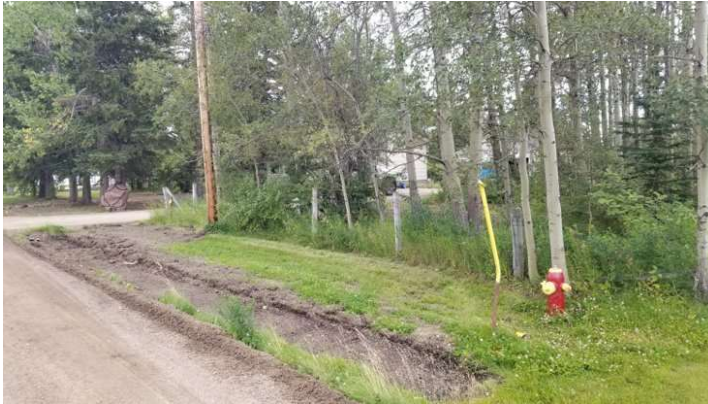
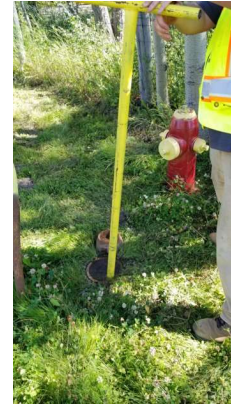
Figure 5.10: Hydrant C

Turn count: 20.5 turns; fully closed and fully opened

Notes: Leaks when valve operated

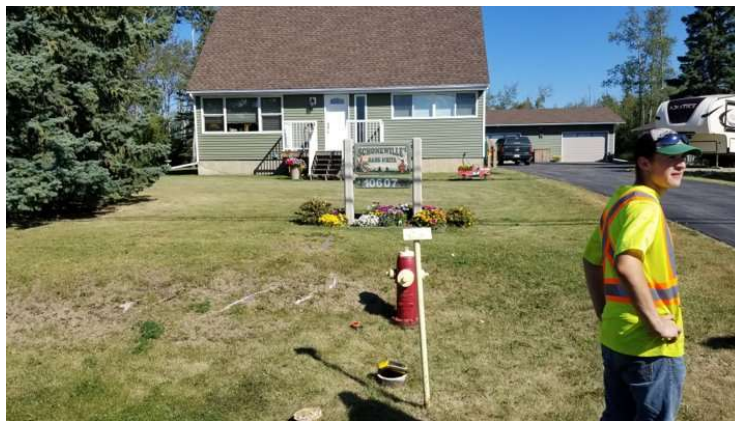
Figure 5.11: Hydrant D

Type: 6-inch isolation Gate Valve

Turn count: 20.25 turns; fully closed and fully opened

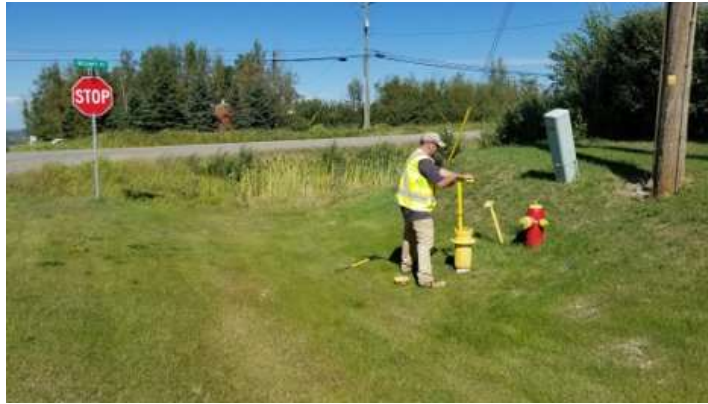
Figure 5.12: Hydrant E

Turn count: 20.5 turns; fully closed and fully opened

Notes: Leaks when valve operated

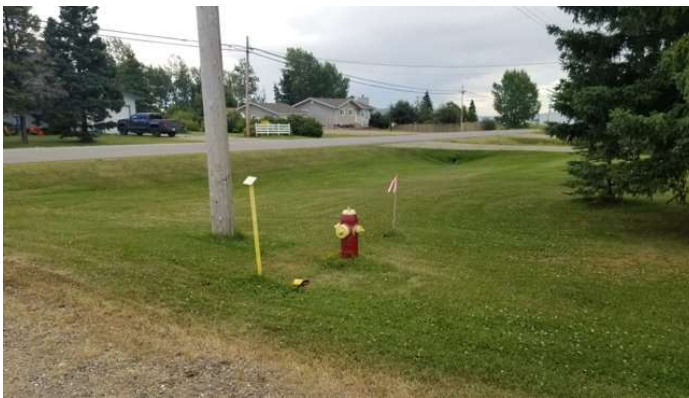
Figure 5.13: Hydrant F

Turn count: 20.25 turns; fully closed and fully opened

Notes: Leaks when valve operated

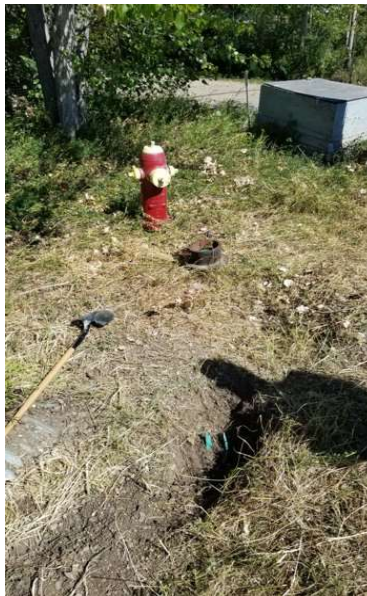
Figure 5.14: Hydrant G

Type: 6-inch isolation Gate Valve

Notes: Valve extension not on valve nut; could not be exercised

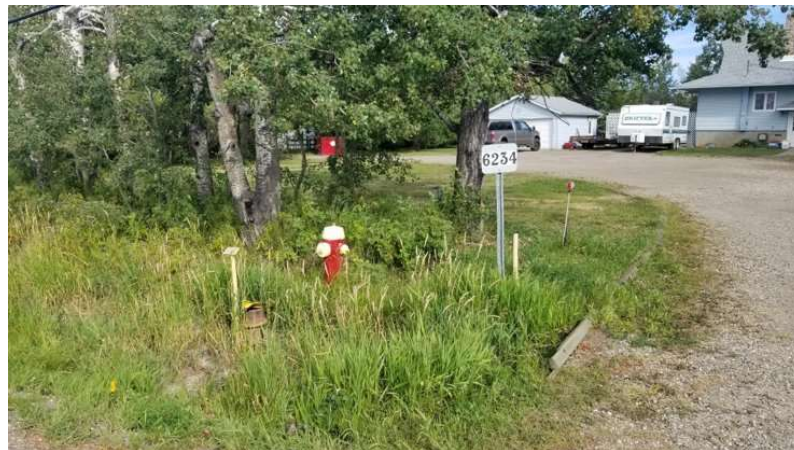
Figure 5.15: Hydrant H

Type: 6-inch isolation Gate Valve

Turn count: 20.25 turns; fully closed and fully opened
