# Sukunka River Landslide (2019) Assessment Report

March 25, 2019

## Background

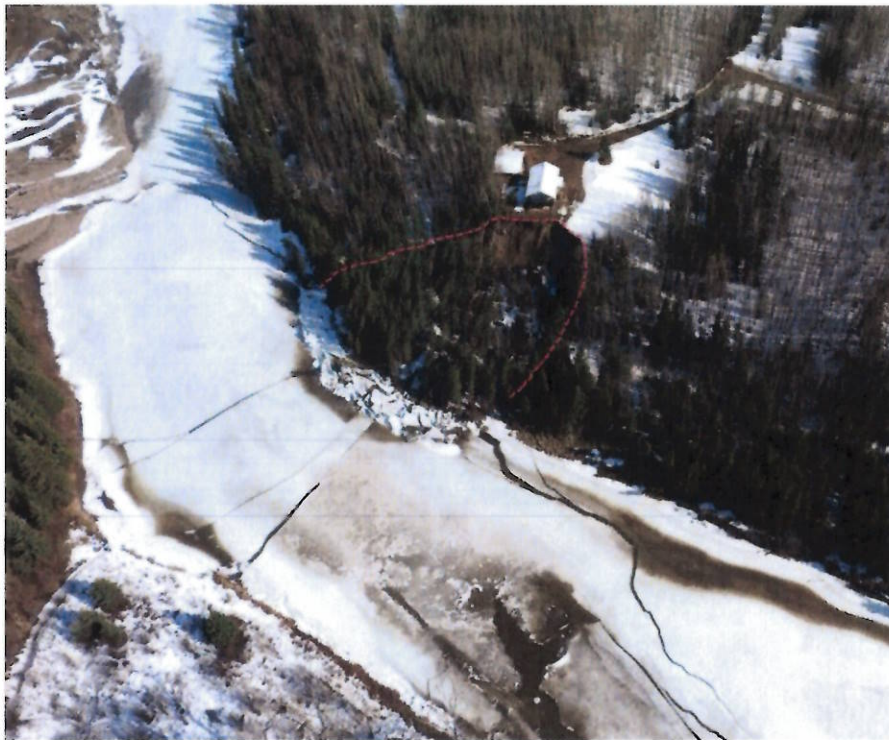
- The landslide occurred on March 23, 2019.
- The width of the landslide is some 60m and the length is some 50m (Fig. 2).
- The landslide's main scarp came to within 2.5m of the porch supports, or 4m from the house foundation (Figs. 3, 4).

Figure 2. Extent of March 23, 2019 landslide along the Sukunka River and its proximity to the dwelling at 8657 Highway 29S.

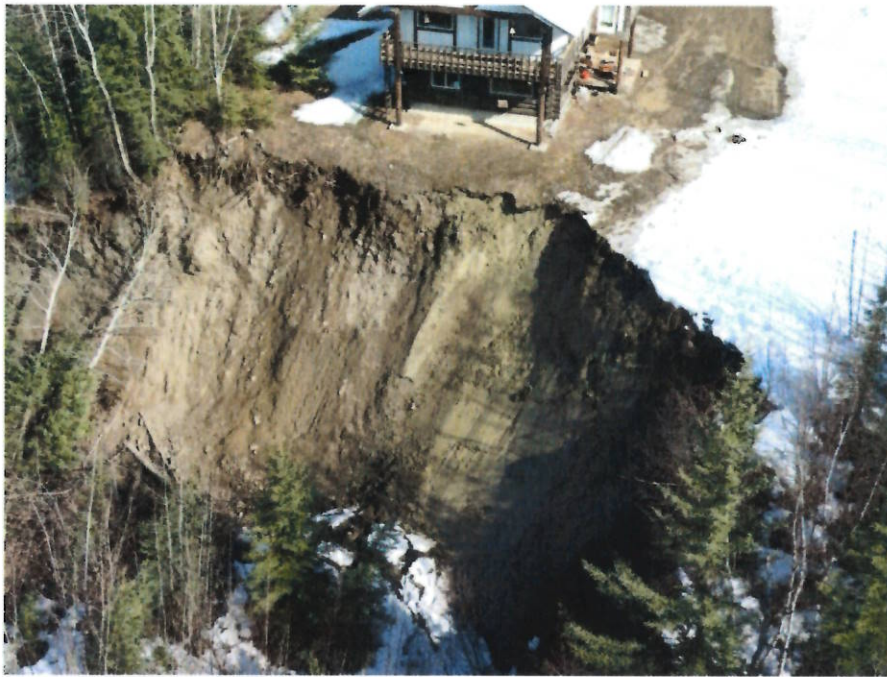
Figure 3. Proximity of the main scarp to the dwelling foundation.

Given the proximity of the house to the main scarp (4m), the height and steepness of the main scarp (10 to 12m), and the impending onset of spring snow melt, ground frost thaw, and enhanced river flows, it is my opinion that this dwelling is currently unsafe for occupation. A subsurface investigation is required to quantify the landslide hazard. This subsurface investigation might involve drilling and laboratory soil property testing. It is recommended that a subsurface investigation be conducted to determine if the dwelling is safe for occupation.

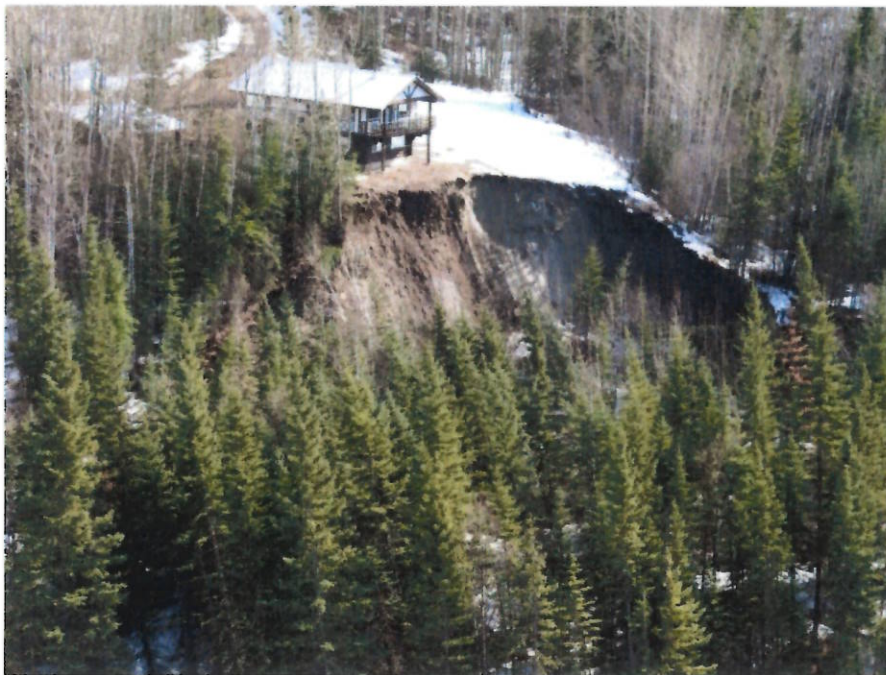
- The main scarp was 10 to 12m high and is near vertical in places.
- Lacustrine (lake bed) clay soils were observed in the main scarp, at the top of the landslide, and near the bottom of the slope. The lacustrine soils appeared contorted in the left (north) lateral scarp, suggesting previous landslide activity (the right lateral scarp was not examined). Further, angular blocks of coarser soils were observed in scarp exposures at several locations which also suggest previous landslide activity.

Figure 4. Oblique photo showing the height and steepness of the main scarp in relation to the dwelling, and proximity of the main scarp to the dwelling.
