## **Peace River Regional District Friesen Assessment**

October 29, 2021 | Revision 1

Submitted to: Peace River Regional District  
Prepared by: McElhanney Ltd.

## Peace River Regional District Friesen Sewer Assessments

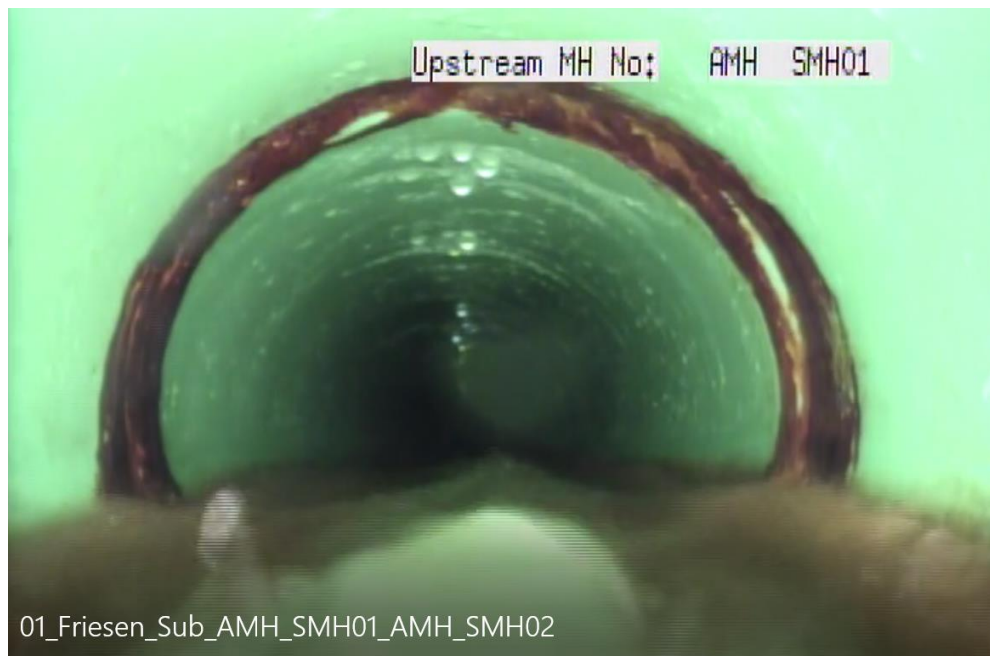
- SMH-01 to SMH-02; 200mm PVC: Pipe is in fair condition, one instance of underwater camera with the pipe 80% full of water (with water level at 30% before and after) indicating sag in the pipe grade. Pipe also shows early signs of structural failure, with several circumferential cracks, as seen in [Figure 3](#). These circumferential cracks may also be PVC repair couplings from past maintenance. The cracks are uniform and lack the characteristic longitudinal crack propagation that PVC pipe usually exhibits under stress failures, so these likely aren't a current cause for concern but should be monitored.

*Figure 3: Circumferential Crack with Minor Infiltration*

- Locating and replacing the segments of pipe exhibiting sagging between SMH-01 and SMH-02, SMH-02 and SMH-03. This work could be performed as point repairs to the system with disturbance only required in the vicinity of the repair. This may require work to reconnect service connections at the new grade if services are located at the underwater sections.

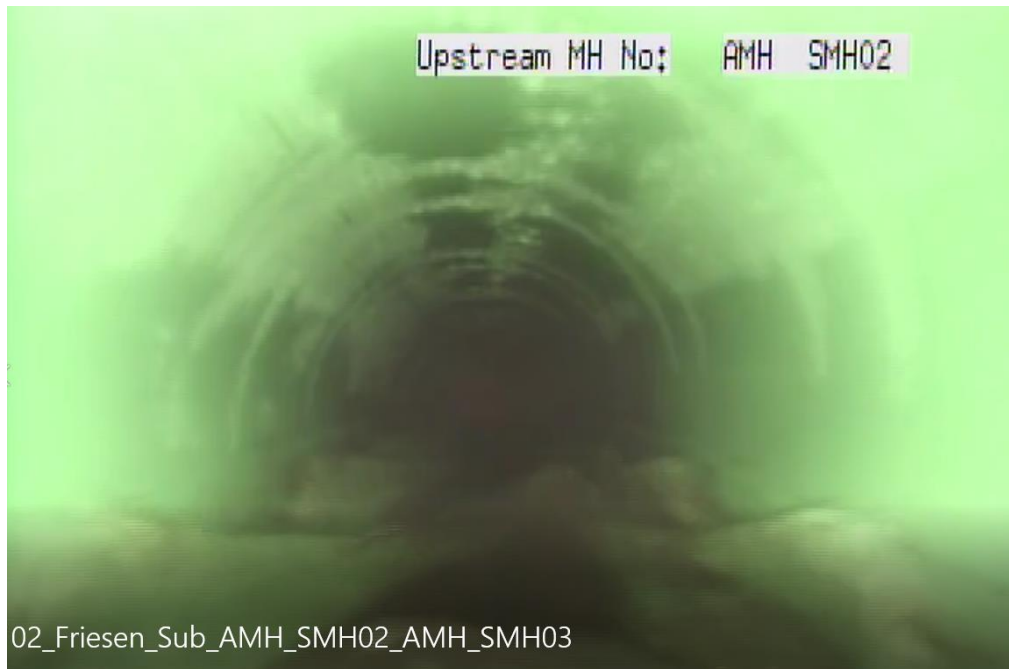
- SMH-02 to SMH-03; 200mm PVC: Pipe is in fair condition, one instance of underwater camera with pipe 80% full of water (with water level at 30% before and after) possibly indicating sag in the pipe grade. Note that this instance of the camera going underwater was within a short distance of the manhole with the sewer having approximately 30% flow ([Figure 4](#)), so the underwater camera may have been due to a hydraulic jump at the manhole interface.

*Figure 4: CCTV Image Taken During Period of Moderate Flow  
Flow may have led to a hydraulic jump condition causing an instance of underwater camera*

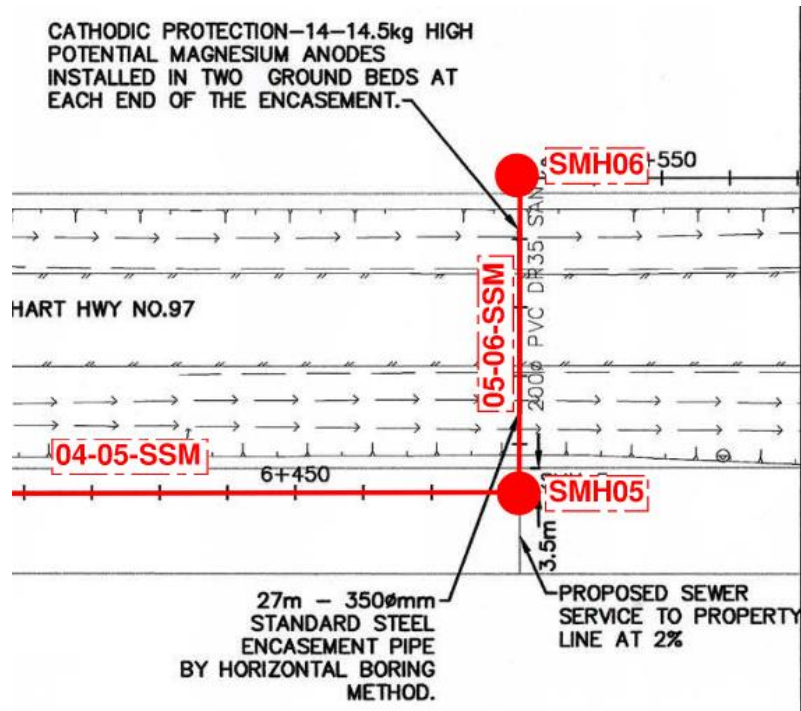
- SMH-03 to SMH-04, 200mm PVC: Pipe in good condition, no defects of note.
- SMH-04 to SMH-05, 200mm PVC: Pipe in good condition, no defects of note.
- SMH-05 to SMH-06; 200mm PVC: Pipe in poor condition, one location of a circumferential crack combined with moderate mineral encrustation. Survey also showed an instance of underwater camera, indicating possible pipe failure and/or collapse beyond the surveyed extent. Note that this pipe is installed in a steel encasement pipe across Highway 97, as shown in [Figure 5](#).

Figure 5: SMH-05 to SMH-06 Installed in 350mm Steel Carrier Pipe to Cross Highway 97

- Replacing the SMH-05 to SMH-06 segment. This segment is exhibiting some structural defects in addition to a large, sagged section with settled gravels. This pipe segment is also located in a casing pipe under the highway, which makes repairs difficult without full replacement. McElhanney recommends locating and reusing the casing pipe to avoid highway disturbance. Reusing the casing pipe may require some modifications to the existing manholes on either side of the highway to match grades. After removal of the carrier pipe, the casing pipe should be inspected by CCTV for defects. Cleaning of all manholes by pressurized water and/or mechanical tools, with attention paid to manholes with encrustation. After cleaning is completed, any deficient manhole construction causing infiltration and encrustation should be noted and repaired with concrete patching.

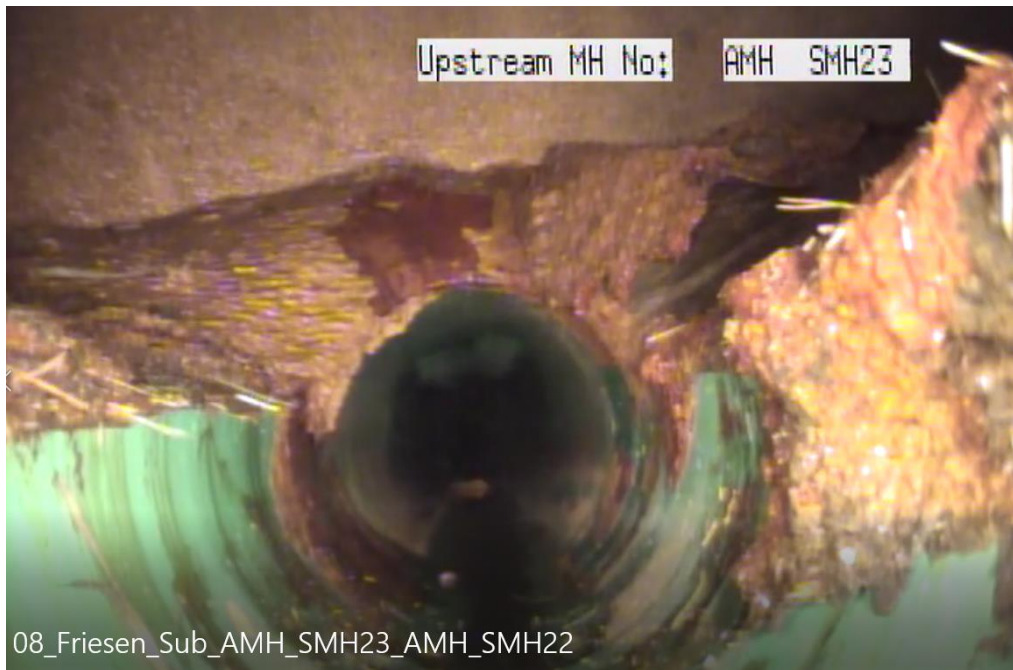
- SMH-03, 1050mm concrete manhole: Manhole in good condition. Some minor infiltration staining.
- SMH-04, 1050mm concrete manhole: Manhole in good condition. Some minor infiltration staining and encrustation near a service on top of the benching.
- SMH-05, 1050mm concrete manhole: Manhole in good condition.
- SMH-06, 1050mm concrete manhole: Manhole in good condition. Some minor infiltration staining.
- SMH-21, 1050mm concrete manhole: Manhole in good condition.
- SMH-22, 1050mm concrete manhole: Manhole in good condition. Some minor infiltration and encrustation near the manhole benching, as seen in [Figure 7](#).

*Figure 7: Encrustation Around Benching of SMH-22*

Cleaning all manholes to clear encrustation is recommended. Once complete, perform concrete patching as required.
