**Peace River Regional  
District  
Chilton Assessment**

October 29, 2021 | Revision 0

## Peace River Regional District Chilton Assessments

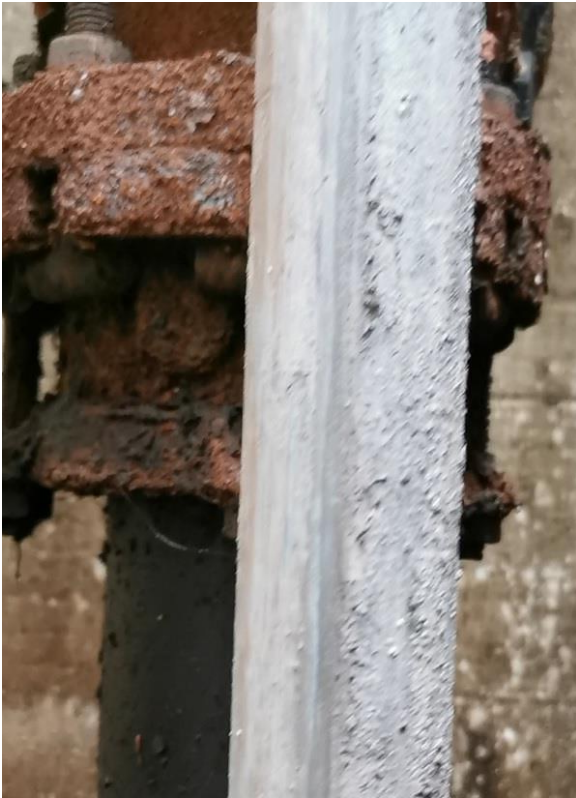
The wet well was found to be in good condition, without damage to the fibreglass surface. Operations staff reported no wet well leakage, nor was any observed during the inspection. Considerable rust was

visible on the galvanized steel pipes and their flanges (*Figure 4*). The check valves, plug valves, and air release valve (*Figure 5*) within the wet well had no reported issues nor were any extraordinary observations reported by the staff.

*Figure 4: Rusted Pipe and Flange in the Wet Well*

Recommended Upgrade	Cost	Class	Priority	Rational
Replace steel piping, fittings, flanges, and valves	\$32,250	B	Medium	Significant corrosion and spalling of paint on the surface and most parts; has reached the end of its design life according to ISC's guideline.
Replace two pumps that were purchased in 2001	\$40,500	B	Medium	Two pumps purchased in 2001 will reach the end of their service life in 4 years according to ISC's guideline. In addition, plugging issues due to low torque can be improved if electrical study confirms power upgrade is possible
Upgrade power supply to a 3-phase power	\$10,000	B	Medium	Upgraded power will limit pump plugging. See <a href="#">Section 2.1.2</a> . Cost estimate does not include utility costs, which can vary significantly and will be determined with study as recommended in <a href="#">Table 2</a> .
Install shut off valve for the pipe outlet	\$3,000	B	Low	Not required for operation; improves station analytics.

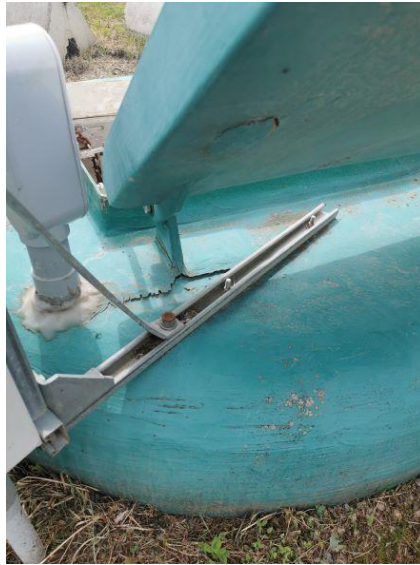
Systems ([Section 2.2](#)). The hinge connection of the hatch door is loose and paint is spalling ([Figure 6](#)). Repair is necessary before the hatch door fails.

*Figure 6: Anchor of Hatch Door Requires Tightening*

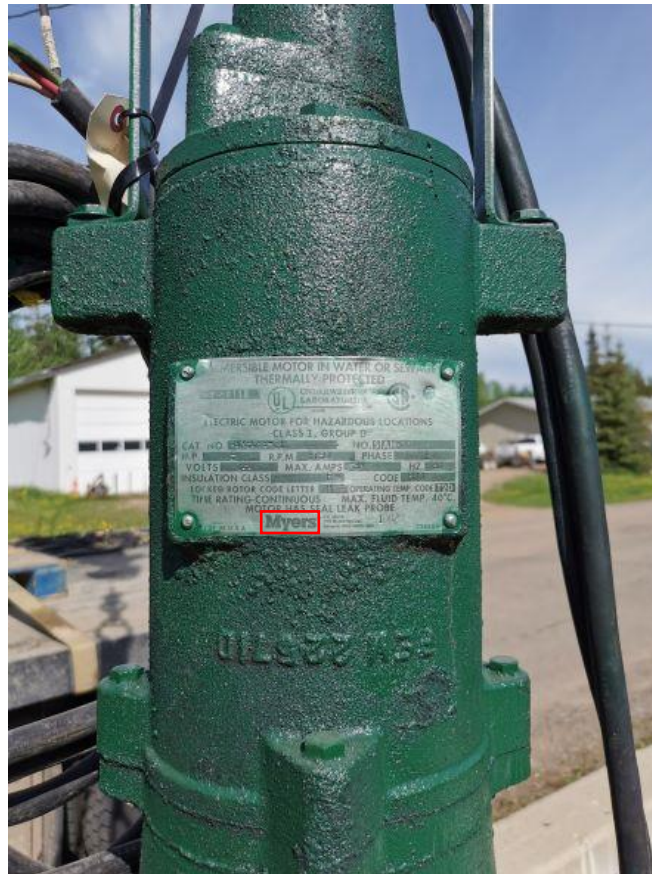
The review of the lift station documentation revealed that the installed pump is a Myers/Barnes; however, the record drawings from the contractor shows a Flygt pump ([Figure 7](#)). The O&M manuals are correct; thus, this is not likely to cause confusion. The documentation will be updated once the pumps are updated in 3 to 5 years; immediate changes are not recommended.

Figure 7: Myers/Barnes Pump Installed

A recommendation from the lift station supplier (Engineered Pump Systems Ltd.) was to upgrade the drive power supply to 3-phase power and upgrade the pumps. Pumps running on 3-phase power have greater torque than the current single-phase pumping system. The lower torque pumps typically cannot overcome additional resistance caused by entrained solids. The pumps are within 5 years of their theoretical end of life. Upgrades to electrical to 3-phase power would limit the issue (if possible, which can be verified in an electrical supply study). If the pumps are replaced, the system controller would also be replaced and should include an hour meter.

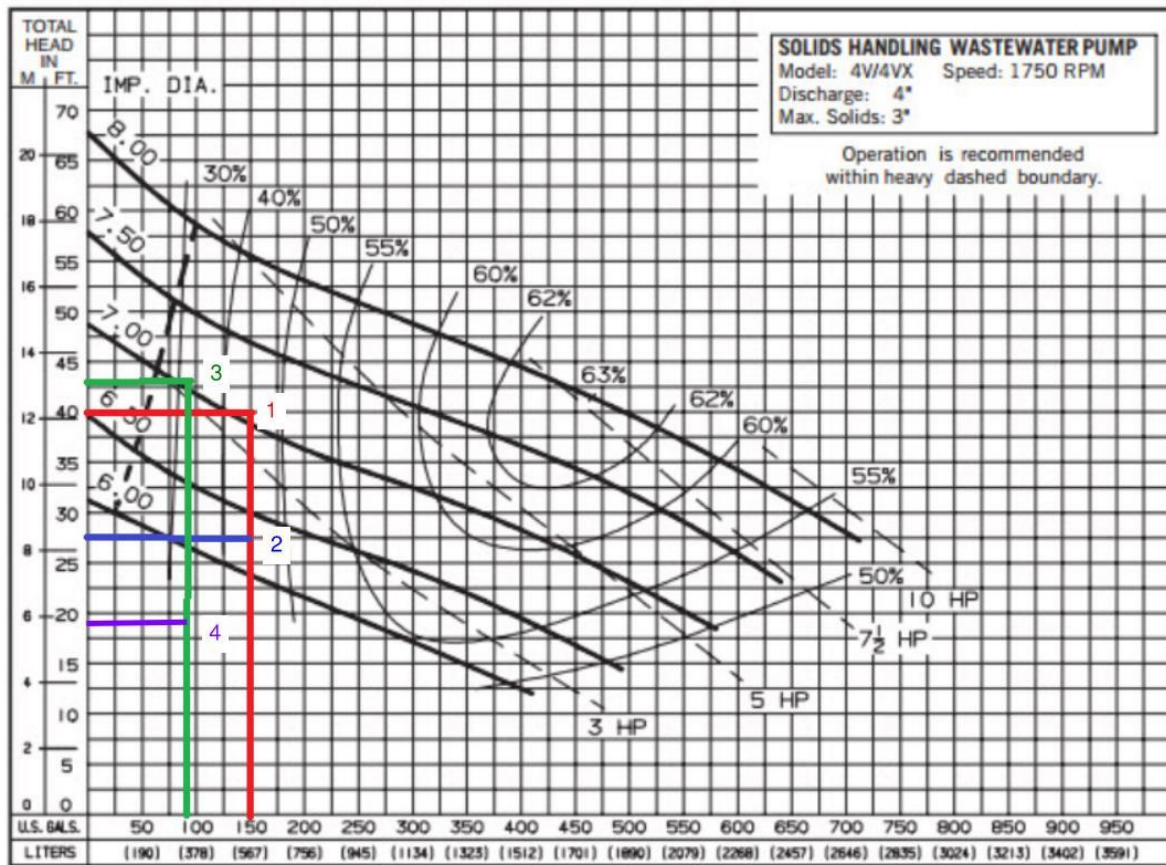
A drawdown test was conducted during the site inspection. The test revealed that the pumps are not performing to specification; the average flow rate was 5.5L/s, which is lower than expected based on the relevant pump curve (expected flow rate would be 9.5L/s). The pressure gauge (*Figure 5*, item 9) was removed prior to the inspection; therefore, a dead-head test was not conducted to confirm shut in pressure. It was noted that the gauge connection was severely corroded; thus, a gauge could not be connected.

The current pumping system is providing sufficient capacity for the area serviced. A theoretical analysis of the pump / forcemain performance based on PRRD record drawings and the pump curve shows a difference in actual performance compared to theoretical. This may be due to wear of the pump impeller, flow restriction in the forcemain or a combination of both.

Figure 8: Pump Curve Comparison – Chilton Lift Station

The total pressure head gap between points 3 and 4 and the performance gap between points 1 and 4 could be caused by:

- i. Increased roughness inside the pipe due to rust and spalling which increases flow restriction.
- ii. Wear on the impeller (according to the PRRD staff who performed regular maintenance on the pump, the two original pump impellers had signs of significant wear and had been trimmed in the past).
- iii. Sediment accumulation in the pipe, which would increase flow resistance and result in reduced flow area within the pipe (see [Section 3.3](#) for recommendations for on-going maintenance for the sewer pipe).

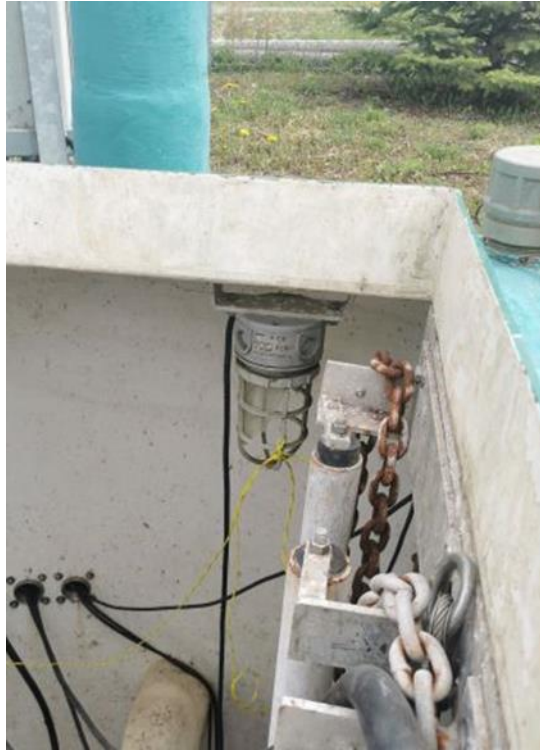
The site pictures appear to show the conduit penetrations routed to external junction boxes containing EYS seals to prevent sewer gas escape. The wiring and connections in the external junction boxes are in good condition, with the power wiring clearly labelled. It was noted that the explosion-proof fixture (the light bulb) is damaged and is an immediate hazard (*Figure 9*). McElhanney recommends repair as soon as possible.

*Figure 9: Damaged Explosion Proof Fixture (Light Bulb)*

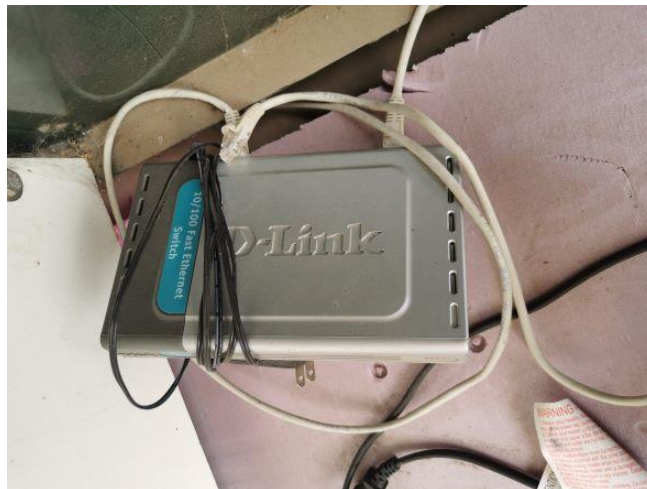
An unused residential grade ethernet switch was found lying at the base of the electrical cabinet (*Figure 10*). Decommissioned equipment should be removed to ensure staff do not think the system is operational.

*Figure 10: Un-used Ethernet Switch*

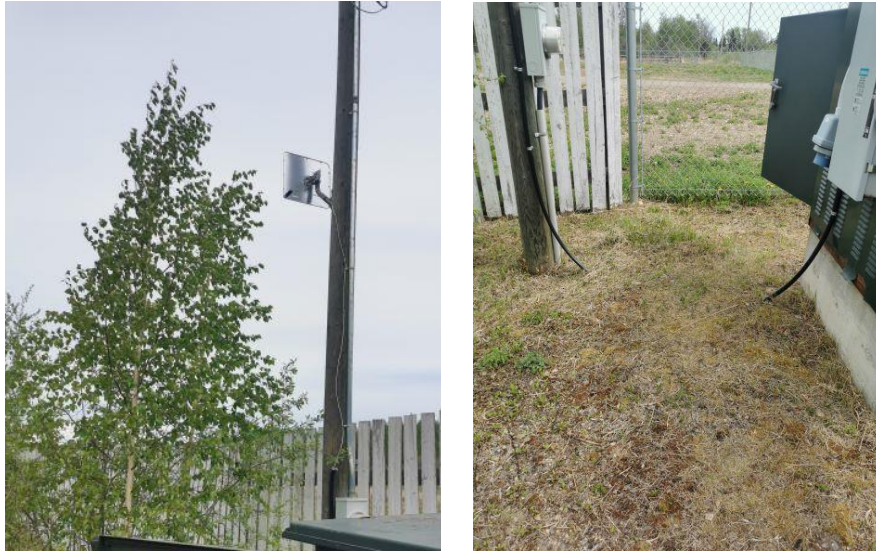
There appears to be a directional antenna installed on the wood pole with the incoming service and meter (*Figure 11*). This cable has been improperly installed and does not meet current electrical code. The antenna cabling should be replaced with a code-compliant installation.

*Figure 11: Antenna and Improperly Installed Cable*

Reinstall cabling for antenna	\$500	D	High	Cable does not meet electrical standard. See <a href="#">Section 2.2</a> .
Install a proper heating unit	\$500	D	High	The current heater is a fire hazard. See <a href="#">Section 2.4</a> .
Remove un-used ethernet switch	Nil	B	Medium	See <a href="#">Section 2.4</a> .
Tighten hinge support of hatch door	\$200	A	Low	See <a href="#">Section 2.1.1</a> .
Reinstall Pressure Gauge	\$600	A	Low	See <a href="#">Section 2.1.2</a> .
Contingency (30%)	\$6,390			
<b>2021 Total</b>	<b>\$27,690</b>

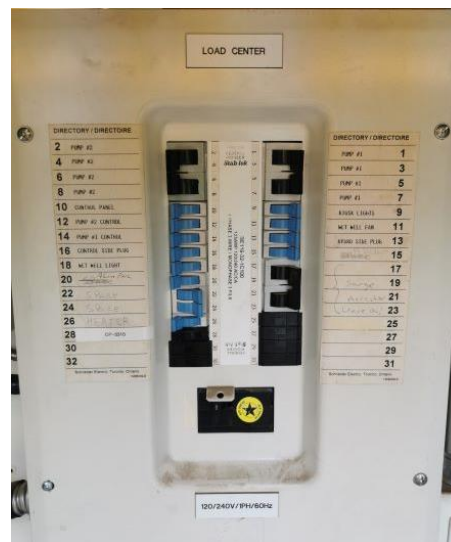
The power breaker panel is located inside the cabinet next to the PCL panel (*Figure 12*). Federal Pioneer breakers are a known fire hazard and do not operate correctly under some conditions. This panel and all associated circuit breakers should be replaced with a currently available panelboard.

*Figure 12: Electrical Panel with Federal Pioneer Breakers*

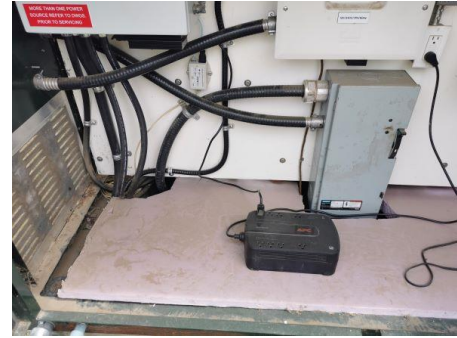
On the west side of the cabinet, cable connections and junction boxes of the electrical components were mounted on the wall at the back of the control panels. At the bottom of the cabinet, a residential grade computer Uninterrupted Power Supply (UPS) is used for backup power (*Figure 13*). There is no monitoring of this UPS system, which could fail at any point. In addition, it may not provide proper equipment protection compared to a UPS suitable for this type of installation (i.e. Liebert GXT5 series or Eaton Powerware 9SX series). Replacement with a municipal quality UPS is recommended.

*Figure 13: Residential Grade UPS*

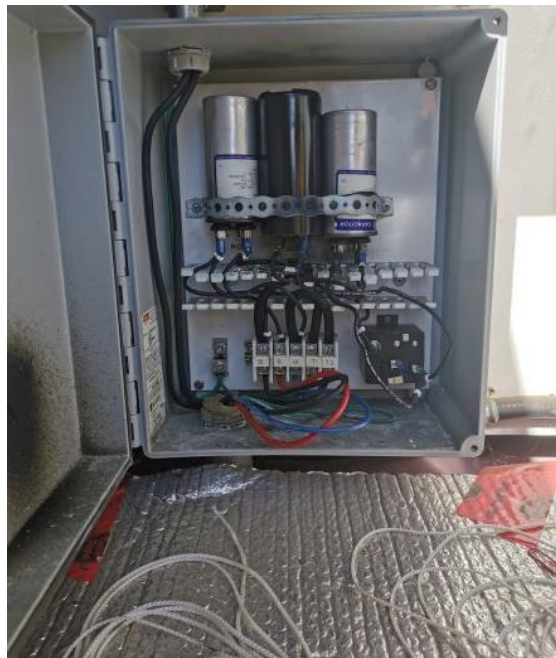
As described in *Section 2.1.3*, the capacitors in the power factor correction cabinet appear to have experienced catastrophic failure in the past and have been replaced (*Figure 14*). Based on the age of the facility and the previous capacitor failure, it is anticipated that another failure is likely. A surge protector should be installed to avoid re-occurrence.

*Figure 14: Capacitor Cabinet with Burn Mark*

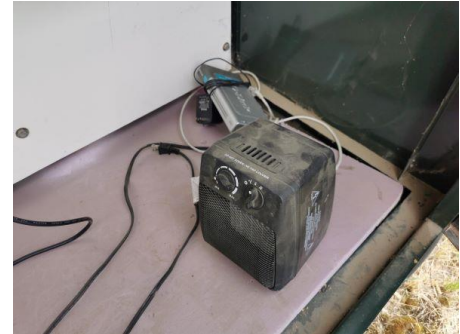
At the bottom of the cabinet on the back side of the control panels (west side), there is a plug-in ceramic heater used to maintain temperature in the cabinet (*Figure 15*). This is a fire hazard as the heater could be placed in front of flammable material or fall over. It should be replaced with a properly sized and installed heating unit.

*Figure 15: Plug-in Ceramic Heater*

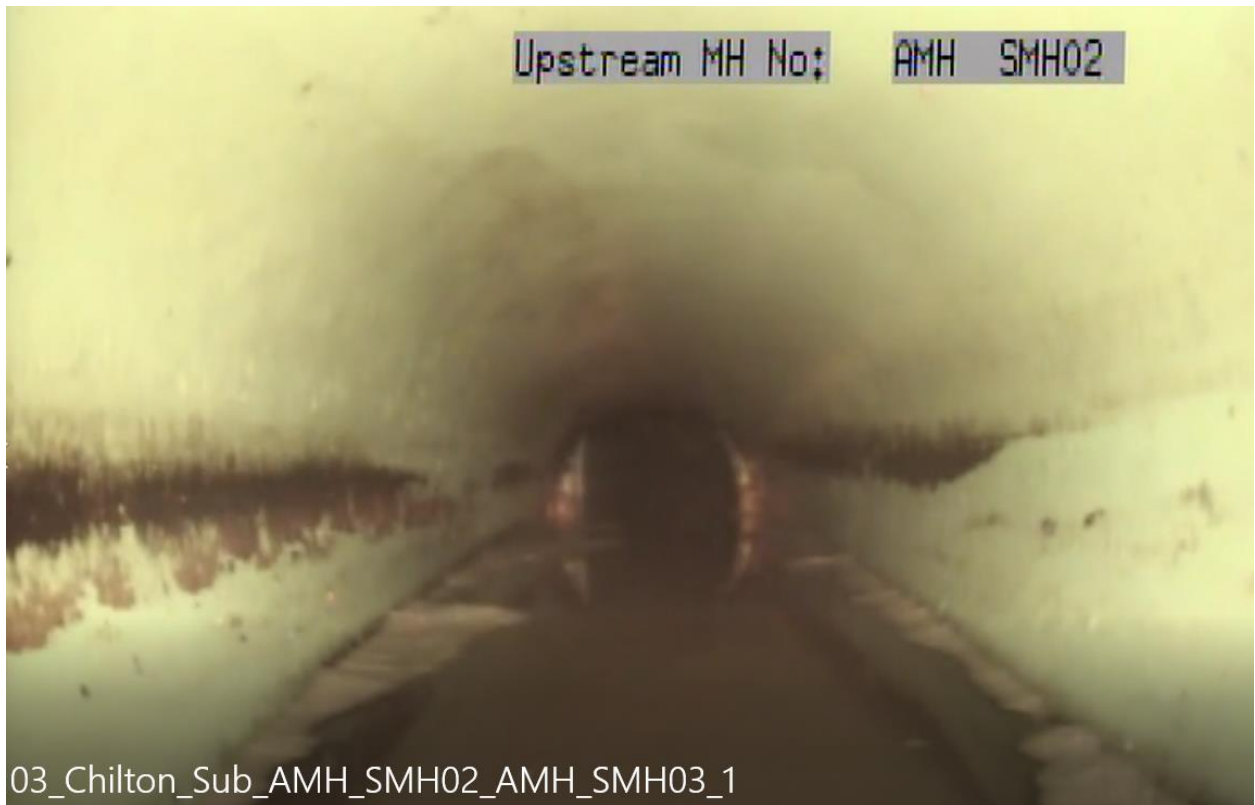
- SMH-01 to SMH-02, 200mm PVC: Pipe in good condition, no defects of note.
- SMH-02 to SMH-03; 200mm PVC: Survey abandoned due to underwater camera with pipe 80% to 100% full of water (with dry sections before and after) indicating large sags in the pipe grade as seen in [Figure 16](#).

*Figure 16: Sags in Pipe Grade Causing Standing Water between SMH-02 and SMH-03*

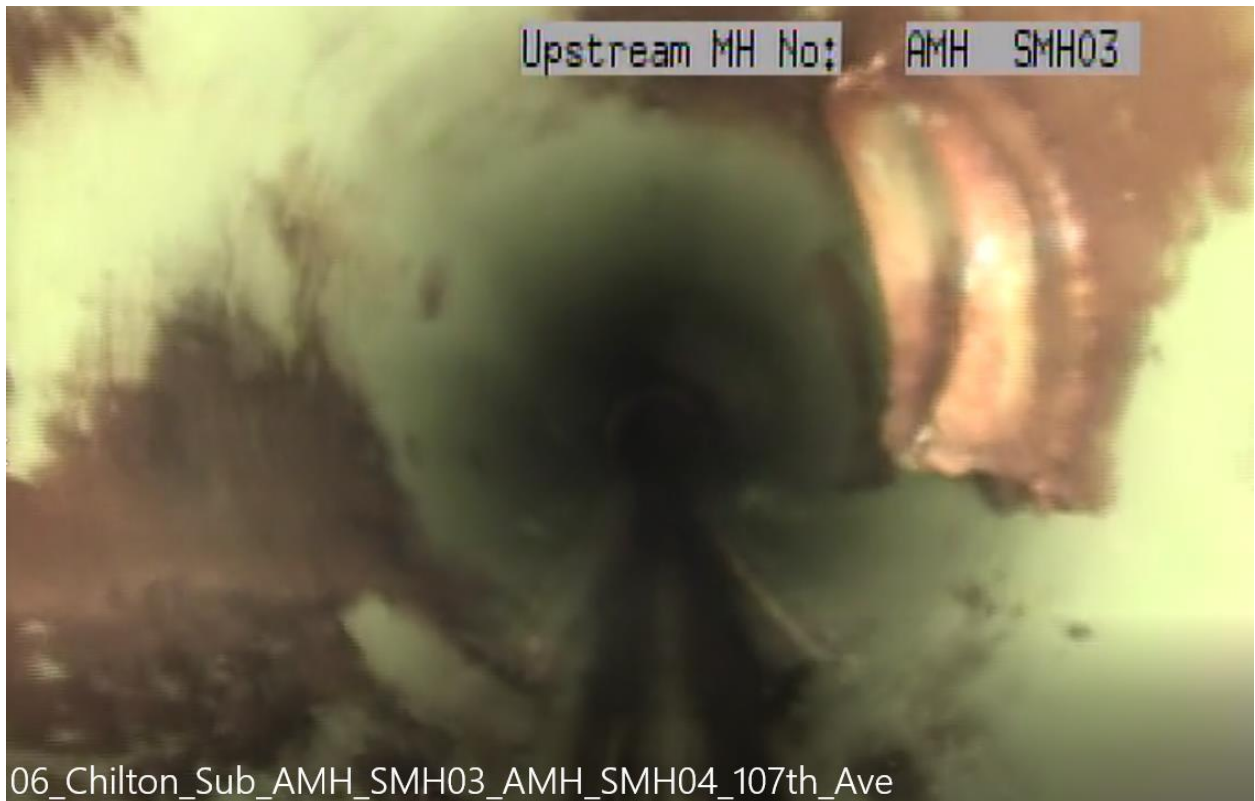
- SMH-03 to SMH-04; 200mm PVC: Several intruding service leads, including an intruding saddle causing the CCTV investigation to be abandoned, as seen in [Figure 17](#). The saddle appears to be installed correctly, but the service is intruding enough to require abandoning the survey and approach from the downstream manhole. There is also a moderate severity infiltration leak and attached deposits at the interface of manhole SMH-04 and the sewer main.

*Figure 17: Intruding Service Caused CCTV Inspection to be Abandoned; Service Installed Correctly and Not Defective*

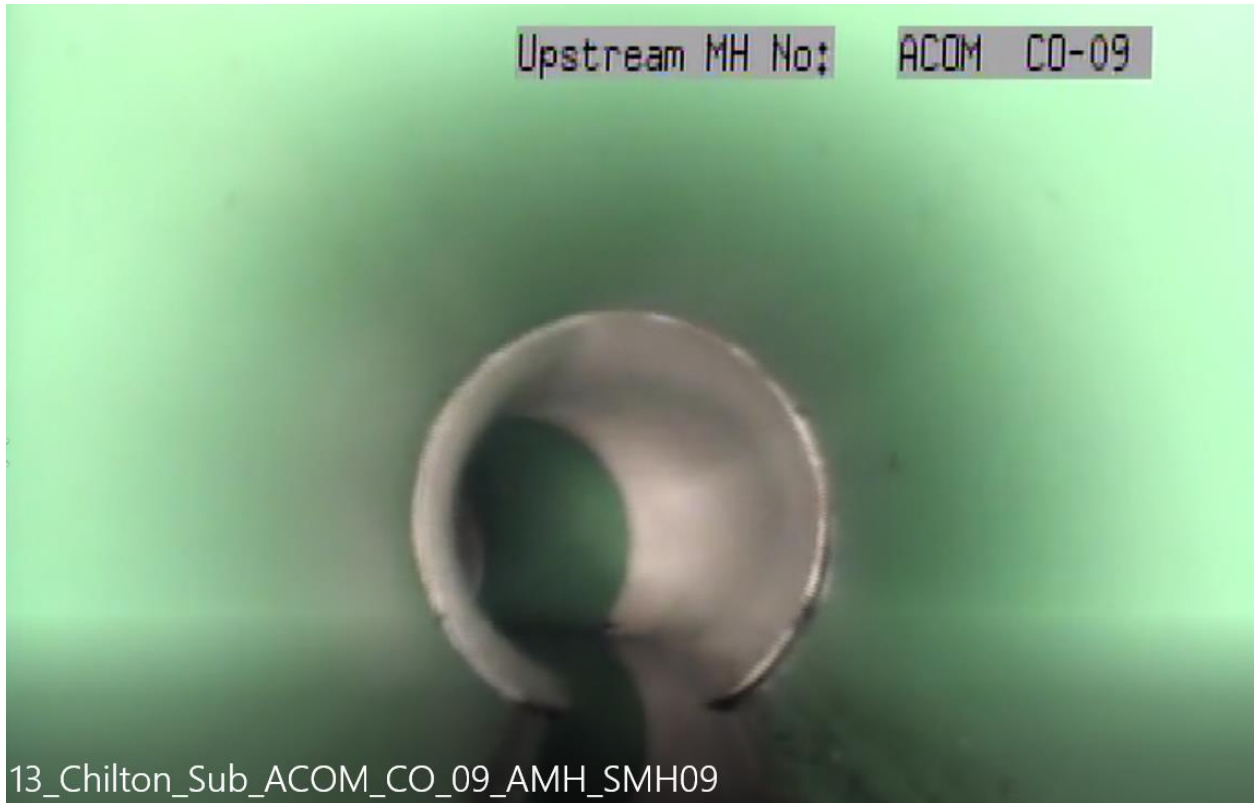
- SMH-09 to SMH-08, 150mm PVC: Pipe is in fair condition. Some sections of increased water level to approximately 20%, indicating minor sags in the pipe grade. Pipe was unable to be surveyed beyond the first cleanout as the pipe was not accessible due to bends in the pipe mainline as seen in [Figure 18](#).

*Figure 18: Bends in Pipe in Mainline Prevented CCTV Camera Survey*

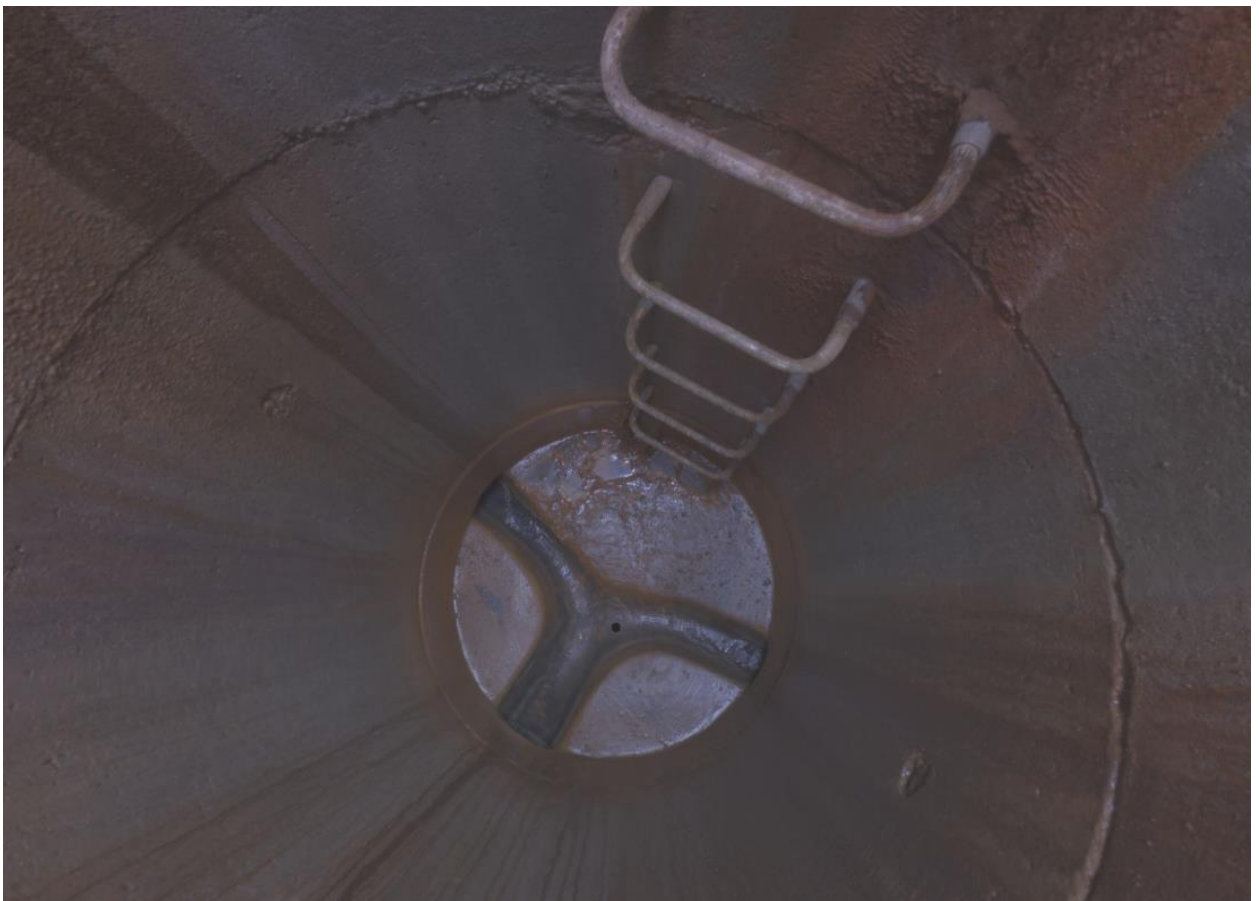
- SMH-01, 1050mm concrete manhole: Manhole in good condition. Some minor infiltration staining and encrustation near the manhole base joint, as seen in [Figure 20](#).

*Figure 20: Some Minor Infiltration Staining and Encrustation in SMH-01*
