PEACE RIVER
REGIONAL DISTRICT

KELLY LAKE SEWER SYSTEM CONDITION ASSESSMENT

KELLY LAKE SEWER SYSTEM CONDITION ASSESSMENT NOVEMBER 2021 FINAL REPORT

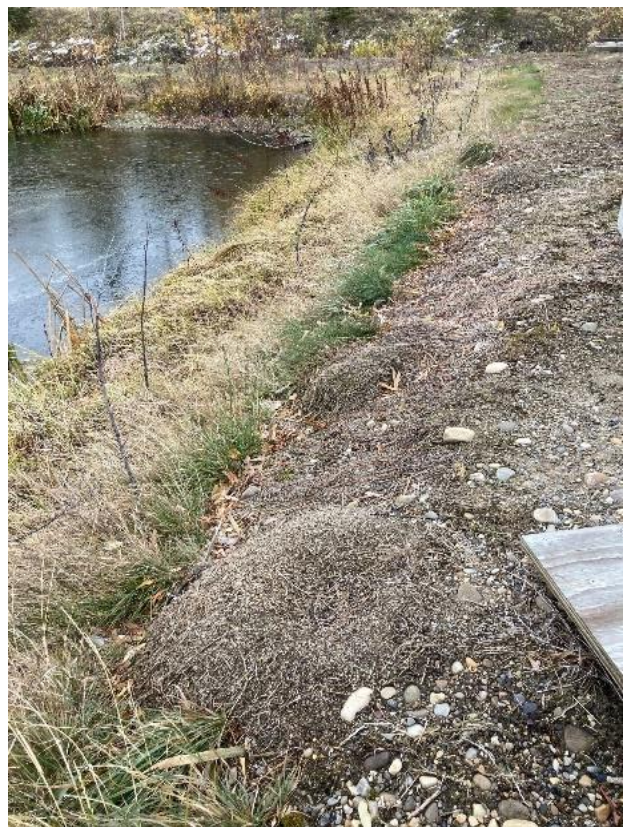
Figure 2: Muskrats Burrows between cell 4 & 5

Numerous muskrats' burrows have been seen on the edges of the various lagoons and along the access roads. This is not causing any functional or structural problems at this time but should be monitored as the accumulation of these could cause the edges to become brittle and lead to the collapse of the roads especially between the cells 3 and 4 where the berm is already unstable and cannot allow heavy rolling equipment to access. Furthermore, this passage is not level and should be reconditioned.

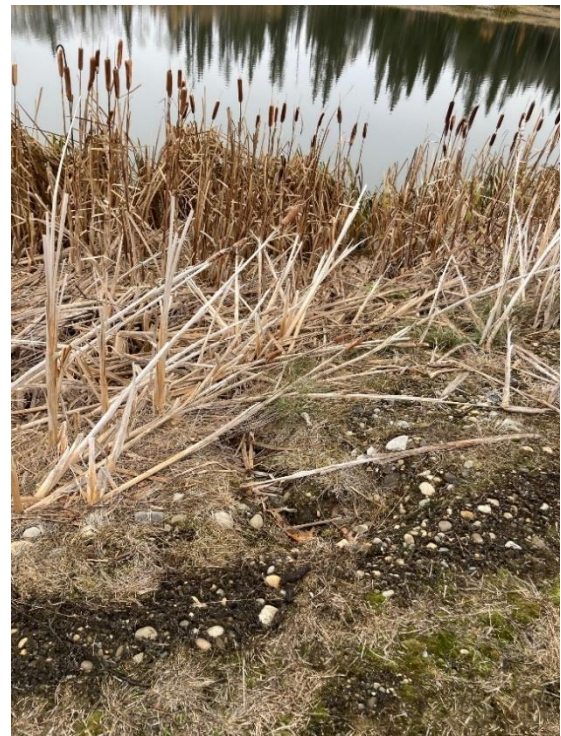
Figure 4: Crevasses between Cell 3 & 5

Repeated overflowing of lagoon 3 has created crevasses as well as a slight subsidence of the road. It is advisable to proceed to a sludge measurement on cells 1, 2 and 3 to evaluate if the design capacity is still maintained and prevent further overflow. In addition, the level of pond 3 should be lowered regularly in anticipation of the high rainfall seasons.

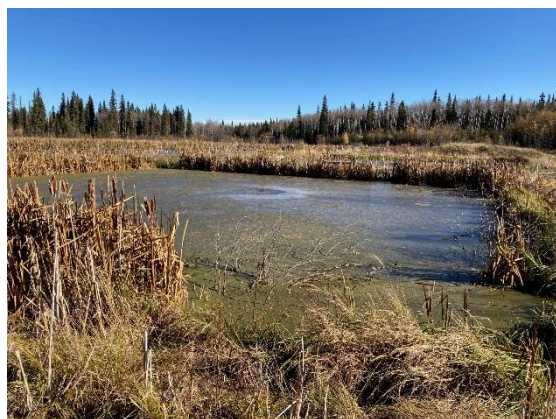
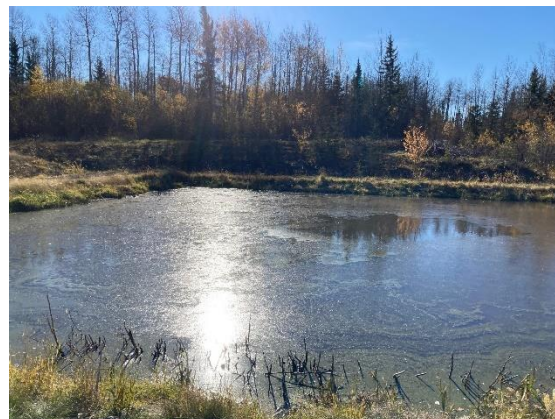
Figure 5 : Cell 1 and Cell 2

The levels of the lagoons observed are within acceptable ranges. Nevertheless, it seems that cell 3 is regularly overflowing. A sludge measurement by sludge judge is recommended for cells 1, 2 and 3.

Recommendations				
Item	Repairs	1-3 years	3-5 years	Estimated Replacement Cost
East Berm of Cell 5	Re-sloping or repacking. Could be part of a larger rehabilitation of the lagoon in the next 15-20 years.		\$50,000 - \$100,000	N/A
Sludge	Sludge Judge	\$3,500		N/A

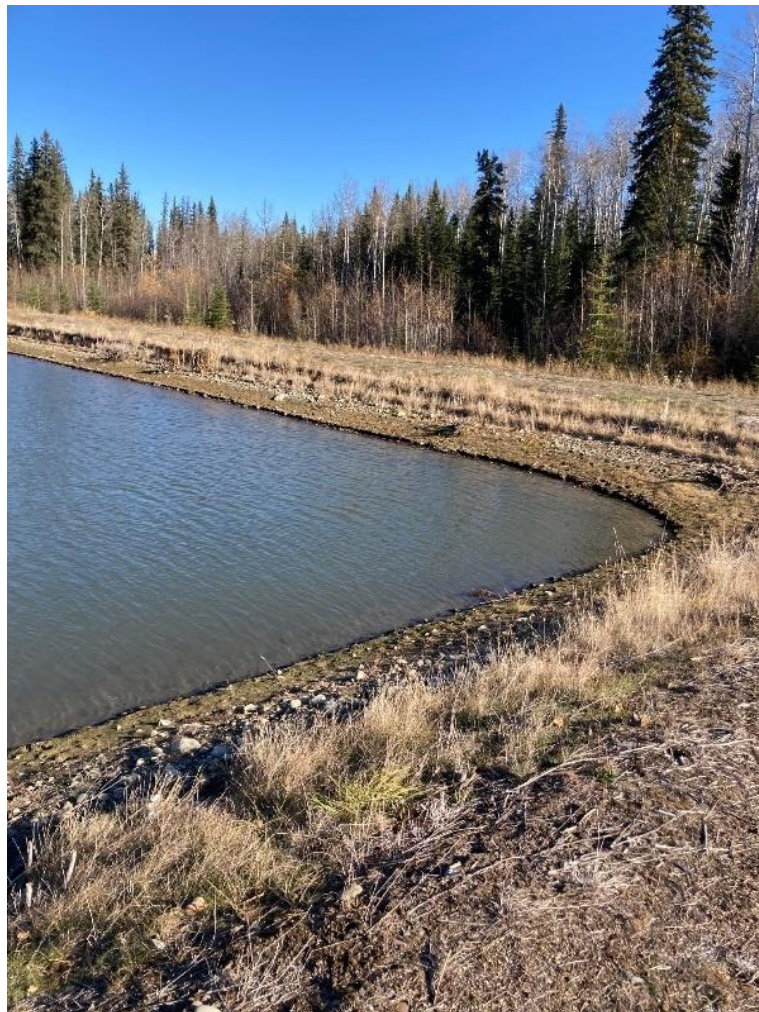
Figure 7 : Cell 5 berm

The berms of the different cells are in average to poor condition. In addition to muskrat burrows and uncontrolled vegetation, there is a strong degradation of the berm slope, especially on the eastern side of lagoon 5. The clay layer is uneven and may result in infiltration and increase risk of collapsing from the surrounding roads.
