Peace River Regional District

**Facility Condition Assessment Report
Charlie Lake Fire Hall**

November 18, 2021

Prepared by:
FCAPX a Division of Roth IAMS
Project No. 21075
www.fcapx.com

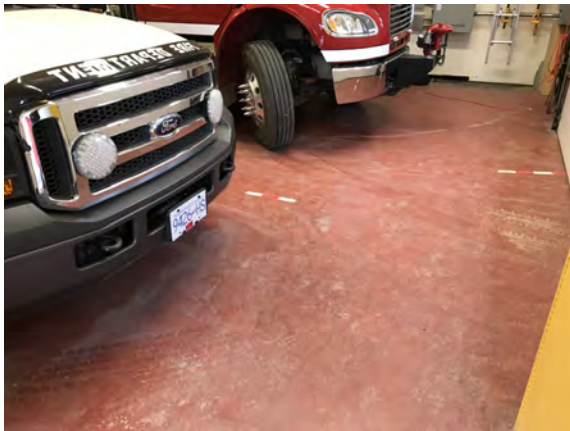
Charlie Lake Fire Hall - A103001

There are some localized cracks and uneven surfaces in the building. A repair allowance has been included herein to repair these areas. The remaining useful life has been left unchanged with the assumption that repairs are completed.

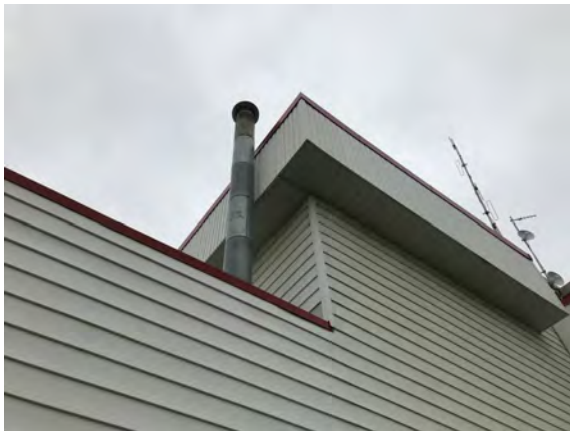
Charlie Lake Fire Hall - B201008

No major deficiencies were observed or reported during the assessment. Gaps were observed in some areas around lights. Also missing soffit on second floor around downspout. It is recommended these gaps be sealed to minimize the risk of pest infestation. Repair as part of maintenance.

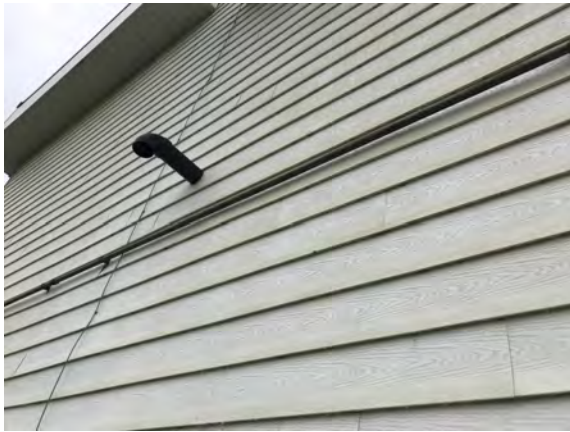
Charlie Lake Fire Hall - B201025

The siding was observed to be generally performing as intended, although sections of damaged and missing siding were noted, along with isolated buckling and stained surfaces. Based on age and observed conditions, short-term replacement is recommended to maintain the performance of the building enclosure, and the building's external aesthetic appeal. In the interim, missing sections of siding are recommended for replacement to mitigate the risk of moisture infiltration.

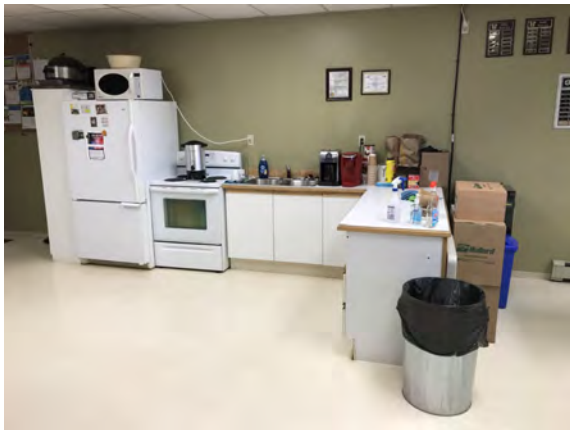
Charlie Lake Fire Hall - C103009

While generally performing as intended, the casework exhibited evidence of wear that is consistent with its age. Lifecycle replacement is recommended in the short-term of the evaluation period.

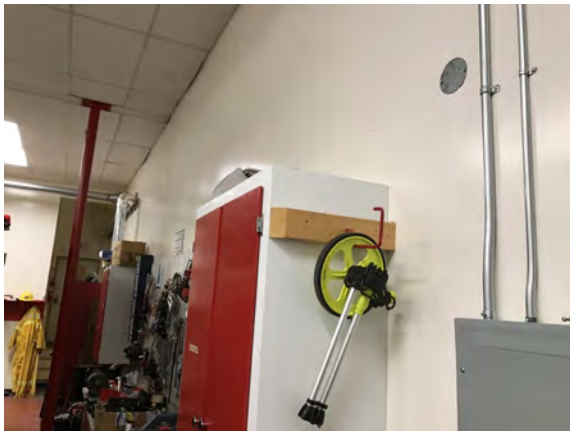
Charlie Lake Fire Hall - C103011

No major deficiencies were observed or reported. The cabinetry observed to be dated. The component will reach its expected useful life, although its remaining useful life has been extended to a later year due to the absence of significant observed or reported deficiencies.

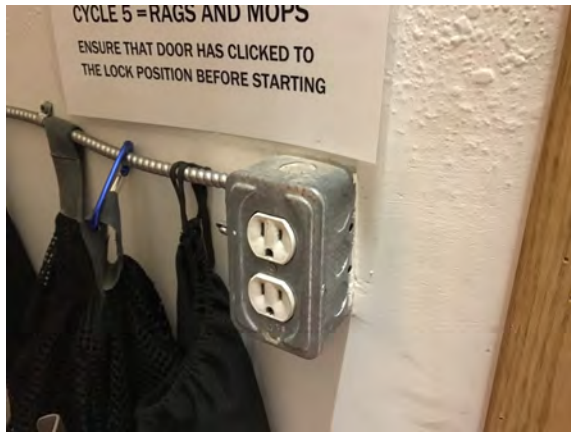
Charlie Lake Fire Hall - D502001

No major deficiencies were observed or reported during the assessment. however, some plugs over sinks did not appear to have ground fault protection. It is recommended to provide GFCI protected plugs over sinks. The cost complete with work is presumed to fall below the cost for repair threshold (\$5,000) and should therefore be completed as a maintenance activity.

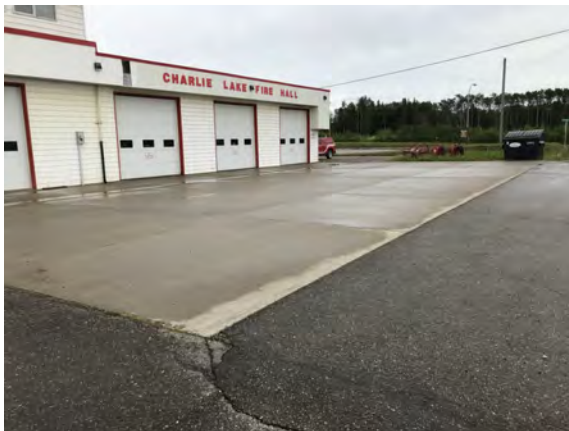
Charlie Lake Fire Hall - G201023

No major deficiencies were observed or reported during the assessment. Site personnel expressed concerns regarding settlement in the compound that may affect the asphalt and gravel yard. In addition, there is reportedly settlement and frost heave at the Main Entry door which is setting off the alarm. An allowance for an engineering study has been provided along with an allowance for repairs. The repair allowance is a placeholder value only. Repair costs will be based on the results or recommendations in the study.
