**Peace River Regional District**

**Facility Condition Assessment Report  
Moberly Lake Fire Hall**

**November 17, 2021**

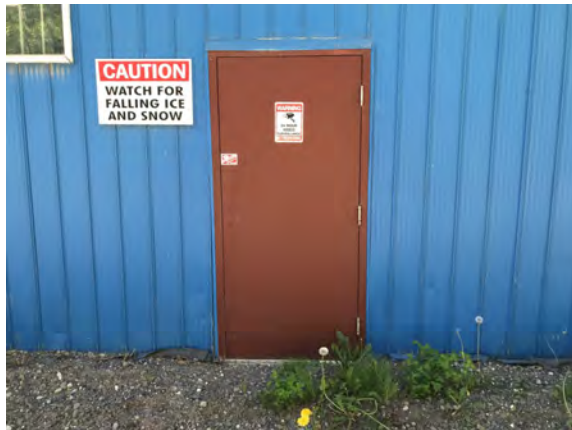
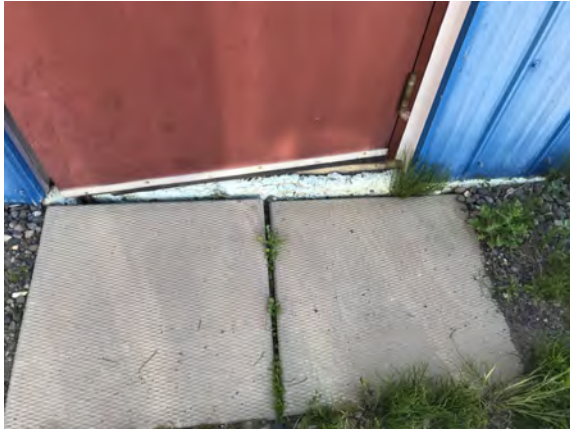
Moberly Lake Fire Hall - B203023

No major deficiencies were observed or reported, however, some doors are marked as exit doors, yet do not have panic hardware. It is recommended to install panic hardware on these doors to meet requirements for emergency exit doors. The cost to complete these repairs is presumed to fall below the cost threshold for repair recommendations (\$5,000) and should be completed as a routine maintenance activity. Doors were installed between 1983 and 1999. The components have surpassed their expected useful life, however, the Remaining Useful Life has been extended to a later year based on the absence of significant deficiencies.

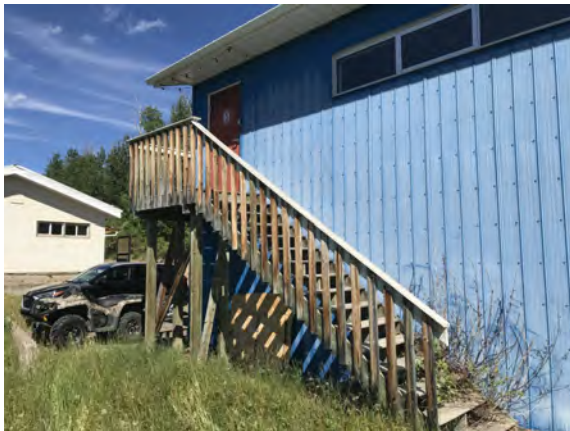
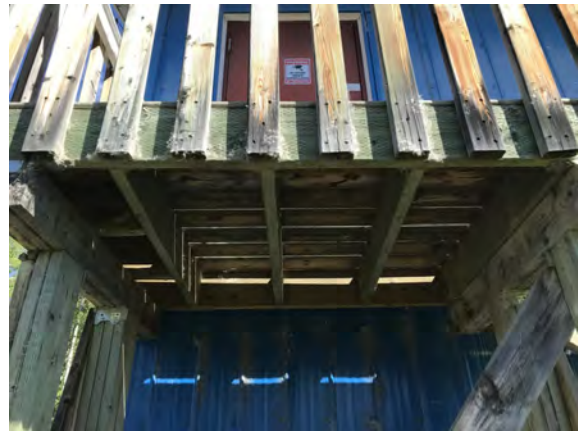
Moberly Lake Fire Hall - C201026

No major deficiencies were observed or reported during the assessment, however, it is recommended to paint the stairs to preserve the wood finish. The cost adjustment factor has been decreased to account for the wood construction.

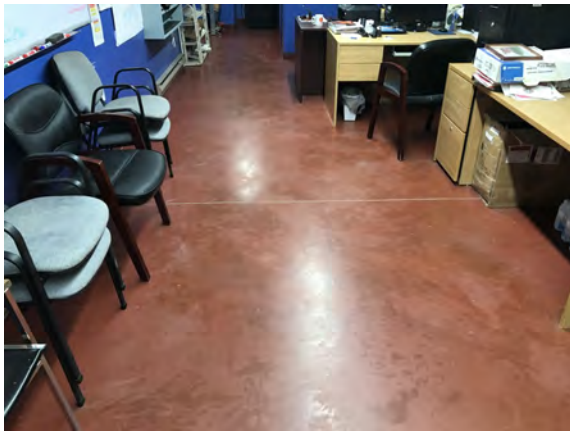
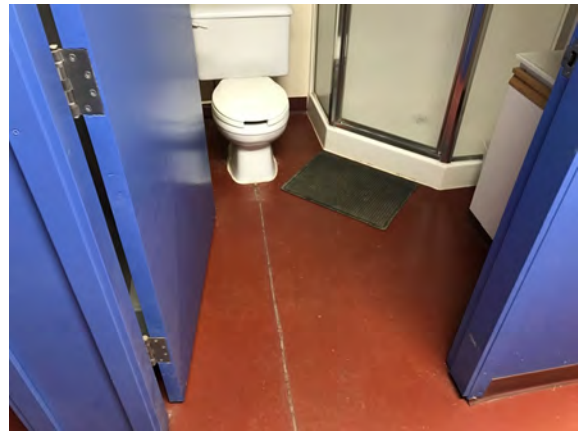
Moberly Lake Fire Hall - C302023

The flooring has exceeded its expected useful life and is exhibiting wear and tear that is consistent with age including separating at seams, lifting, and worn finishes in high traffic areas. Lifecycle replacement is recommended.

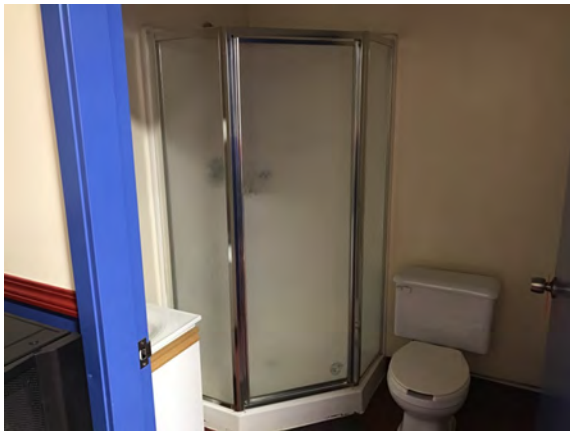
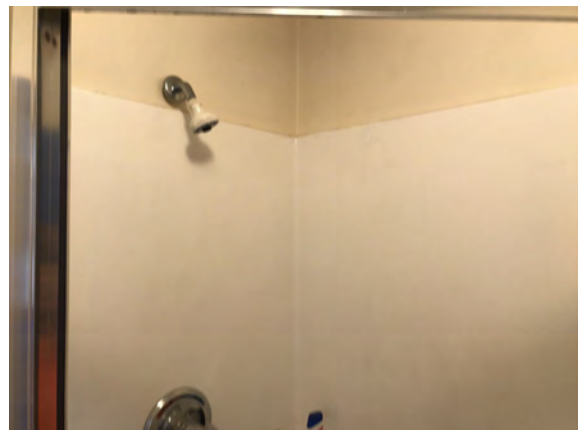
Moberly Lake Fire Hall - D201012

The components have surpassed their expected useful life, however, due to limited or less than average use, they remain in good condition. Remaining Useful Life has been extended to a later year based on the absence of significant deficiencies.

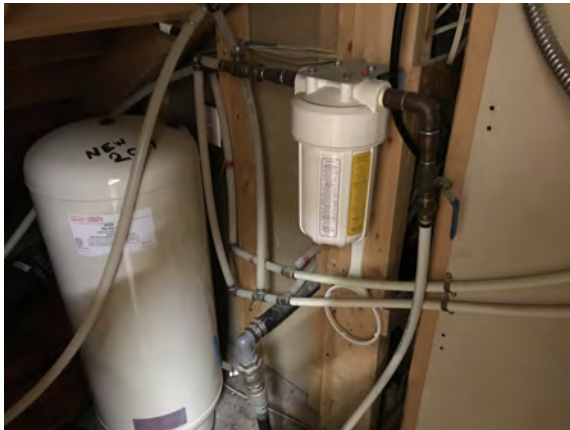
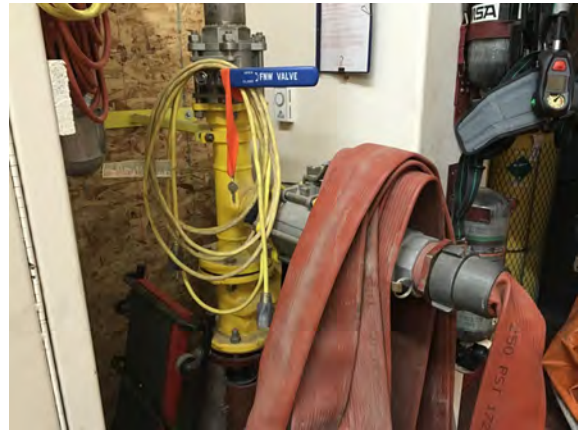
Moberly Lake Fire Hall - D202001

No major deficiencies were observed or reported. A large portion of the domestic water piping was replaced in 2017. The components have surpassed their expected useful life, however, the Remaining Useful Life has been extended to a later year based on the absence of significant deficiencies.

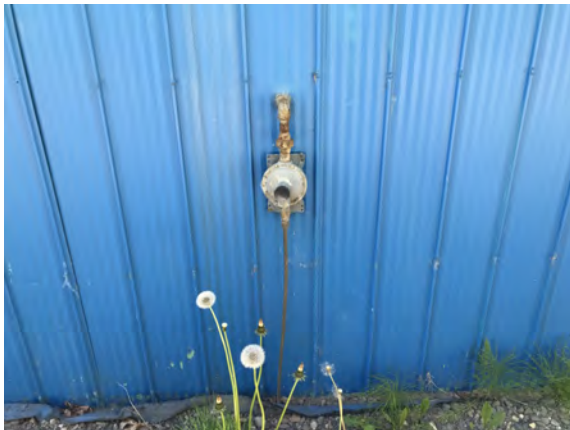
Moberly Lake Fire Hall - D203001

No major deficiencies were observed or reported, however, exterior sections of gas piping should be inspected/tested by a qualified technician due to the presence of oxidation on the piping. Once inspected/tested, piping should be repainted as a maintenance activity. The cost to assess/test and repaint exterior sections of piping is presumed to fall below the cost threshold for repair recommendations (\$5,000) and should therefore be completed as a maintenance activity. In the absence of significant deficiencies being observed or reported, lifecycle replacement has been deferred. The exterior propane tank is utility-owned and operated and is not included within this report. The cost adjustment factor has been reduced to account for the limited amount of gas-fired equipment.

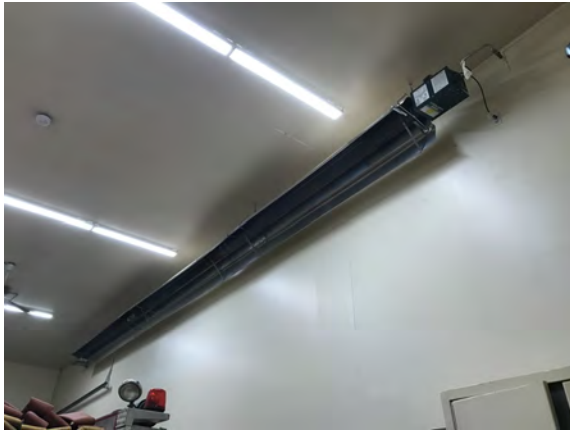
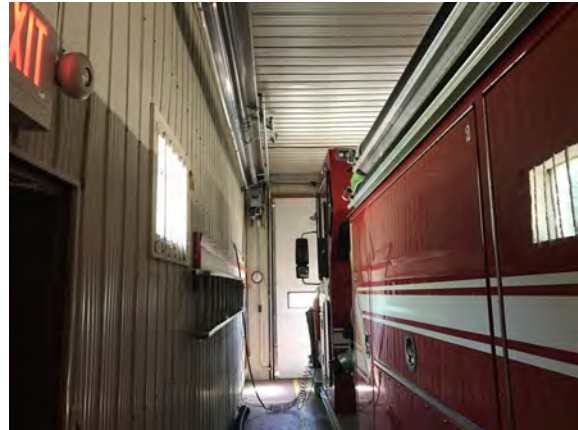
Moberly Lake Fire Hall - D302032

No major deficiencies were observed or reported, however, the equipment has exceeded its expected useful life and therefore has a higher likelihood of failure. Lifecycle replacement is recommended.

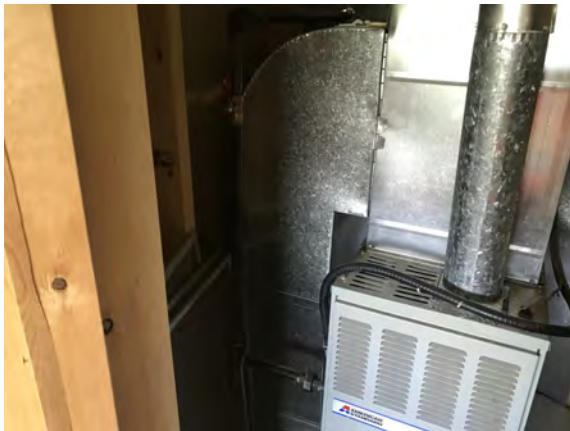
Moberly Lake Fire Hall - D304001

No major deficiencies were observed or reported. There was a noted lack of make-up air and exhaust systems present in vehicle bays. It is recommended to consult with local authorities having jurisdiction to ensure that existing infrastructure provides adequate airflow/air exchange in vehicle bays.

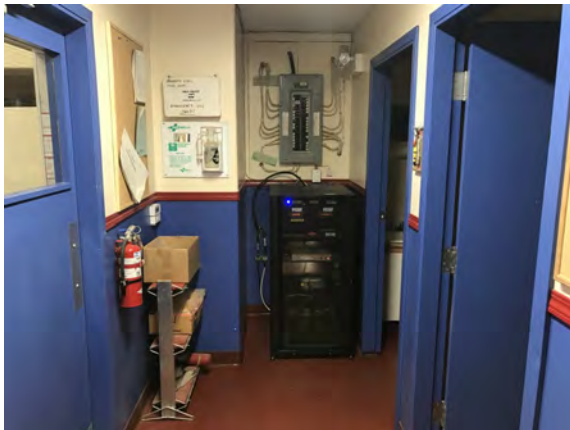
Moberly Lake Fire Hall - D501005

No major deficiencies were observed or reported, however, the panel is blocked by server equipment. Server equipment should be relocated as a maintenance activity.

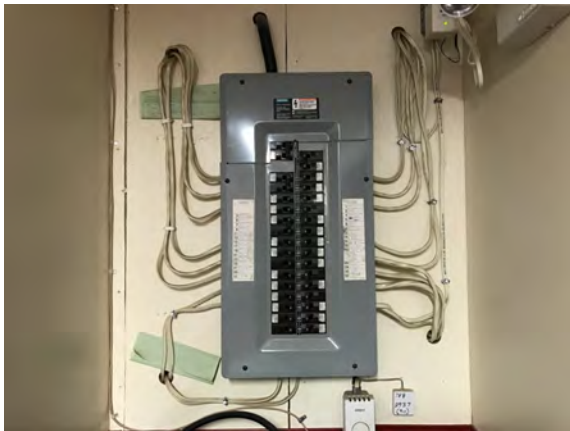
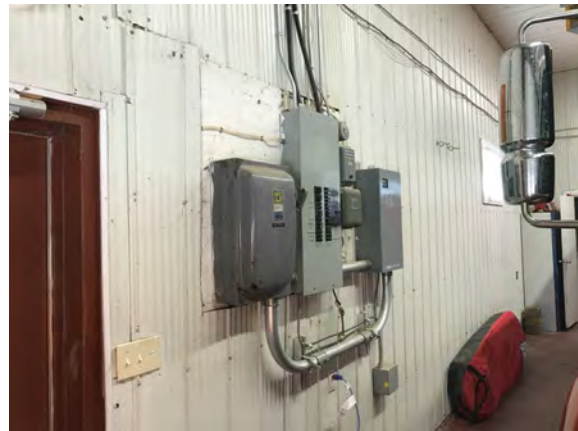
Moberly Lake Fire Hall - D502001

No major deficiencies were observed or reported, however, the plug installed over the sink in the kitchen should be replaced with a GFCI rated plug as a maintenance activity.

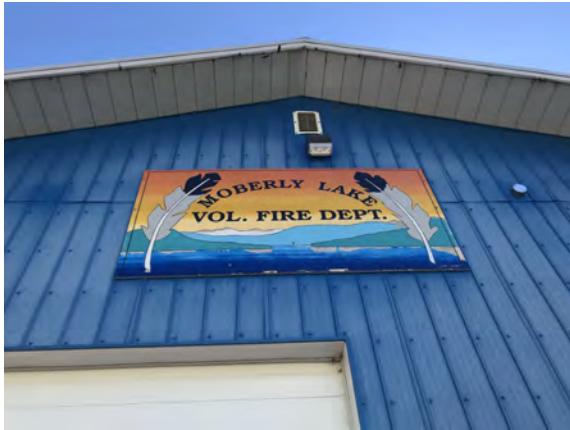
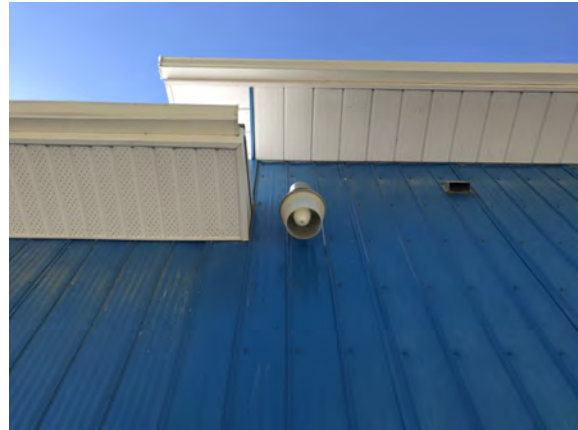
Moberly Lake Fire Hall - D502041

No major deficiencies were observed or reported, however, the remaining incandescent fixtures should be replaced with LED as a routine maintenance activity.
