Peace River Regional District

**Facility Condition Assessment
Report Cache Creek Community
Hall**

November 16, 2021

Prepared by:
FCAPX a Division of Roth IAMS
Project No. 21075
www.fcapx.com

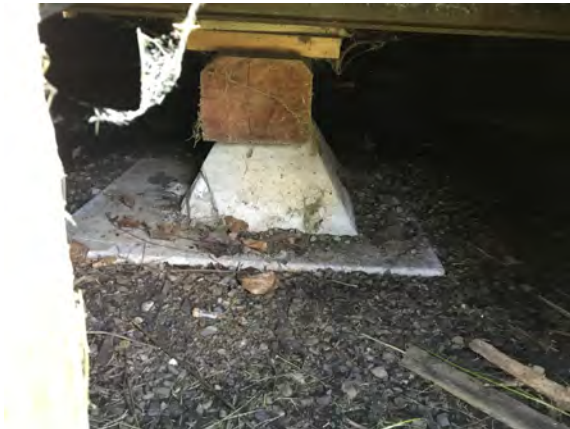
Cache Creek Community Hall - A101001

While the majority of this system is concealed by perimeter skirting, a visible section showed the facility bearing on a pre-cast concrete block and what appears to be a precast concrete paver. It is assumed based on the suspected age of the materials, that this was a recent repair. Based on areas of deterioration and rot visible on the above-grade structure, it is likely that the same issues extend to the wood foundation elements. An engineering study is recommended to investigate the integrity of the building structure and foundations. A placeholder repair has been provided, pending results of the study. The remaining useful life has been left unchanged with the assumption that an engineering study and repairs are completed.

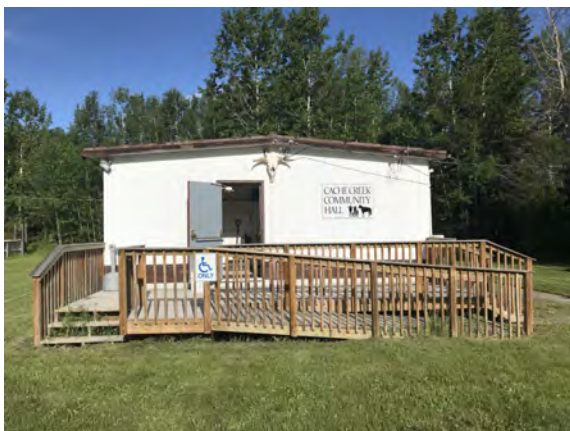
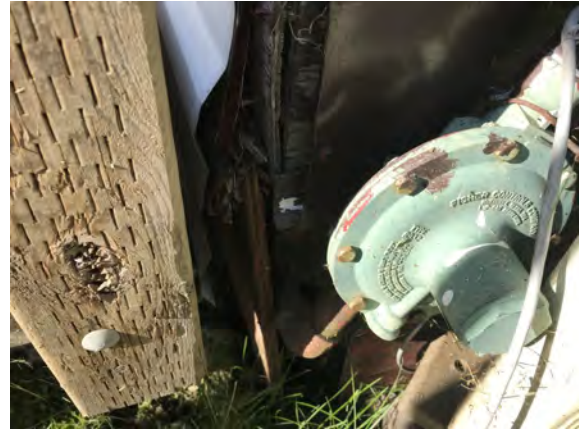
Cache Creek Community Hall - B103001

Where visible on the northeast corner, wood framing and plywood cladding were observed to be rotted and deteriorated. An engineering study is recommended under A101001 - Standard Foundations to investigate the integrity of the building structure and foundations. A placeholder repair has been provided herein, pending results of the study. The remaining useful life has been left unchanged with the assumption that an engineering study and repairs are completed.

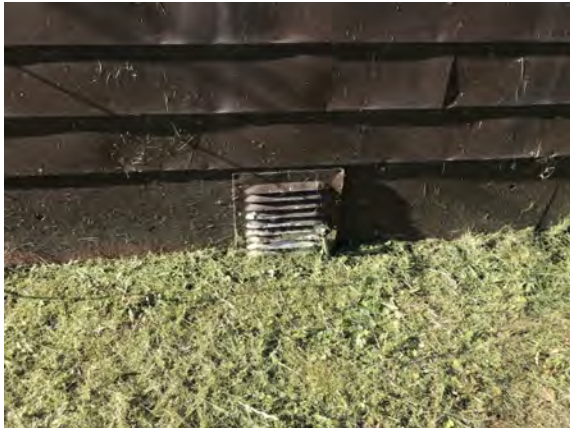
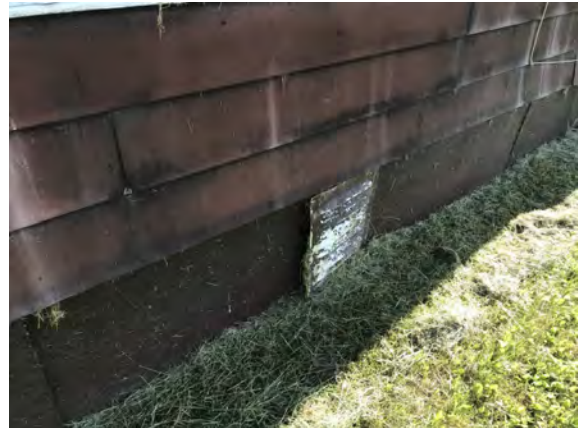
Cache Creek Community Hall - B201005

Grilles were rusted and coming loose from the wall. Some louvres were bent. Lifecycle replacement is recommended within the short-term of the evaluation period.

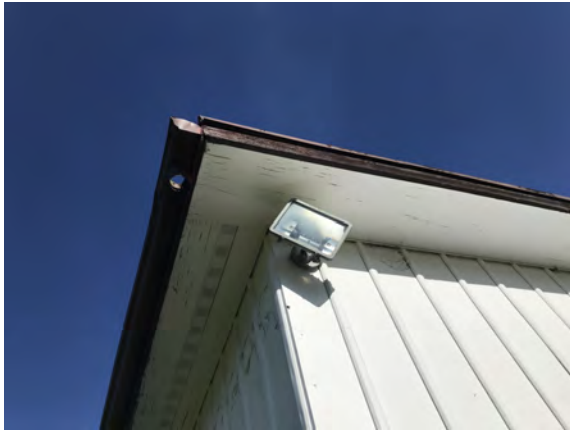
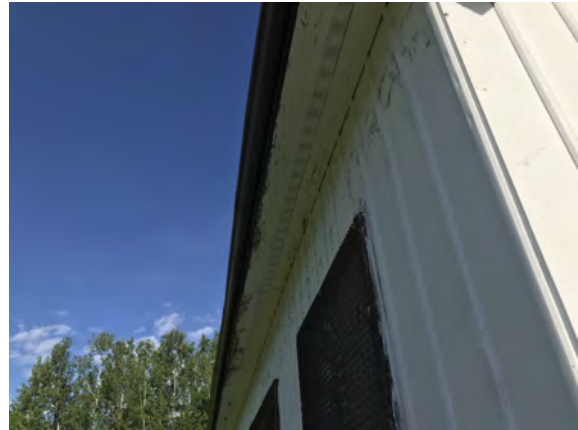
Cache Creek Community Hall - B201008

Soffits were observed to have peeling paint and evidence of rot. Lifecycle replacement is recommended within the short-term evaluation period. The difficulty factor has been increased to account for the small quantity.

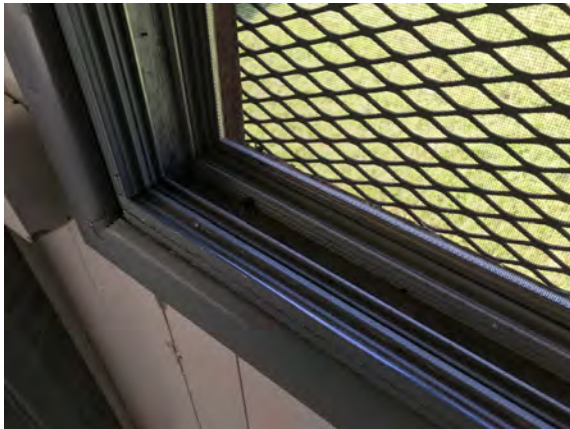
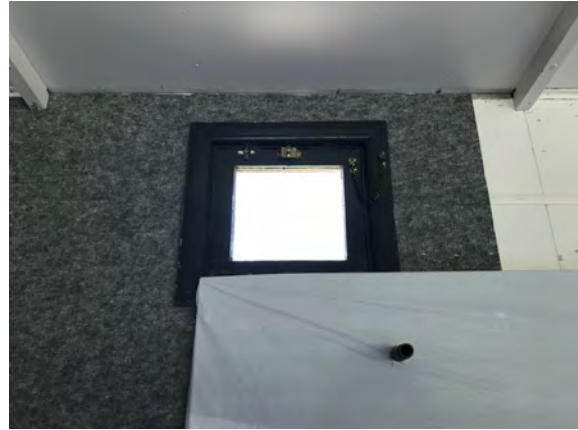
Cache Creek Community Hall - B202001

Windows are reportedly drafty in cold weather and are stiff to operate. Windows have exceeded their expected useful life and are exhibiting wear and tear that is consistent with age. Lifecycle replacement is recommended within the short-term of the evaluation period.

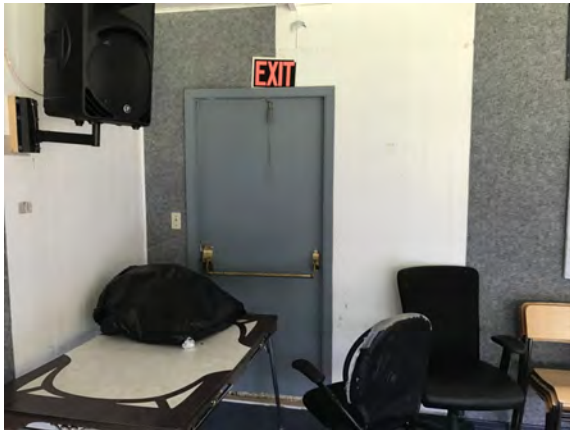
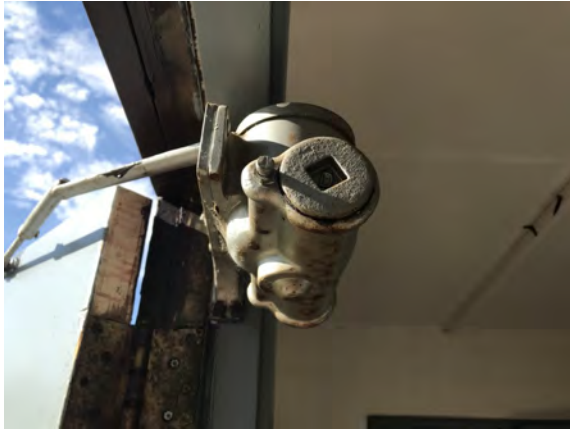
Cache Creek Community Hall - B203024

Door frames were observed to have visible staining and rot. Door panels were beginning to separate and crack at the base. The door closer on the north door has been removed and the closer on the east door is stiff to operate and has evidence of past or present hydraulic oil leaks. Lifecycle replacement within the short-term of the evaluation period is recommended. Objects were observed to be blocking emergency exit paths and egress doors. Items should be removed from the exit pathway immediately.

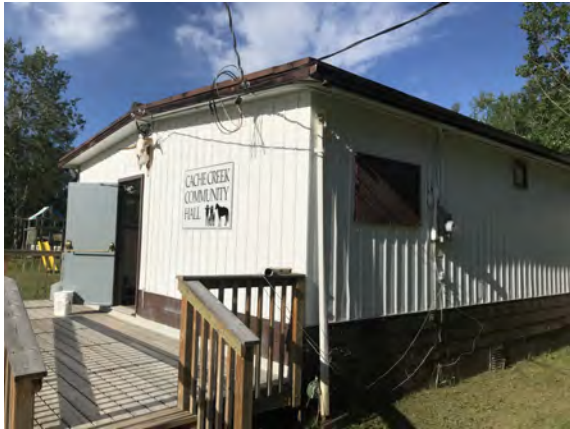
Cache Creek Community Hall - B301005

No major deficiencies were observed or reported, however, downspouts were not properly affixed to gutters. Downspouts should be refastened as a routine maintenance activity. The component has exceeded its expected useful life, although its remaining useful life has been extended to a later year due to the absence of significant observed or reported deficiencies.

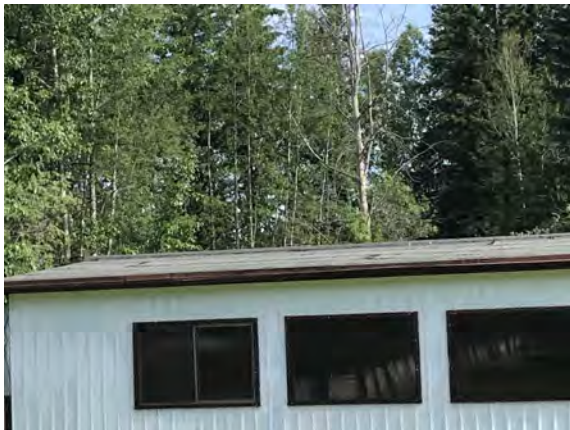
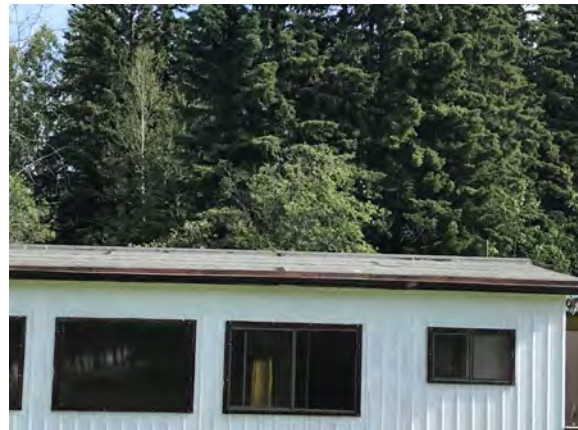
Cache Creek Community Hall - B301022

The roof was not accessible at the time of review, however, when viewed from ground level it exhibited wear and tear that is consistent with age. While there are no reported leaks, based on age and observed condition, lifecycle replacement is recommended within the short-term of the evaluation period.

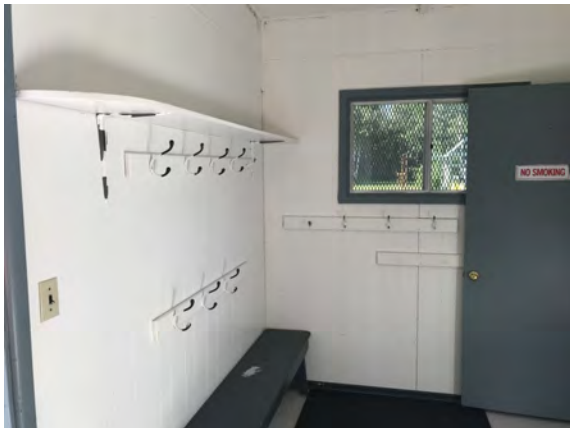
Cache Creek Community Hall - C101001

No major deficiencies were observed or reported. The difficulty factor has been decreased to account for the limited number of interior partitions. Based on the construction year it is recommended to undergo hazardous materials testing prior to initiating any repair/replacement activities, as a precautionary measure.

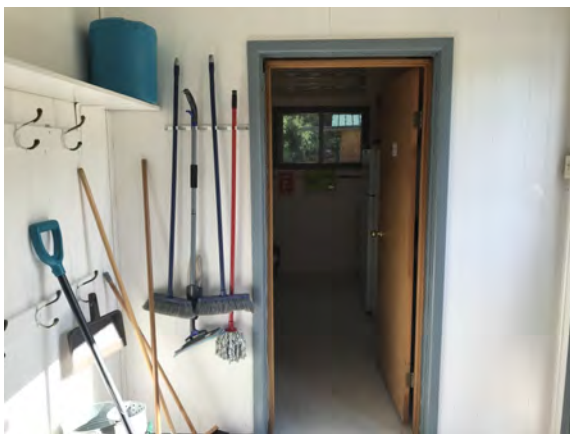
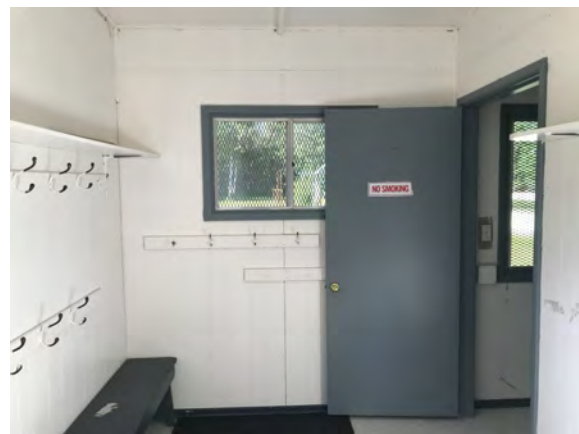
Cache Creek Community Hall - C102022

No major deficiencies were observed or reported.

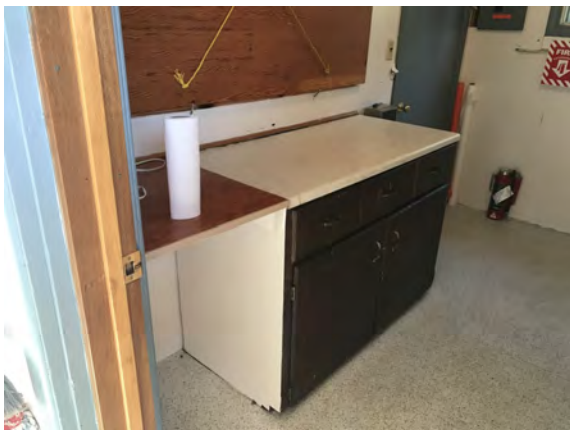
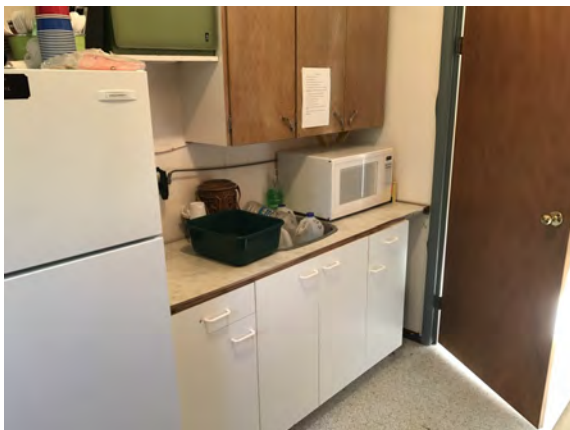
Cache Creek Community Hall - C103009

Countertops had laminate finishes missing or peeling in spots. Cabinets have exceeded their expected useful life and are exhibiting wear and tear that is consistent with age. Lifecycle replacement is recommended within the short-term of the evaluation period.

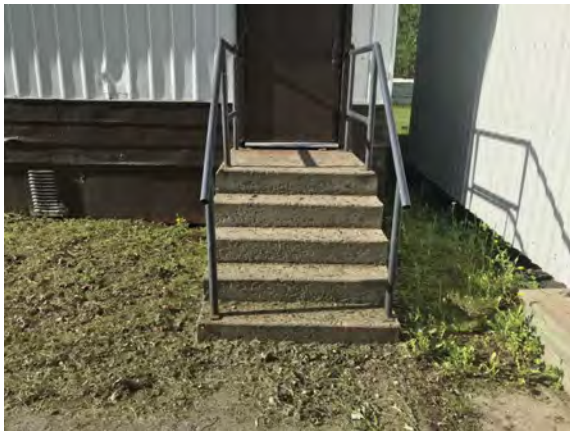
Cache Creek Community Hall - C201002

No major deficiencies were observed or reported, however, there was heavy pitting and scaling of the concrete finish that should be repaired as a routine maintenance activity.

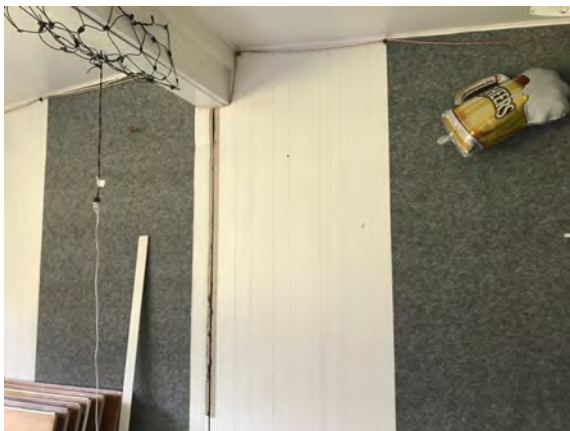
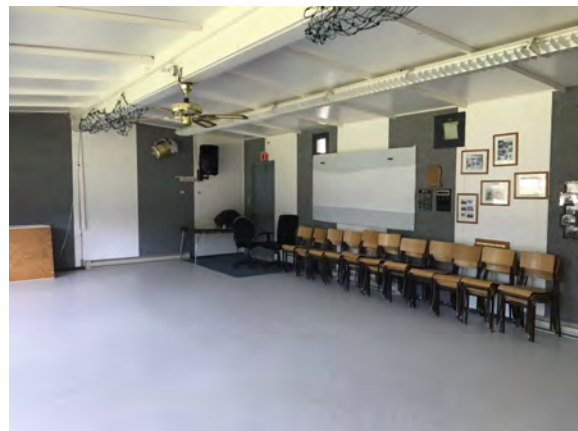
Cache Creek Community Hall - C301005

While the paint finish was observed to be in fair condition at the time of assessment, it is likely that it will require renewal within the short-term of the evaluation period. The difficulty factor has been decreased to account for the limited number of interior walls.

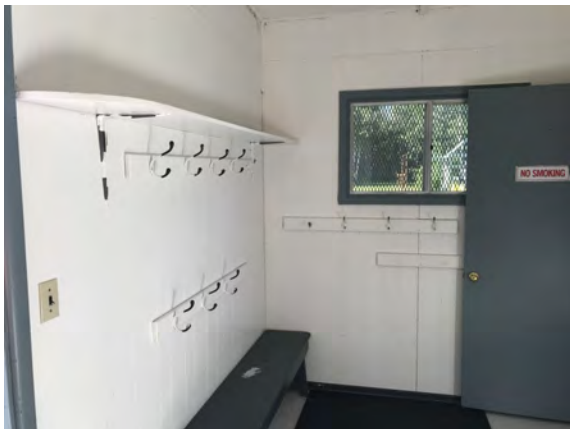
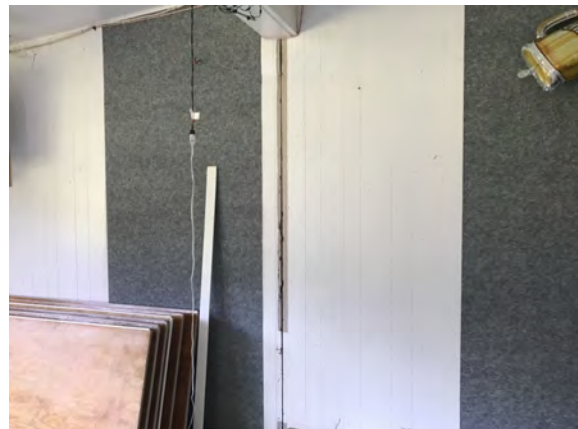
Cache Creek Community Hall - C301022

No major deficiencies were observed or reported. The difficulty factor has been reduced to account for the type of wainscoting.

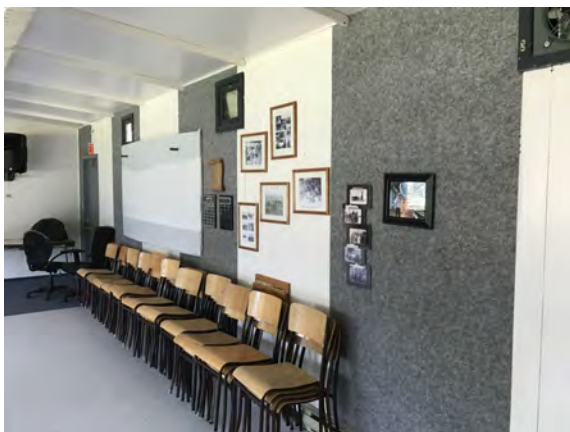
Cache Creek Community Hall - C301024

No major deficiencies were observed or reported.

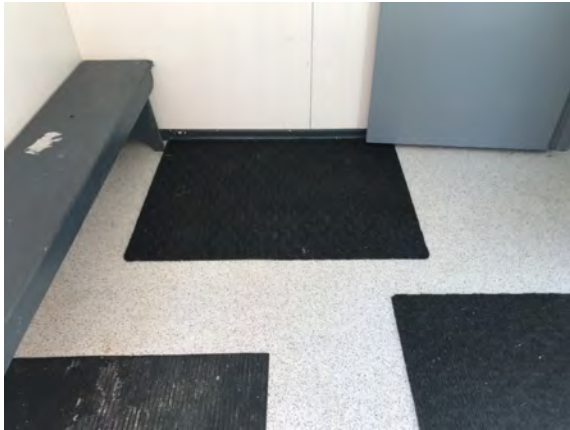
Cache Creek Community Hall - C202027

No major deficiencies were observed or reported during the assessment. The component has exceeded its expected useful life, although its remaining useful life has been extended to a later year due to the absence of significant observed or reported deficiencies.

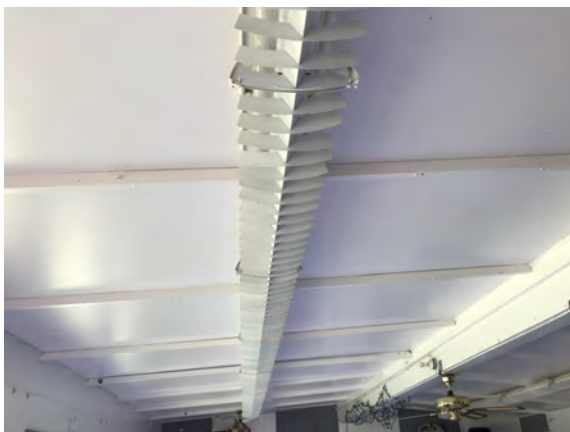
Cache Creek Community Hall - C303006

No major deficiencies were observed or reported.

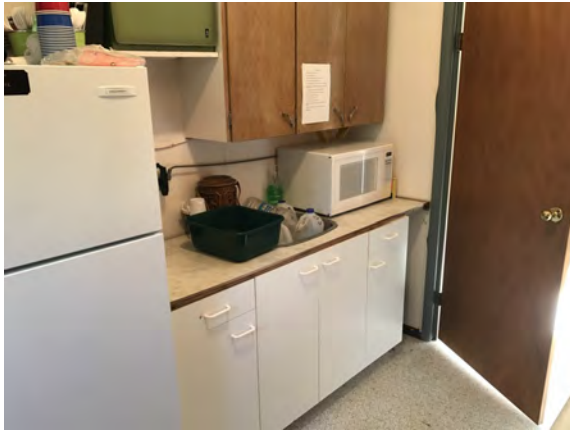
Cache Creek Community Hall - D201004

The sink has exceeded its expected useful life and therefore, lifecycle replacement is recommended within the short-term evaluation period.

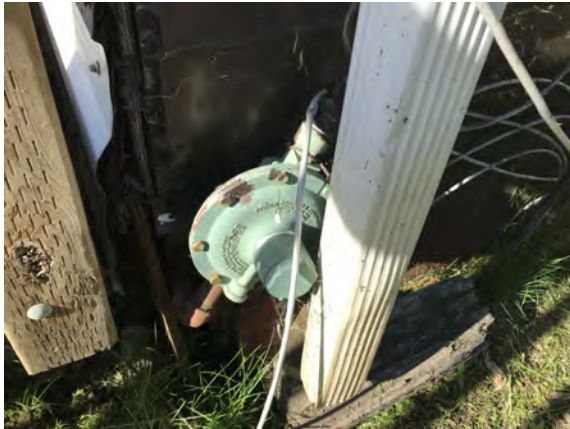
Cache Creek Community Hall - D301002

This system is no longer in use and should be removed. The cost to remove the equipment is presumed to fall below the repair threshold (\$5,000) and should therefore be completed as a routine maintenance activity. For the sake of this report, due to the system no longer being in use, the difficulty factor has been reduced to a negligible amount to reflect the lack of capital replacement needed.

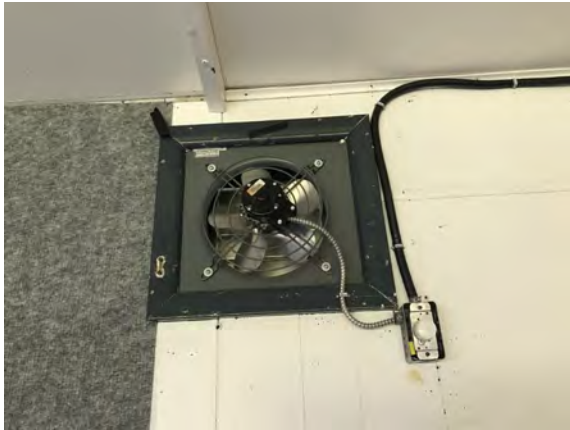
Cache Creek Community Hall - D304031

No major deficiencies were observed or reported. The difficulty factor has been decreased to account for the size of the fan.

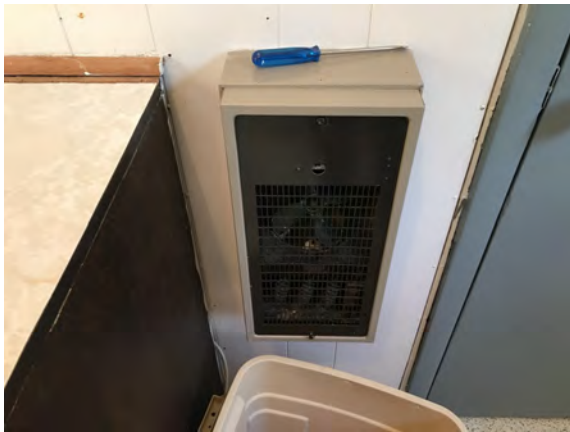
Cache Creek Community Hall - D305008

The heater has exceeded its expected useful life and is exhibiting wear and tear that is consistent with age. Lifecycle replacement is recommended within the short-term of the evaluation period.

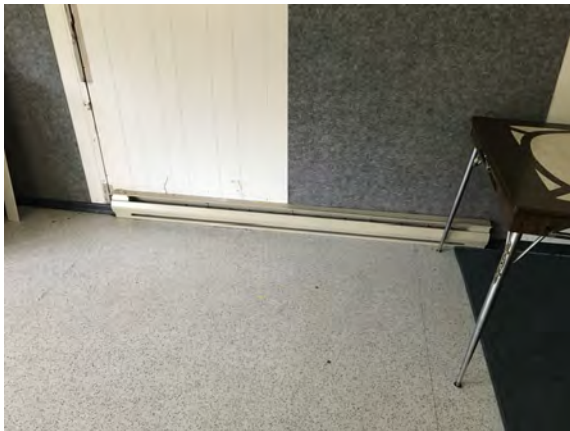
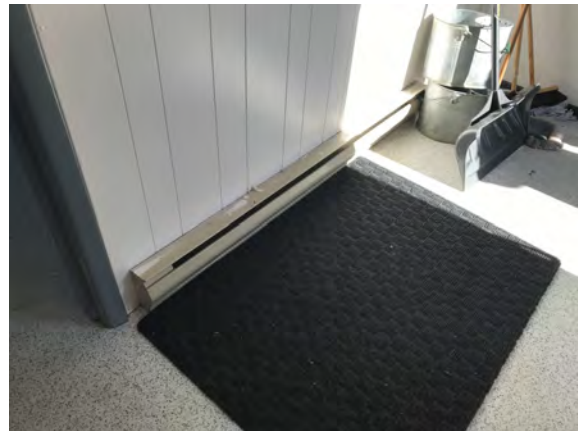
Cache Creek Community Hall - D305010

No major deficiencies were observed or reported during the assessment. The component has exceeded its expected useful life, although its remaining useful life has been extended to a later year due to the absence of significant observed or reported deficiencies.

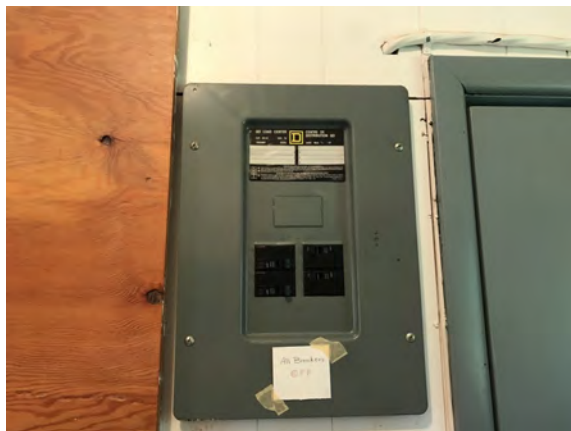
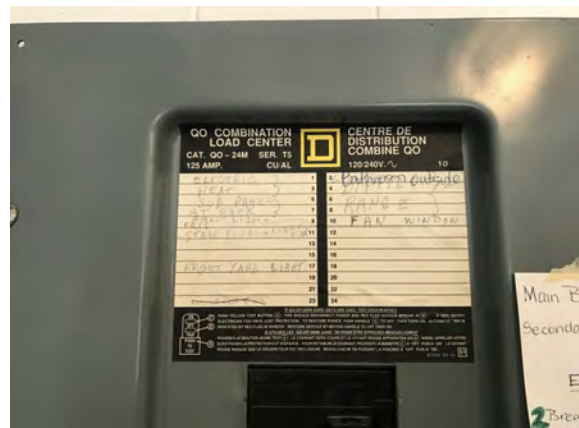
Cache Creek Community Hall - D501033

No major deficiencies were observed or reported

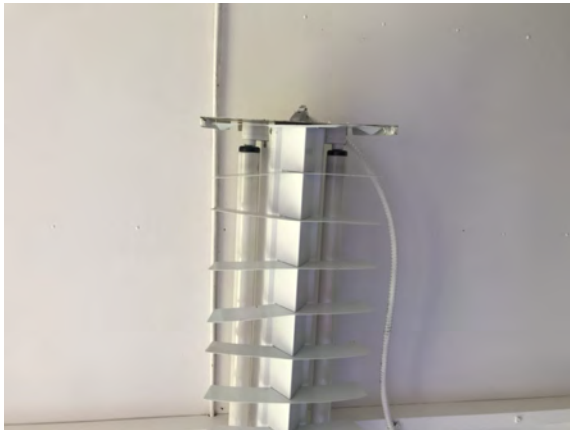
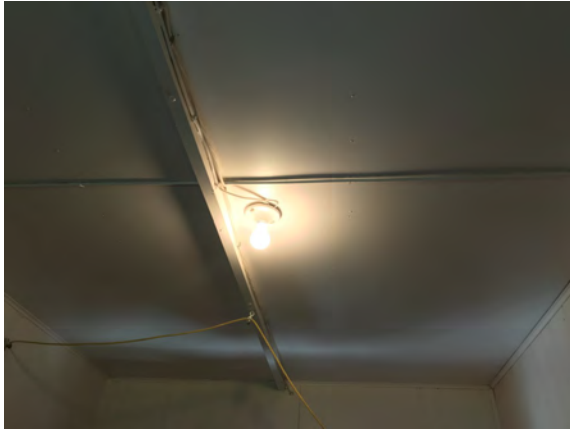
Cache Creek Community Hall - D502002

No major deficiencies were observed or reported, however, T12 fluorescent fixtures may be difficult to locate parts due to obsolescence. Lifecycle replacement is therefore recommended within the short-term of the evaluation period. At the time of lifecycle replacement, it is recommended to install energy-efficient lighting. The difficulty factor has been decreased to account for the small number of fixtures.

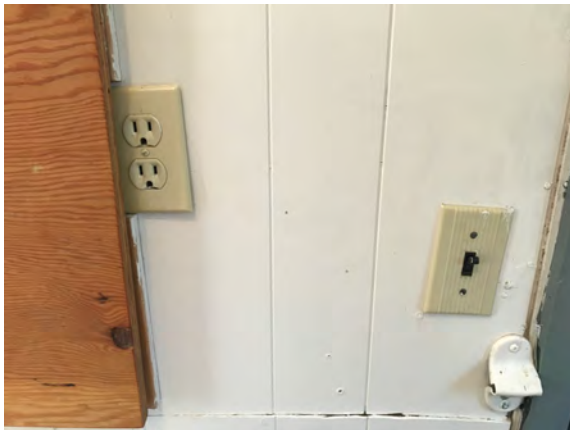
Cache Creek Community Hall - D502011

No major deficiencies were observed or reported, however, some faceplates were damaged and should be replaced as a maintenance activity. Lifecycle replacement has been deferred.

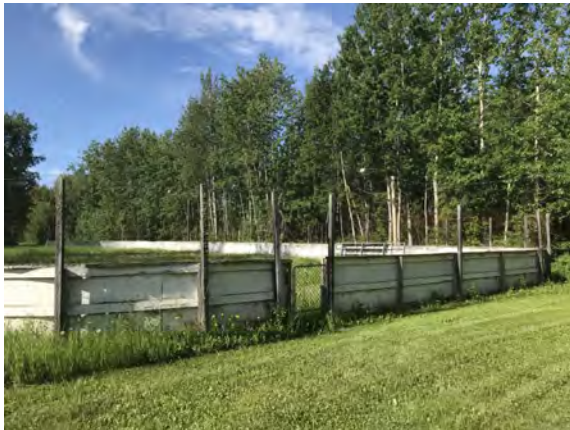
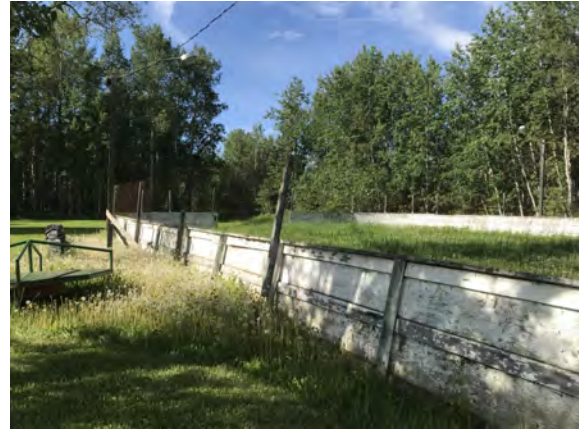
Cache Creek Community Hall - F104024

The wood was observed to be rotted. Posts are out-of-plumb and leaning inward. Wire fencing is rusted and deteriorated. Lifecycle replacement is required in the short term to restore functionality, and to mitigate a potential safety hazard. The difficulty factor has been decreased to account for the design and materials used for the dasher board assembly.

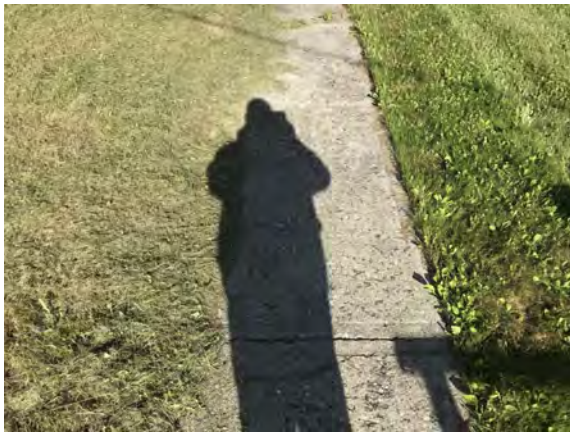
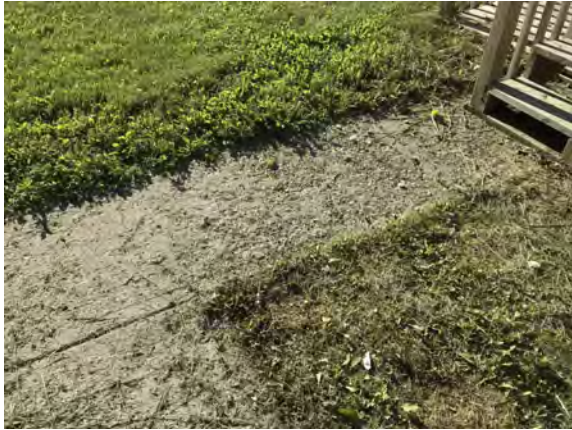
Cache Creek Community Hall - G203022

Concrete surfaces were scaled and spalling at building entrances. The concrete has exceeded its expected useful life and is exhibiting wear and tear that is consistent with age. Lifecycle replacement is recommended within the short-term of the evaluation period.

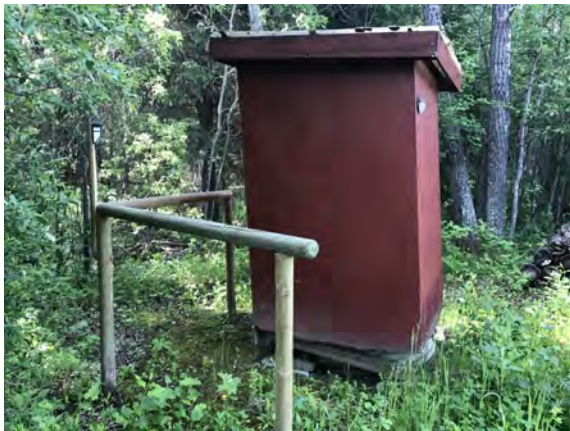
Cache Creek Community Hall - G204022

No major deficiencies were observed or reported during the assessment. The component has exceeded its expected useful life, although its remaining useful life has been extended to a later year due to the absence of significant observed or reported deficiencies.

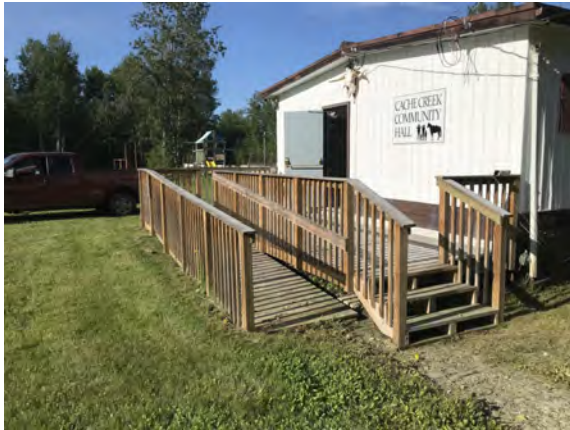
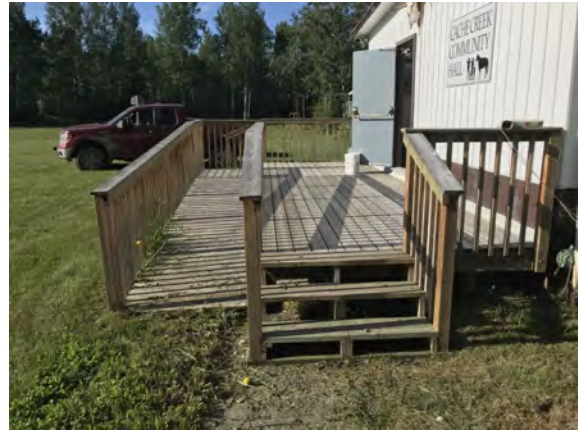
Cache Creek Community Hall - G204096

No major deficiencies were observed or reported.
