Peace River Regional District

**Facility Condition Assessment Report
Golata Creek Community Hall**

November 18, 2021

Prepared by:
FCAPX a Division of Roth IAMS
Project No. 21075
www.fcapx.com

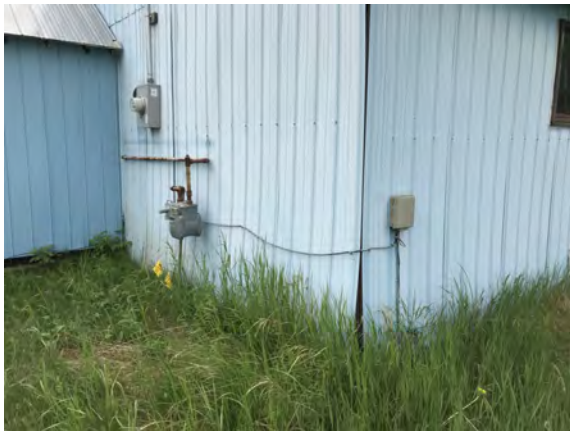
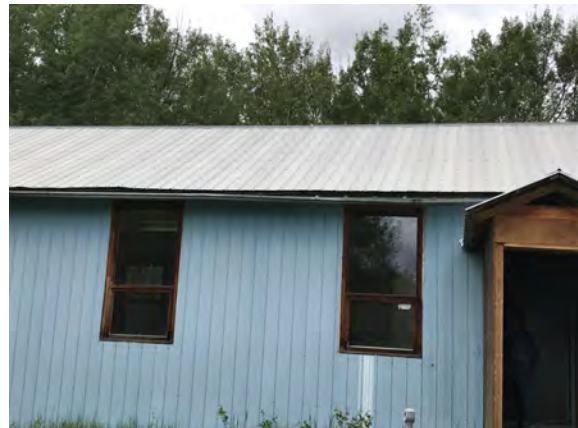
Golata Creek Community Hall - B201024

No major deficiencies were observed or reported during the assessment. Sections of siding are pulling away from wall surfaces, mostly around the crawl space. To be secured as a maintenance activity.

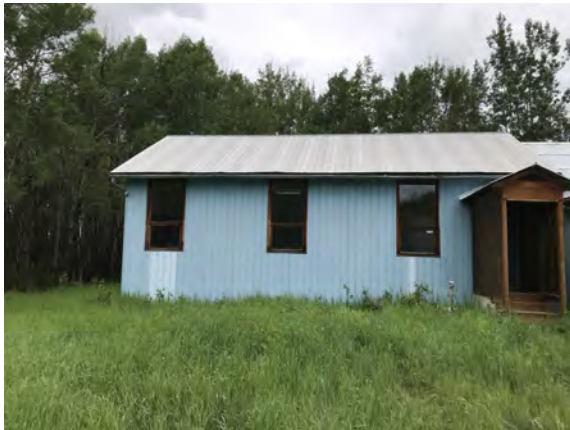
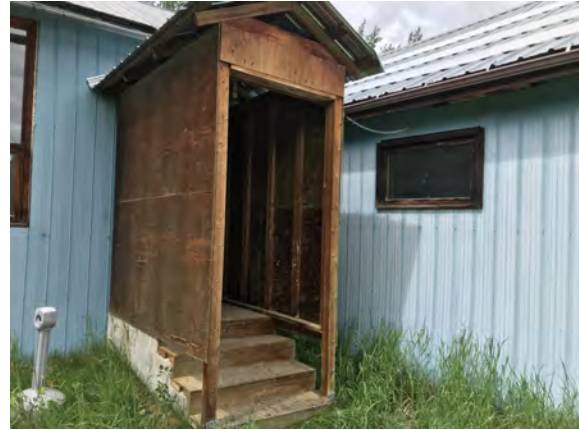
Golata Creek Community Hall - B201008

No major deficiencies were observed or reported during the assessment. No evidence of water leaks were identified during the assessment. Paint finishes on the frames were observed to be worn. The component will reach its expected useful life within the short term evaluation period. Refinishing of exterior wood frame surfaces is expected to be handled as a maintenance activity. Lifecycle replacement of the windows has been extended to a later year given the absence of significant deficiencies.

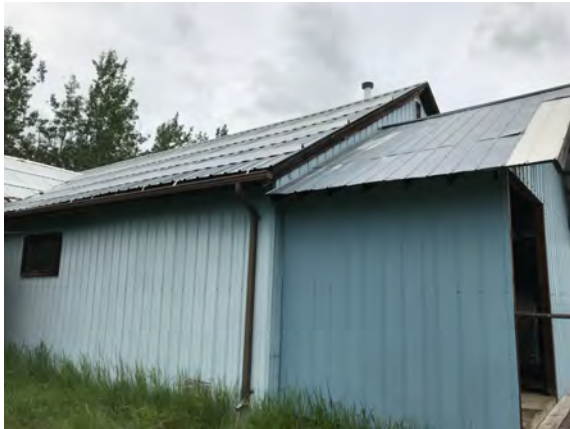
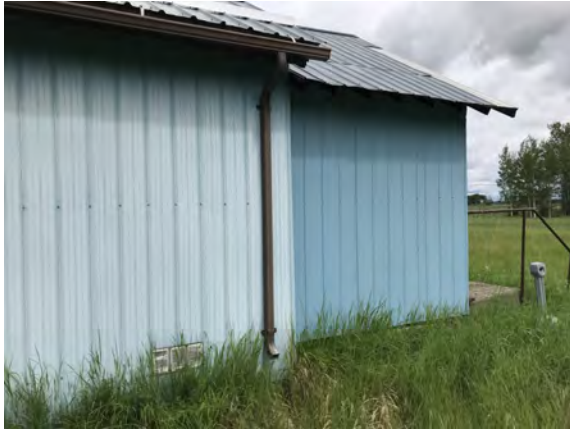
Golata Creek Community Hall - B301005

No major deficiencies were observed or reported during the assessment. Downspouts with missing/detached extensions and damaged gutters near the school entrance to be repaired as maintenance.

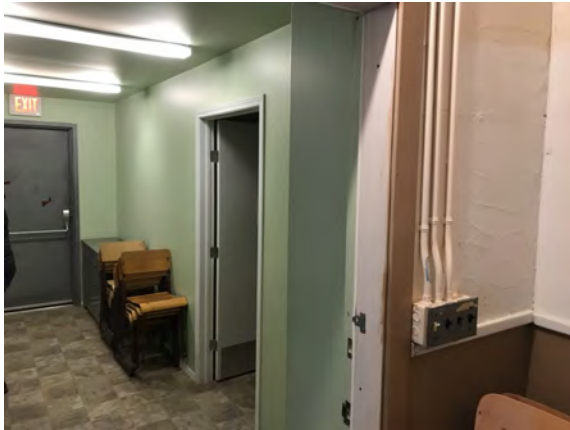
Golata Creek Community Hall - C101001

No major deficiencies were observed or reported during the assessment. Previous water damage above men's washroom repair as part of maintenance.

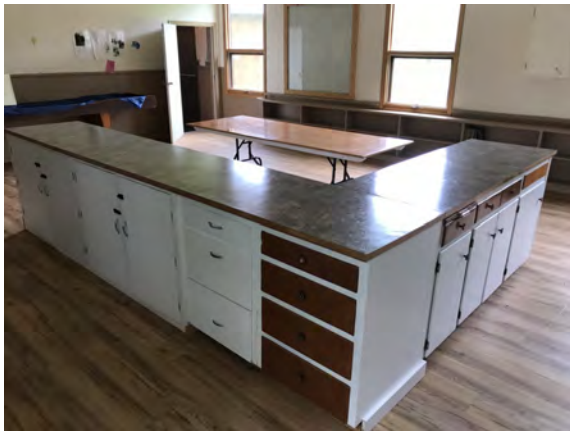
Golata Creek Community Hall - C103009

No major deficiencies were observed or reported during the assessment. The cabinets are dated. The component will reach its expected useful life, although its remaining useful life has been extended to a later year due to the absence of significant observed or reported deficiencies.

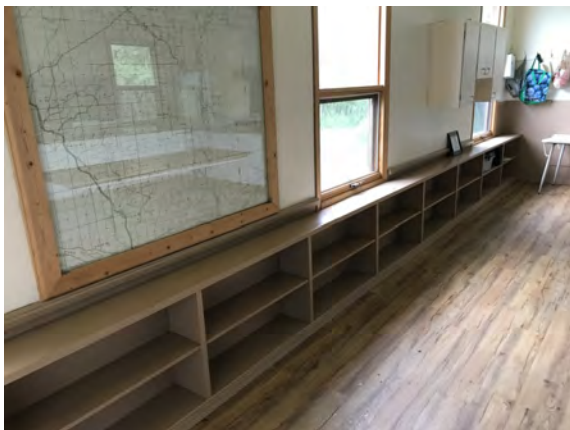
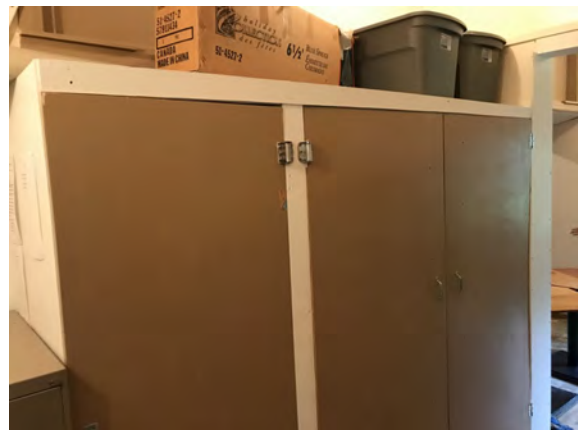
Golata Creek Community Hall - C103011

No major deficiencies were observed or reported during the assessment. The cabinets are dated. The component will reach its expected useful life, although its remaining useful life has been extended to a later year due to the absence of significant observed or reported deficiencies.

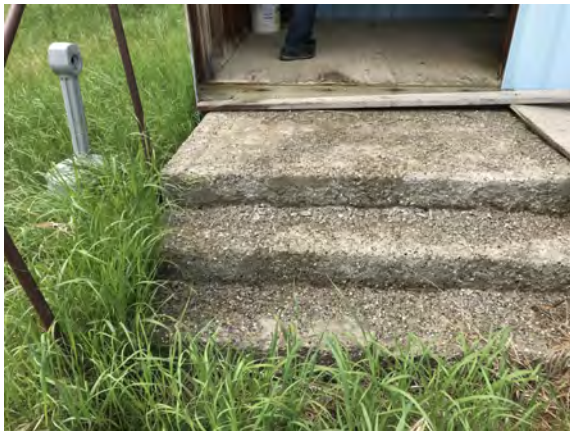
Golata Creek Community Hall - C201002

Exterior stairs were observed to be worn and deteriorated. Lifecycle replacement is recommended within the short-term evaluation period.

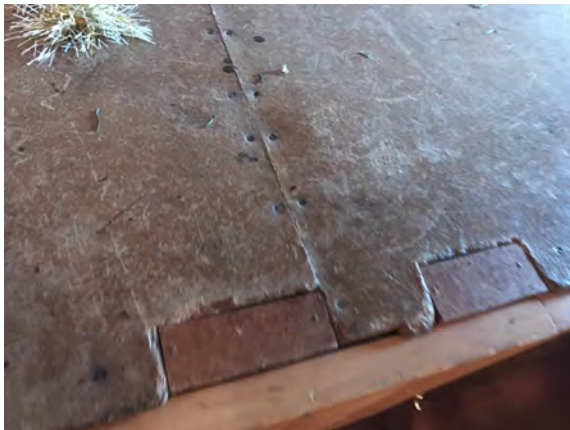
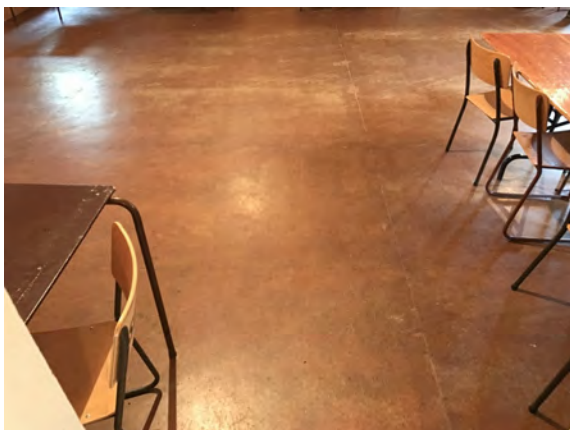
Golata Creek Community Hall - C302003

The flooring was observed to be worn. No major deficiencies were reported. The component has exceeded its expected useful life, although its remaining useful life has been extended to a later year due to the absence of significant observed or reported deficiencies.

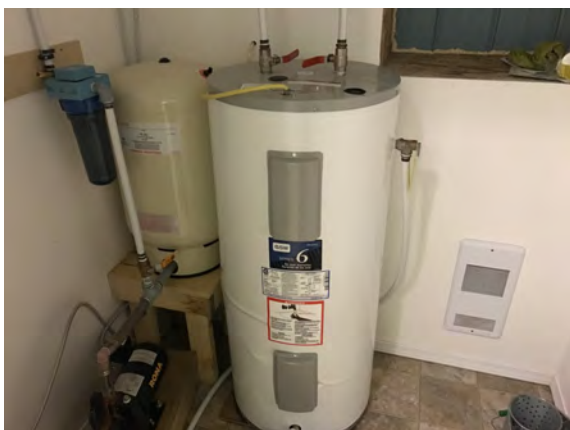
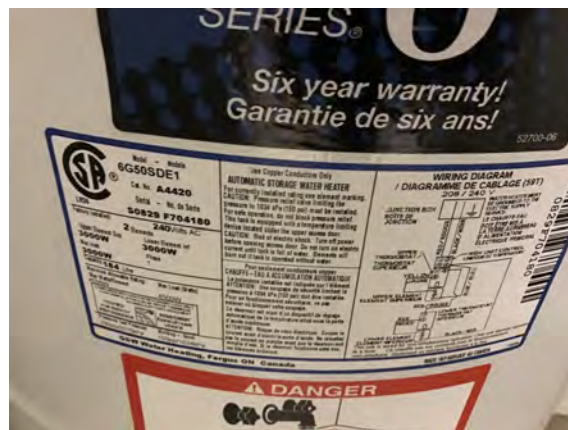
Golata Creek Community Hall - D202033

The domestic hot water tank is in poor condition as it is non-functioning. Replacement is recommended.

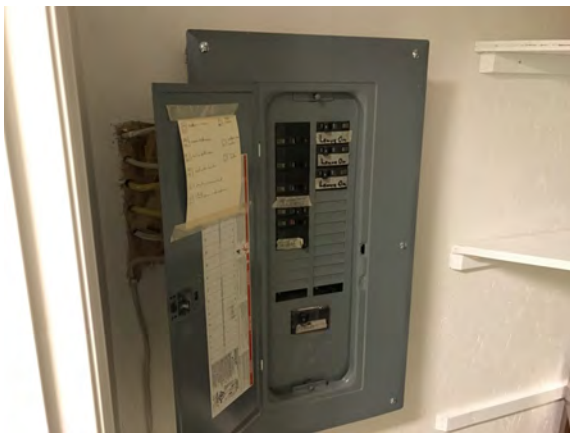
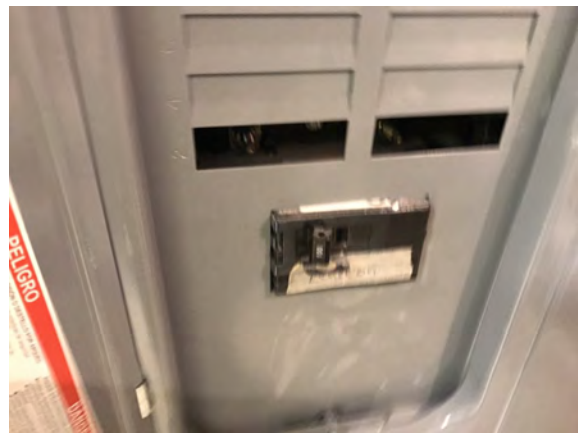
Golata Creek Community Hall - D501033

No major deficiencies were observed or reported during the assessment. Missing filler plates on unused breaker slots for the panel install as maintenance.

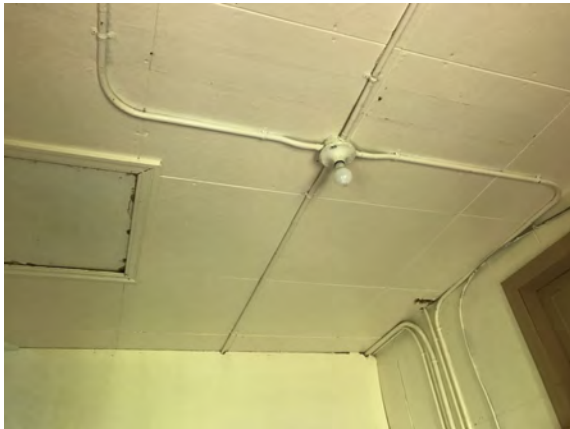
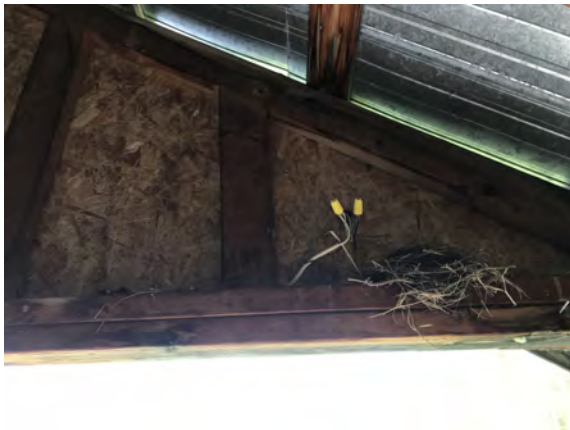
Golata Creek Community Hall - D502001

No major deficiencies were observed or reported during the assessment. Exposed wiring in the exterior canopy, install exterior junction box as part of maintenance.
