Peace River Regional District

**Facility Condition Assessment Report
Upper Halfway Community Hall**

November 16, 2021

Prepared by:
FCAPX a Division of Roth IAMS
Project No. 21075
www.fcapx.com

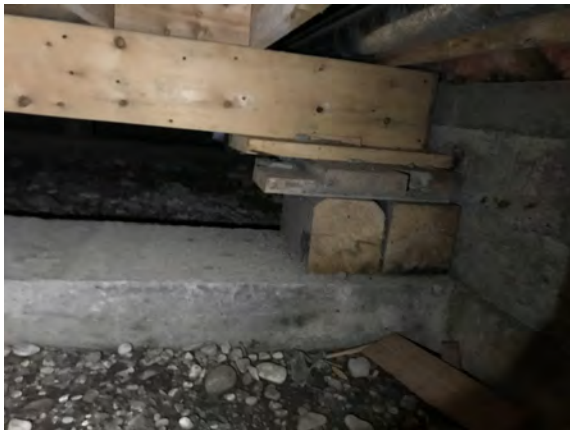
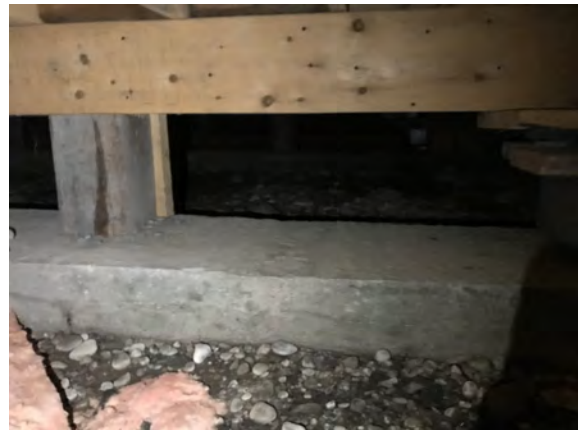
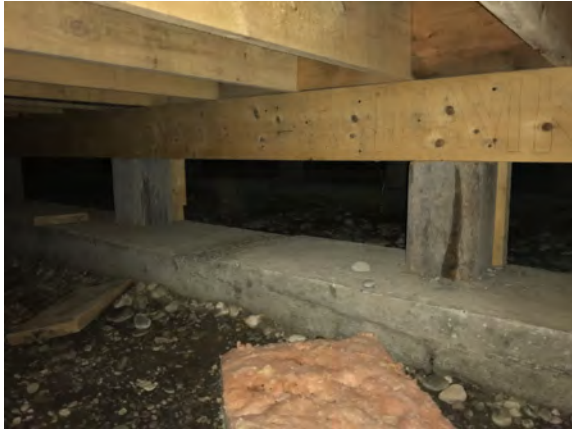
Upper Halfway Community Hall - A101001

No major deficiencies were observed or reported.

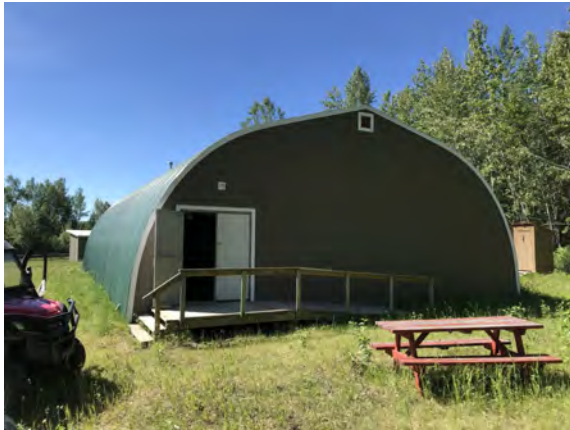
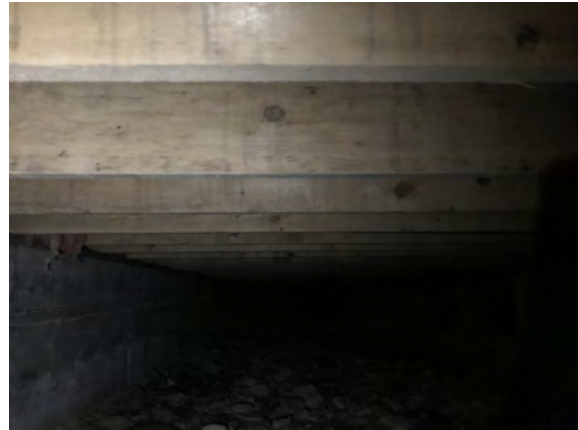
Upper Halfway Community Hall - B103001

No major deficiencies were observed or reported.

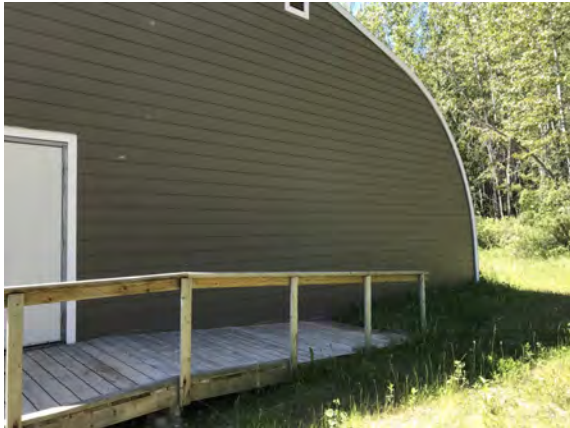
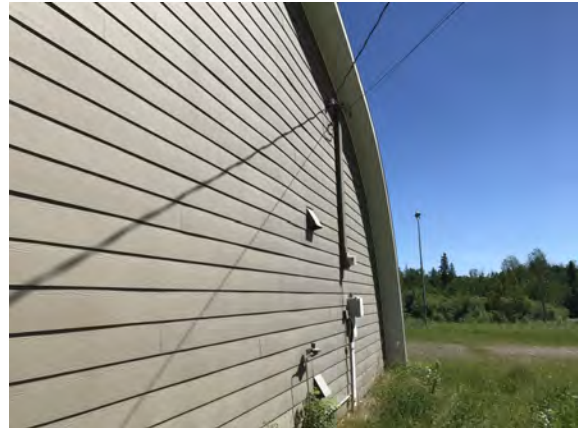
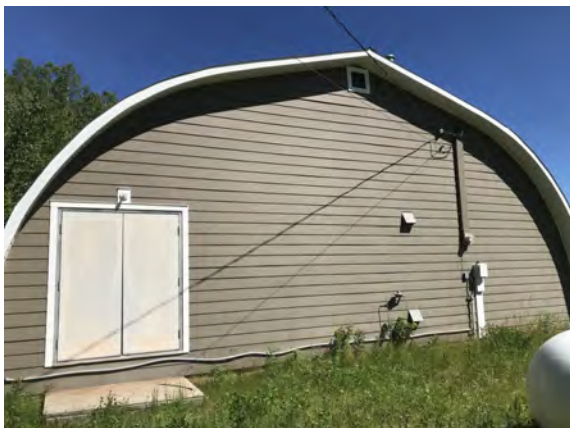
Upper Halfway Community Hall - B201025

No major deficiencies were observed or reported. The cost adjustment factor has been adjusted to account for 60 SM of siding at \$160/SM.

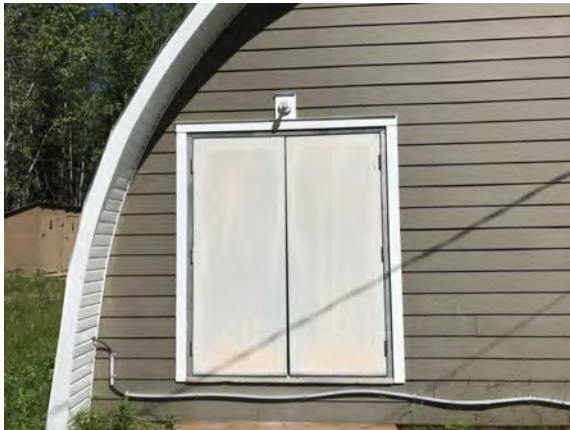
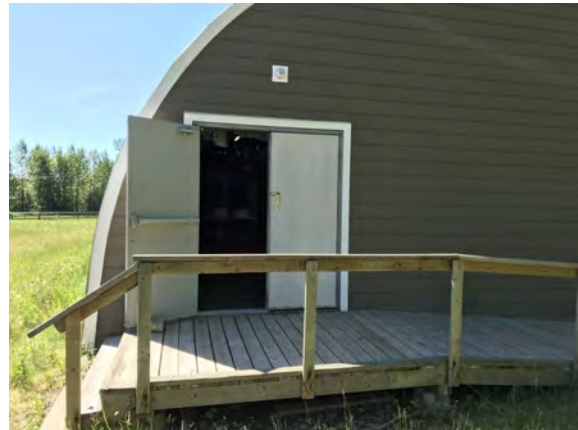
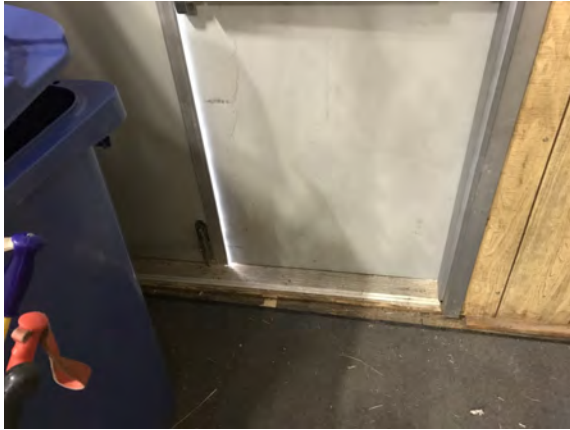
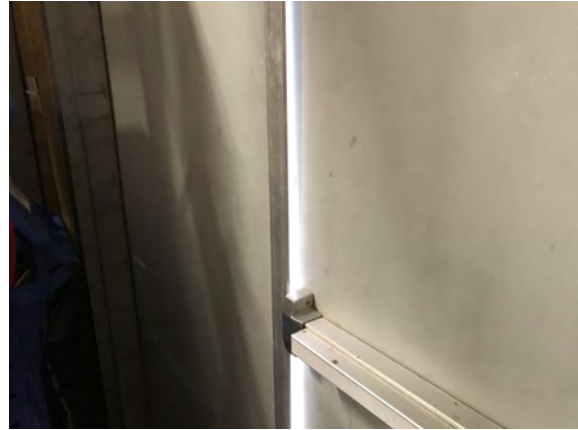
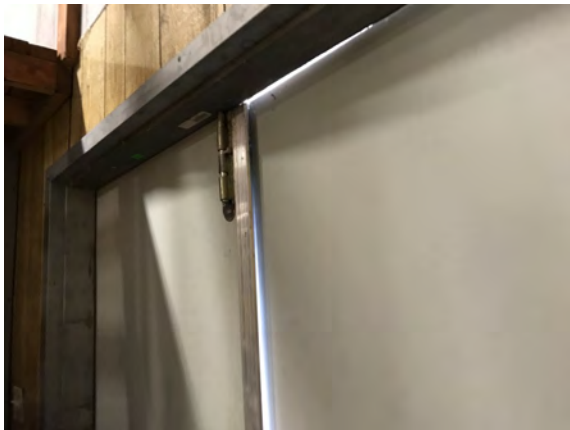
Upper Halfway Community Hall - B203026

The south exit doors had gaps and damage that is consistent with break-in attempts. It is recommended to repair or replace the damaged doors. The cost to complete these repairs is presumed to fall below the cost threshold for repair recommendations (\$5,000) and should be completed as a routine maintenance activity. The remaining useful life has been left unchanged with the assumption that repairs are completed.

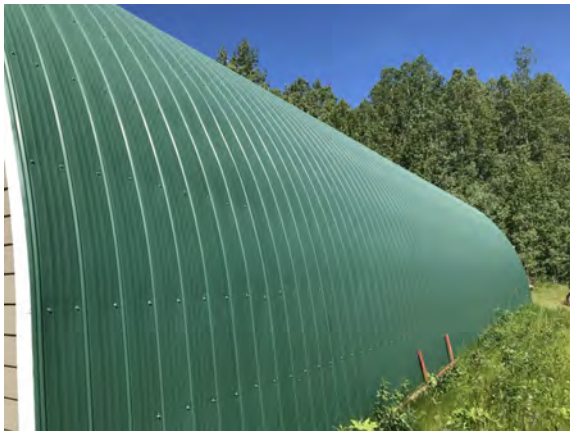
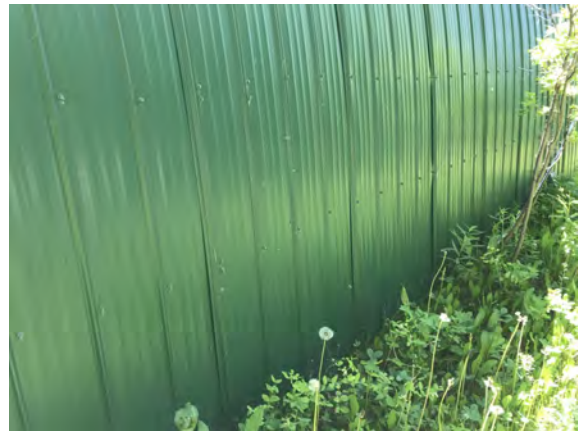
Upper Hallway Community Hall - B301028

No major deficiencies were observed or reported.

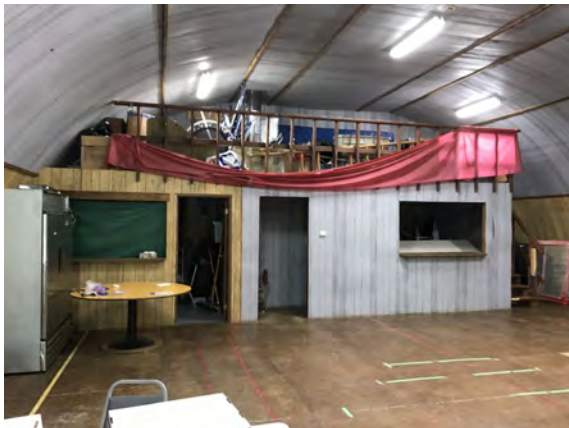
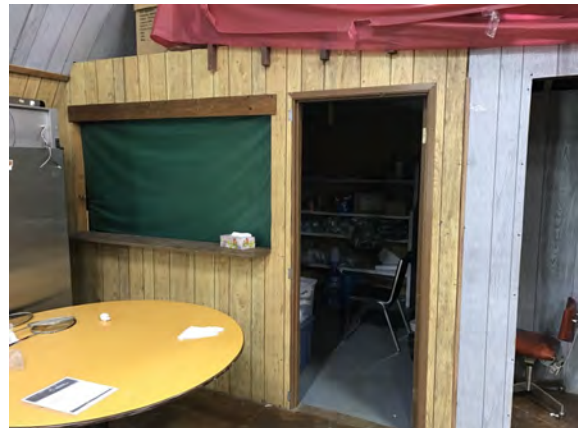
Upper Halfway Community Hall - C101001

No major deficiencies were observed or reported. A hazmat study is recommended based on the construction year. A cost to undertake a hazardous materials study has been provided herein.

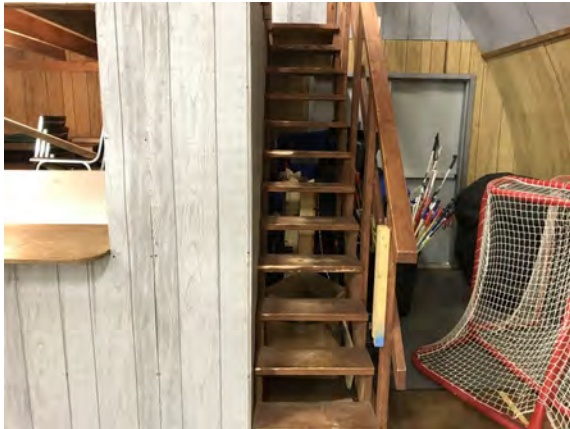
Upper Hallway Community Hall - C201001

No major deficiencies were observed or reported, however, the stairs are very narrow. It is recommended to consult with local authorities having jurisdiction to ensure the staircase meets legislative code requirements. Worn tread surfaces are recommended to be refinished as a maintenance activity.

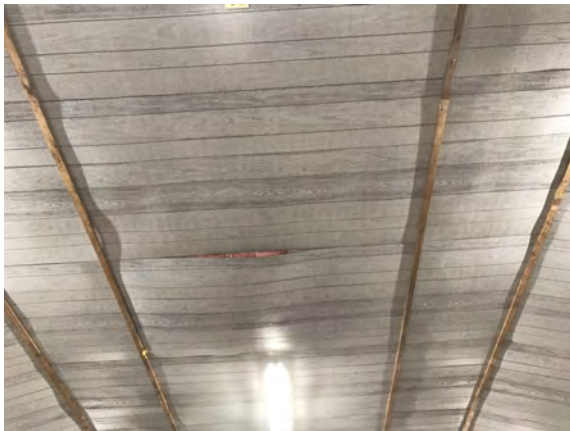
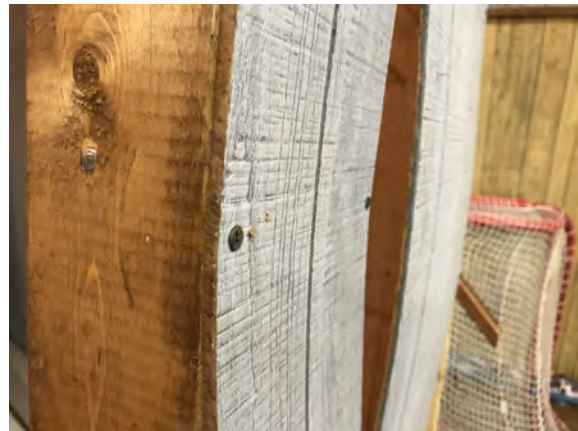
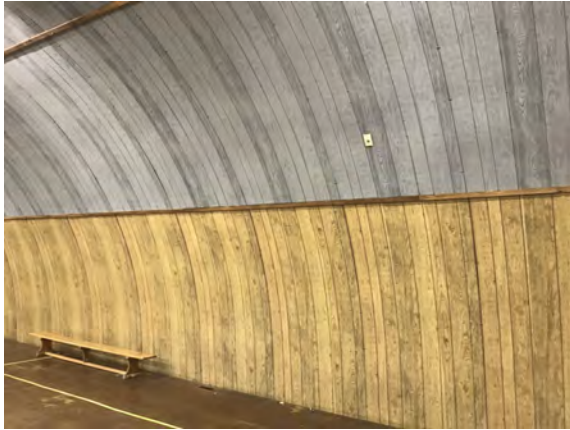
Upper Hallway Community Hall - C301022

The paneling has exceeded its expected useful life and is exhibiting heavy wear and tear, gouging, and buckling. Lifecycle replacement is recommended. The difficulty factor has been reduced to account for the material type.

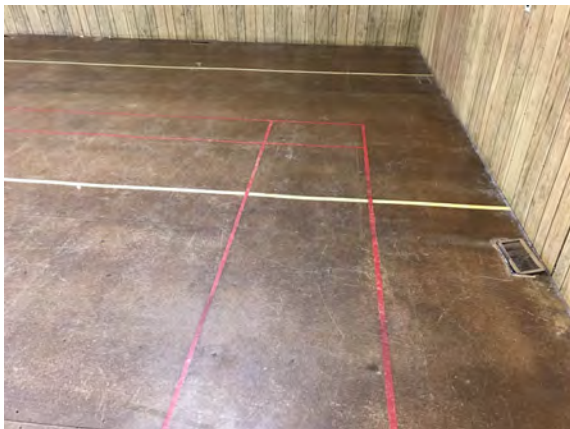
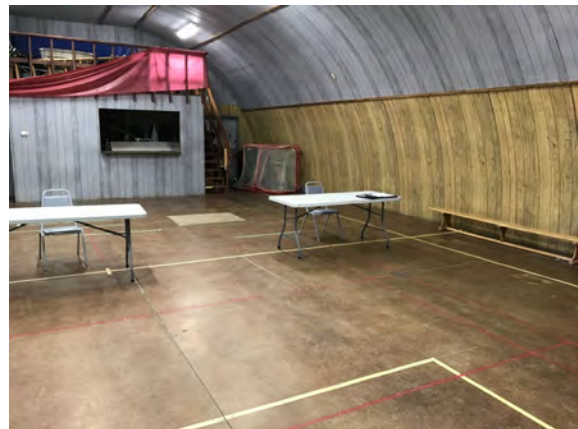
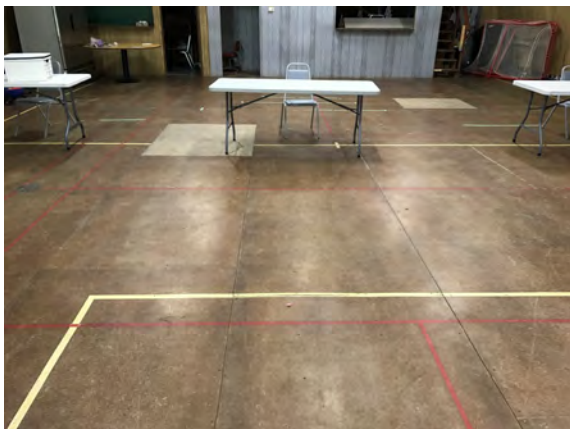
Upper Hallway Community Hall - C302023

The flooring has exceeded its expected useful life and is exhibiting heavy wear and tear. Lifecycle replacement is recommended.

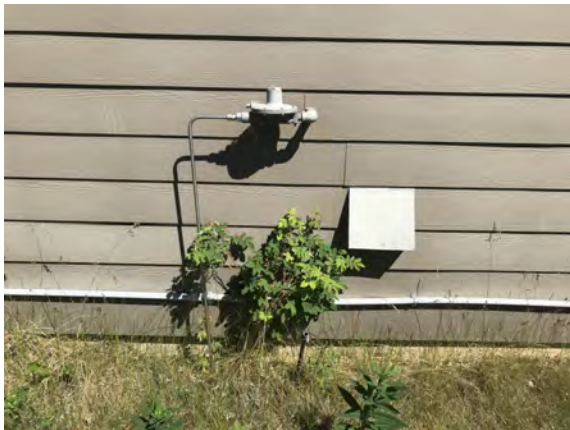
Upper Halfway Community Hall - D301002

No major deficiencies were observed or reported. The component will reach its expected useful life, however replacement has been extended to a later year due to the absence of significant deficiencies. The exterior propane tank is utility-owned and operated and is not included within this report.

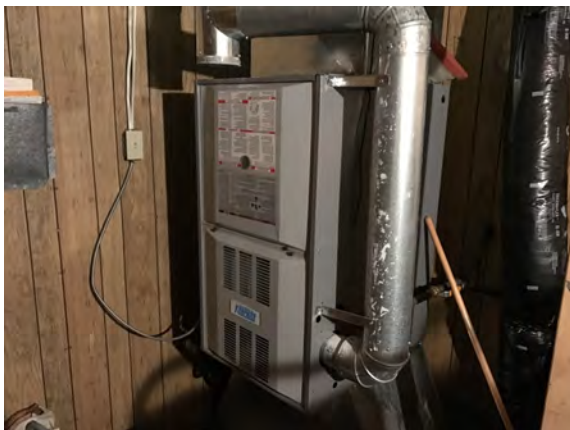
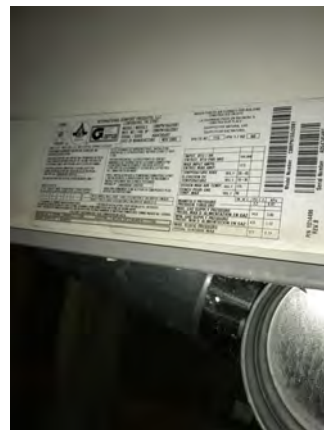
Upper Hallway Community Hall - D302003

No major deficiencies were observed or reported. The component will reach its expected useful life, however replacement has been extended to a later year due to the absence of significant deficiencies.

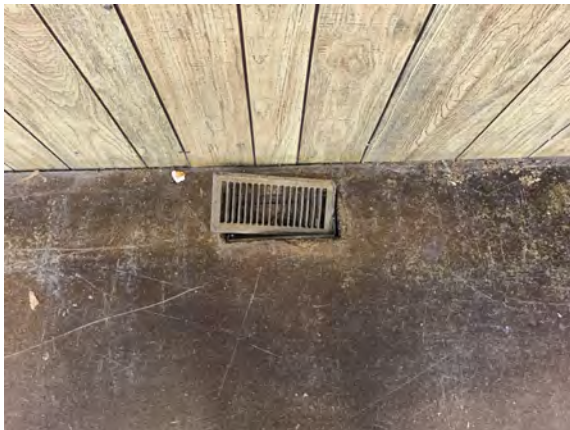
Upper Hallway Community Hall - D304001

No major deficiencies were observed or reported, however, some floor registers were damaged or misaligned and should be repaired as a routine maintenance activity.

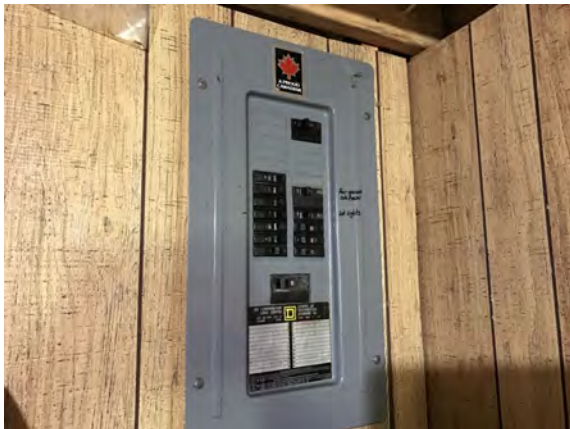
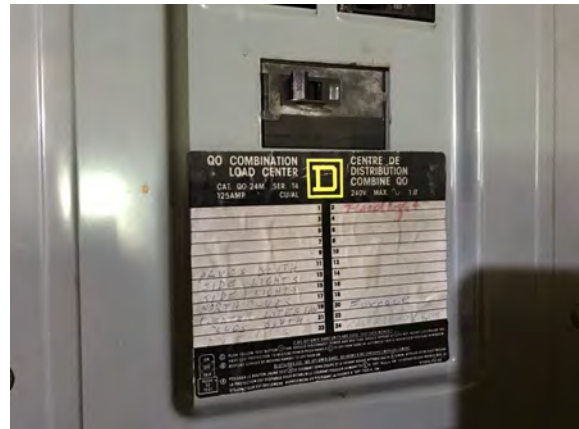
Upper Hallway Community Hall - D501005

No major deficiencies were observed or reported. The component will reach its expected useful life, however replacement has been extended to a later year due to the absence of significant deficiencies.

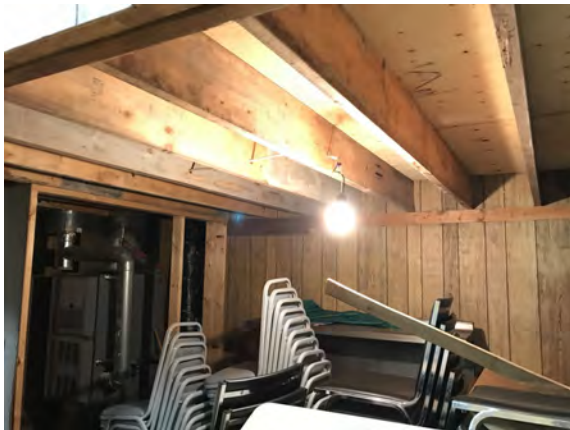
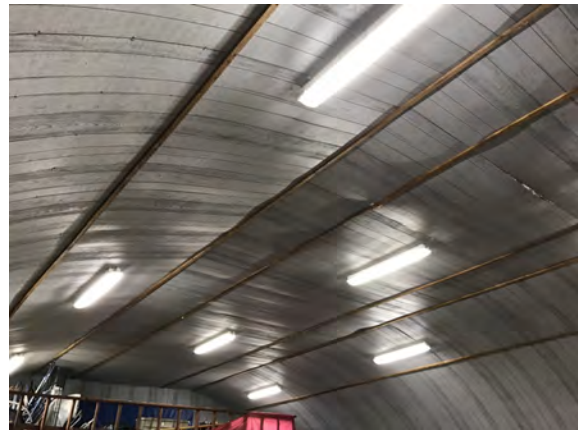
Upper Hallway Community Hall - D502002

No major deficiencies were observed or reported, however, the incandescent fixtures in concessions and storage area were loose, and featured exposed wiring maretted to a light socket. It is recommended to immediately install lighting fixtures that enclose bare wiring. The cost to complete these repairs is presumed to fall below the cost threshold for repair recommendations (\$5,000) and should be completed as a routine maintenance activity. The remaining useful life has been left unchanged with the assumption that repairs are completed within the immediate term. The cost factor has been decreased to account for the small number of lighting fixtures.

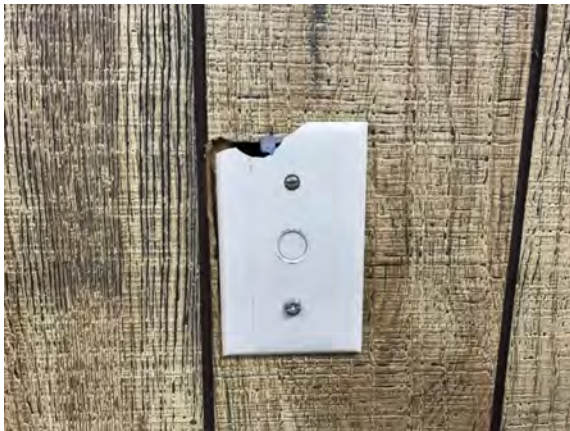
Upper Hallway Community Hall - D502011

No major deficiencies were observed or reported, however, some faceplates were damaged or missing and should be replaced as a routine maintenance activity. It is recommended to consult with local authorities having jurisdiction to determine the need for smoke/fire detection for the facility.

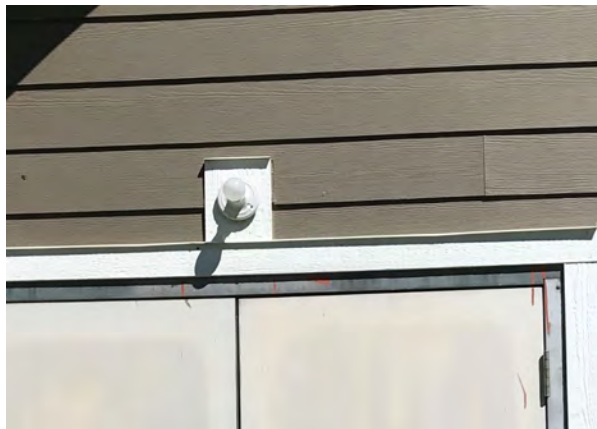
Upper Hallway Community Hall - D502041

The light fixtures are without lenses. Exterior lights have exceeded their expected useful life. Lifecycle replacement is recommended.

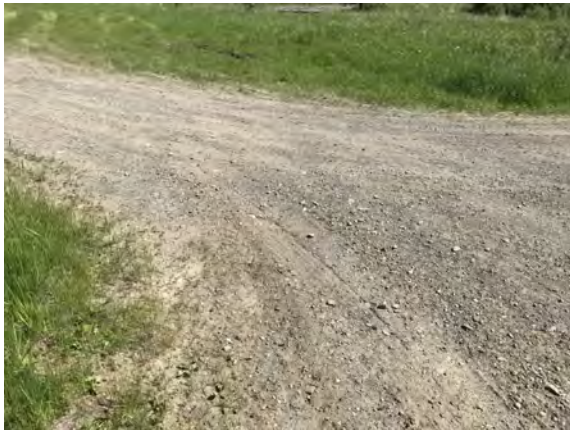
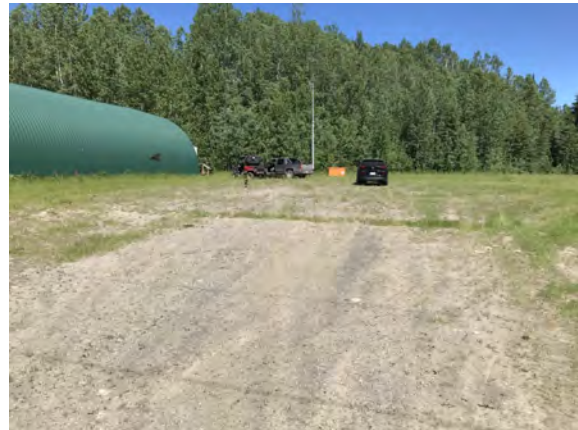
Upper Hallway Community Hall - G201025

No major deficiencies were observed or reported.

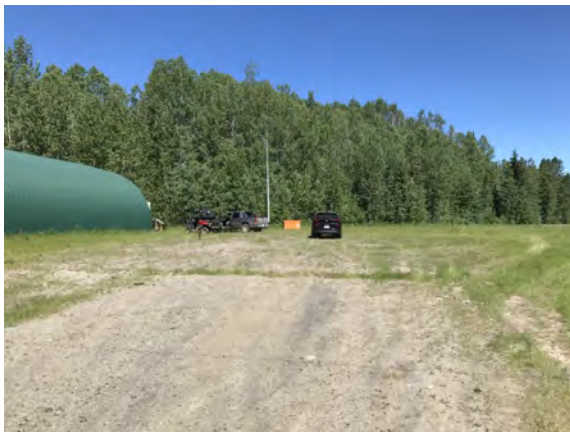
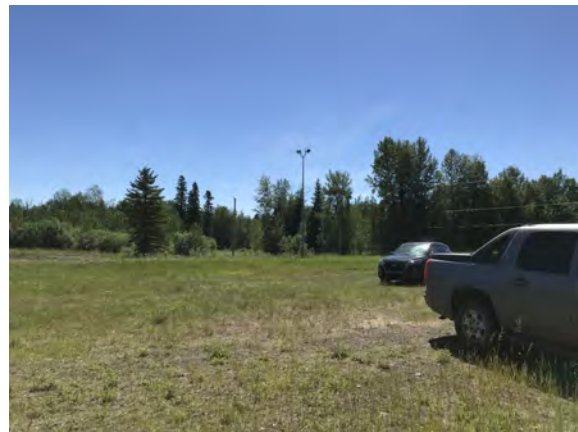
Upper Halfway Community Hall - G202024

The parking lot should have the gravel surface renewed as it is overgrown with vegetation.

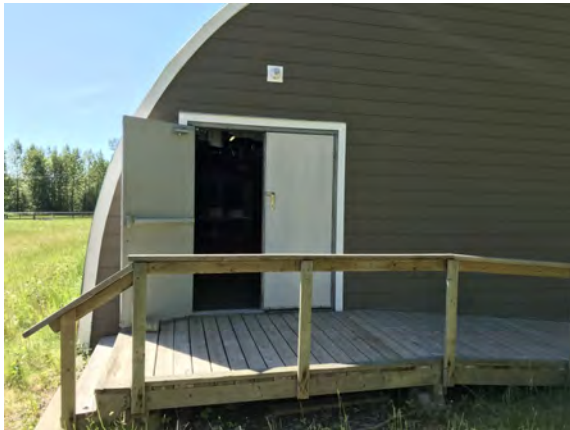
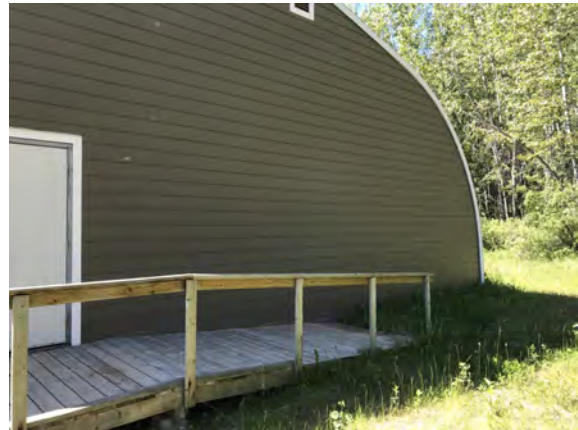
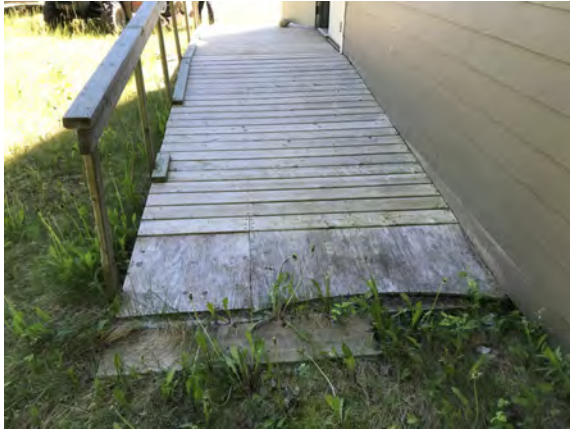
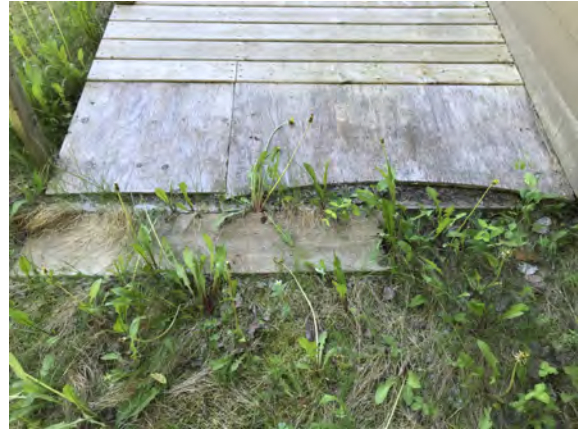
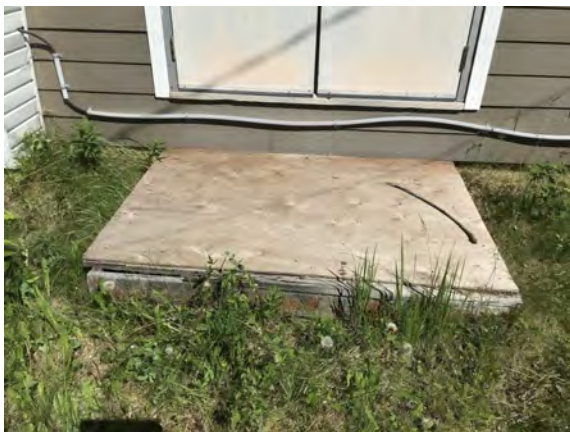
Upper Halfway Community Hall - G203029

No major deficiencies were observed or reported, however, there is some localized damage to the bottom of the entrance ramp that should be repaired as a routine maintenance activity. It is recommended to consult with the local authority having jurisdiction to determine if the exit ramp and platform configuration is in compliance with national building code requirements.

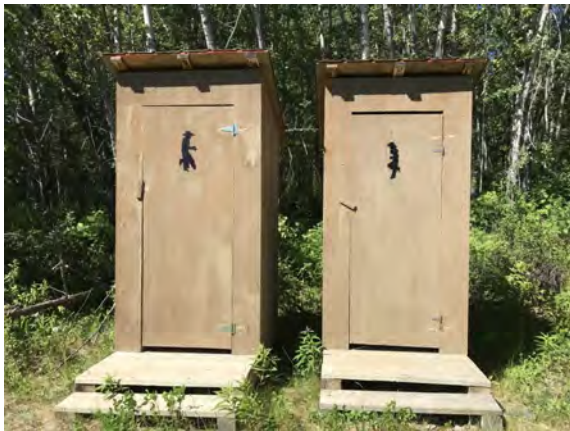
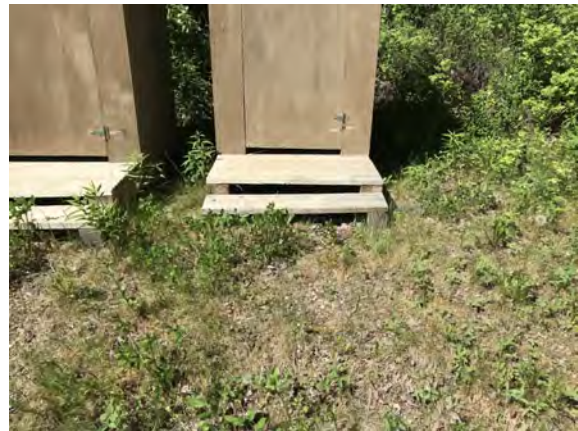
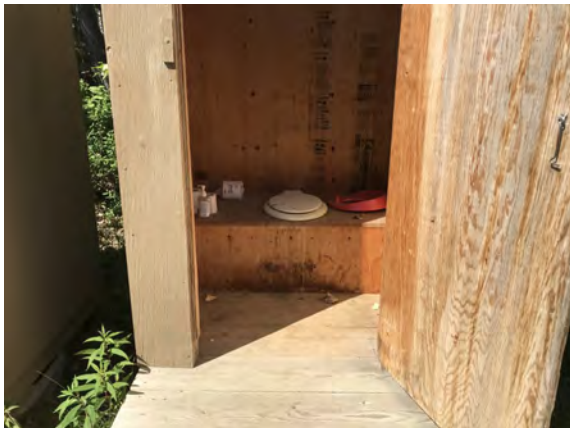
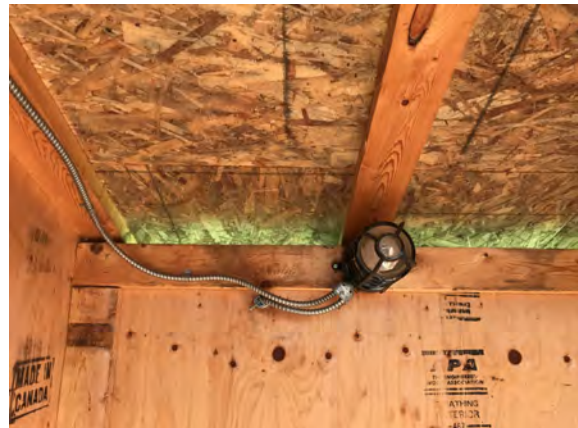
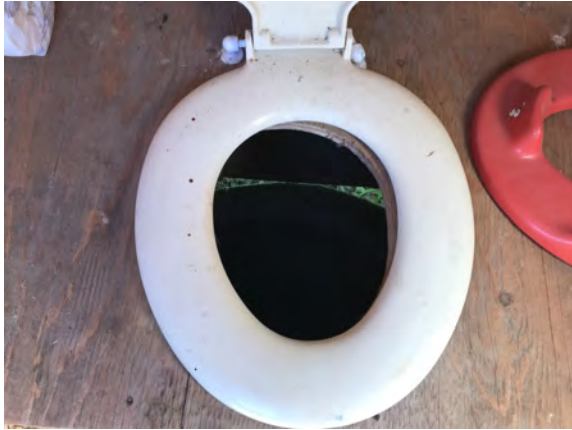
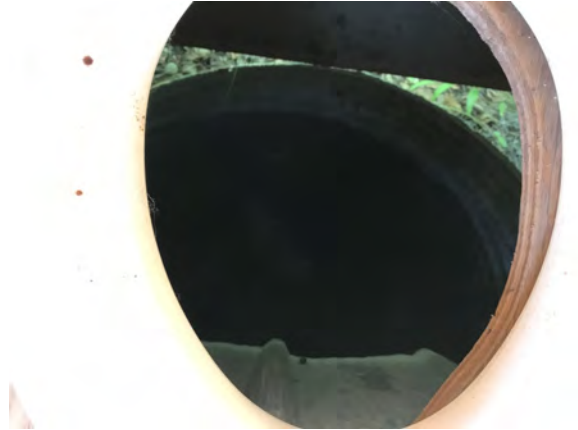
Upper Hallway Community Hall - G204099

No major deficiencies were observed or reported. The cost adjustment factor has been decreased to account for the small structure sizes.

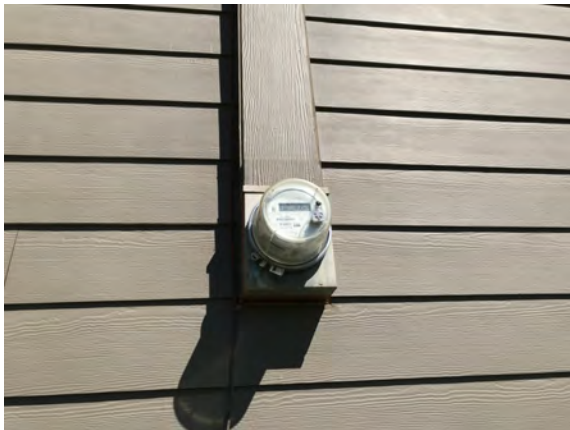
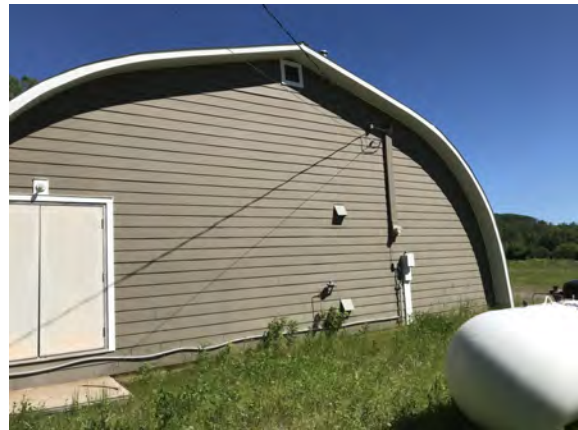
Upper Hallway Community Hall - G401011

No major deficiencies were observed or reported.

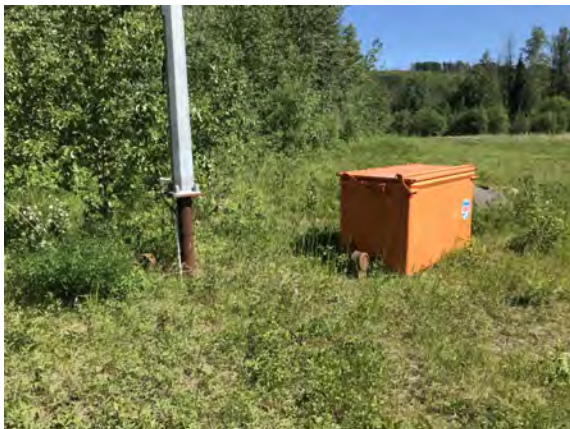
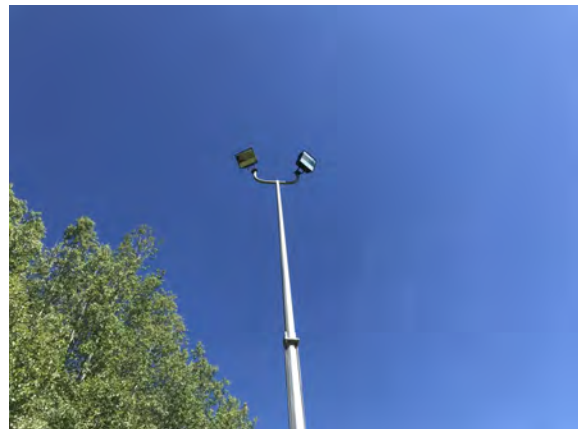
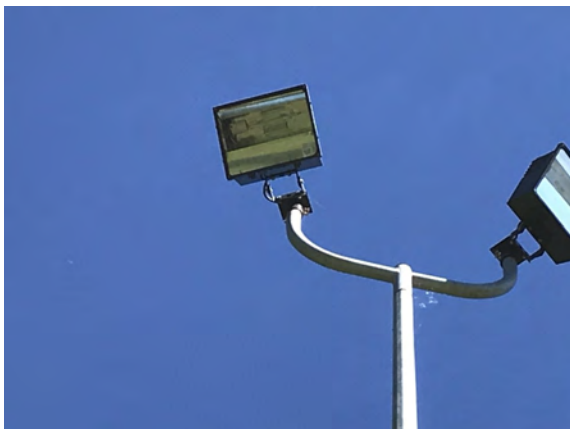
Upper Hallway Community Hall - G402011

No major deficiencies were observed or reported. The component has exceeded its expected useful life, however replacement has been extended to a later year due to the absence of significant deficiencies.
