**Peace River Regional District**

**Facility Condition Assessment Report  
North Peace Fall Fair Grounds**

**November 18, 2021**

Prepared by:  
FCAPX a Division of Roth IAMS  
Project No. 21075  
[www.fcapx.com](http://www.fcapx.com)

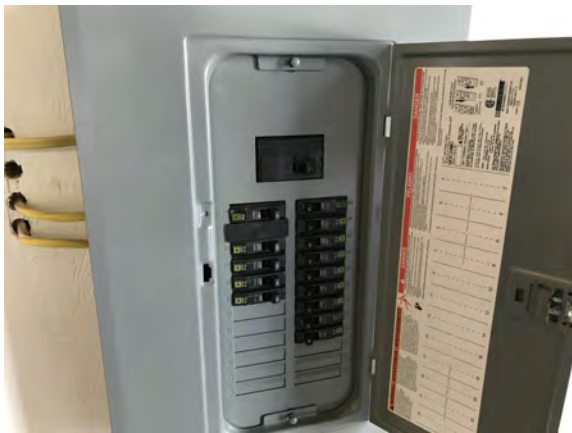
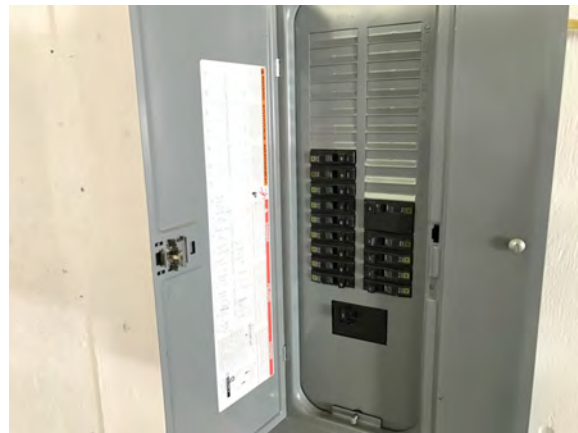
North Peace Fair Grounds - Adeline Kelly Exhibit - D501033

No major deficiencies were observed or reported during the assessment. The difficulty factor has been increased based on the panel sizes.

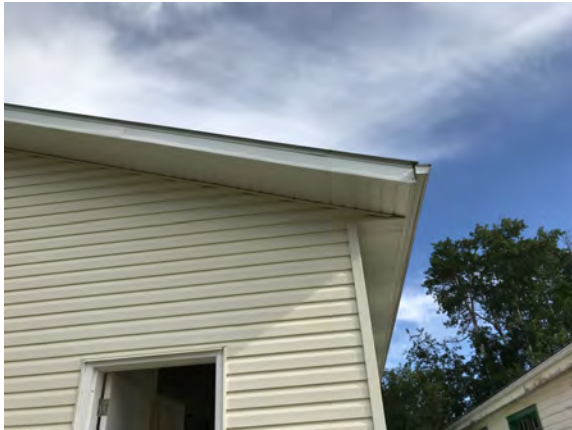
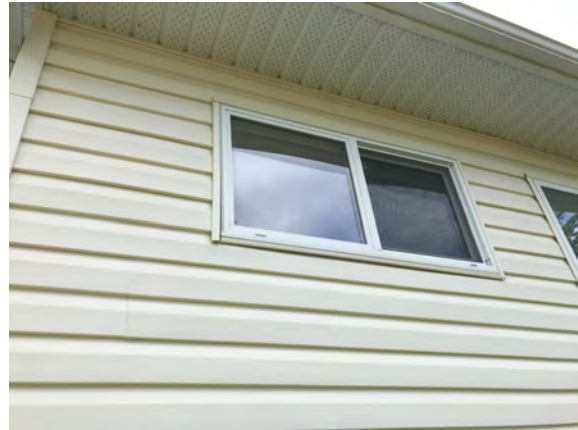
North Peace Fair Grounds - Washroom Building - B201008

No major deficiencies were observed or reported during the assessment.

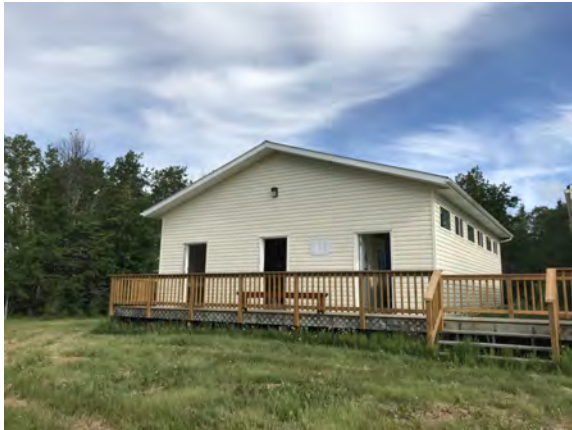
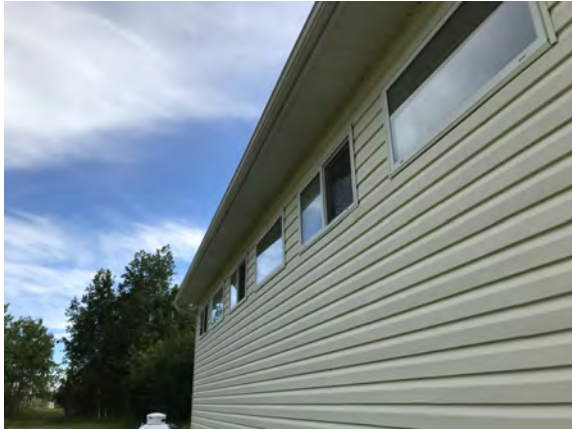
North Peace Fair Grounds - Washroom Building - B201025

No major deficiencies were observed or reported during the assessment. The component has achieved its expected useful life, although its remaining useful life has been extended to a later year due to the absence of significant observed or reported deficiencies.

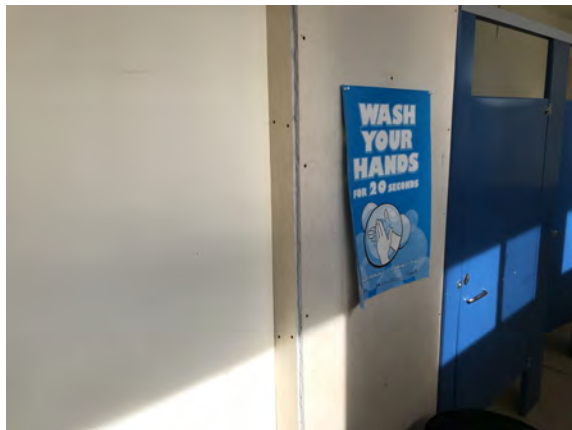
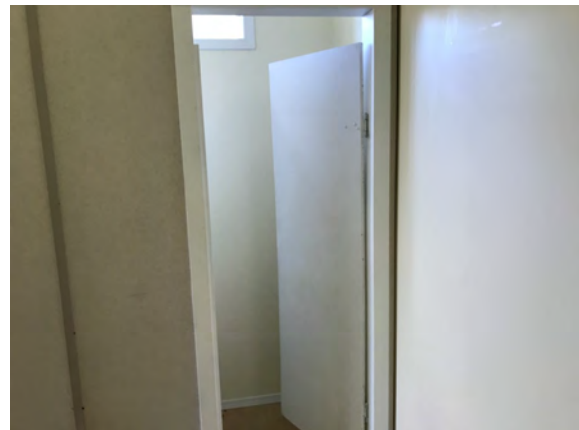
North Peace Fair Grounds - Washroom Building - C101001

No major deficiencies were observed or reported during the assessment.

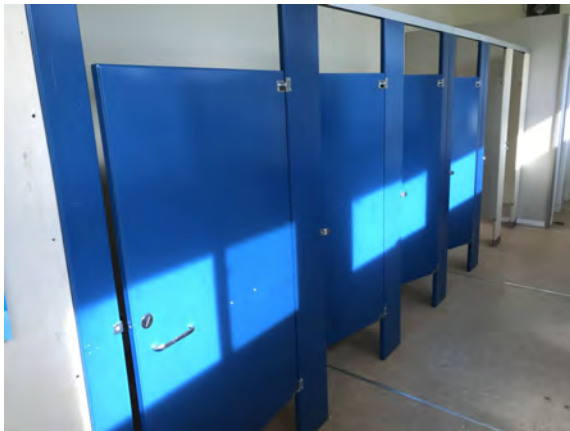
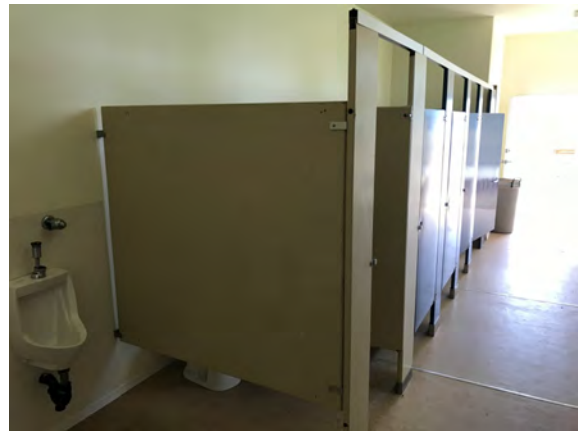
North Peace Fair Grounds - Washroom Building - C103026

No major deficiencies were observed or reported during the assessment. The component has exceeded its expected useful life, although its remaining useful life has been extended to a later year due to the absence of significant observed or reported deficiencies.

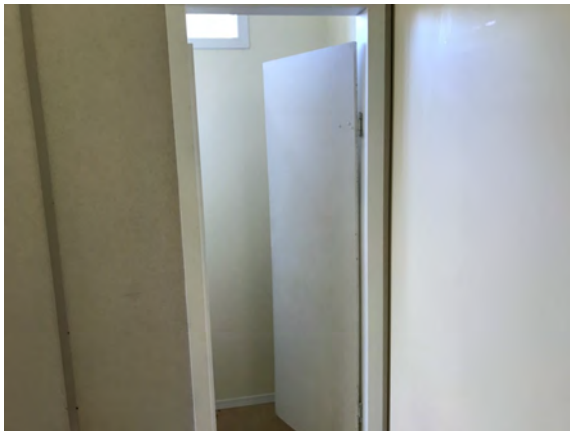
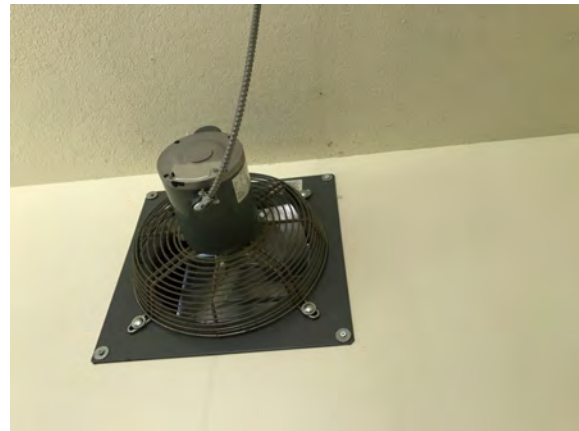
North Peace Fair Grounds - Washroom Building - C301005

No major deficiencies were observed or reported during the assessment. The component has exceeded its expected useful life, although its remaining useful life has been extended to a later year due to the absence of significant observed or reported deficiencies.

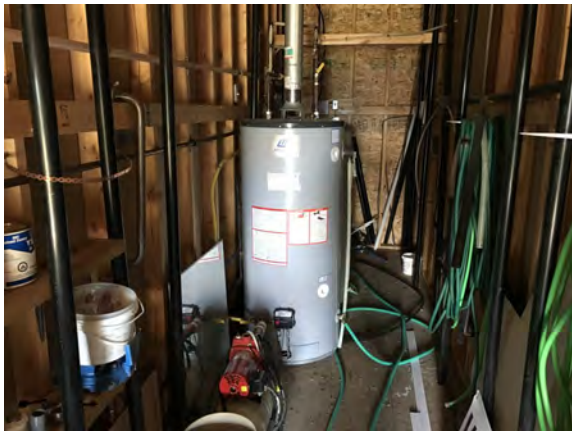
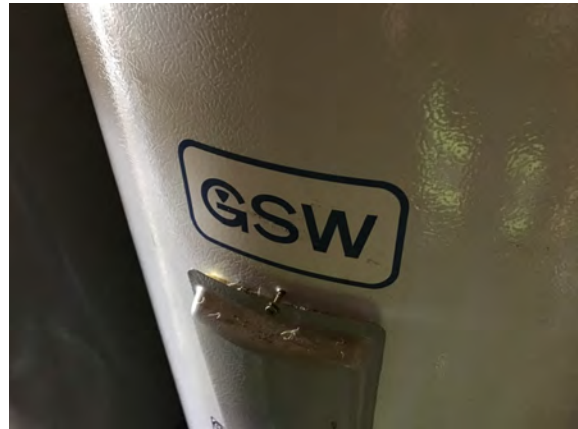
North Peace Fair Grounds - Washroom Building - D202033

No major deficiencies were observed or reported during the assessment.

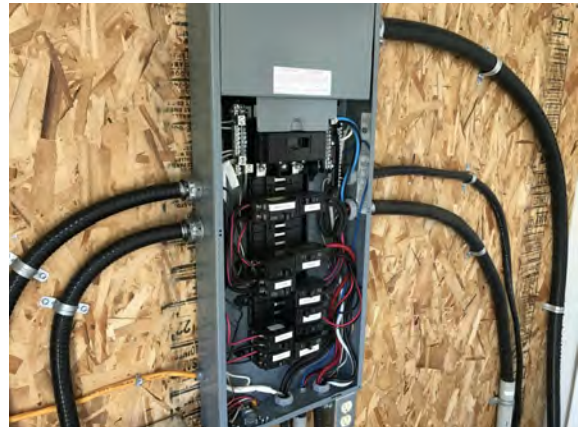
North Peace Fall Fair Grounds - Site - G401020

<b>Element Description</b>	
Name	G401020 - Site Panelboards
Installation Year	1979
Condition	3 - Fair
Expected Useful Life	40 Years
Remaining Useful Life	4 Years
Renewal Year	2025
Quantity / Unit of Measure	1 / Each
Unit Cost	\$7,000.00
Difficulty / Regional / Soft Cost Factors	0.50 / 1.867 / 1
Replacement Cost	\$6,534.50
