Peace River Regional District

**Facility Condition Assessment Report
Moberly Lake Community Hall**

November 16, 2021

Prepared by:
FCAPX a Division of Roth IAMS
Project No. 21075
www.fcapx.com

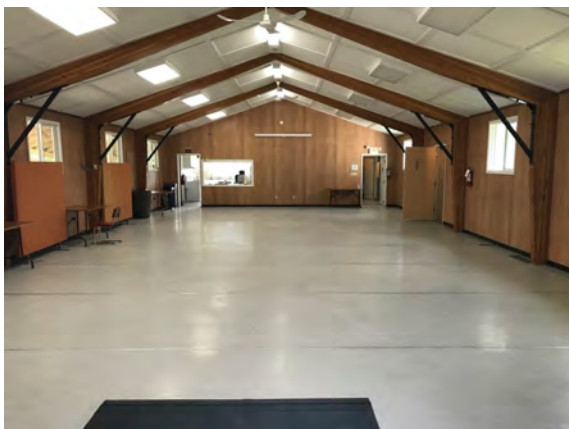
Moberly Lake Community Hall - B103001

No major deficiencies were observed or reported, however, there was evidence of past leaks in the great hall ceiling. It is recommended to remove interior finishes and assess for water damage to roof structures. As the remaining useful life falls outside the evaluation window for the oldest installed section, this system has been combined using the oldest known install date (1991).

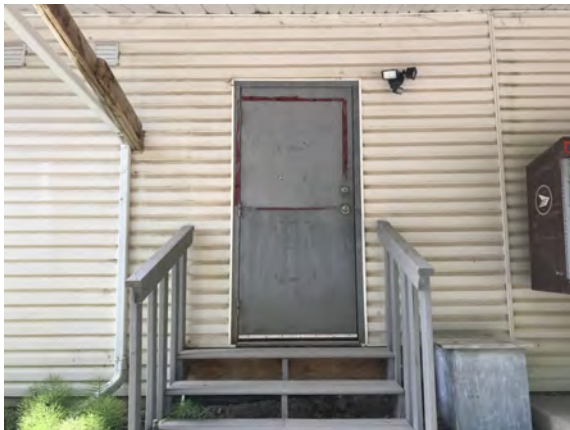
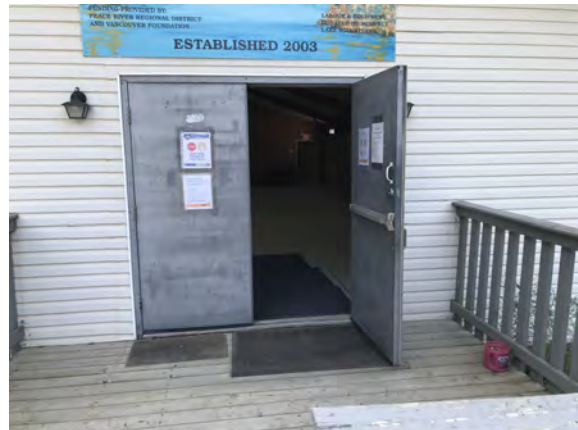
Moberly Lake Community Hall - B203023

No major deficiencies were observed or reported, however, metal doors are unpainted. Doors should be painted as a routine maintenance activity.

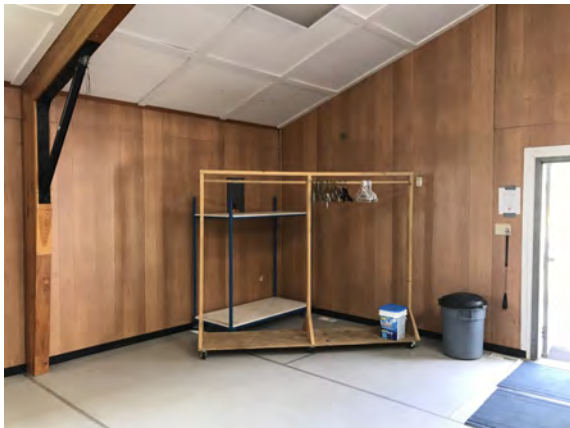
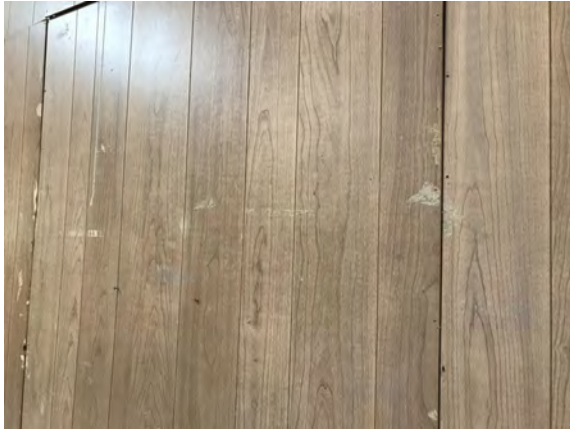
Moberly Lake Community Hall - C301022

The paneling has exceeded its expected useful life and is exhibiting wear and tear that is consistent with age including localized damage, panels pulling away from the walls, and an otherwise dated and worn appearance. Lifecycle replacement is recommended. The difficulty factor has been reduced to account for the material type.

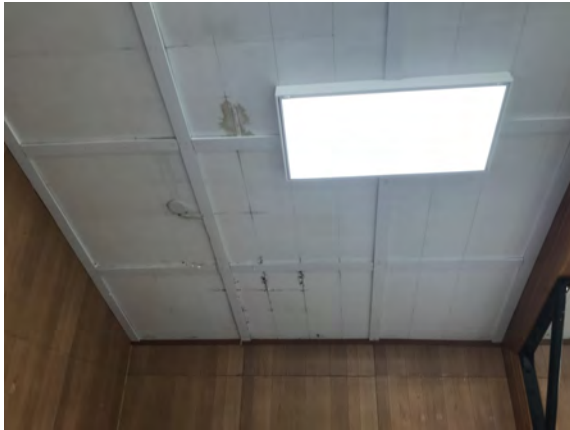
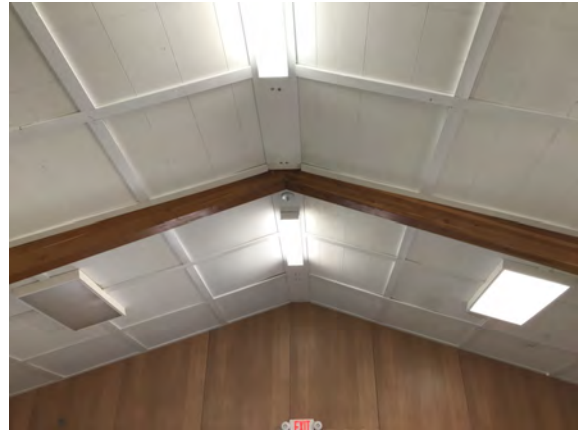
Moberly Lake Community Hall - C303004

Ceiling panels were stained from past leaks and deteriorated in some areas. Ceiling panels have exceeded their expected useful life and are exhibiting wear and tear that is consistent with the age of the materials. Lifecycle replacement is recommended.

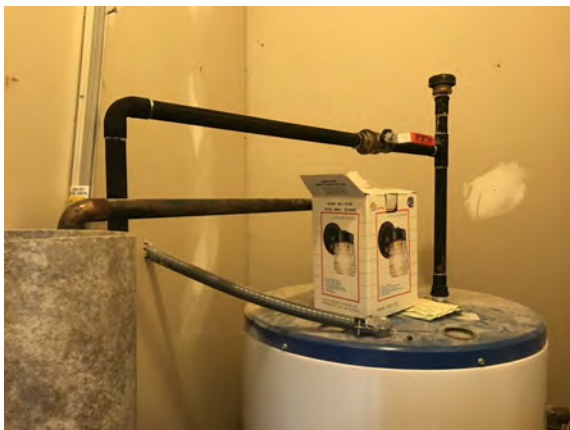
Moberly Lake Community Hall - D202035

No major deficiencies were observed or reported, however, based on the age of the unit, lifecycle replacement is recommended within the short-term evaluation period.

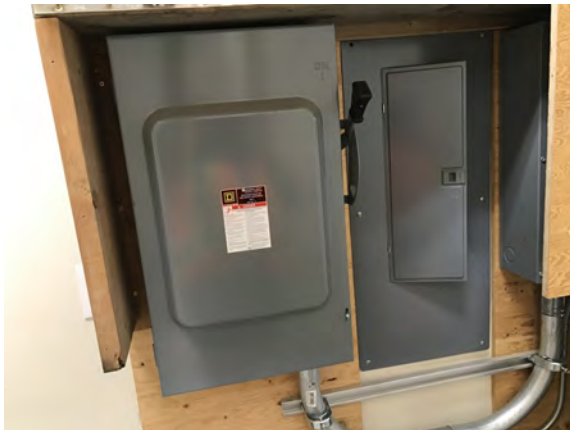
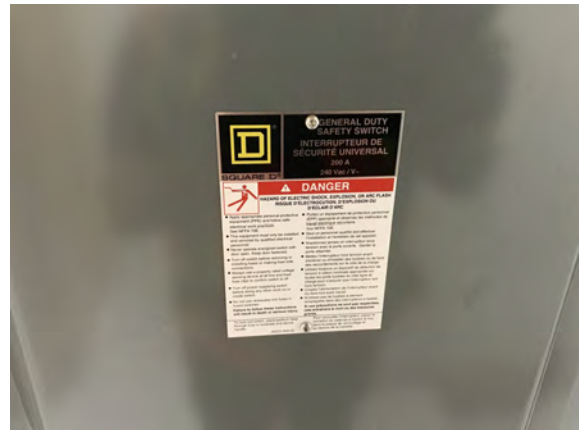
Moberly Lake Community Hall - D501025

No major deficiencies were observed or reported. The difficulty factor has been decreased to account for the small size of the switches. It is recommended to label the switches as a maintenance activity.

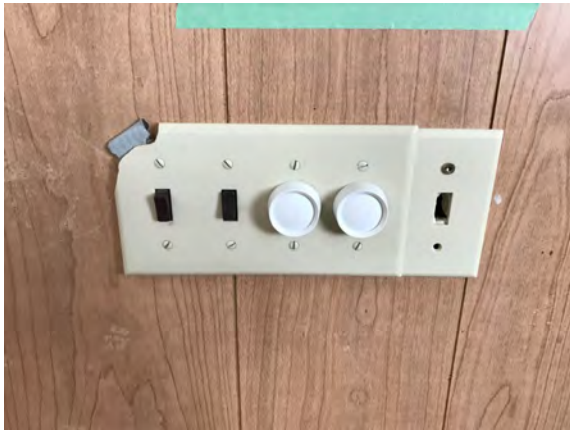
Moberly Lake Community Hall - D502001

No major deficiencies were observed or reported, however, some light switch faceplates were damaged or broken and should be replaced. The cost to complete these repairs is presumed to fall below the cost threshold for repair recommendations (\$5,000) and should be completed as a routine maintenance activity.
