**North Peace Fall
Fairgrounds - Structural
Condition Assessments
and BC Fire Code
Assessments (Rev. 1)**

June 23, 2023

Submitted to: Peace River Regional District
Prepared by McElhanney

Structural Condition Assessments and BC Fire Code Assessments (Rev. 1)

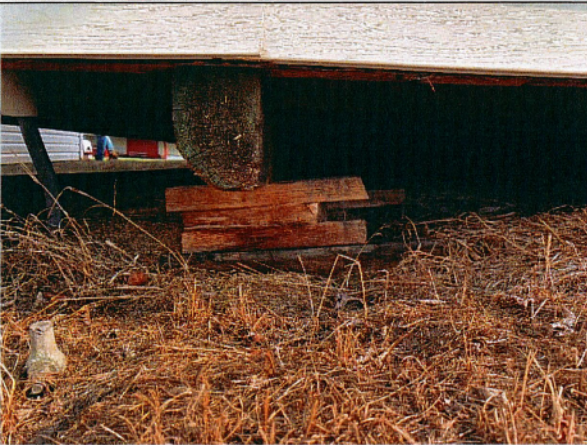
<p style="text-align: center;">Timber foundation on a pile of untreated lumber</p>

- All communal buildings that are being kept should be on a repair/replacement plan, particularly for the foundations as they are all insufficient in design and construction.

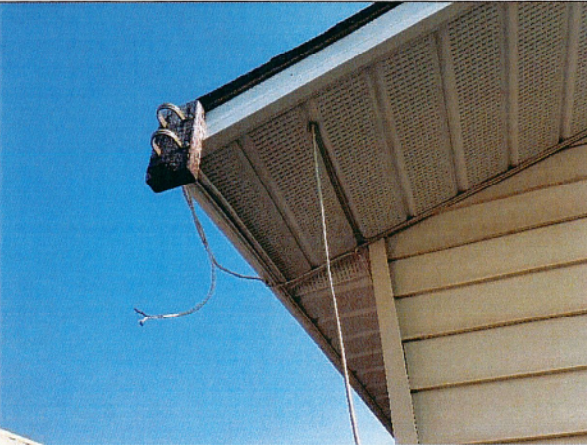
<p style="text-align: center;">Exposed wires</p>

- An electrician should be brought in to address exposed wires, the exposed busbar in the seacan shed, and the cabinets for all panels should be replaced with weatherproof lockable enclosures.

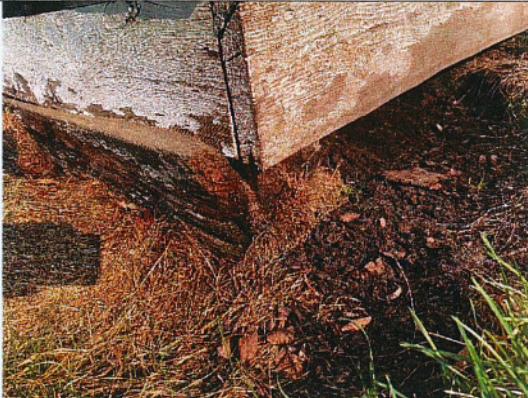
Untreated timber foundation on ground

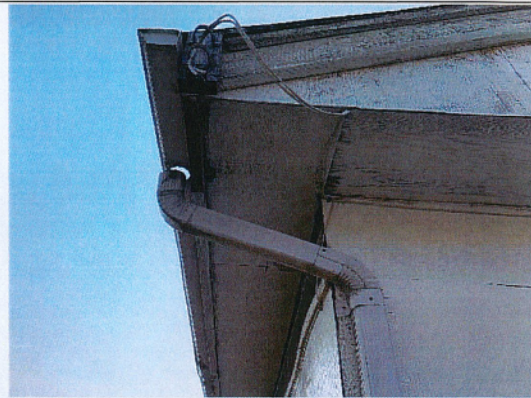
Exposed Wire

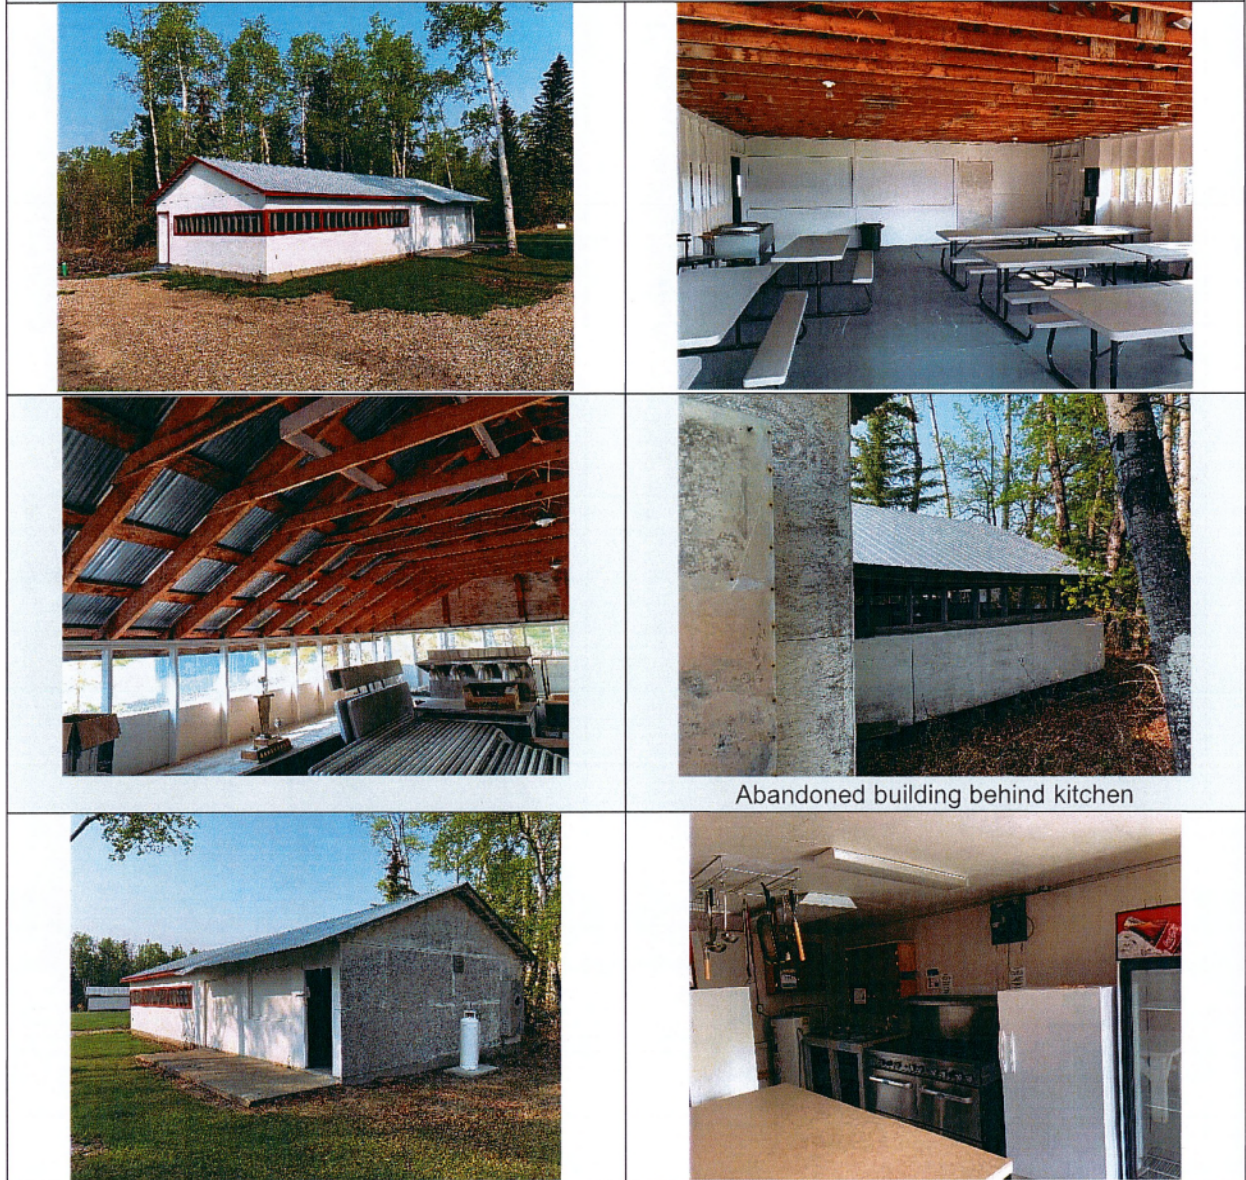
- The abandoned building behind the kitchen and dining hall is visibly in very poor condition, with a sagging roof, visible water damage, a poor foundation as noted in 4.2. Due to the condition of the building, it was only reviewed from the outside. As it is no longer used by the fair, it is not considered to currently have any large risk to safety, granted it be classified as abandoned and remain unused.

Abandoned building behind kitchen

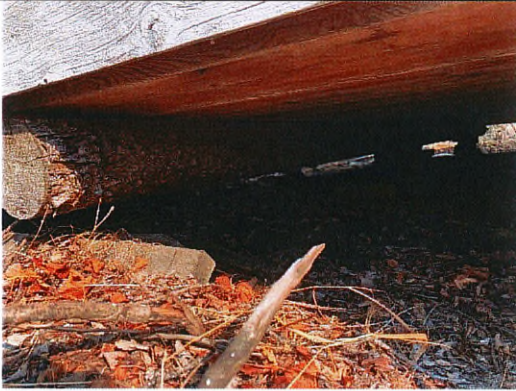
Round log foundation

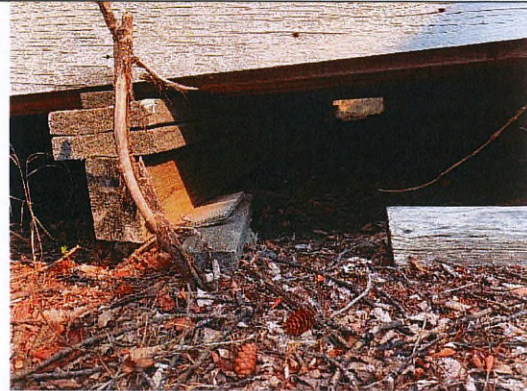
Untreated timber foundation

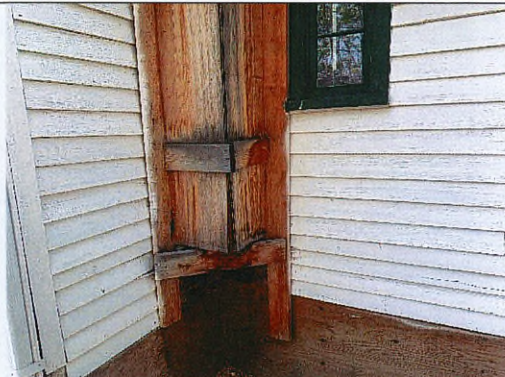
- The church chimney is inadequately supported in its current state and is unsafe.

Chimney requiring removal

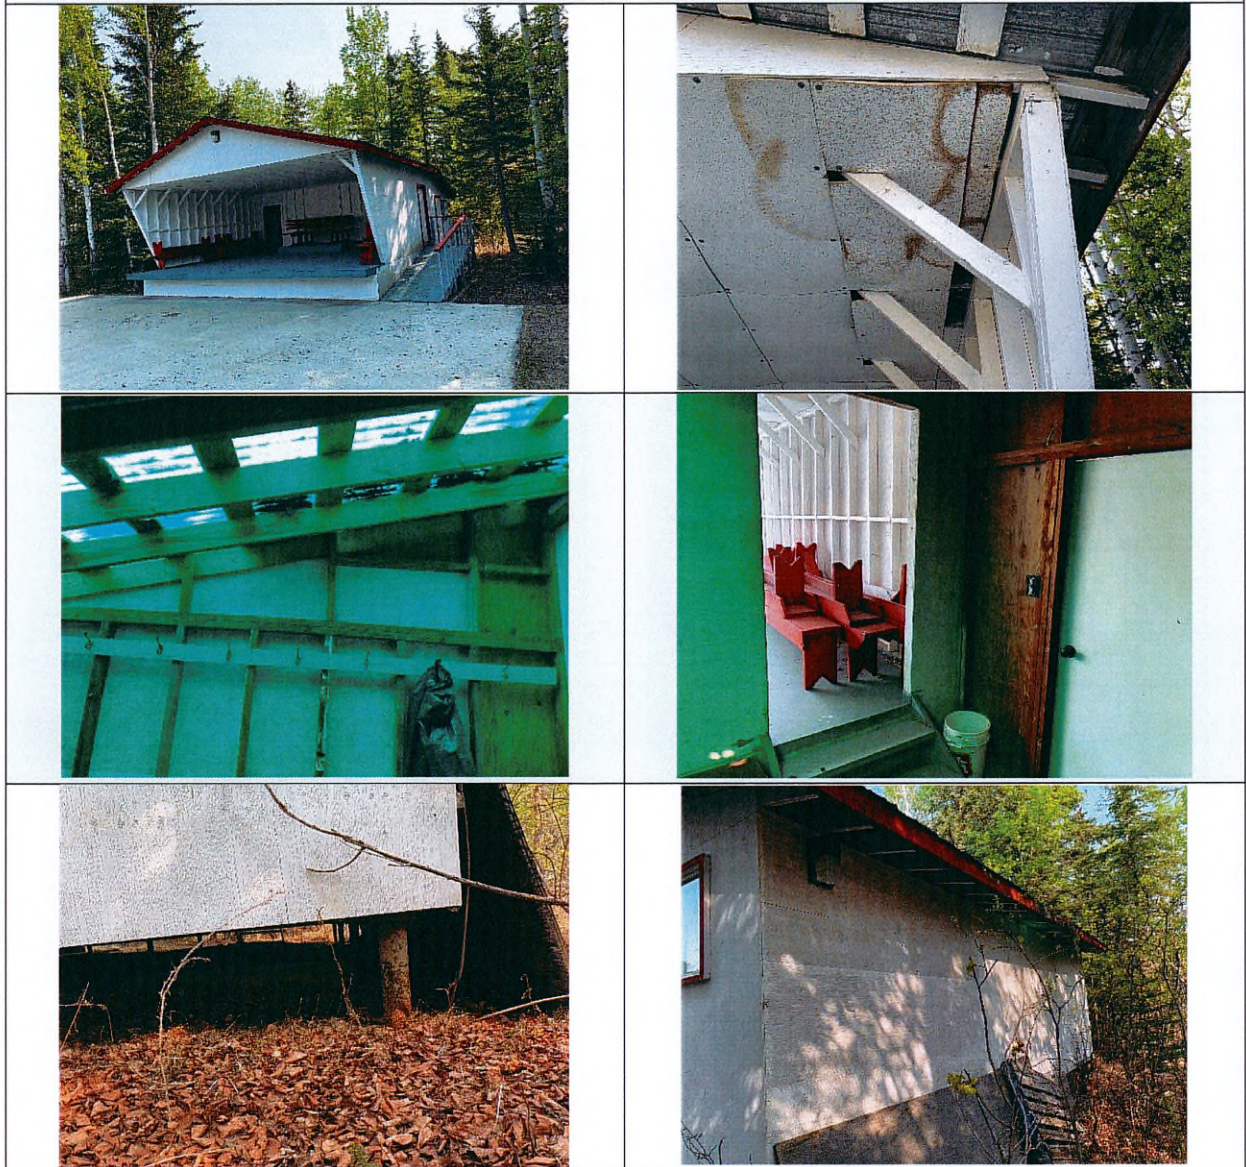
Element: Stage	GOOD	FAIR	POOR	NOT REVIEWED	NOT APPLICABLE
Condition:	<input type="checkbox"/>	<input type="checkbox"/>	<input checked="" type="checkbox"/>	<input type="checkbox"/>	<input type="checkbox"/>

- The highest risk building is the stage. The design of the stage appears to be insufficient for the expected loads, and the slanted design does not possess any additional bracing to prevent lateral movement in the direction of the tilted members. In addition, the stage is showing beginning signs of failure, severe water damage in a number of locations which may affect the structure's long-term performance; instability of the stage floor, and poor performance of the roof.

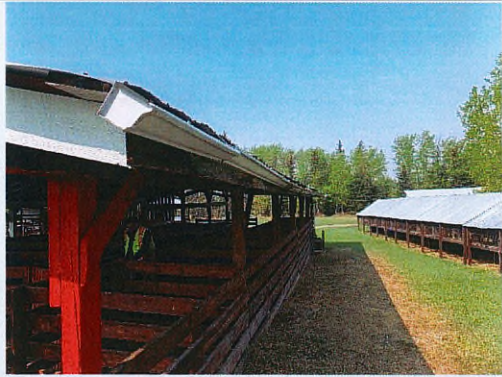
Gutters in poor condition

- All gutters and downspouts should be replaced.
- Any unnecessary or poorly sealed openings and penetrations should be better sealed by a contractor to prevent water ingress.

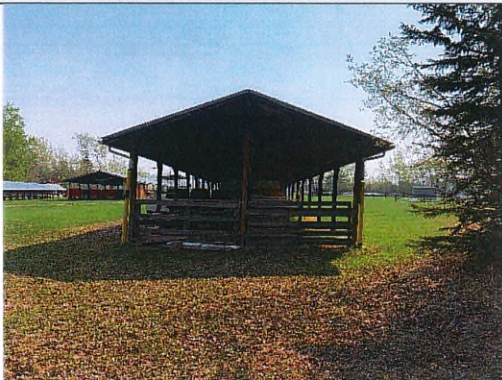
- A couple of the pole barns are severely tilted and have no adequate lateral bracing to support them from any wind loads in certain directions.
- The structures that appear to be failing and may not survive many more winter seasons or moderate weather events are the short pole barn by the arenas and concession stand, as well as the long pole barn in the middle of the property. These are immediate concerns and should be addressed.

Leaning (long pole barn)

- The barns identified to be noticeably failing in the above sections should have limited access to all people attending the fair, and they should be repaired or replaced in the very near future as they are a safety concern in their current state, and it will progressively get worse if not addressed soon. They should be labeled as a safety concern to the public through signage.
- All electrical panels should be provided with waterproof, lockable enclosures.
- All gutters and downspouts should be replaced.
- The other barns that aren't an immediate concern should be put on a repair schedule as they do have clear structural deficiencies that may eventually progress beyond repair if left unattended.
- The loose hay being stored openly should be moved and stored properly, away from public access.

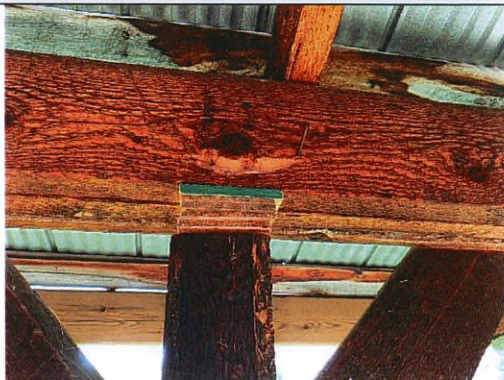
plywood shims column to beam

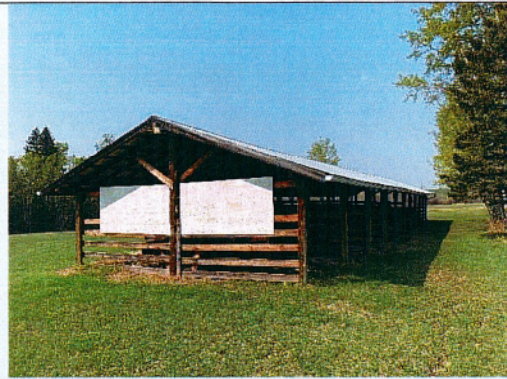
- All of the pole barns appear to have similar structural concerns, mainly with the performance of the framing elements. The main roof beams appear to be sagging at least slightly for majority of the barns, and some sections of framing have wood shimmed between columns and beams to reach the required height. Many of the beams are also incorrectly spliced, which may be contributing to accelerated failures.

Roof sagging in various locations

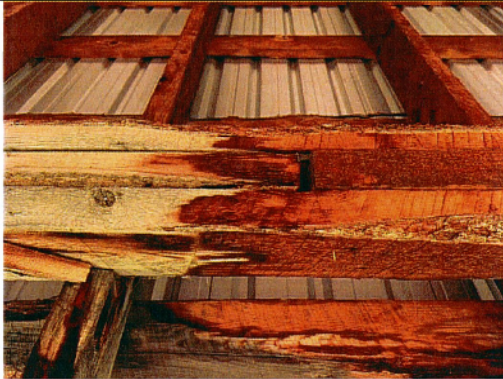
Incorrect splice

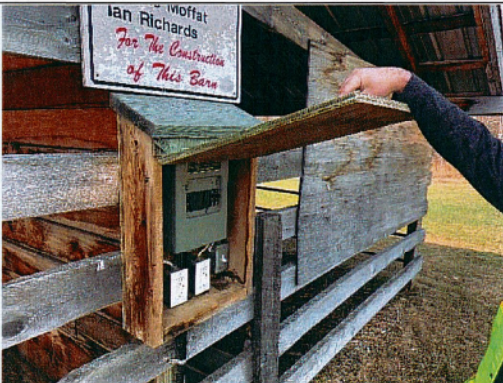
Unlocked not weatherproof panel enclosure

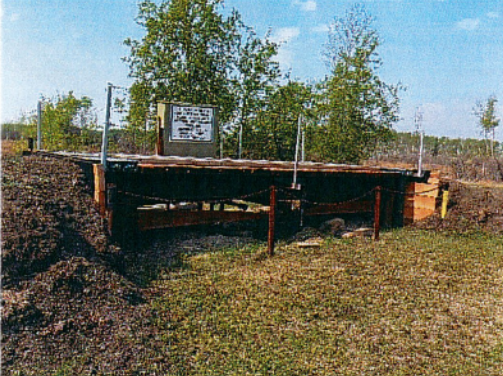
<p data-bbox="444 926 591 953">Weight scale</p>

- The scale was not included in our scope to conduct a full review of structurally, but there are some large concerns, mainly for code compliance. These concerns include:
 - No adequate railing on the edge of the scale.
 - No maximum weight rating posted.
 - Untreated timber supports.
 - Untreated wood retaining wall.
- The weight rating not being posted and missing adequate guardrails are the more immediate concern. If the weight rating is exceeded, the scale may fail beyond repair and may cause injury to anyone on or nearby at the time.

- The bridge should have railings and lighting added before the next fair.
- The scale should be reviewed and given a maximum weight rating that is posted on the scale.
- Railings should be added to the scale to prevent falling if people attempt to walk across it.
- The water tower should be decommissioned and demolished prior to the next fair as it is a safety hazard.

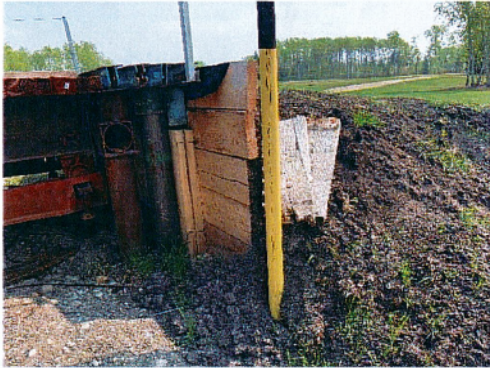
<p data-bbox="899 919 1370 947">Weight scale with untreated retaining wall</p>				
  <p data-bbox="480 1333 558 1360">Bridge</p>

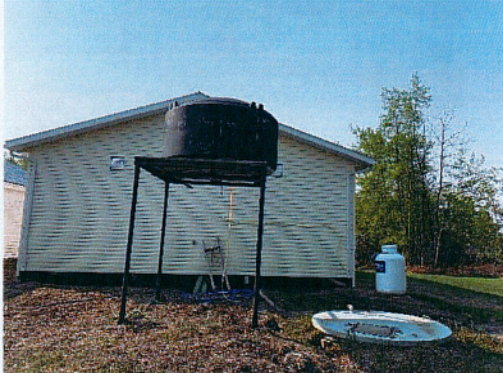
<p data-bbox="1062 1333 1208 1360">Water tower</p>

- The water tower was noted to be out of commission and unused, however the supports are very visibly leaning due to the positioning of the water storage container and the inadequacy of the initial structure. It should be fully taken apart and removed to avoid risk of injury to passersby.

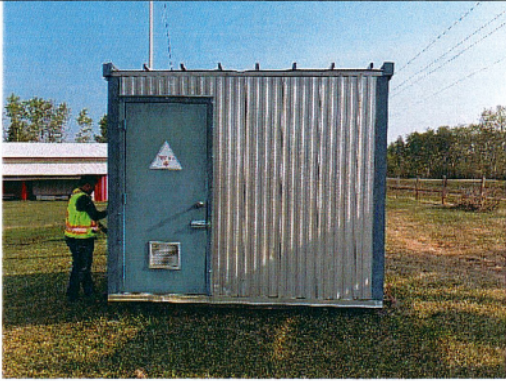
<p data-bbox="472 1747 563 1774">Seacan</p>

- A number of small storage containers and structures were comprised of small seacan type buildings on steel or concrete supports. These appeared to be in generally good condition with no apparent structural concerns.
- One of the containers has an electrical panel with exposed busbar, while the container is locked to the public, this should be reviewed for employee and volunteer safety.
