ROLLA WASTEWATER TREATMENT PLANT CONDITION ASSESSMENT

FINAL - 2020-10-26

PEACE RIVER REGIONAL DISTRICT
CONFIDENTIAL
PROJECT NO. 201-07251-00
AUGUST 2020

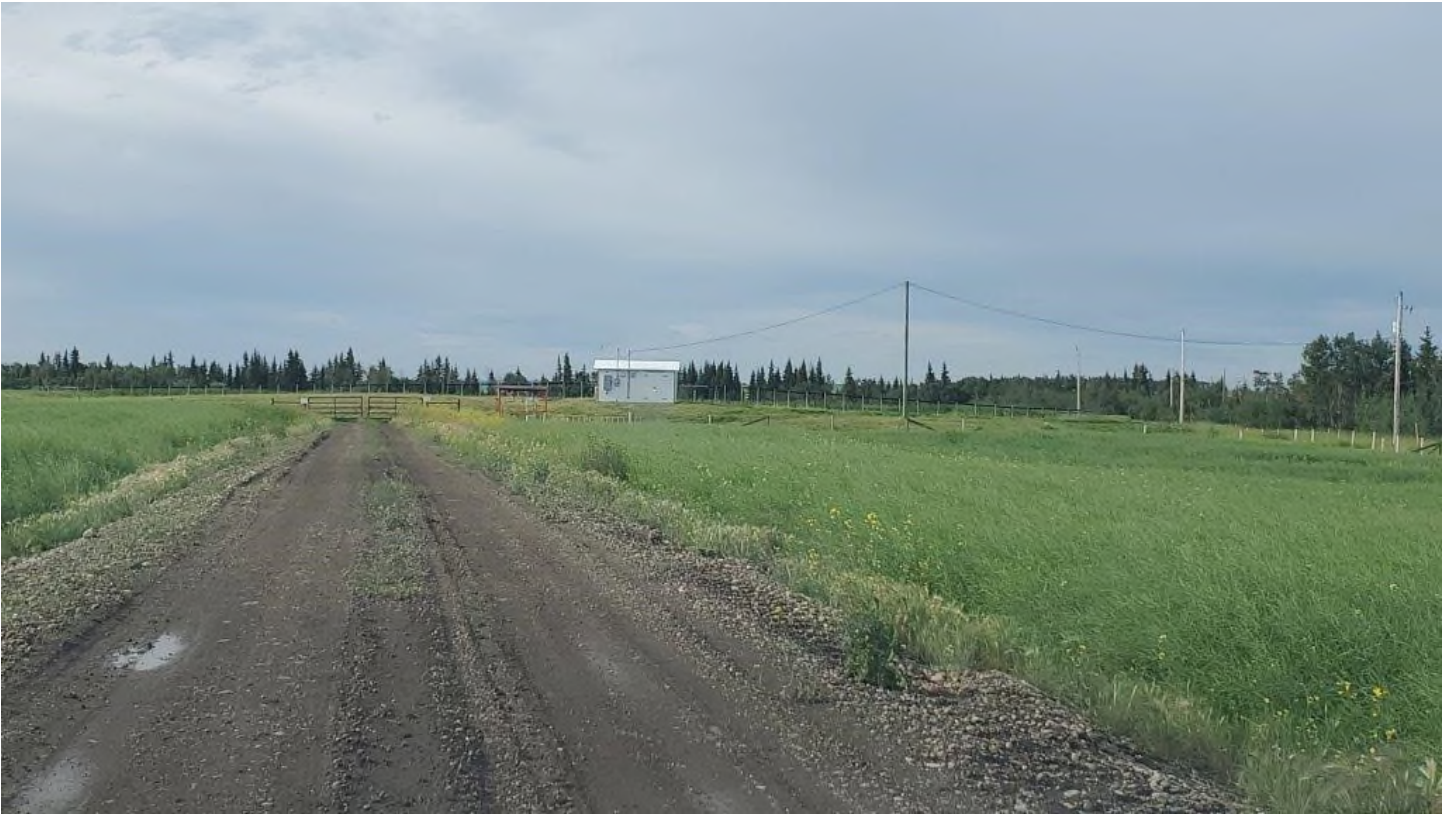
Figure 3: Access Road Photo from Assessment Site Visit (2020-07-28)

The treatment plant site is accessed off Sweetwater Road, 0.5km east of Rolla Road. The narrow gravel road is 1600m long and is maintained by the local farmer and gas company. It is passable during dry conditions for high clearance vehicles. The access road for the treatment plant is 400m long and is maintained by PRRD.

The portion maintained by PRRD should be improved for better access for lower clearance vehicles and all-weather travel. An estimated volume of gravel to supplement the access road and parking area was determined to be 200m long by 4m wide, by 100mm thick, or 80 m³.

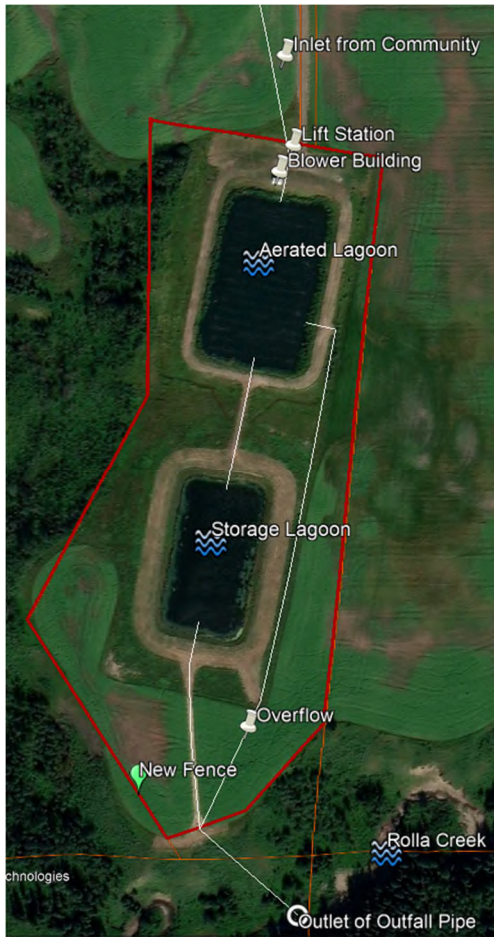
Figure 4 - Proposed New Fence

One portion of the property not surrounded by fence is the outfall piping. Access to the valves and discharge piping during annual discharge is through cultivated fields. This area should be surrounded by fence with a road access to the discharge piping manholes. Encompassing the entire property would require 1200m of barbed wire fence.

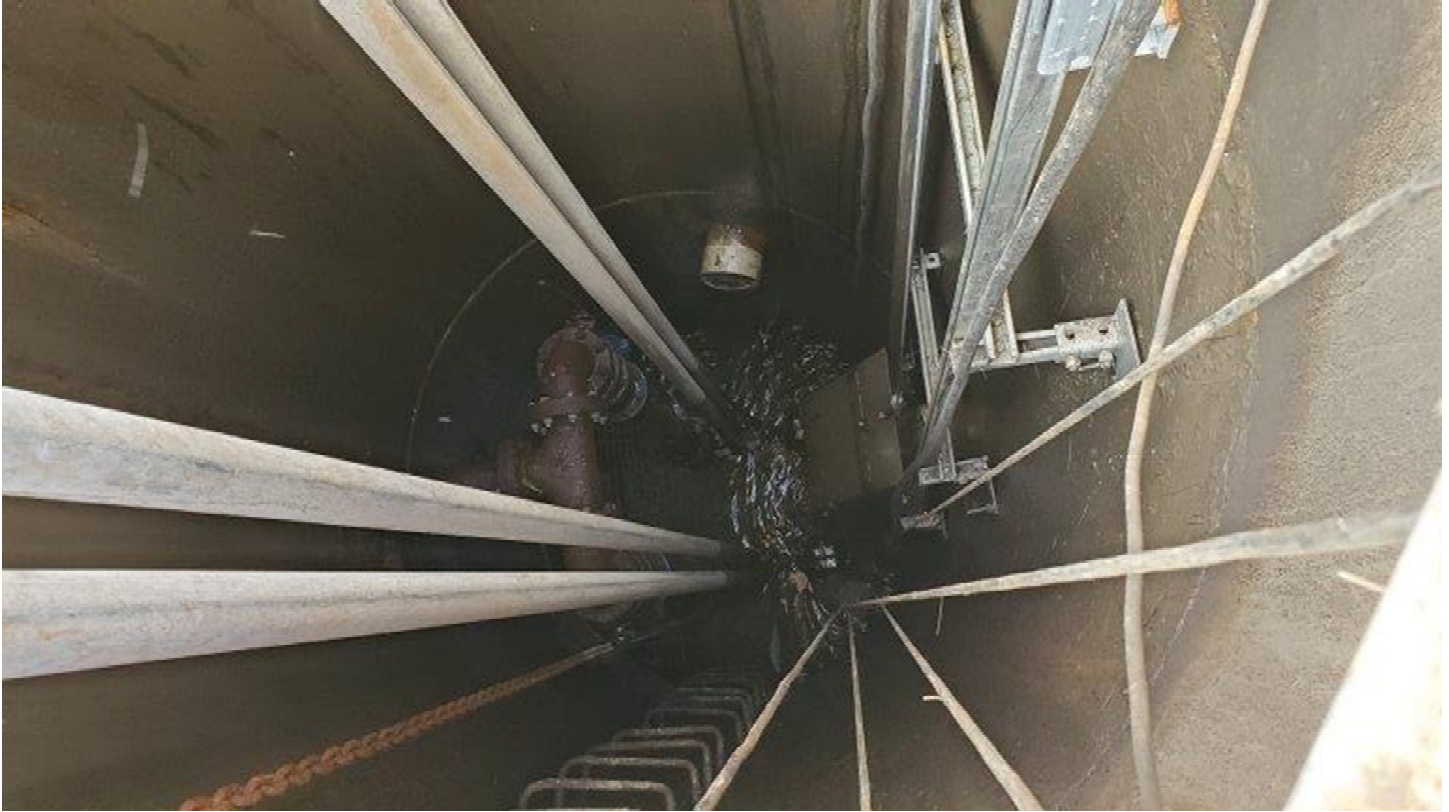
Figure 5: Lift Station Manhole Photo from Assessment Site Visit (2020-07-28)

The lift station was found to be generally in good condition with several urgent repairs to be made.

It is currently not possible to enter the lift station without a portable man-rescue tripod system. In addition, several rungs are missing from the ladder which should be replaced, to facilitate entry, even with a man-rescue tripod system. The existing ladder rungs should be removed so that personnel are not tempted to use them. Portable ladders should be used.

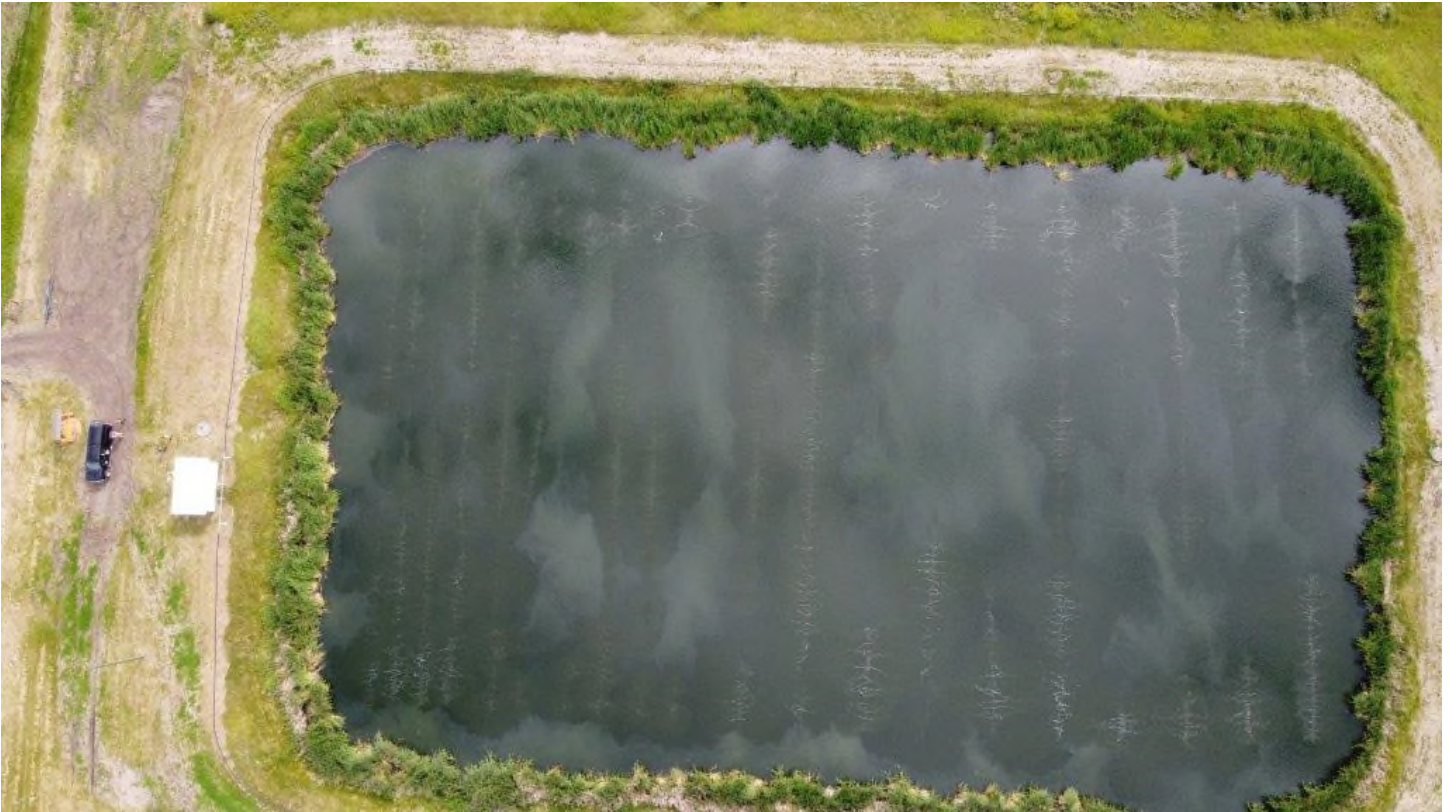
Figure 7: Aeration Lagoon Aerial Photo from Assessment Site Visit (2020-07-28)

The size of the lagoons and height of the berms were originally designed based on expected annual flows. The population of Rolla is not growing, however, wet weather can cause increased infiltration into the system. Anecdotally from the operators, consecutive wet years can cause water levels to be very high. However, to the operators' knowledge, no overflows have occurred. Weekly inspections by operators include monitoring the lagoon levels.

Otherwise, the berms for both lagoons appear to be in satisfactory condition. There are no shrubs or trees growing in the berms. No evidence of burrowing animals. No evidence the lagoons have ever topped, or any erosion on the banks.

We would recommend that the Cell #2 lagoon level gauge is calibrated with the lagoon overflow level. This could be done with a survey of the overflow level from Cell #1 and transposing that level to the Cell #2 level gauge.

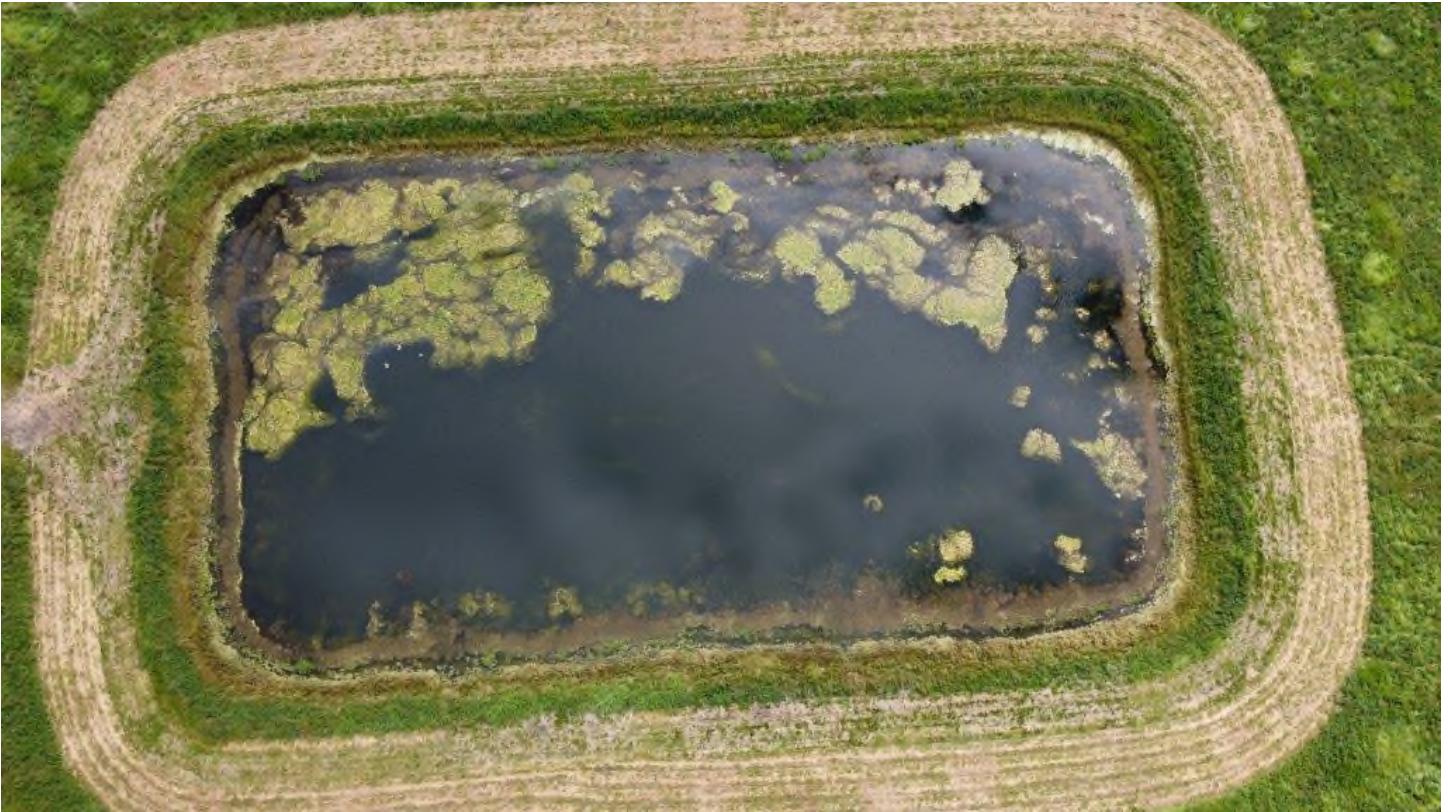
Figure 8: Storage Lagoon Aerial Photo from Assessment Site Visit (2020-07-28)

The storage lagoon was constructed in 2002. This asset is generally in good condition with the opportunity for future upgrades if necessary.

There are no shrubs or trees growing in the berms. No evidence of burrowing animals. No evidence the lagoon has ever topped, or any erosion on the banks.

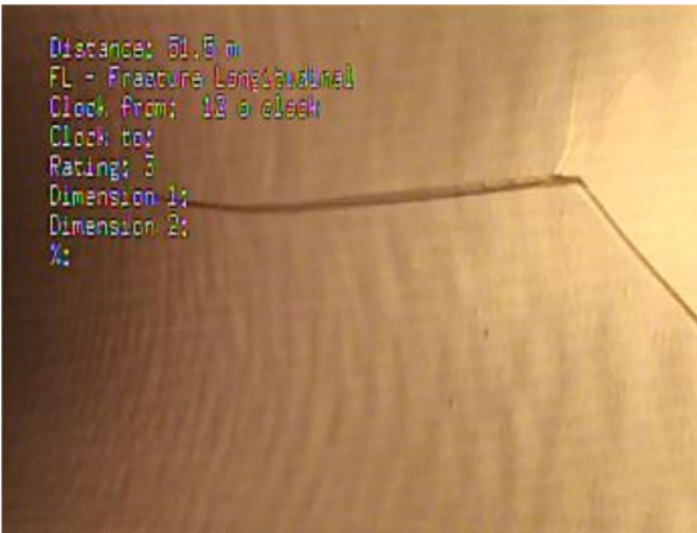
Figure 9 - Longitudinal Fracture in Overflow Pipe

As can be seen from the CCTV reports, there are several deficiencies in the overflow piping. One section has a sag, there are several sections of “bent” pipe, and a couple structural failures in the PVC pipe.

This overflow pipe from the aerated lagoon to the manhole on the outfall pipe is for emergency purposes only if the lagoons happen to overflow in a given year. It is not critical that the pipe be kept in perfect condition due to the unlikelihood that it would ever be used. The deficiencies that have been noted will not affect the flow capacity. However, over time, the structural deficiencies will get worse and eventually the pipe may collapse.

The pipe will likely serve its purpose for many years however, it may suddenly collapse without anyone knowing it. It is important to repair the structural failures. We would recommend spot repairs instead of full pipe replacement.

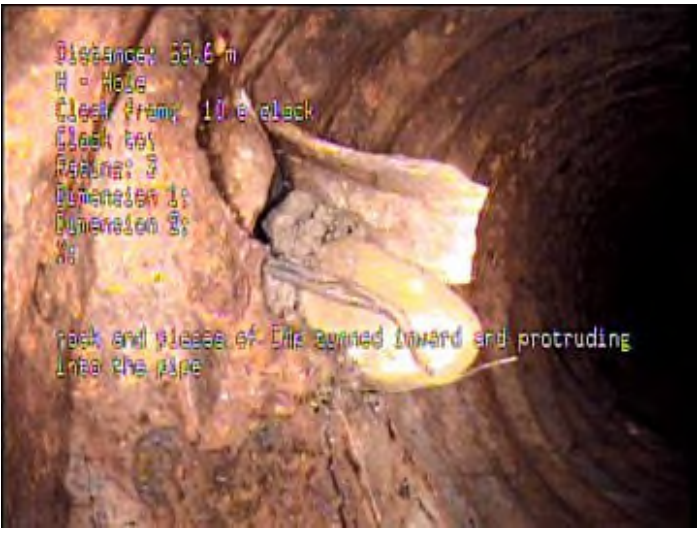
Figure 11 - Protrusion in Steel Outfall Pipe

- Corrosion hole on side of pipe – 14m from SMH 9S toward outfall
- Stick stuck in pipe - 15m from SMH 9S toward Outlet
- Roots protruding at joint – 17.7m from SMH 9S toward outfall
- Hole in pipe at 26m from SMH 9S toward outfall
- Deformed (dented) pipe at 40m from SMH 9S toward outlet
- Protrusions through pipe wall at 70m from SMH 9S
- Gravel debris just inside outfall end

This pipe should be replaced, however the constructability challenges with installing a new pipe down the steep bank make this a complex replacement.

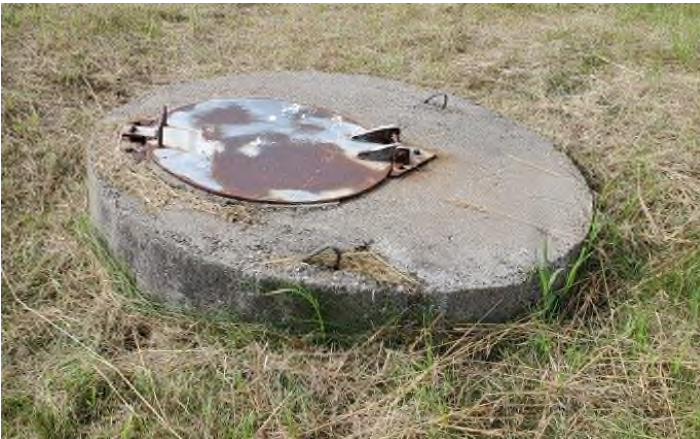
The manhole bases and barrels appear to be in satisfactory condition. However, the lids were rusted and not secure. Recommendation to replace six manhole lids with more common cast iron frame and cover.

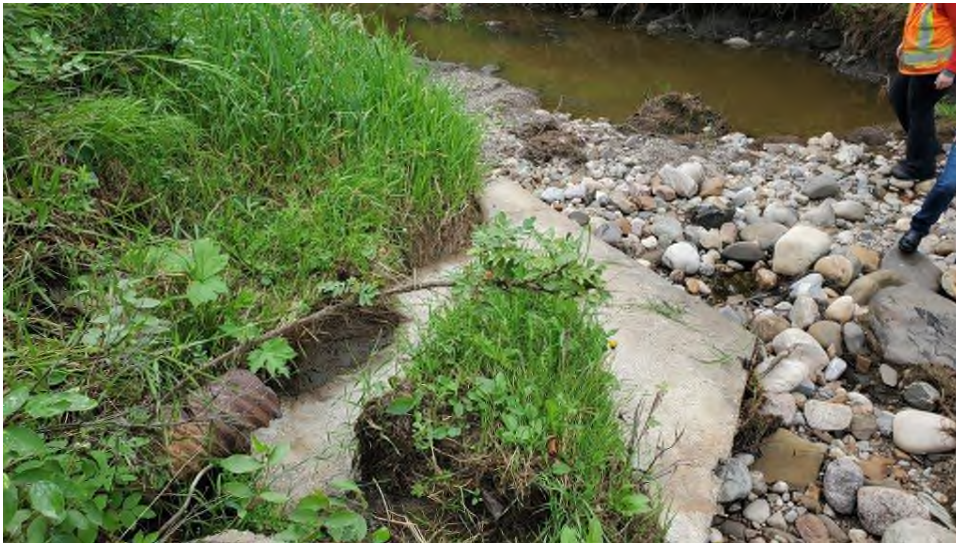
Figure 13: Outfall Structure Photo from Assessment Site Visit (2020-07-28)

The splashpad has evidently settled and moved somewhat over the years. The splashpad should be replaced or shored up, and protect with riprap to prevent it moving again.
