Condition Assessment Report

YXJ Subdivision Water Network and Sewer Network

Draft Report Prepared for:
Peace River Regional District

By:
Pure Technologies, a Xylem Brand
November 27th, 2020

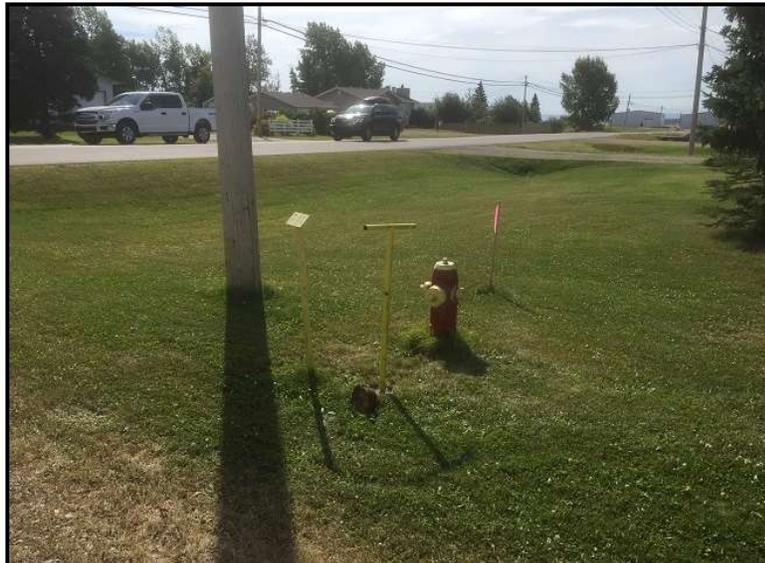
All hydrants, hydrant isolation valves, all main line valves and any located service valves (curb-boxes) in the subdivision were sounded using an X-Mic ®. This is an electronic device similar to a microphone or a stethoscope with which a trained operator can detect leaks on a water pipe. One leak was located during the survey. This was a leak on a hydrant lead on the hydrant located outside 10330 257 Rd. (Figure 5.1). Good leak noise was audible on the hydrant and on the secondary isolation valve. When the isolation valve was operated, the leak noise increased and water began to surface in the valve box. This indicated that the valve itself was the likely source of the leak and maintenance is required as soon as possible.

Figure 5.1: Leak on hydrant located outside 10330 257 Road

Prior to this survey a similar leak on the southernmost hydrant on Rowantree Ave had been noted and stopped by Peace River Regional District. These two leaks were the likely cause of any ongoing substantial water loss within the community. Meter readings at the main subdivision supply were taken 48 hours apart after the leak detection survey with one of these leaks still needing attention.

These revealed an average of 16 l/h being fed into the system which is within the bounds of normal domestic usage. The repair of the remaining hydrant leak should reduce this further.

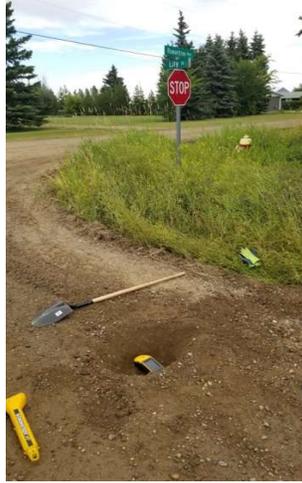
Figure 5.3: Inline Valve#3

Type: 6-inch Gate Valve
Location: South of Lily-Rowantree

Notes: Buried 1 foot under gravel and raised back up while onsite. Value stuck and could not be turned.

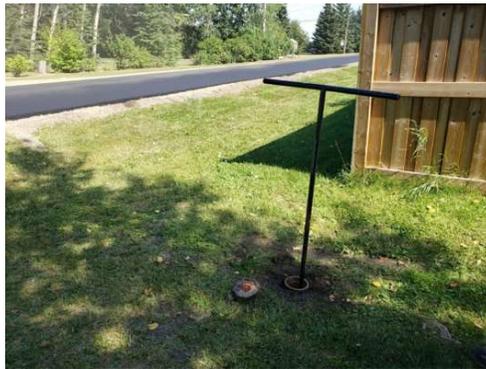
Figure 5.4: Inline Valve#4

Notes: Cap was stuck on and repaired onsite

Turn count: approximately 17.75 turns; fully closed and fully opened

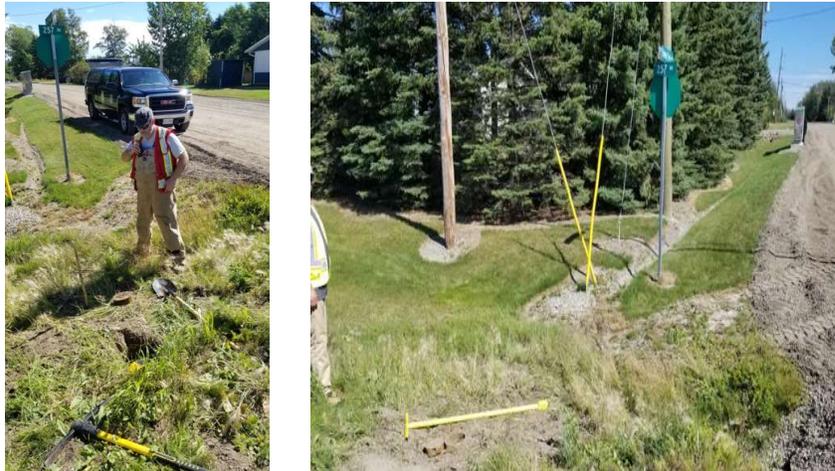
Figure 5.5: Inline Valve#5

Notes: Buried 1 foot in ditch; raised back up while onsite

Turn count: approximately 19.5 turns; fully closed and fully opened

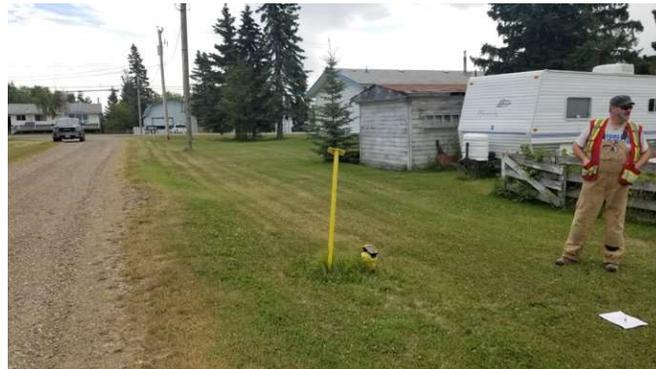
Figure 5.6: Inline Valve#6

Location: Off of gravel right of way, southeast of 257 road and Rowentree

Turn count: 20.25 turns; fully closed and fully opened

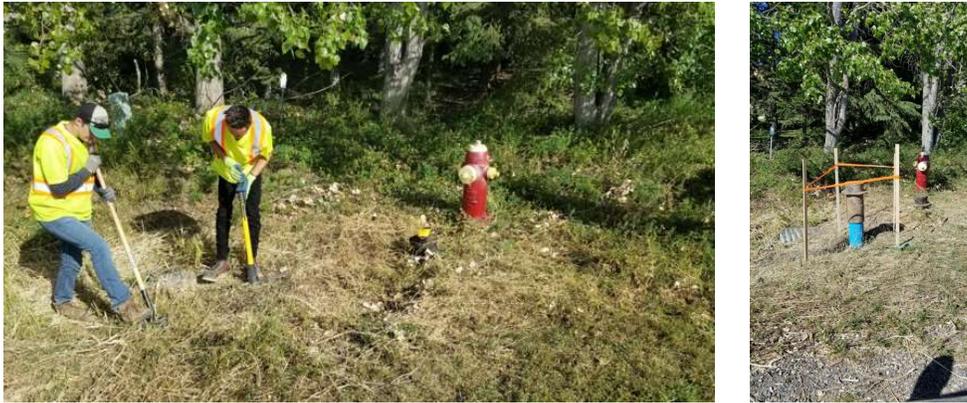
Figure 5.7: Inline Valve#7

Location: On 242 road (242 road – 257 road intersection)

Notes: Valve was buried, and casing broken; cleaned up and raised. Valve could not be exercised.

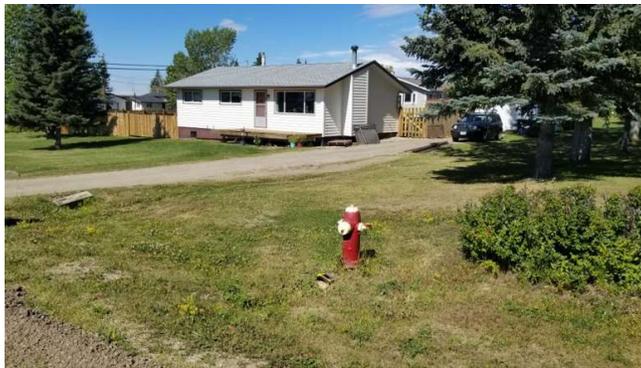
Figure 5.8: Hydrant A

Turn count: 19.5 turns; fully closed and fully opened

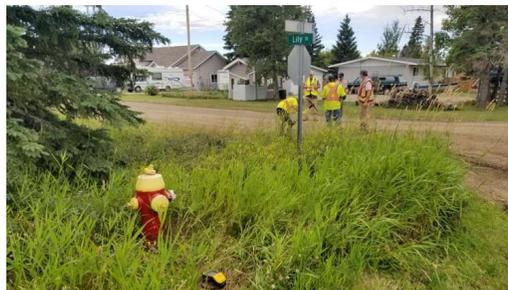
Figure 5.9: Hydrant B

Turn count: 20.25 turns; fully closed and fully opened

Notes: Keys stuck on extension

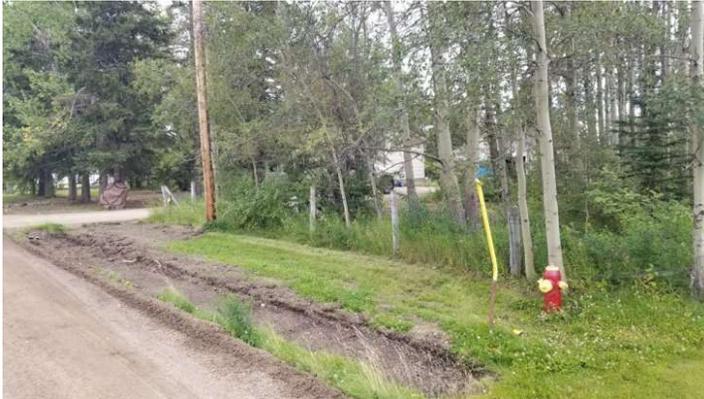
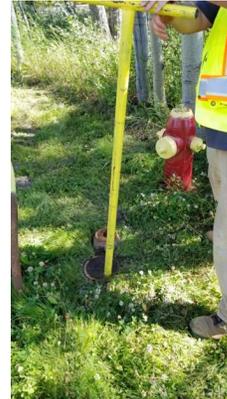
Figure 5.10: Hydrant C

Turn count: 20.5 turns; fully closed and fully opened

Notes: Leaks when valve operated

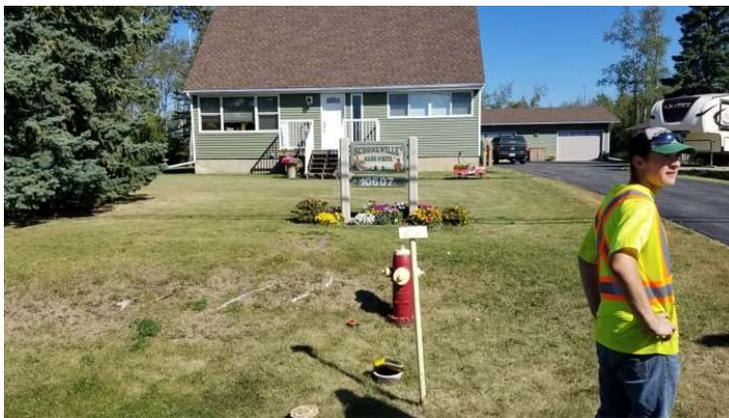
Figure 5.11: Hydrant D

Turn count: 20.25 turns; fully closed and fully opened

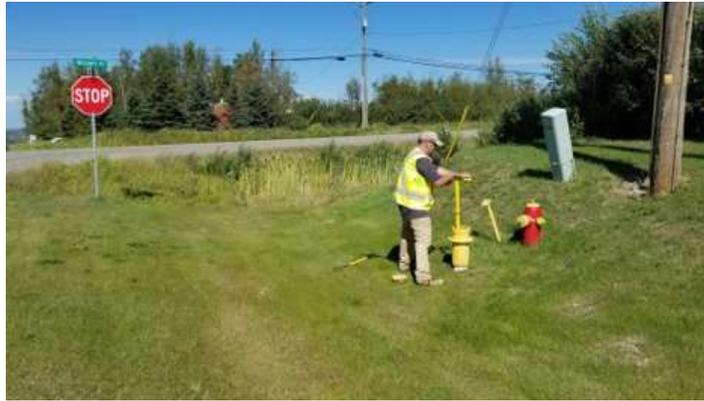
Figure 5.12: Hydrant E

Turn count: 20.5 turns; fully closed and fully opened

Notes: Leaks when valve operated

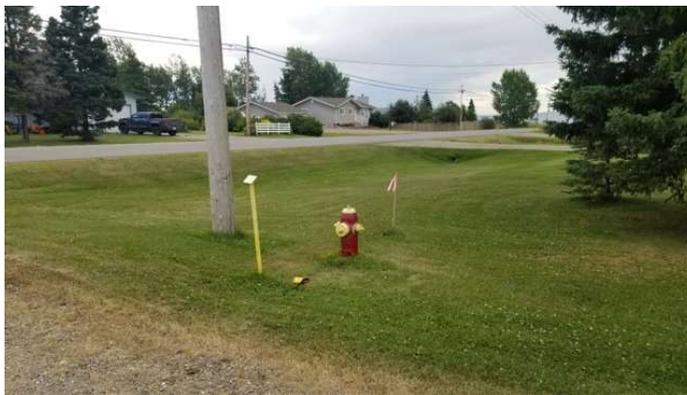
Figure 5.13: Hydrant F

Turn count: 20.25 turns; fully closed and fully opened

Notes: Leaks when valve operated

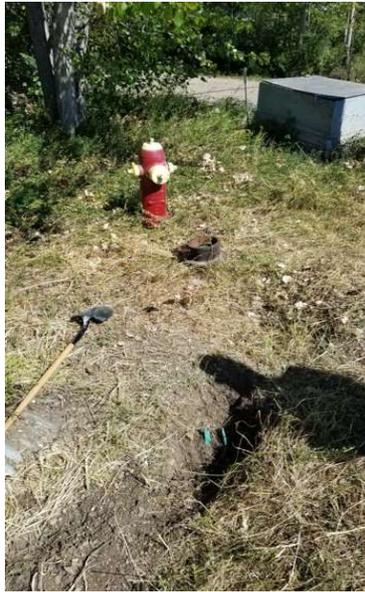
Figure 5.14: Hydrant G

Notes: Valve extension not on valve nut; could not be exercised

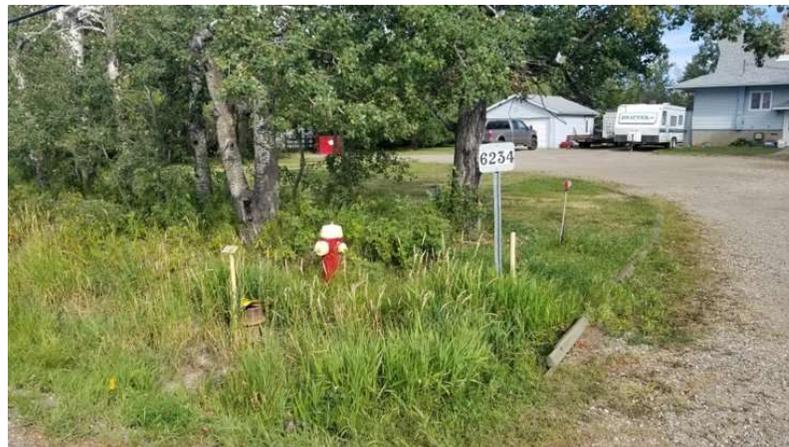
Figure 5.15: Hydrant H

Turn count: 20.25 turns; fully closed and fully opened

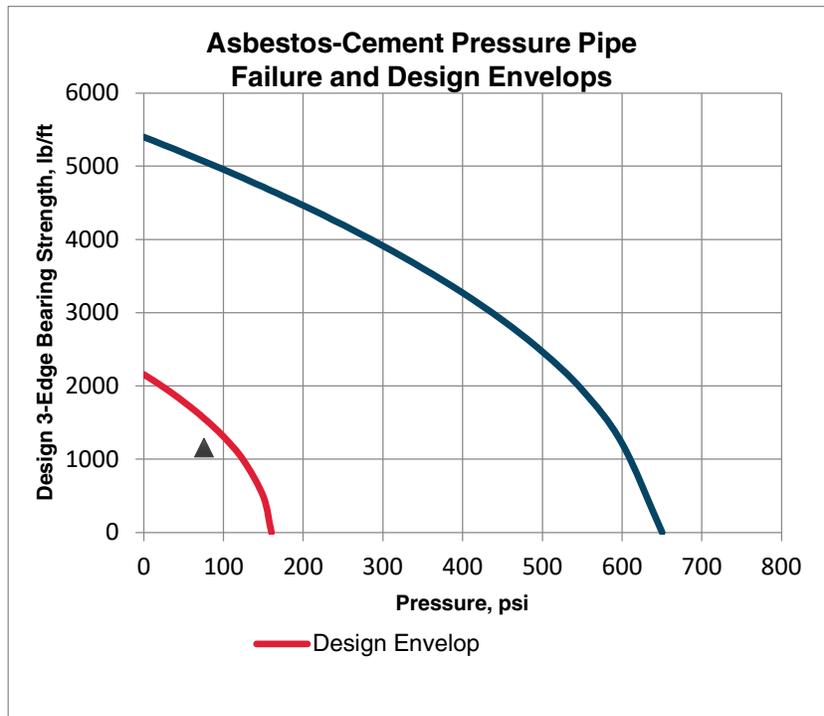
Figure 7.4: Design and Failure Envelop for 6-in Class 150 AC Water Pipe

Using the AWWA C400 design (i.e., burst) internal pressure of 632 psi and a design external (crush) load of 5400 lb/ft, the failure envelop for the 6-inch Class 150 AC pipe can be calculated and plotted (blue line in Figure 7.4). Then applying the AWWA C401 recommended factors of safety of 4 for internal pressure and 2.5 for external (crush) load, the allowable or design envelope can be established (red line in Figure 7.4). Figure 7.4 shows the two curves, failure and design, for a 6-inch Class 150 AC pipe meeting the performance requirements of AWWA C400.

Superimposed on this design and failure graph in Figure 7.4 is the intersection of the maximum working pressure of 75 psi and the external load of 1,210 lb/ft. This point falls well below the design line, meaning the pipe exceeds the recommended minimum safety requirements in AWWA C401. Table 7.2 below shows the factors of safety in pressure and external crush load for the 75 psi maximum working pressure and 9 ft. of soil burial with live load.

The AWWA C401 design check found the pipe, assuming no significant degradation, to be operating well within the defined safety limits recommended by the AWWA standard. In fact, the factor of safety in pressure was 8.0 and for external load 4.19. This is versus a recommended minimum value of 4.0 and 2.5, respectively.
