Dawson Creek Landfill Closure Plan and Assessment

Peace River Regional District

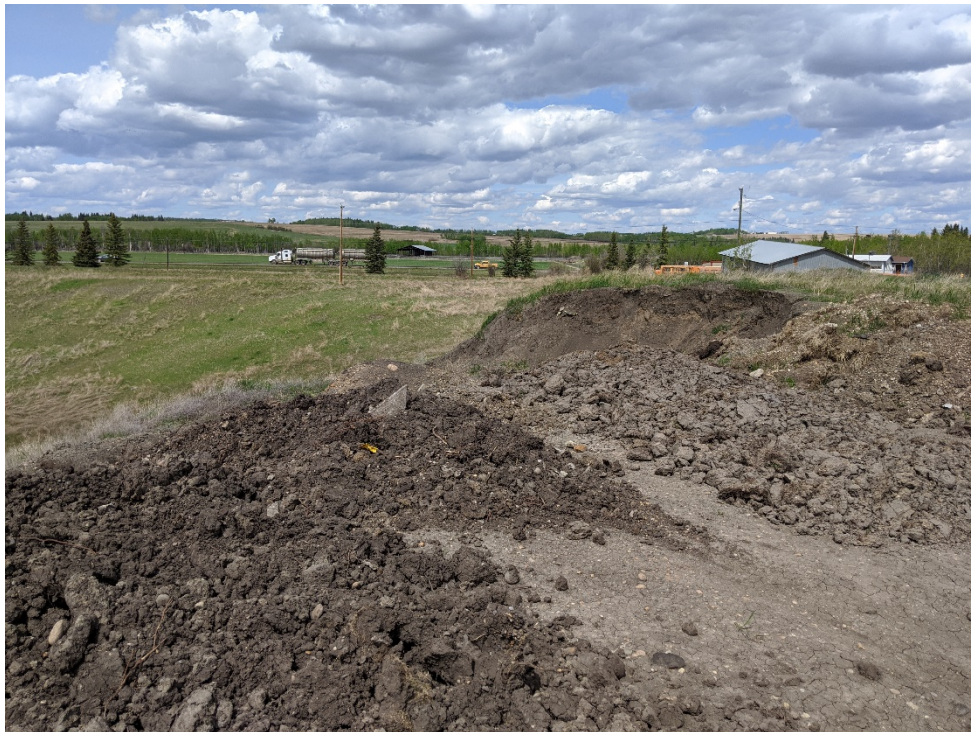
IMG_20200528_132226.jpg

Photo 2 - Loose soil and steep slopes along the top of slope of the landfill cover.
Looking north at center of the site.

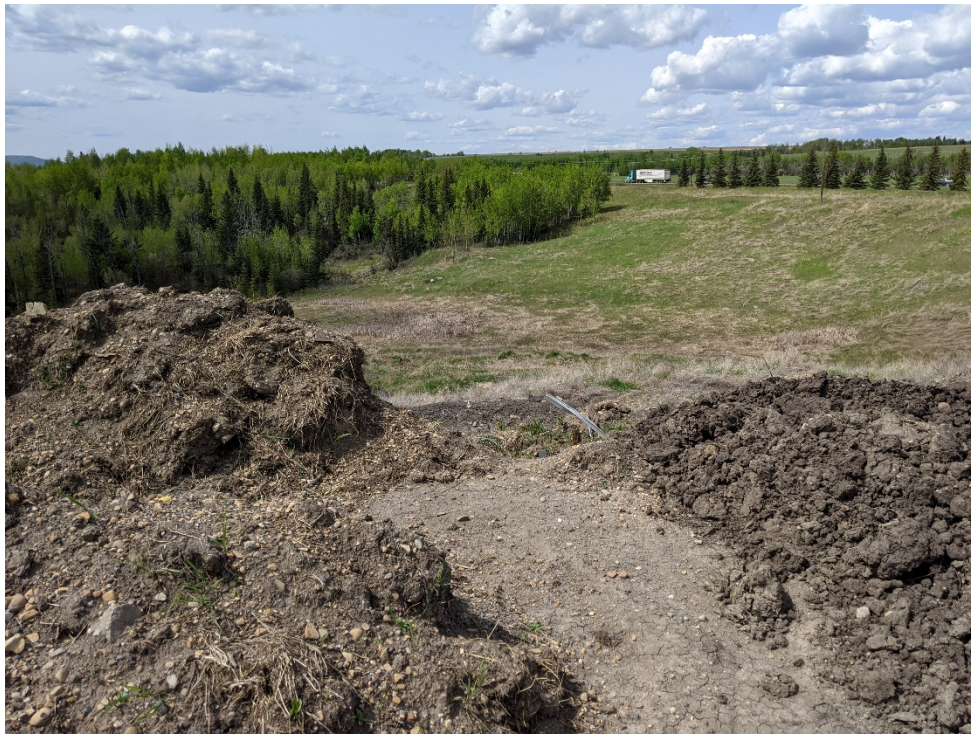
IMG_20200528_132227.jpg

Photo 3 - Loose soil in foreground at the top of the landfill slope. General topography looking southwest from the center of the site.

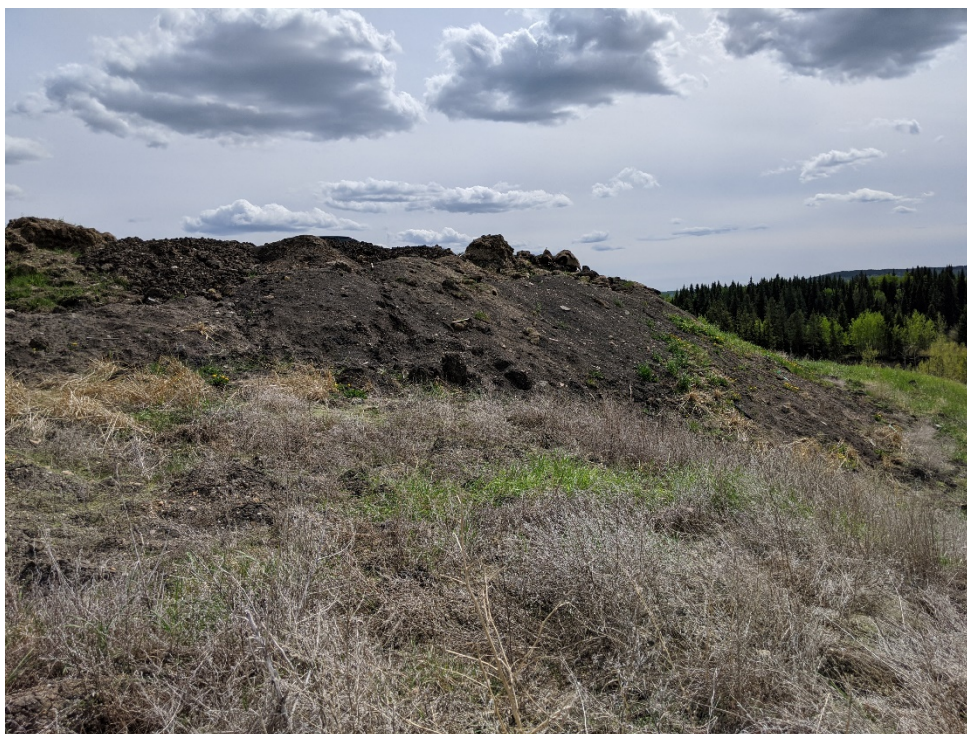
IMG_20200528_132526.jpg

Photo 5 - Exposed, loose soil at the top of the landfill's south slope. Looking east.

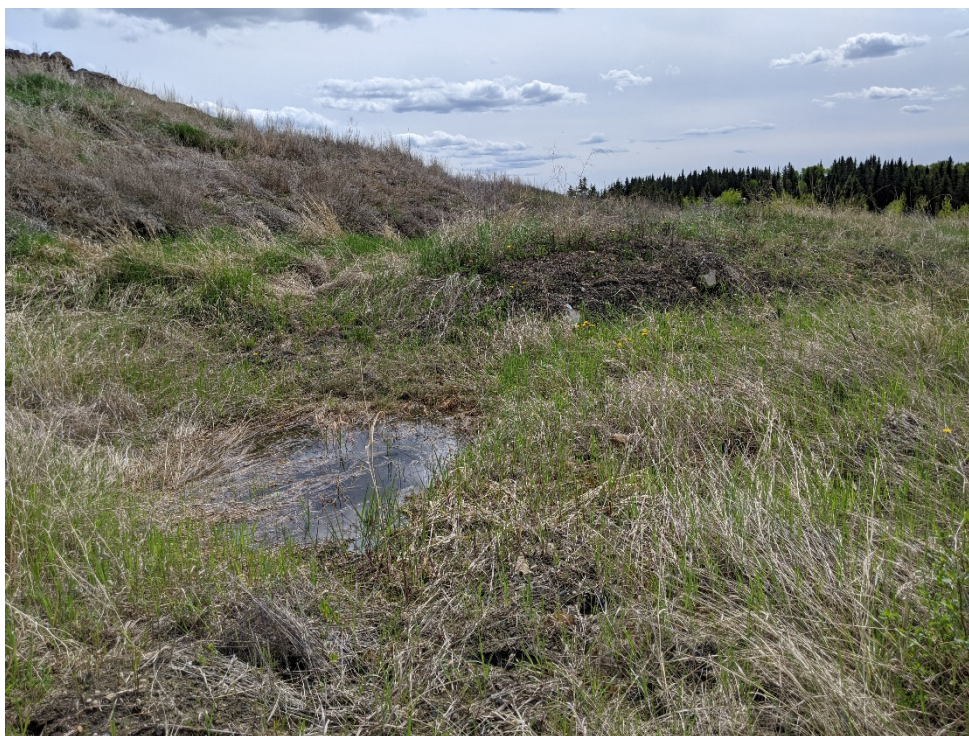
IMG_20200528_132722.jpg

Photo 6 Pond near toe of southwest landfill slope. Looking east.

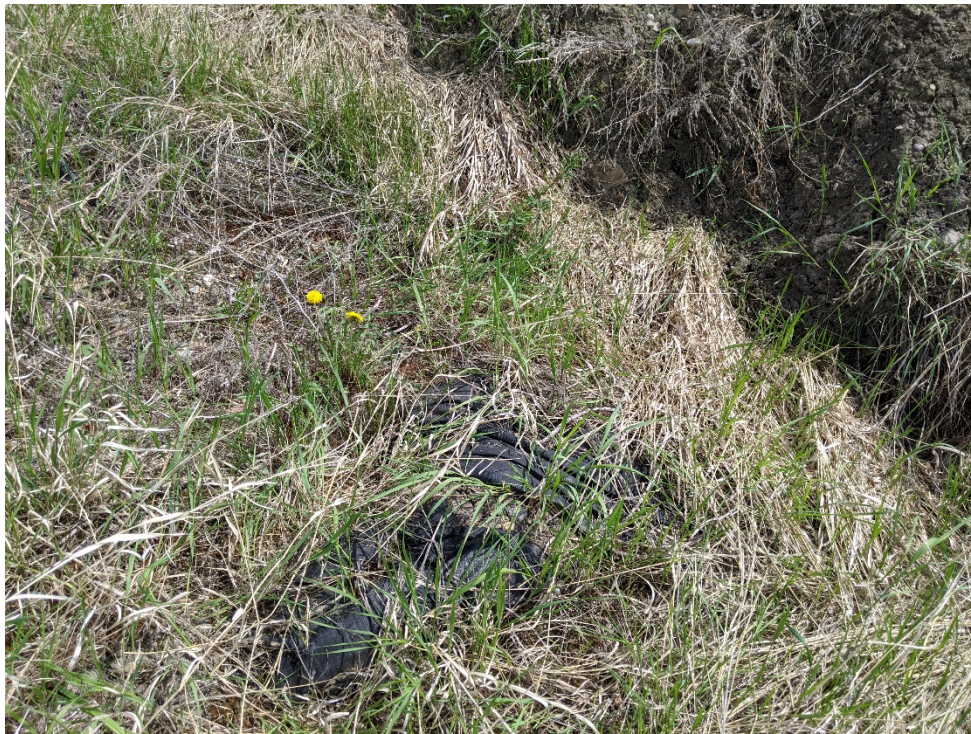
IMG_20200528_132655.jpg

Photo 7 - Exposed geosynthetics near pond on southwest slope.

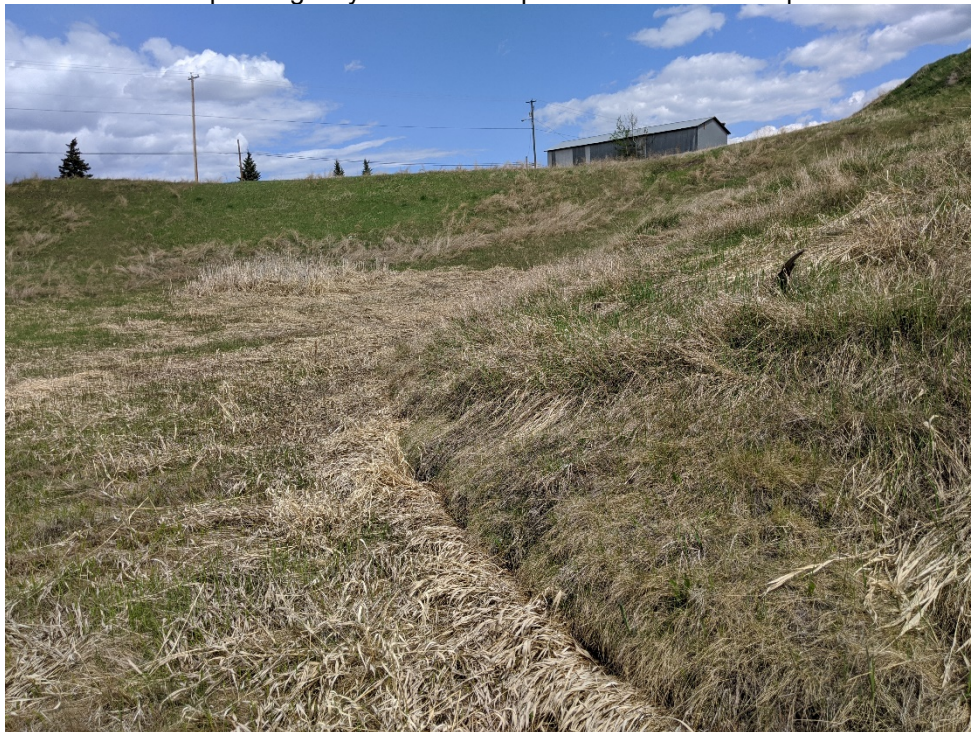
IMG_20200528_132812.jpg

Based on the existing conditions of the Site, the landfill cover appears to be discontinuous likely from differential settlement of the landfilled waste as indicated by the observed cracking and sloughing of soil.

Photo 8 - Crack in soil observed at toe of slope along west side of landfill may be result of soil creep. Looking northeast.

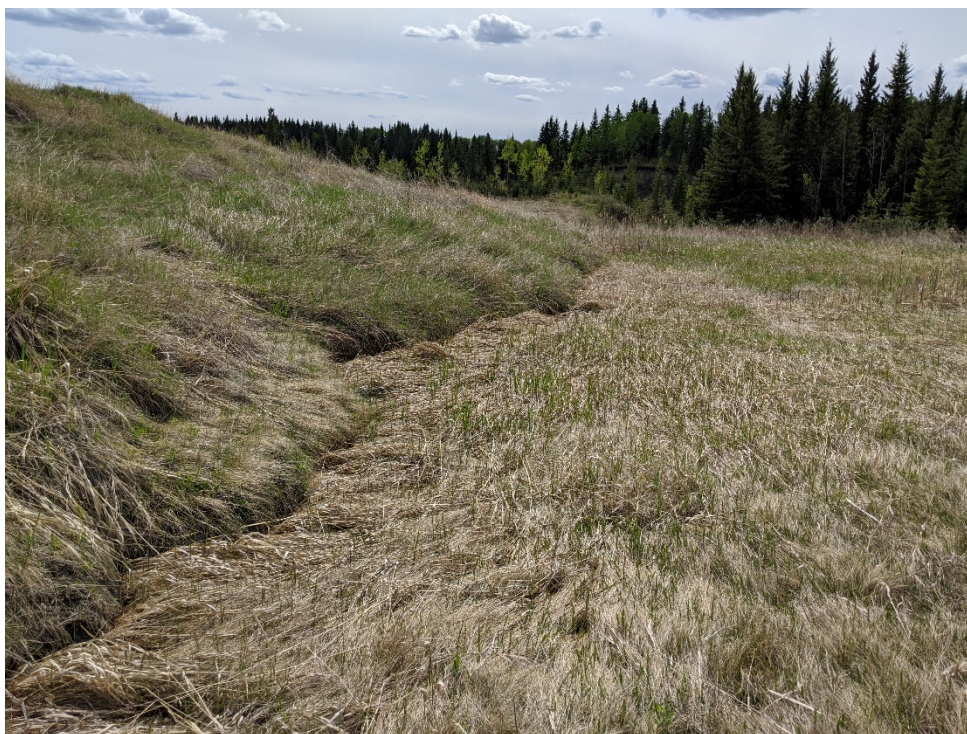
IMG_20200528_132816.jpg

Photo 9 - Crack in soil observed at toe of slope along west side of landfill. Looking south.

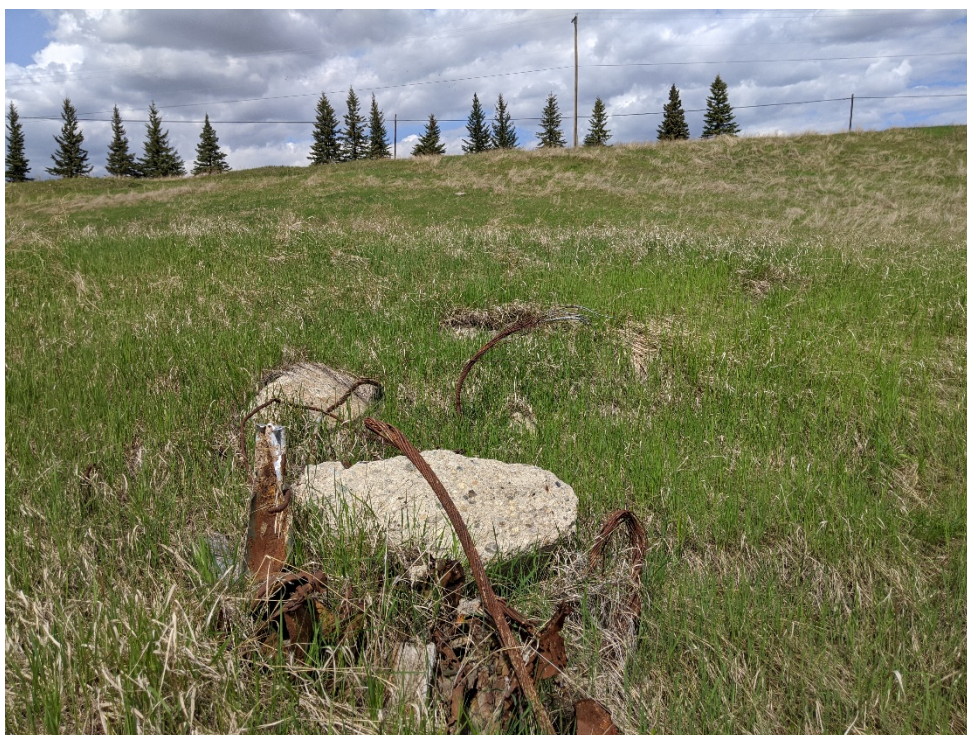
IMG_20200528_132909.jpg

Photo 10 - Construction debris at west side of landfill. Looking north.

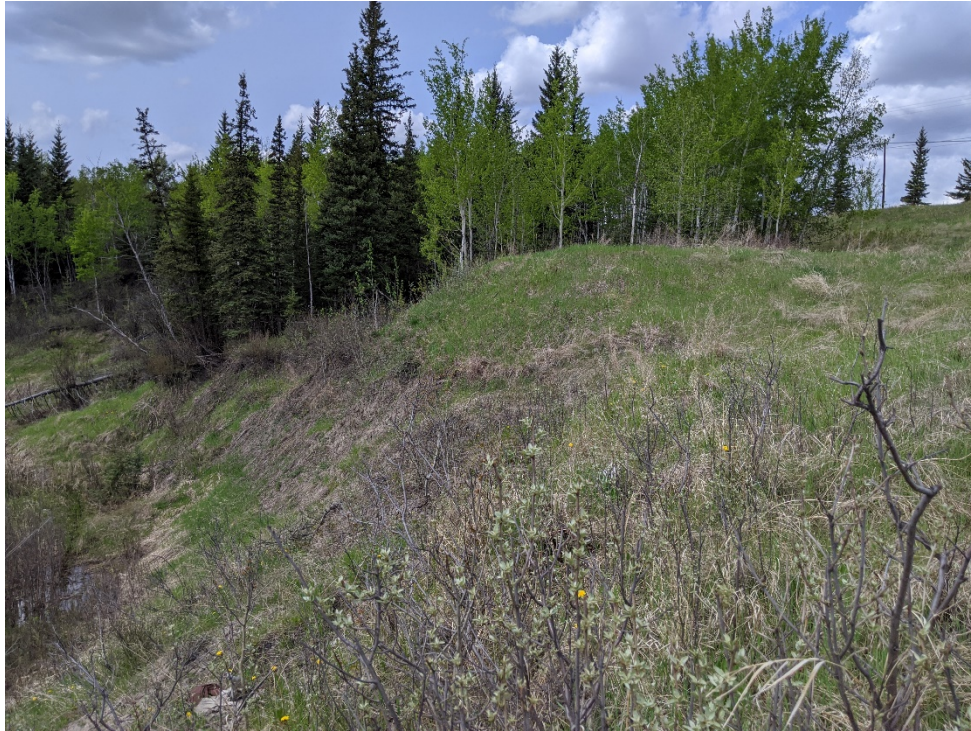
IMG_20200528_133000.jpg

Photo 11 - West perimeter of site at Dawson Creek.
Looking northwest. Rusty steel debris observed on bank.

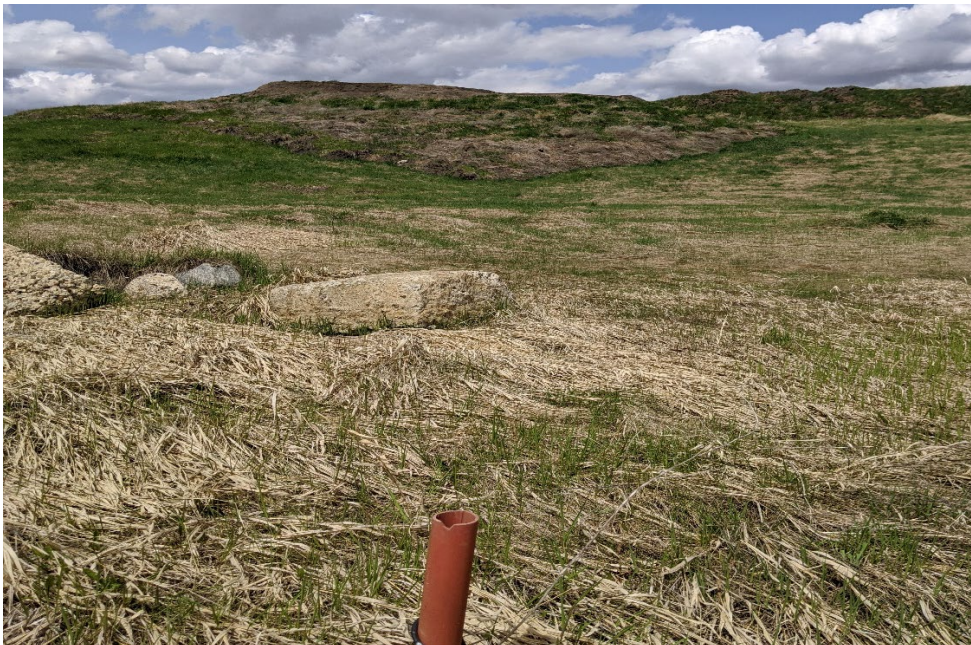
IMG_20200528_133916.jpg

Photo 14 - South side of landfill slope with soil creep observed.
Looking north. Monitoring location in foreground.

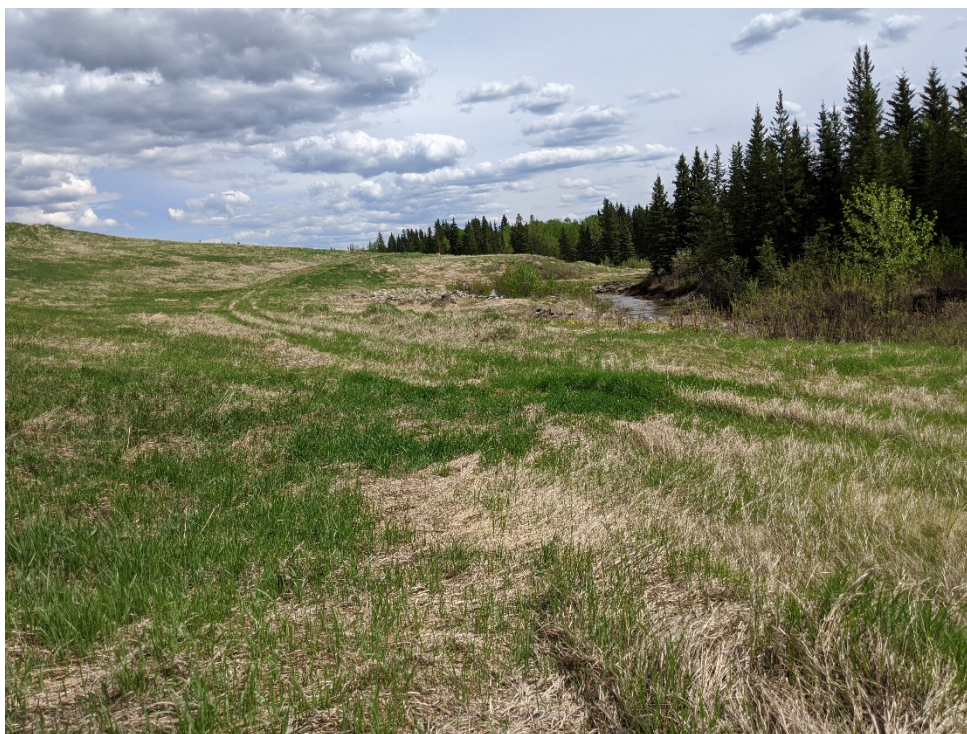
IMG_20200528_133607.jpg

Photo 15 - General topography looking east at southeast landfill slopes.
Concrete debris pile at mid-ground in center of photo.

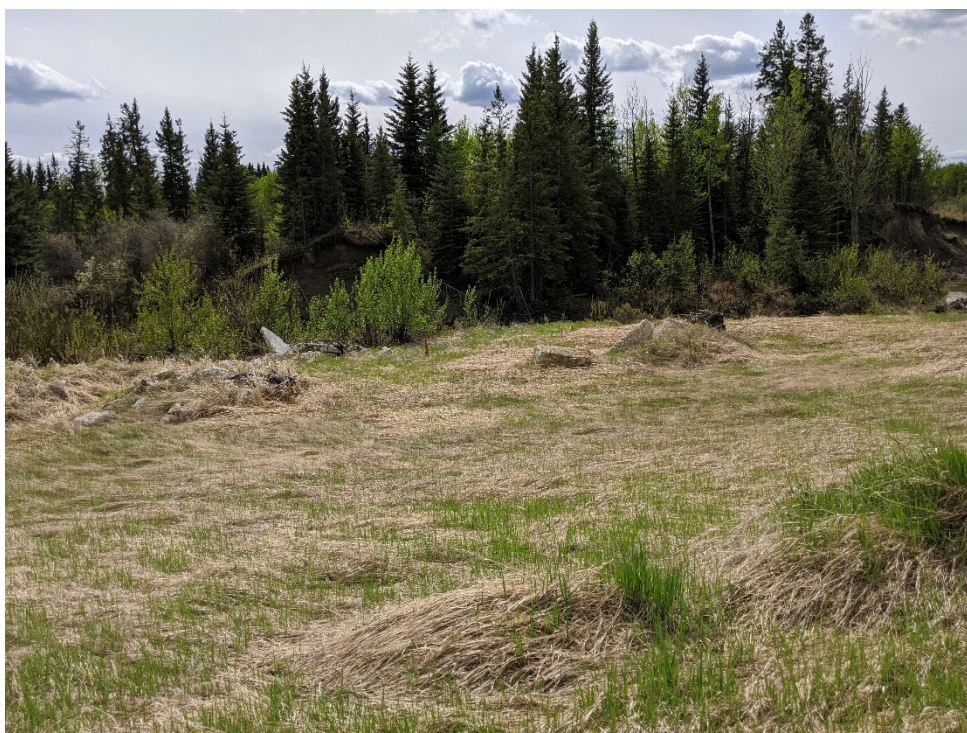
IMG_20200528_133830.jpg

Photo 16 - Concrete debris piles at south side of landfill. Looking southwest.

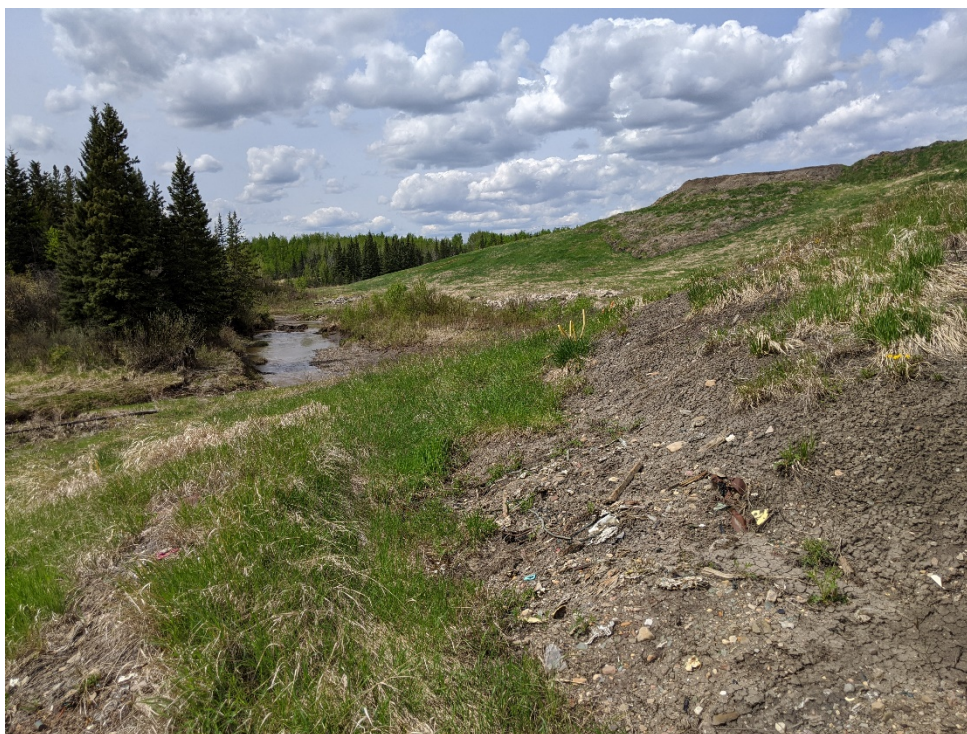
IMG_20200528_134641.jpg

Photo 17 - Exposed waste on the landfill's southeast side slope. Looking west.

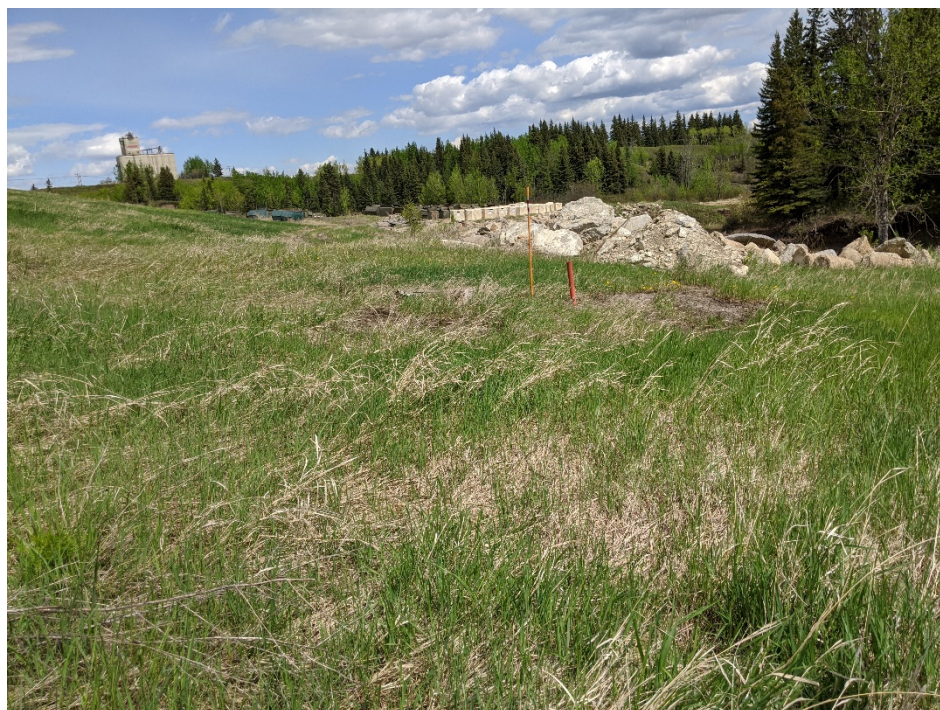
IMG_20200528_134700.jpg

Photo 18 - Concrete debris piles and monitoring location at southeast corner of site. Sparse vegetation around monitoring location was observed. Looking southeast.

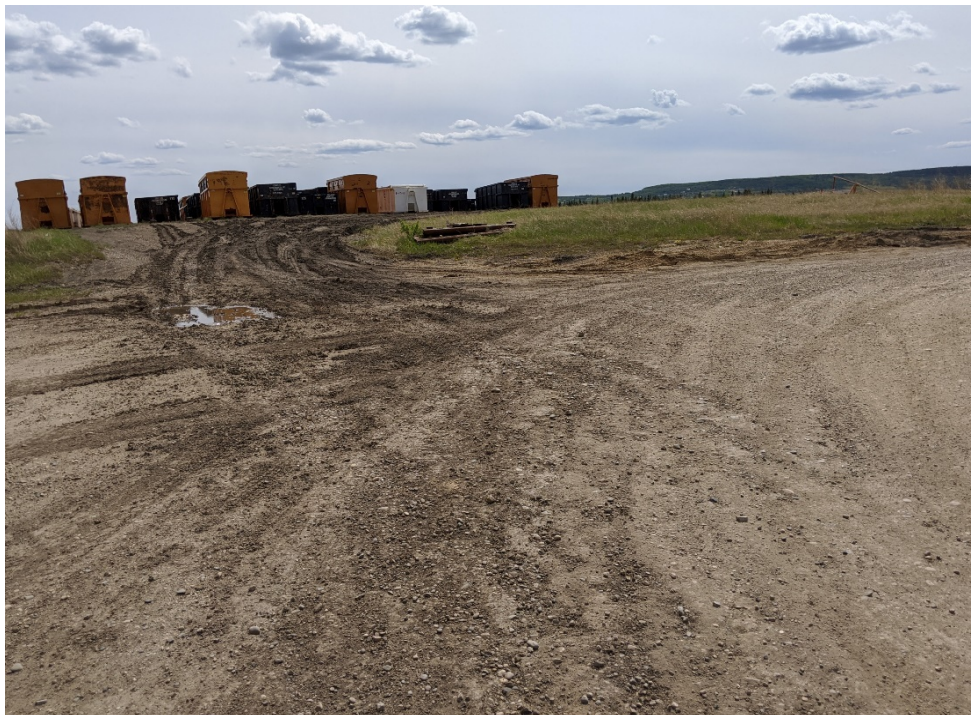
IMG_20200528_135454.jpg

Photo 22 - Top of landfill area used as storage by transfer station operations.
Looking south.
