To:	Gerritt Lacey, Solid Waste Manager	Date:	February 20, 2024
c:		Memo No.:	
From:	Sarah Keith	File:	704-SWM.SWOP04801-01
Subject:	New Landfill Feasibility – Chetwynd Area Stage 1: Site Selection – Site Reconnaissance

This memo undertakes Stage 1: Site Selection - Site Reconnaissance which is intended to build off the Landfill Siting Memo to complete a more detailed surface review of potential landfill development based on visual attributes associated with the environmental conditions as well as geotechnical and overall suitability for landfill operations.

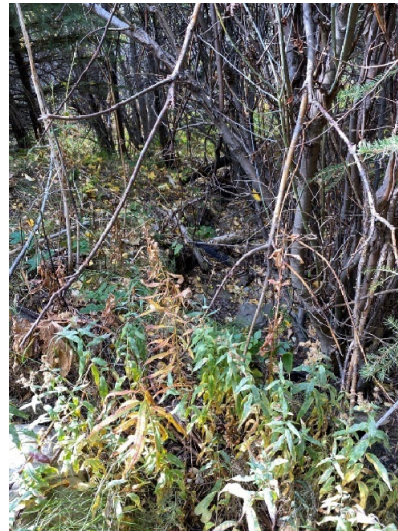
- The initial slope from the highway was quite steep.
 - Tetra Tech crossed an unmapped drainage feature in the southeast quadrant. This feature was situated east-west towards the highway and was very similar to the mapped drainage feature described earlier. Similarly, this feature was observed as dry at the time of the reconnaissance (Photo 3 and Photo 4).

Photo 4: P42 – Small dry unmapped drainage feature

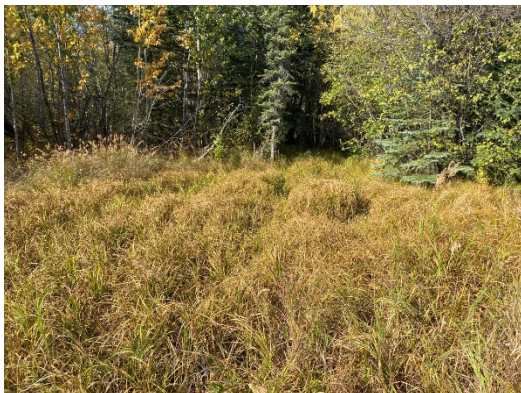
- An isolated grassy area or potential unmapped wetland was noted within this southeast quadrant (Photo 5 and Photo 6).

Photo 5: P45-48 – Potential Unmapped Wetland

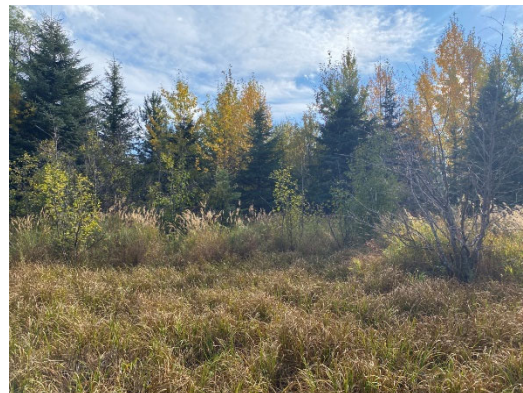
Photo 6: P45-48 – Potential Unmapped Wetland

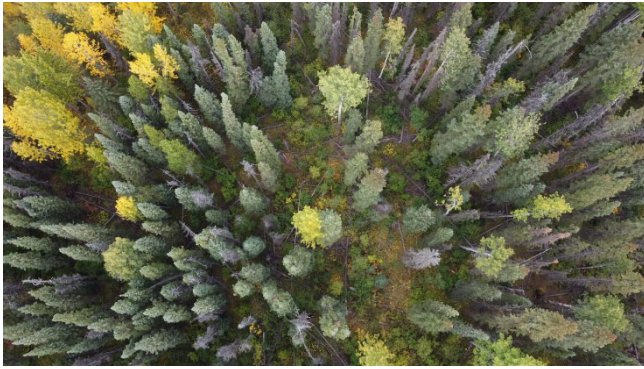
Photo 7: Western Half of Area A

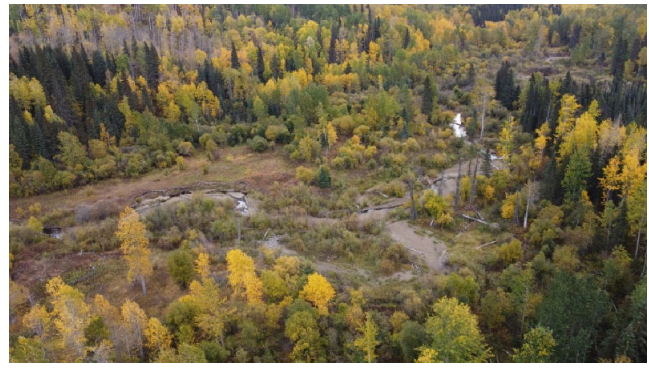
- Deadman Creek is situated through the northwest quadrant flowing northward, and was ground truthed during the site reconnaissance. A small hut was noted along this watercourse near the north boundary of Site A. This watercourse can be seen in Photo 8.

Photo 8: Watercourse in the Northwest Quadrant of Area A

- Deadman Creek (watershed code 230-744800-51600) is mapped through the northwest corner of the area (Photo 8). Several small, mapped tributaries run from east to west across the area. Deadman Creek is the only watercourse in the site documented to be fish-bearing. A reference map of the watercourses noted during the site reconnaissance can be seen on Figure 2.

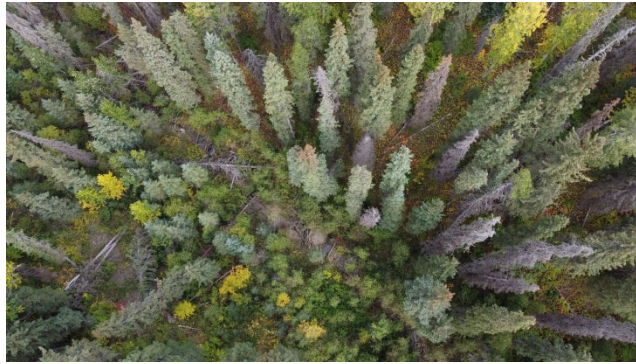
- The mapped watercourse which extended from the southwest quadrant was less obvious with the UAV, however, a small drainage feature was noted. This feature showed signs of surface water from the aerial view and can be seen in Photo 9.

Photo 9: Mapped Watercourse in the Southwest Quadrant of Area A

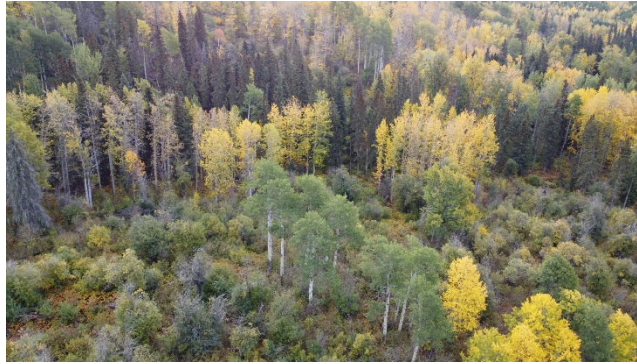
- Vegetation observed during the site visit along the eastern half of the area was typical of the white spruce-aspen-step moss association within the Boreal White and Black Spruce moist warm (BWBSmw) biogeoclimatic zone (Photo 10). A detailed inventory of plant species observed was not conducted but forest stands on the eastern half of the area differed from the western half. The eastern half of the area consisted of dry mixed forest dominated by mature trembling aspen (*Populus tremuloides*), balsam poplar (*Populus balsamifera*), and white spruce (*Picea glauca*), while the western half consisted of wet spruce forest dominated by white and black spruce (*Picea mariana*). Sections of forest within the eastern half of the area have been harvested and replanted with lodgepole pine (*Pinus contorta*).

Photo 10: Typical Tree Community Within Area A

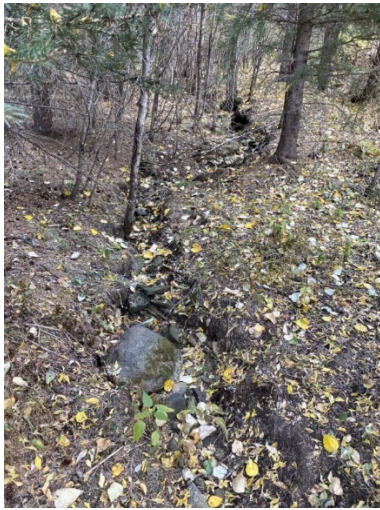
- The southeast tributary of Deadman Creek that is mapped through the east half of Area A consists of a small ephemeral channel, which was dry during the assessment (Photo 11). In addition, no culvert or signs of a watercourse were found where this tributary is mapped to cross the highway.

- This portion of the channel is a 'stream' under the BC WSA and could indirectly support fish and fish habitat under the *Fisheries Act*.
- There were no obvious signs of a watercourse (distinguishable channel, suitable substrates, flowing water, etc.) at the mapped location of the northeast tributary of Deadman Creek. In addition, no culvert or signs of a watercourse were found where this tributary is mapped to cross the highway.

Photo 11: P42 - Southeast Tributary of Deadman Creek

- A more detailed watercourse assessment is recommended to identify suitable setback distances, if applicable.

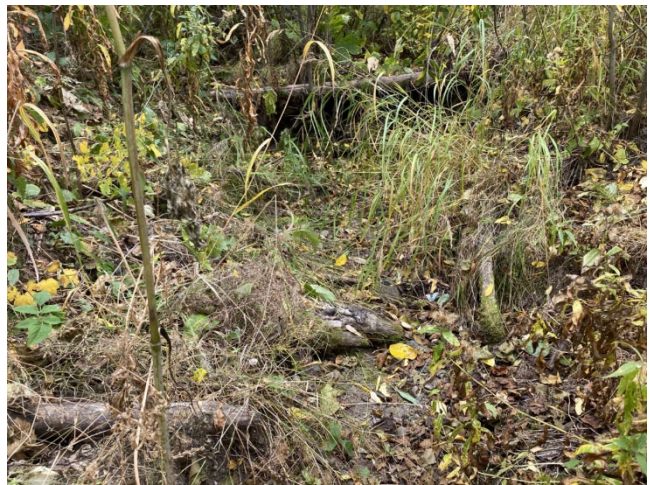
- There were two unmapped ephemeral channels found north of the northeast tributary. These channels were dry at the time of observation and had poorly defined banks with minimal gravel substrate (Photo 12).

Photo 12: P30 - Ephemeral Channel Near the Northeast Tributary of Deadman Creek

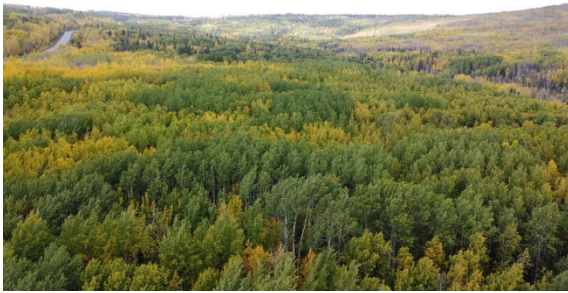
Photo 15: Site B Looking North (Highway to the West)

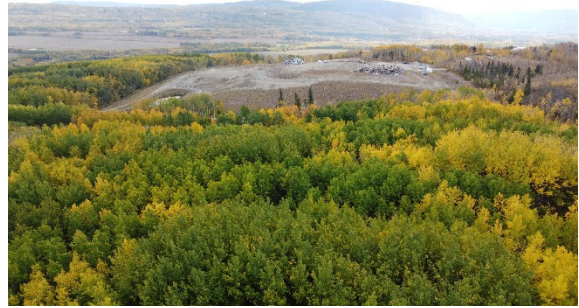
Photo 16: Site B Looking South (Active Landfill in background)

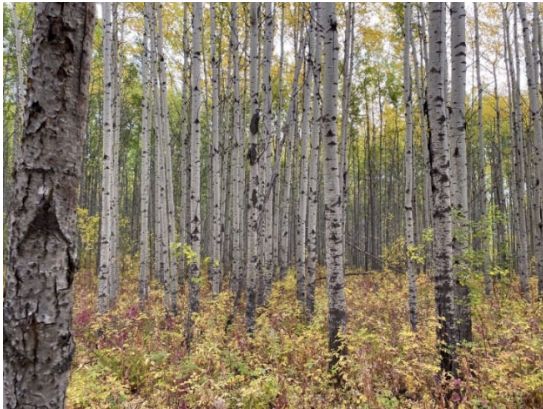
- Area B consisted of an open deciduous forest typical of the white spruce-aspen-step moss association within the BWBSmw biogeoclimatic zone. Young trembling aspen (*Populus tremuloides*) was the dominant tree species and nootka rose (*Rosa nutkana*) was the dominant shrub species observed.

Photo 17: P33 - Typical Forest Stand Within Area B

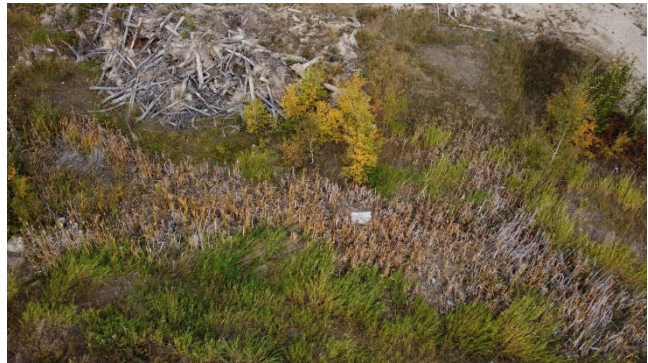
- No aquatic features were observed during the site reconnaissance within the site boundaries, but a wetland and watercourse were identified in the desktop search and are located immediately west of the site boundaries.
- A watercourse and adjacent marsh wetland (Photo 18) are found between Area B and the existing Chetwynd landfill. This area would likely be disturbed if Area B was chosen as a future landfill location.

Photo 18: Marsh Wetland South of Area B

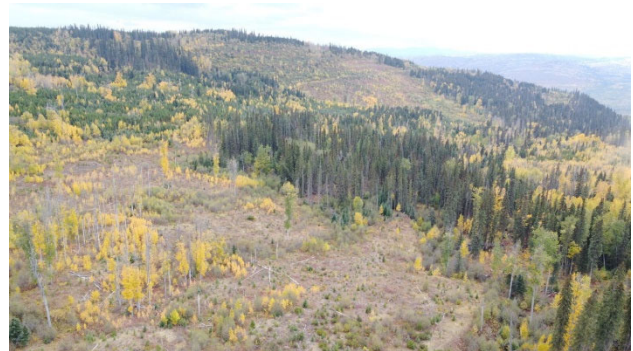
- Tetra Tech accessed the site from the Lone Prairie Road; however, due to the dense forest, access was limited.
- The north half of the area is dominated by a steep slope gaining elevation towards the northwest. This steep slope was visually assessed to not be suitable for landfill development. The grade was not determined; however, it is likely greater than 10% on average which is generally not recommended for landfill development due to higher risk of slope instability. The northern boundary of the site was noted to drop off at an even steeper grade towards Pine River situated approximately 1 km north and northwest of the site. These abrupt changes in elevation near the northern boundary created a narrow plateau at the high point of the site. This area can be seen in Photo 20 along with the drop off towards Pine River northwest of the site (Photo 21).

Photo 20: Steep Slopes in Area C2

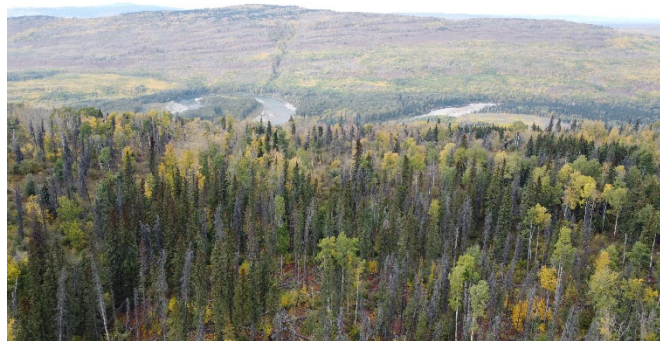
Photo 21: Looking Northwest - Drop off to Pine River

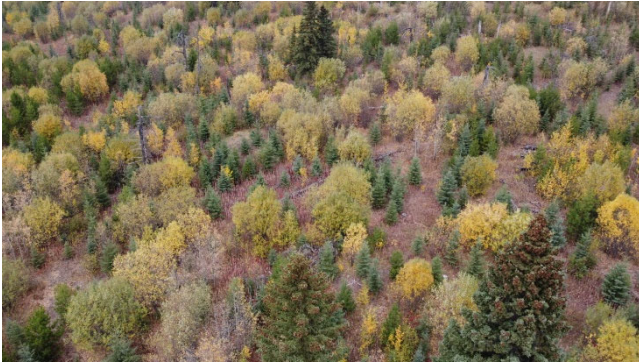
Photo 22: Example of Trees Found in the Northern Half of Area C2

- Area C2 is covered with a matrix of mixed boreal forest of various age classes (Photo 22). Large areas of the site have been logged, with the area naturally regenerating a mix of lodgepole pine, white spruce, and aspen. Large veteran trees remain sparsely scattered throughout harvested areas, and unharvested areas contain mature spruce and aspen forest.

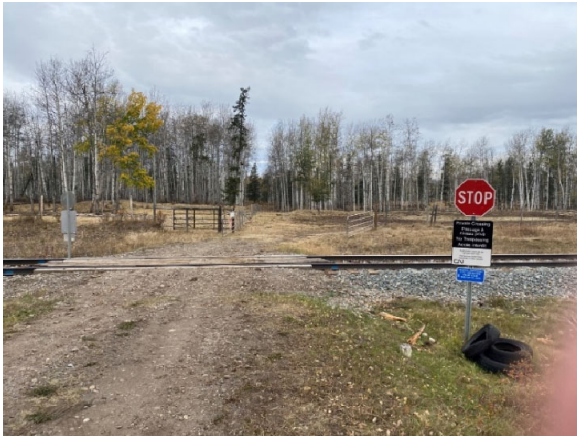
Photo 25: Rail Crossing in Area L

- The prospective site is approximately 440 Ha including the area located on the east side of the road.
- A rail line is situated near the eastern boundary of the site that parallels the Jackfish Lake Road. The rail line is located on the west side of the road and can be seen in Photo 25.

- Tetra Tech accessed the site at a rail crossing where it was clear that this crossing is used for cattle access and grazing within the site. Photo 26 displays one of the many cattle trails throughout the site. A fenced area and gate were noted west of the rail line adjacent to the crossing.

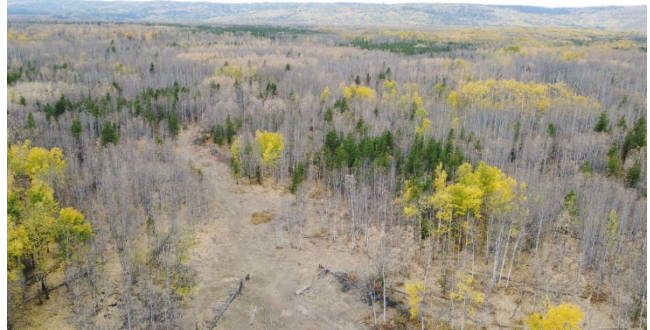
Photo 26: Overview of Area L and a Cattle Trail

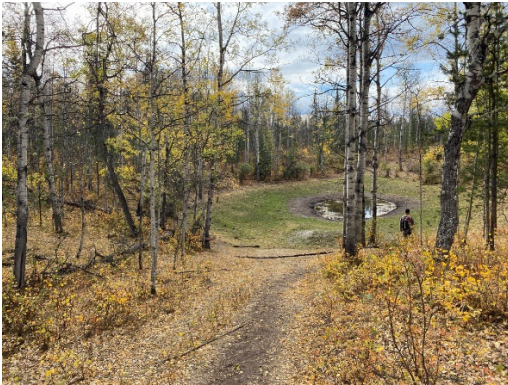
wetlands. Photos 27, 28, and 30 show this mapped wetland and no observable watercourse associated with these features.

Photo 27: Open Water Wetland

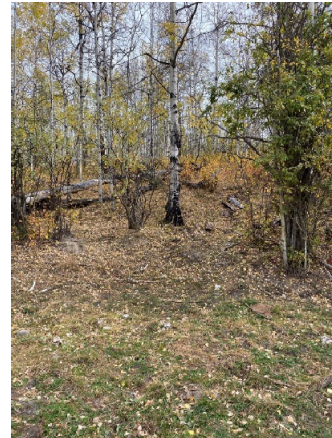
- A mapped watercourse orientated east to west was ground truthed as not present at various locations across the site. No discernable drainage feature or watercourse (either wet or dry) were noted through the site. This mapped feature included a small waterbody which was ground truthed as one of the mapped

Photo 28: No Observable Mapped Location of Water Course

- The watercourse mapped from east to west along the centre of the site was not found. There were no signs of a watercourse (distinguishable channel, flowing water, etc.) at the mapped location.

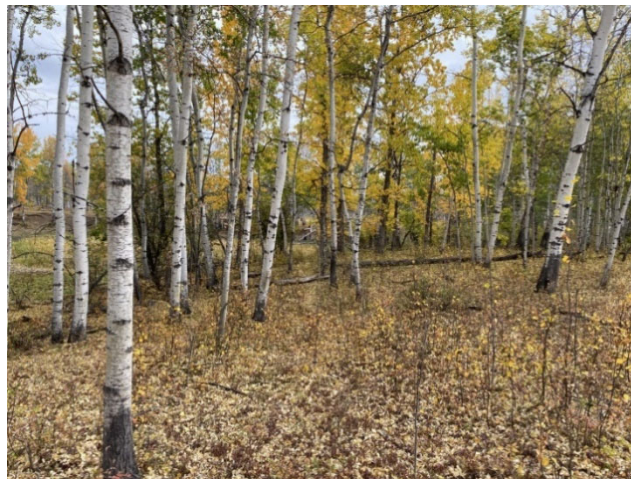
- The vegetation observed within Area L was typical of open rangeland in the BWBSmw zone. A detailed inventory of plant species observed was not conducted but the boreal forest stand was dominated by trembling aspen (Photo 29). Due to the heavily grazed nature of the site, shrubs were sparse.
- A Canada Warbler (*Cardellina canadensis*) occurrence was documented approximately 280 m north of the site boundary.

Photo 29: Typical Forest within Area L
