PEACE RIVER REGIONAL DISTRICT

Rural Budgets Administration Committee Meeting Agenda

November 25, 2021, Immediately Following EADC
1981 Alaska Avenue, Dawson Creek, BC

**Facility Condition Assessment Report
Charlie Lake Fire Hall**

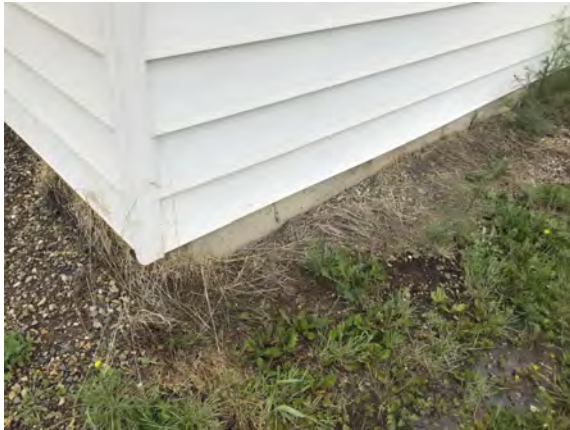
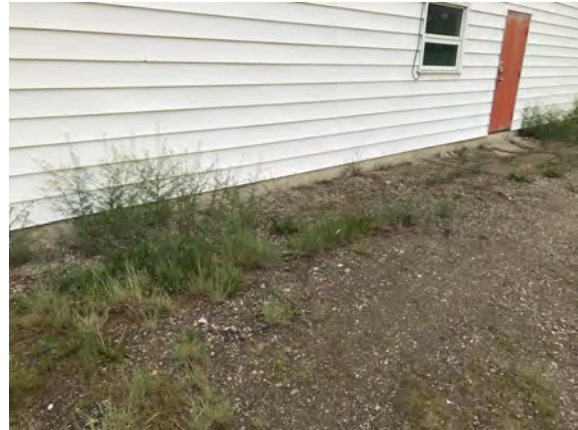
Charlie Lake Fire Hall - A101001

No major deficiencies were observed or reported during the assessment.

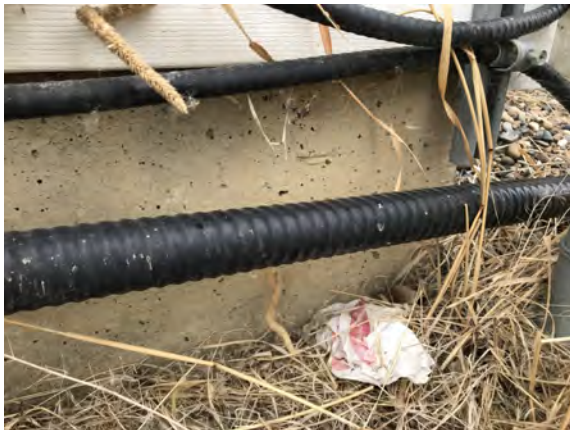
Charlie Lake Fire Hall - A101001

No major deficiencies were observed or reported during the assessment.

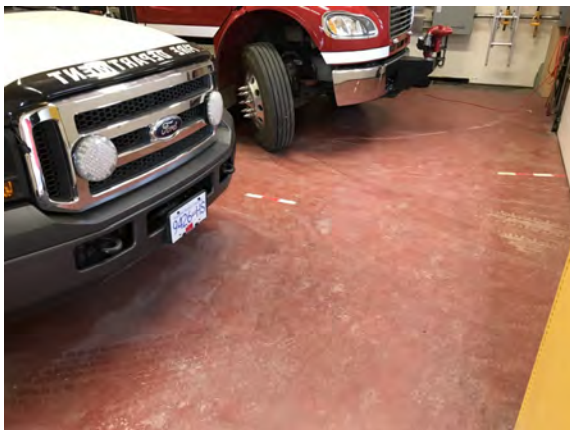
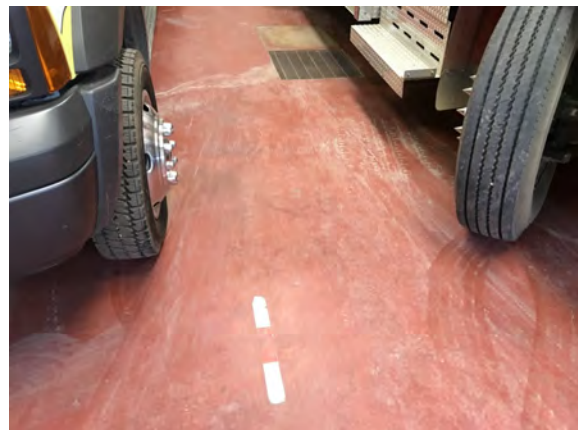
Charlie Lake Fire Hall - A103001

There are some localized cracks and uneven surfaces in the building. A repair allowance has been included herein to repair these areas. The remaining useful life has been left unchanged with the assumption that repairs are completed.

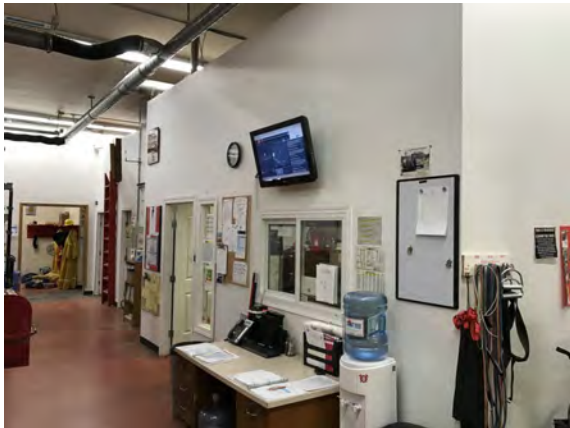
Charlie Lake Fire Hall - B101001

No major deficiencies were observed or reported during the assessment.

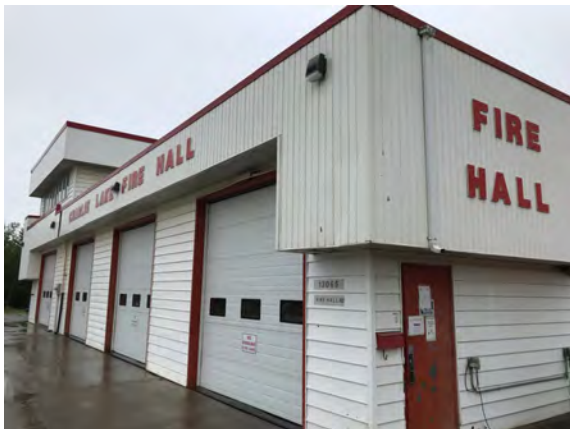
Charlie Lake Fire Hall - B103001

No major deficiencies were observed or reported during the assessment.

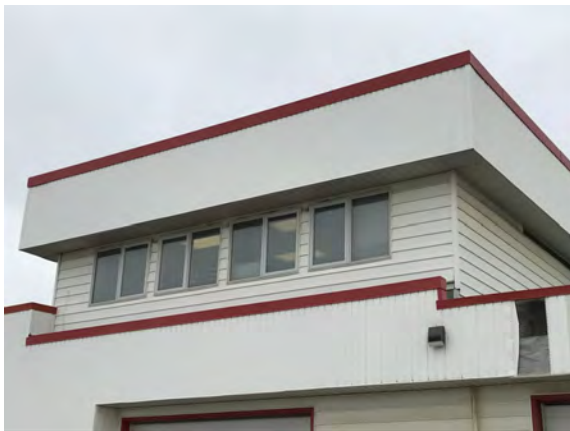
Charlie Lake Fire Hall - B201025

The window frames appeared to remain serviceable although they exhibited wear and discoloration that is generally consistent with their age. Condensation was observed between the glass panes on a few windows on the north elevation (conference room) and on the mezzanine loft, suggesting glazing unit seal failure.

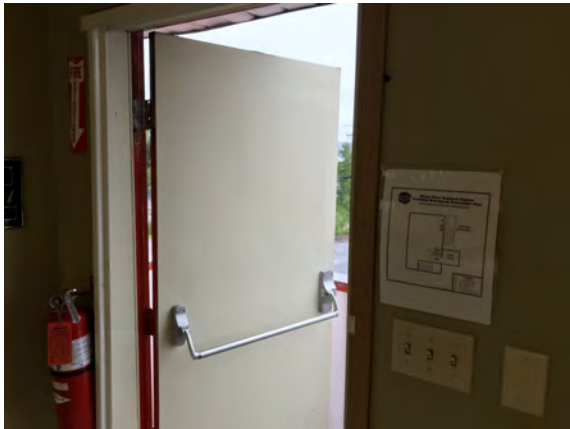
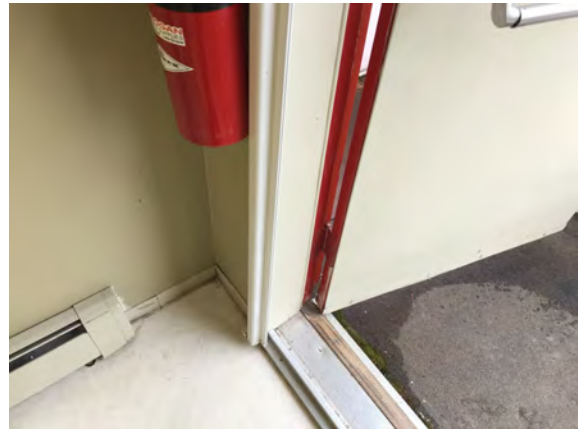
Charlie Lake Fire Hall - B203023

Exterior steel doors have reached the end of their expected useful life and are exhibiting wear and tear that is consistent with the age of the materials including loose hardware, difficulty latching (second floor emergency exit), and worn painted panels. Lifecycle replacement is recommended within the short-term of the evaluation period.

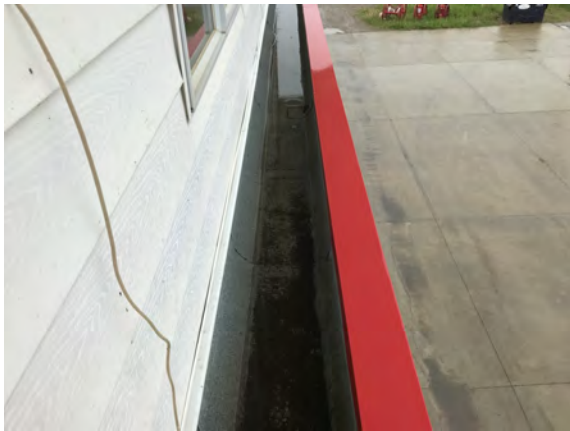
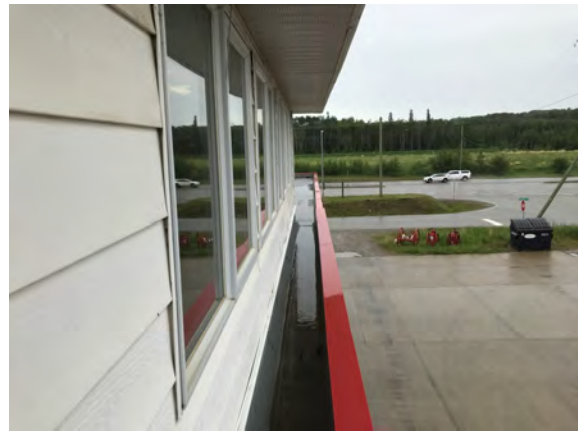
Charlie Lake Fire Hall - B301023

Roof access was not available during the assessment. Where visible, the gutters were observed to have inadequate drainage. It is recommended repairs be conducted in the short-term to address the drainage issues. An allowance for repairs has been provided.

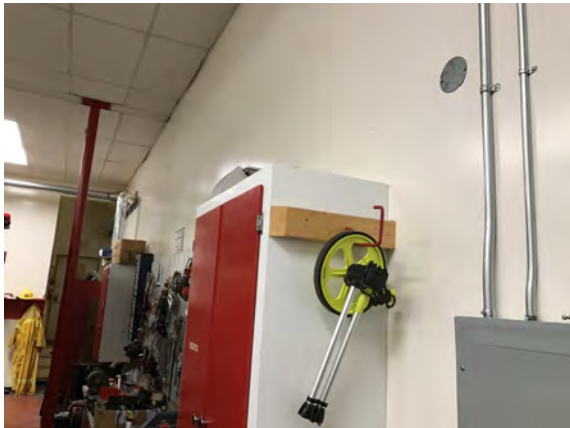
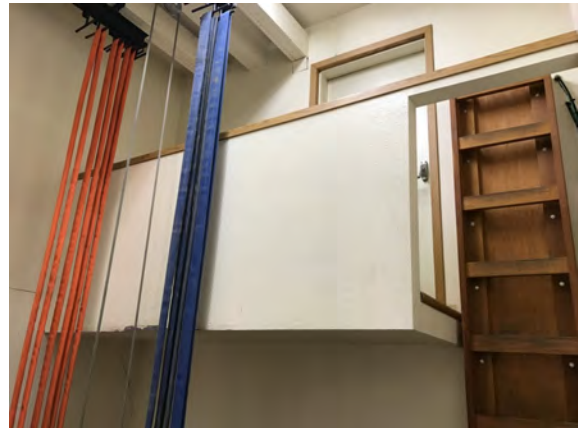
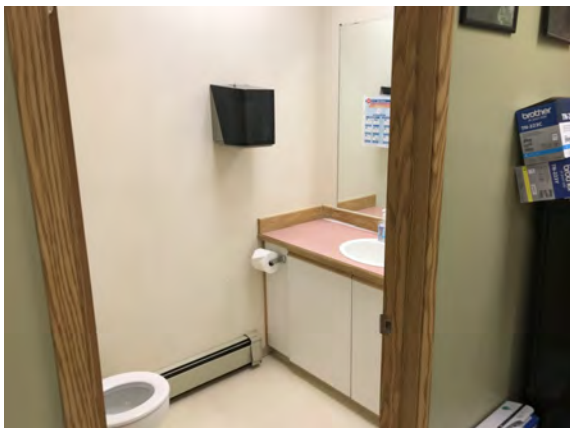
Charlie Lake Fire Hall - C101001

No major deficiencies were observed or reported during the assessment.

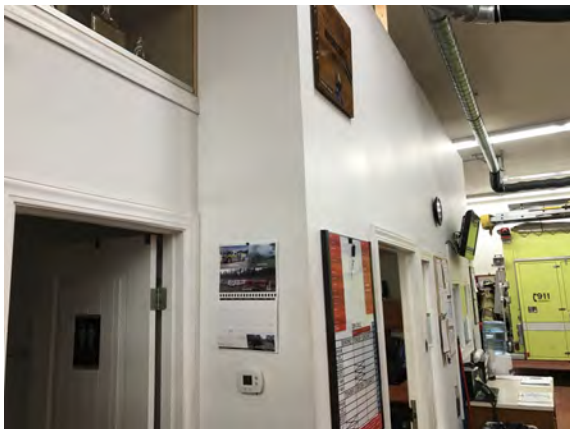
Charlie Lake Fire Hall - C101001

No major deficiencies were observed or reported during the assessment.

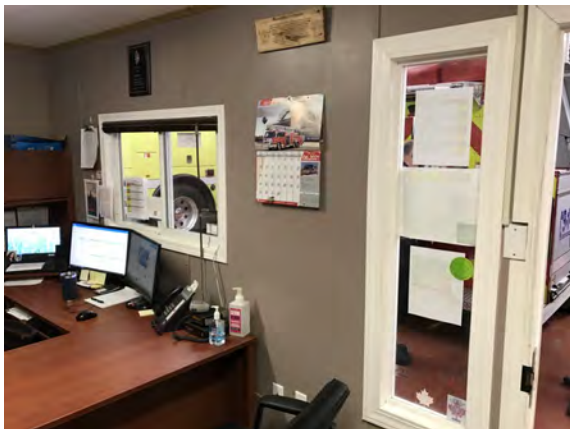
Charlie Lake Fire Hall - C101005

No major deficiencies were observed or reported during the assessment.

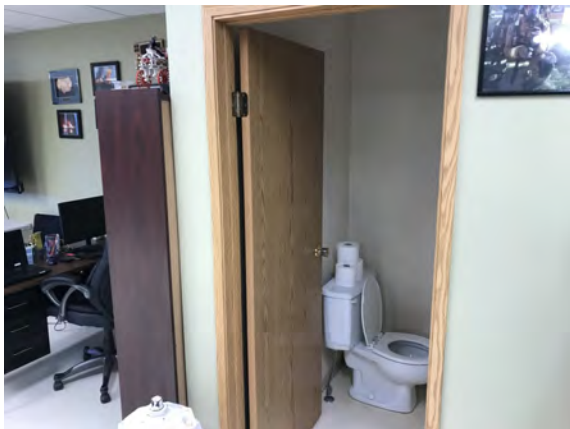
Charlie Lake Fire Hall - C102022

No major deficiencies were observed or reported during the assessment.

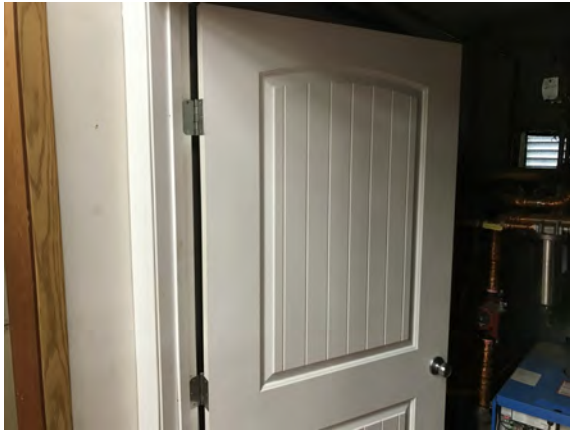
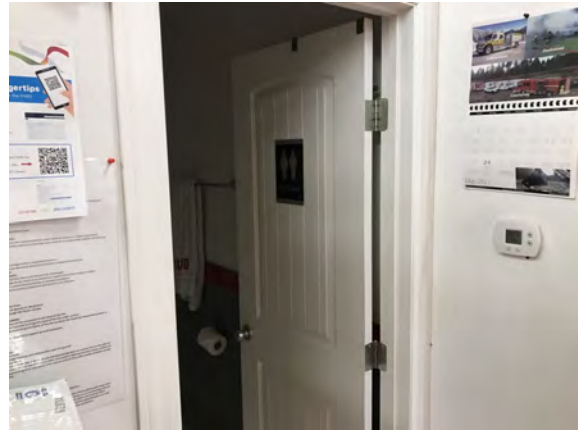
Charlie Lake Fire Hall - C102022

No major deficiencies were observed or reported during the assessment.

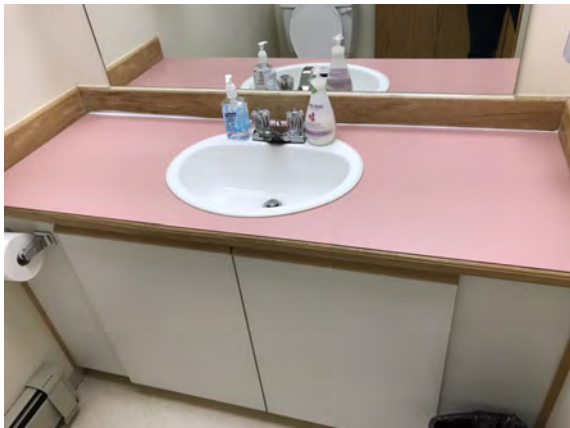
Charlie Lake Fire Hall - C103010

No major deficiencies were observed or reported during the assessment. The component has exceeded its expected useful life, although its remaining useful life has been extended to a later year due to the absence of significant observed or reported deficiencies. The difficulty factor has been increased based on the vanity design.

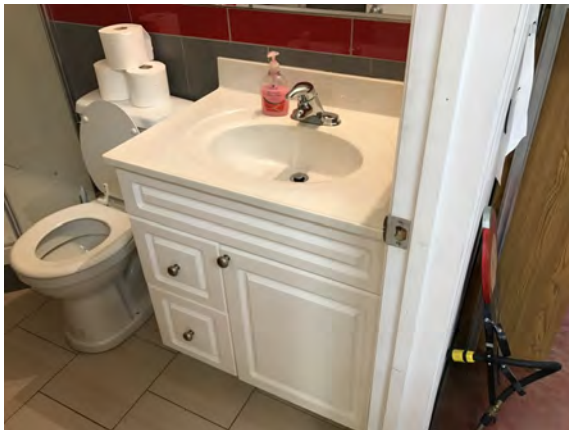
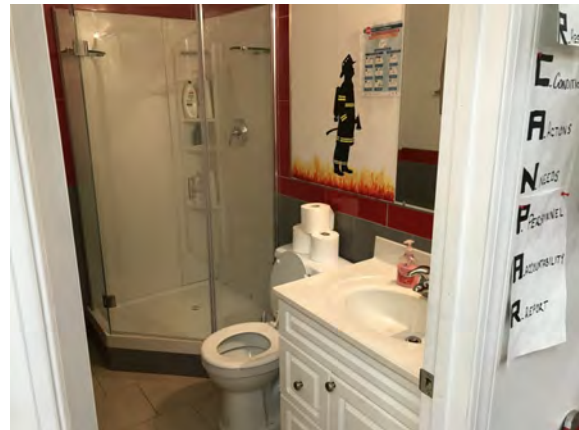
Charlie Lake Fire Hall - C103010

No major deficiencies were observed or reported during the assessment. The difficulty factor has been increased based on the vanity design.

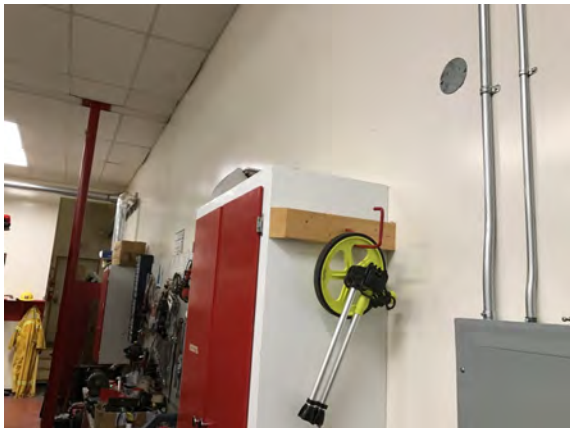
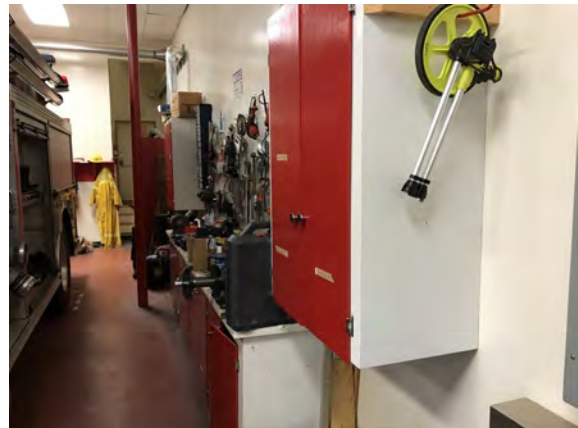
Charlie Lake Fire Hall - C103011

No major deficiencies were observed or reported. The cabinetry observed to be dated. The component will reach its expected useful life, although its remaining useful life has been extended to a later year due to the absence of significant observed or reported deficiencies.

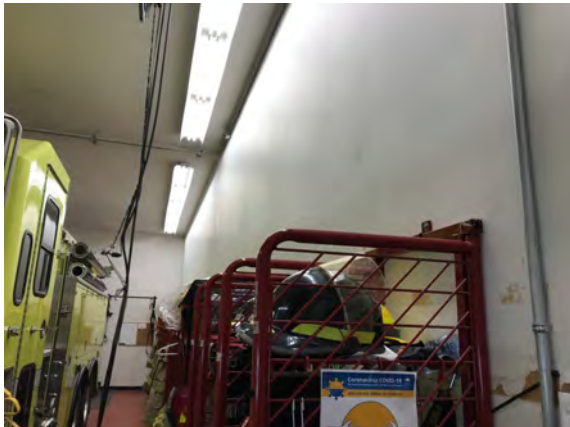
Charlie Lake Fire Hall - C103099

No major deficiencies were observed or reported during the assessment.

Recommendations #1 - Other Fittings	
Type	Life Cycle Replacement
Year	2040
Cost	\$56,010.00

Replace Other Fittings

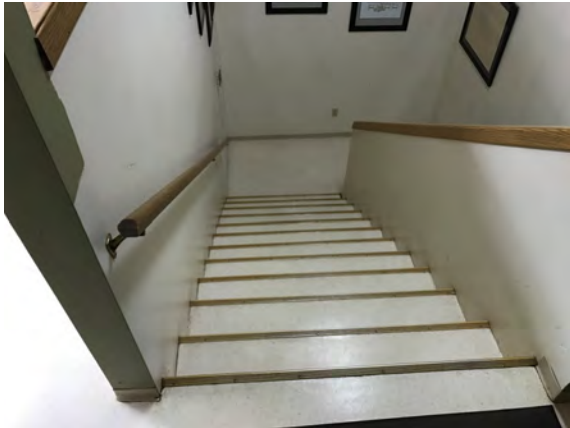
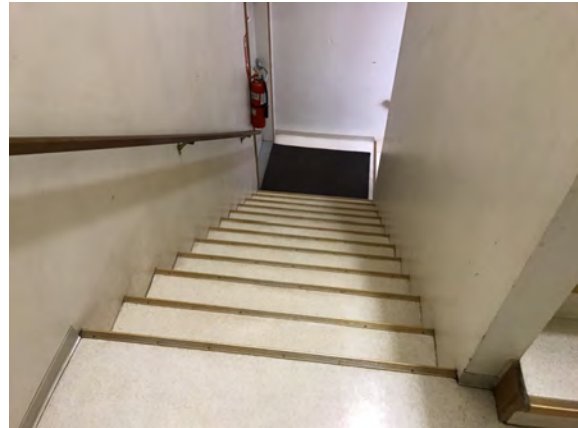
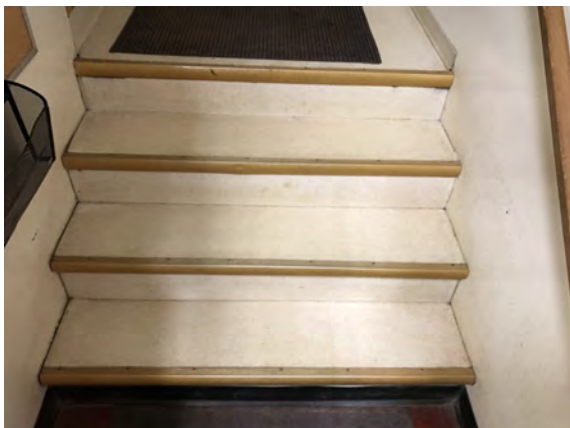
Charlie Lake Fire Hall - C201001

No major deficiencies were observed or reported during the assessment.

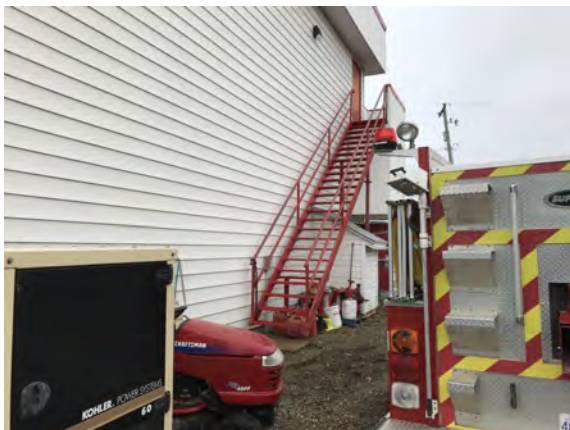
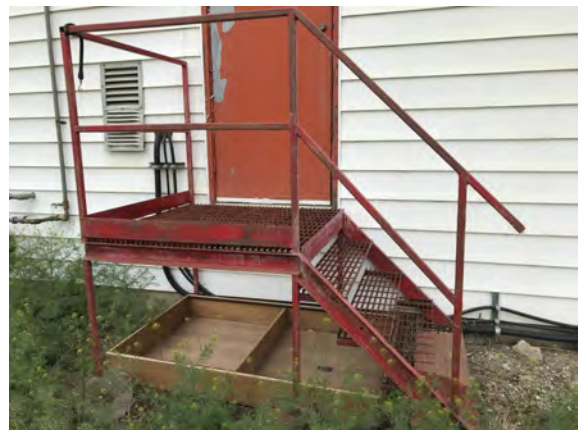
Charlie Lake Fire Hall - C201002

No major deficiencies were observed or reported during the assessment. Periodic refinishing of steel surfaces is expected to be handled as a maintenance activity.

Recommendations #1 - Exterior Stair Construction	
Type	Life Cycle Replacement
Year	2027
Cost	\$57,877.00

Replace Exterior Stair Construction

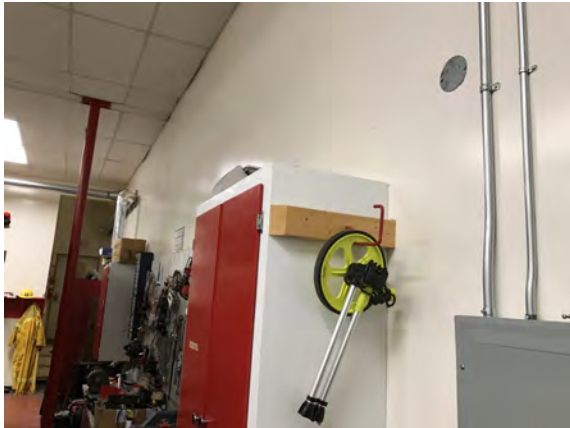
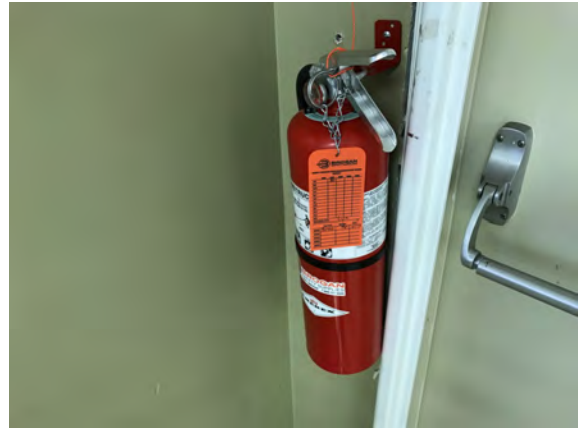
Charlie Lake Fire Hall - C301005

While the paint finish was observed to be in fair condition at the time of assessment, it is likely that it will require renewal within the short-term of the evaluation period.

Recommendations #1 - Paint Wall Covering	
Type	Life Cycle Replacement
Year	2026
Cost	\$46,600.32

Replace Paint Wall Covering

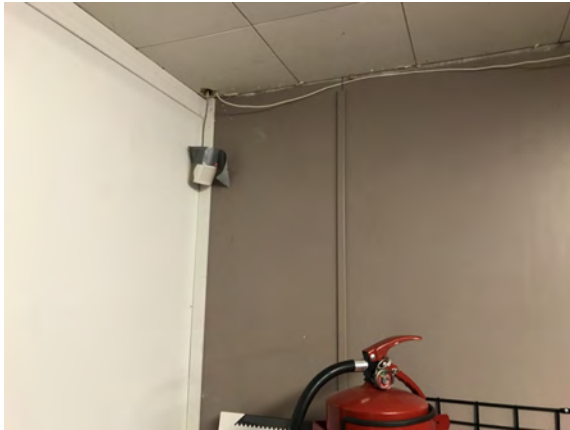
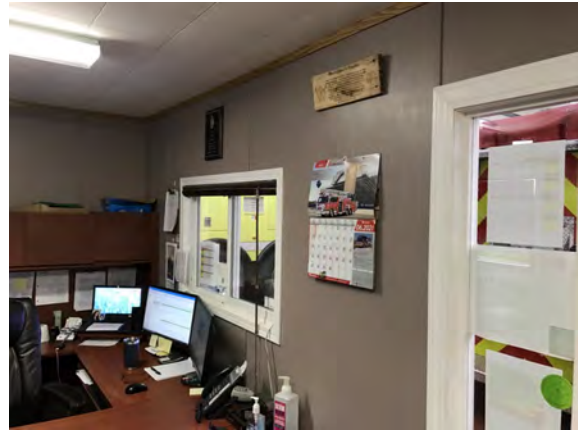
Charlie Lake Fire Hall - C301022

The component has exceeded its expected useful life, although its remaining useful life has been extended beyond the short-term of the evaluation period due to the absence of significant observed or reported deficiencies. The difficulty factor has been adjusted based on the design of the wall finish.

Recommendations #1 - Wood Wall Finish	
Type	Life Cycle Replacement
Year	2027
Cost	\$4,032.72

Replace Wood Wall Finish

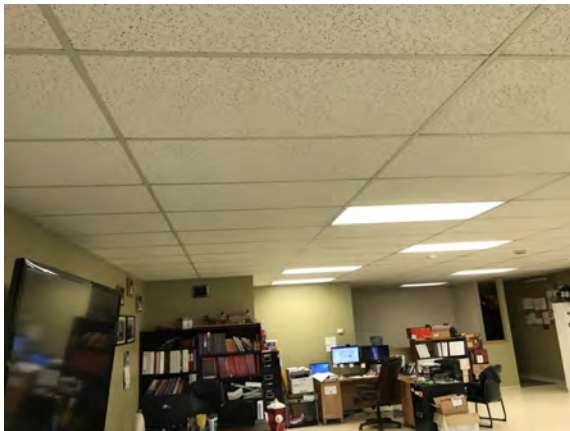
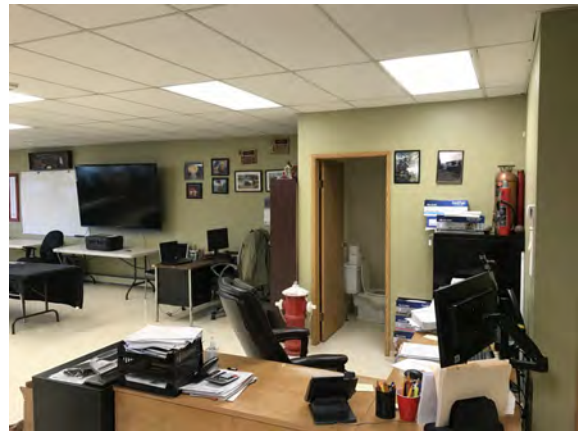
Charlie Lake Fire Hall - C303007

The component has exceeded its expected useful life, although its remaining useful life has been extended beyond the short-term of the evaluation period due to the absence of significant observed or reported deficiencies.

Recommendations #1 - Suspended Acoustic Ceiling Panels	
Type	Life Cycle Replacement
Year	2027
Cost	\$25,540.56

Replace Suspended Acoustic Ceiling Panels

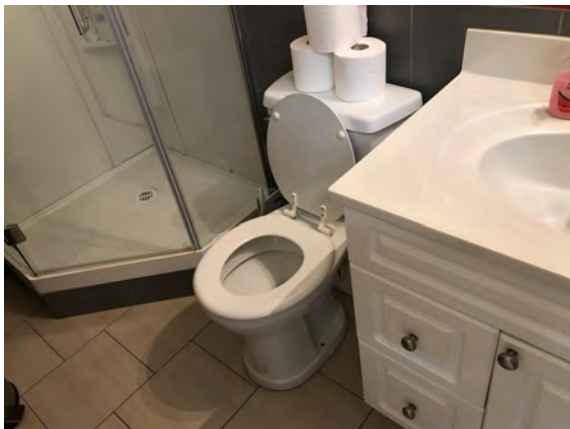
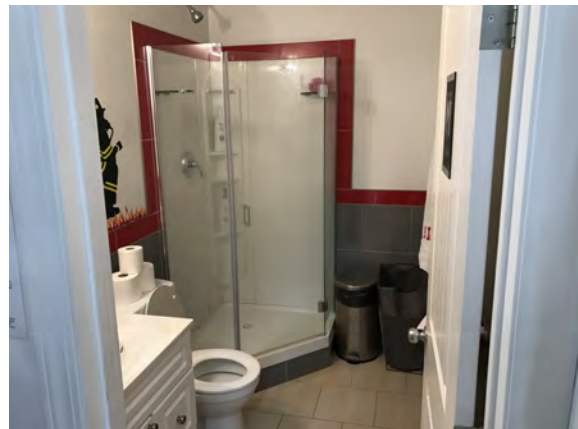
Charlie Lake Fire Hall - D201001

No major deficiencies were observed or reported during the assessment.

Recommendations #1 - Water Closets	
Type	Life Cycle Replacement
Year	2049
Cost	\$3,734.00

Replace Water Closets

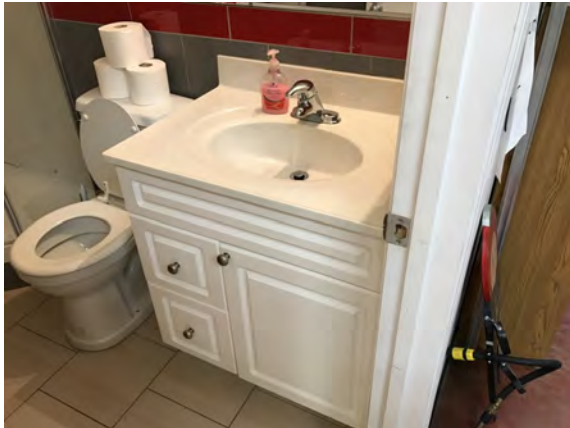
Charlie Lake Fire Hall - D201003

No major deficiencies were observed or reported during the assessment.

Replace Lavatories

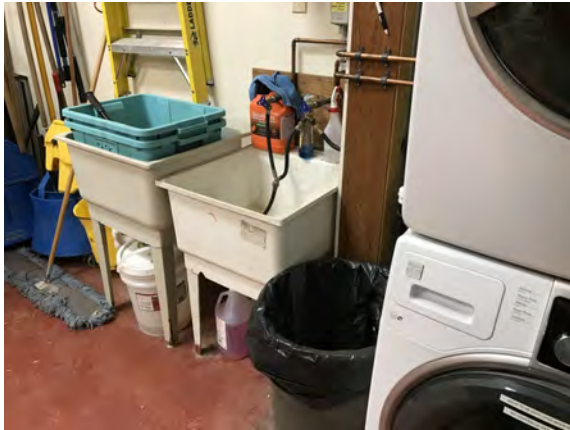
Charlie Lake Fire Hall - D201004

No major deficiencies were observed or reported during the assessment. The difficulty factor has been adjusted based on the component design.

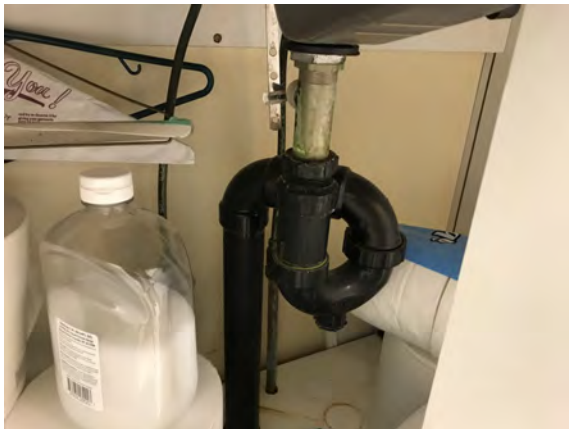
Charlie Lake Fire Hall - D203001

Original sanitary waste and vent lines were presumably repaired or replaced as part of renovation activities performed subsequent to the building's construction. For reporting purposes, an average installation year of 1987 has been assumed. No major deficiencies were observed or reported during the assessment.

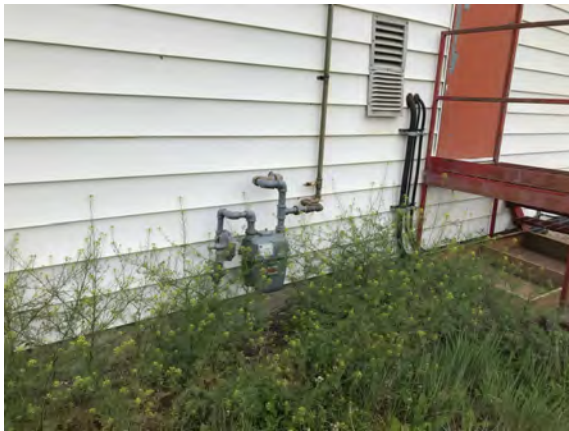
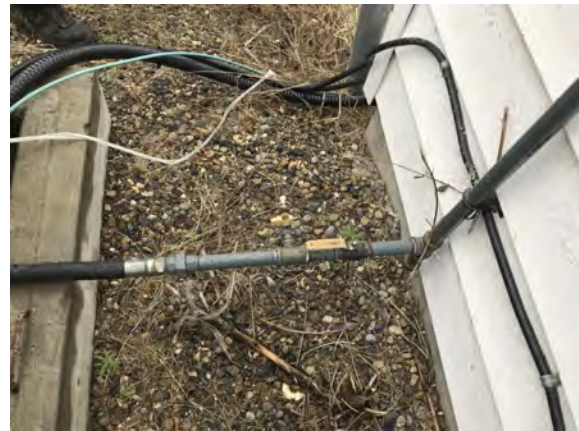
Charlie Lake Fire Hall - D301002

No major deficiencies were observed or reported during the assessment. Periodic refinishing of external pipe runs is expected to be performed as a maintenance activity to address surface corrosion and wear.

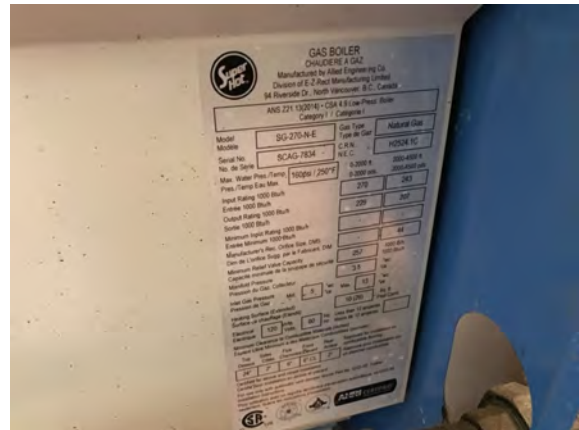
Charlie Lake Fire Hall - D302002

No major deficiencies were observed or reported during the assessment. Supports for the boiler's chimney are missing/damaged, replace as part of maintenance.

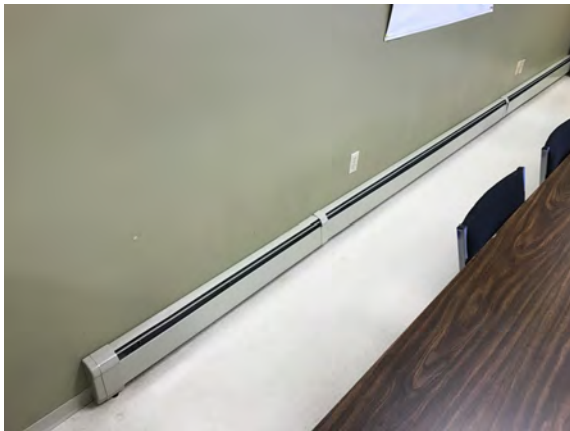
Charlie Lake Fire Hall - D305004

The component has exceeded its expected useful life, although its remaining useful life has been extended beyond the short-term of the evaluation period due to the absence of significant observed or reported deficiencies.

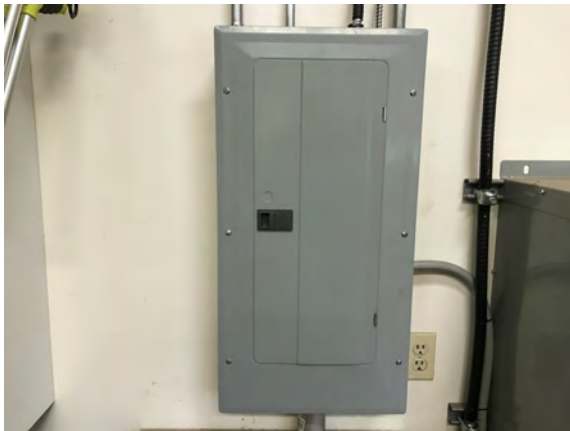
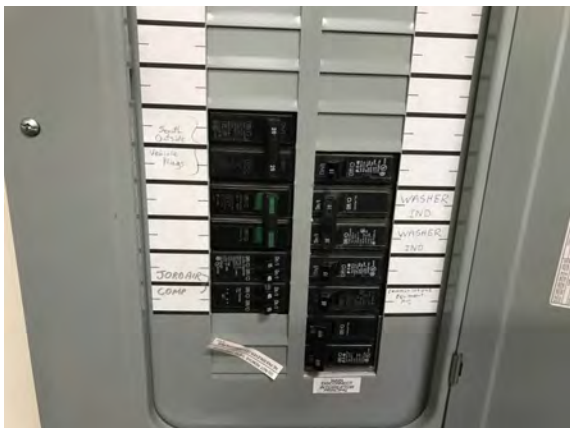
Charlie Lake Fire Hall - D501005

No major deficiencies were observed or reported during the assessment. The difficulty factor has been adjusted based on the panel sizes/amperages.

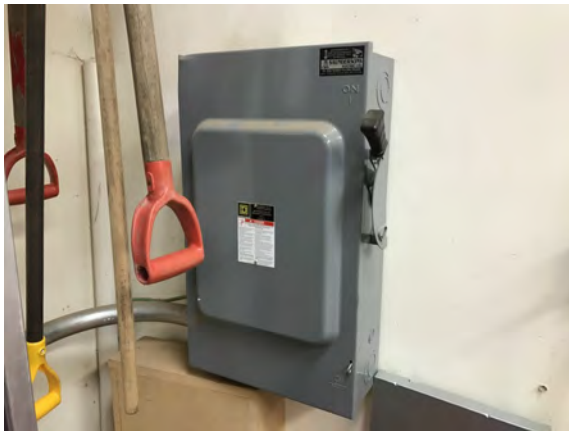
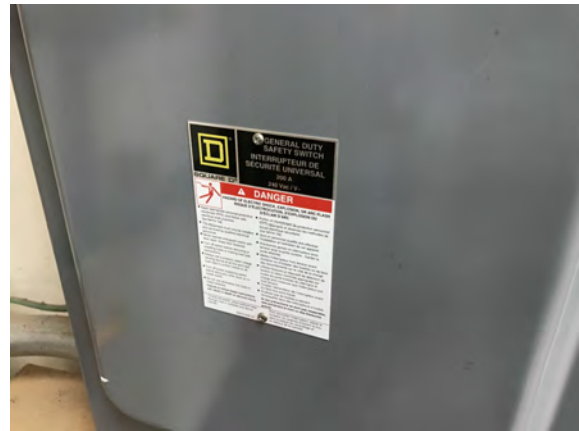
Charlie Lake Fire Hall - D501025

No major deficiencies were observed or reported during the assessment. The difficulty factor has been adjusted based on the switch amperage.

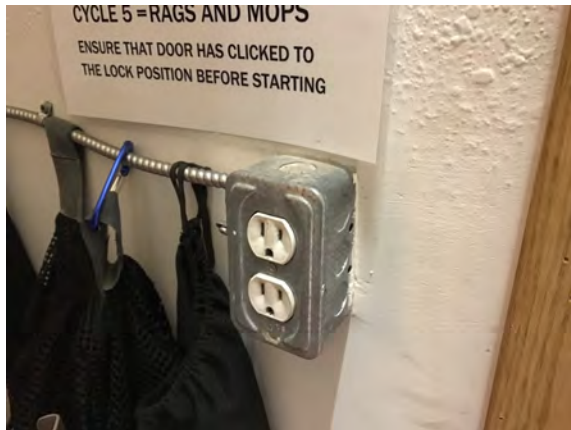
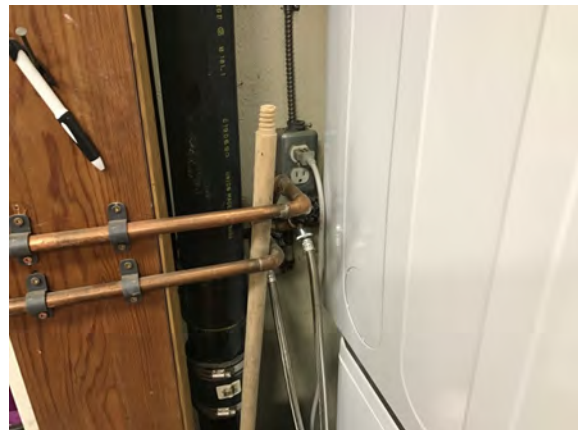
Charlie Lake Fire Hall - D502001

No major deficiencies were observed or reported during the assessment. however, some plugs over sinks did not appear to have ground fault protection. It is recommended to provide GFCI protected plugs over sinks. The cost complete with work is presumed to fall below the cost for repair threshold (\$5,000) and should therefore be completed as a maintenance activity.

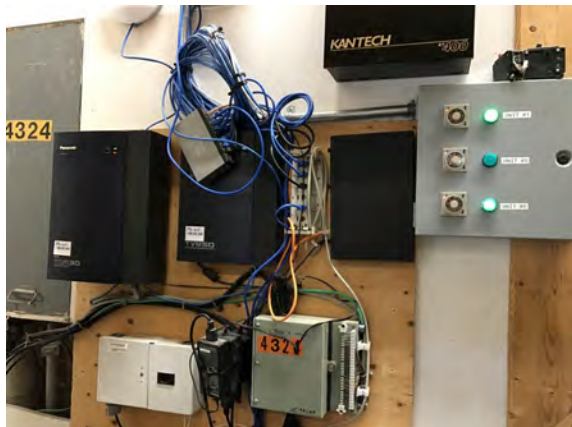
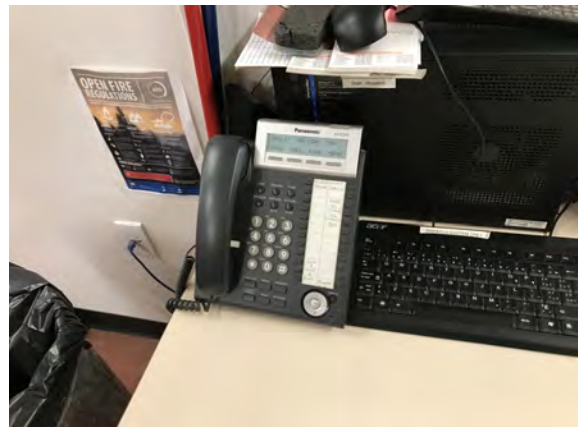
Charlie Lake Fire Hall - D503002

No major deficiencies were observed or reported during the assessment.

Recommendations #1 - Telecommunication Systems	
Type	Life Cycle Replacement
Year	2035
Cost	\$5,825.04

Replace Telecommunication Systems

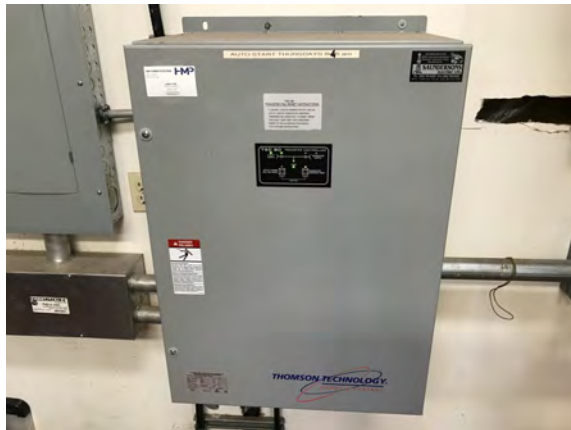
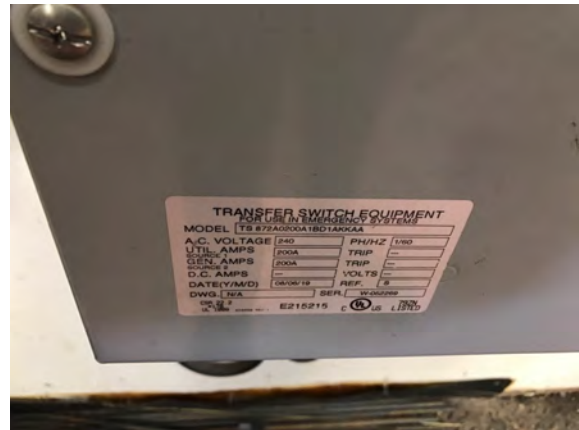
Charlie Lake Fire Hall - D509031

No major deficiencies were observed or reported during the assessment.

Recommendations #1 - Automatic Transfer Switches (ATSs) up to 400A	
Type	Life Cycle Replacement
Year	2050
Cost	\$14,002.50

Replace Automatic Transfer Switches (ATSs) up to 400A

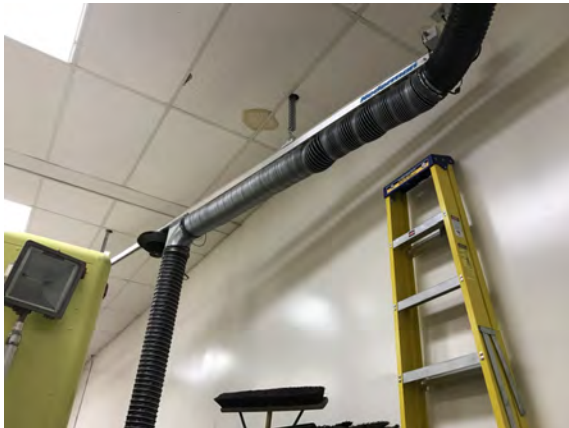
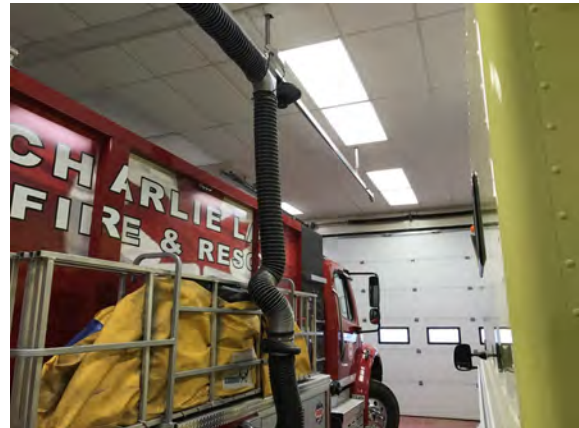
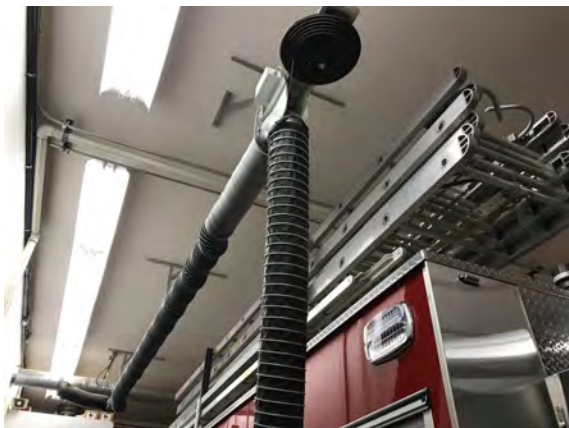
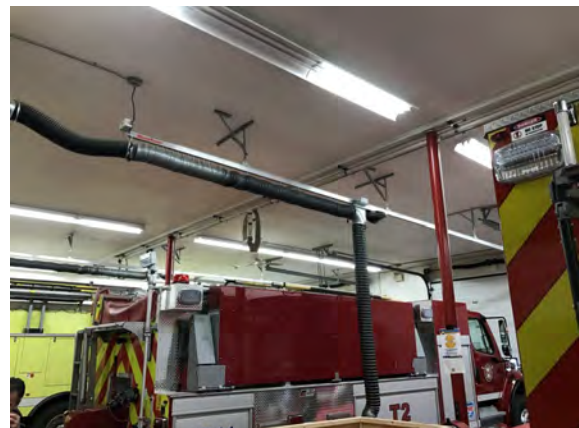
Charlie Lake Fire Hall - E102010

No major deficiencies were observed or reported during the assessment.

Recommendations #1 - Vehicle Exhaust Systems	
Type	Life Cycle Replacement
Year	2035
Cost	\$70,012.50

Replace Vehicle Exhaust Systems

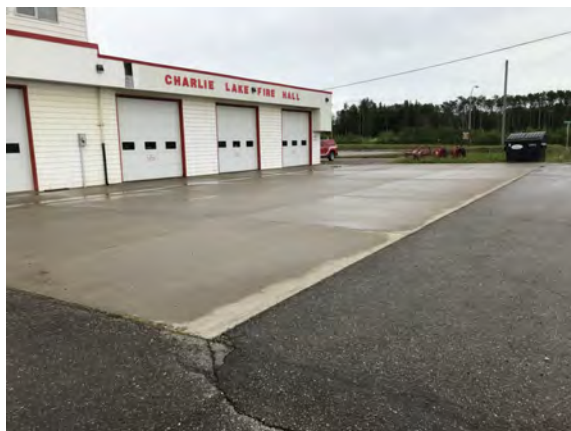
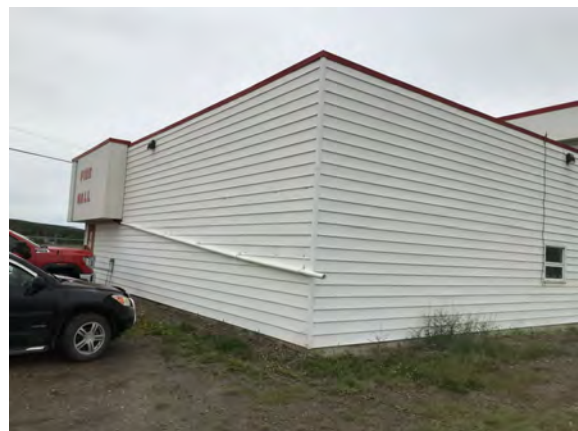
Charlie Lake Fire Hall - G201023

No major deficiencies were observed or reported during the assessment. Site personnel expressed concerns regarding settlement in the compound that may affect the asphalt and gravel yard. In addition, there is reportedly settlement and frost heave at the Main Entry door which is setting off the alarm. An allowance for an engineering study has been provided along with an allowance for repairs. The repair allowance is a placeholder value only. Repair costs will be based on the results or recommendations in the study.

Recommendations #1 - Study - Yard Settlement	
Type	Engineering Study
Year	2021
Cost	\$5,000.00

Based on the limited understanding of the component condition, further investigation is recommended to confirm settlement of ground around the building. The scope of the investigation should include potential remedial options, a renewal schedule and a cost to address the deficiencies and mitigate further deterioration.

Recommendations #2 - Repair - Yard Grading	
Type	Major Repair
Year	2022
Cost	\$30,000.00

Budgetary repair allowance to undertake a remedial action to address the observed deficiencies and mitigate further deterioration.

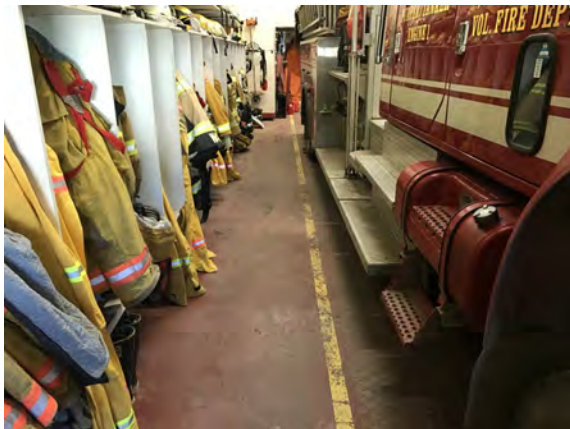
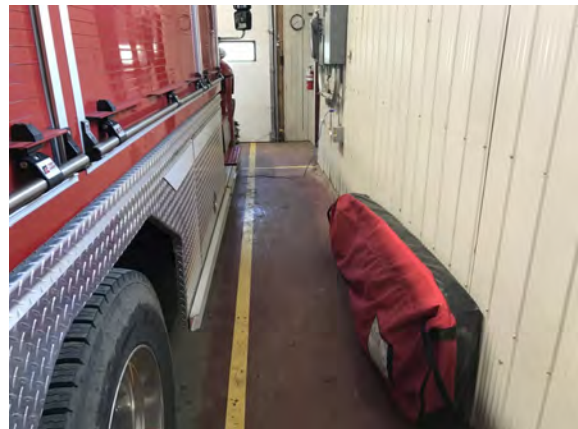
No major deficiencies were observed or reported. It is understood that the original building was constructed in 1983, and the west addition was constructed in 1999. As the remaining useful life falls outside the evaluation window for the oldest installed section, this system has been combined using the oldest known install date (1983).

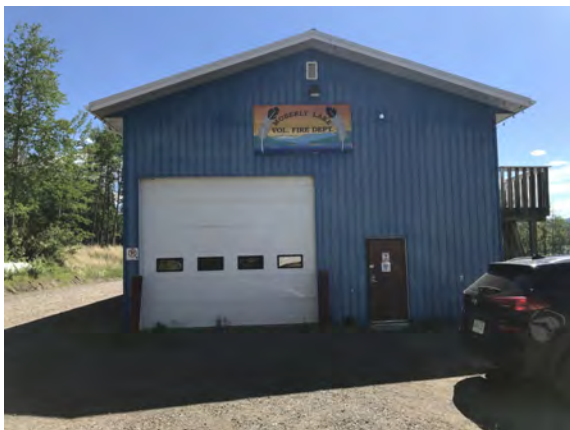
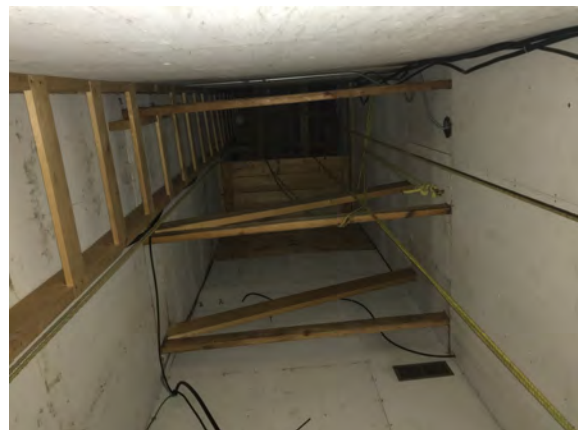
No major deficiencies were observed or reported, however, the wood ladder and wood platforms constructed within the hose tower are reportedly unsafe. As a result, the hose tower is not in use. It is recommended to provide an automated winch system for the hose drying tower to eliminate the need to climb the tower. Unsafe wood infrastructure should be removed. A cost to provide an automated hoist system has been provided. Additionally, in the 1999 vehicle bay, there is a through-wall penetration lined with galvanized ductwork that should be investigated. If used for combustion air, it is recommended to install a grill or fan as a maintenance activity. The Fire Chief indicated onsite that the tower could be removed altogether as it has not been in use for several years with no impact on operations. As the remaining useful life falls outside the evaluation window for the oldest installed section, this system has been combined using the oldest known install date (1983).

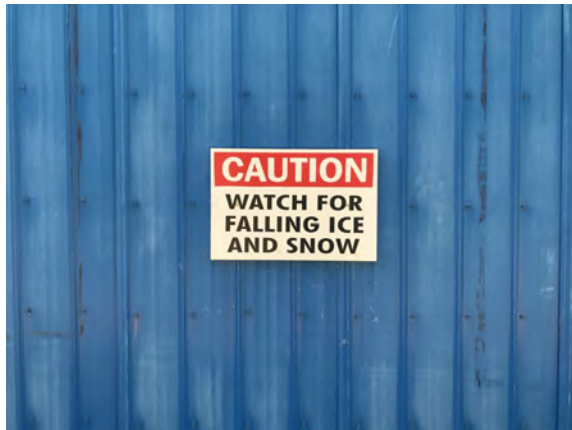
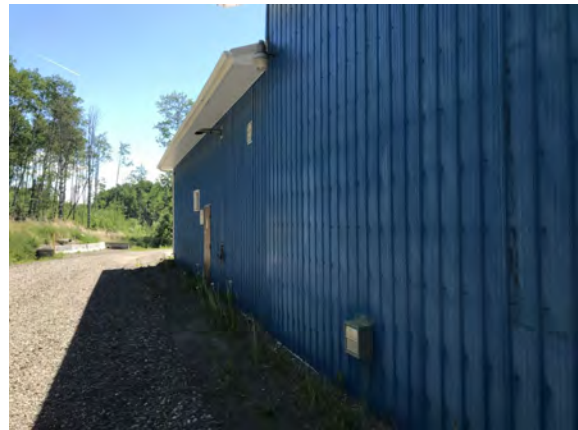
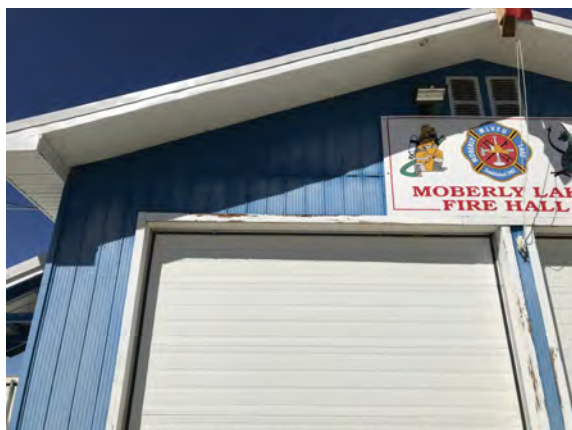
The paint is worn and sun-damaged. The paint is thin in spots. Lifecycle replacement is recommended to preserve the metal siding.

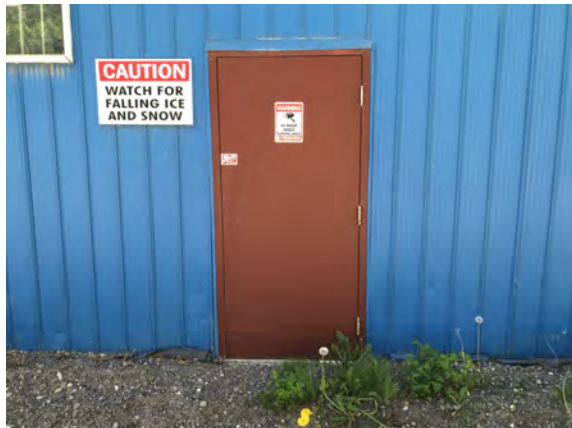
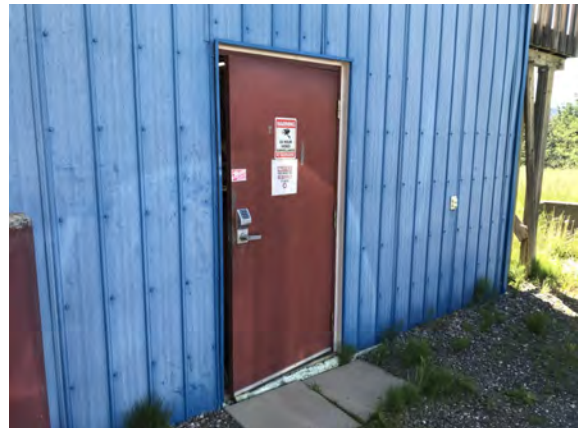
No major deficiencies were observed or reported, however, some doors are marked as exit doors, yet do not have panic hardware. It is recommended to install panic hardware on these doors to meet requirements for emergency exit doors. The cost to complete these repairs is presumed to fall below the cost threshold for repair recommendations (\$5,000) and should be completed as a routine maintenance activity. Doors were installed between 1983 and 1999. The components have surpassed their expected useful life, however, the Remaining Useful Life has been extended to a later year based on the absence of significant deficiencies.

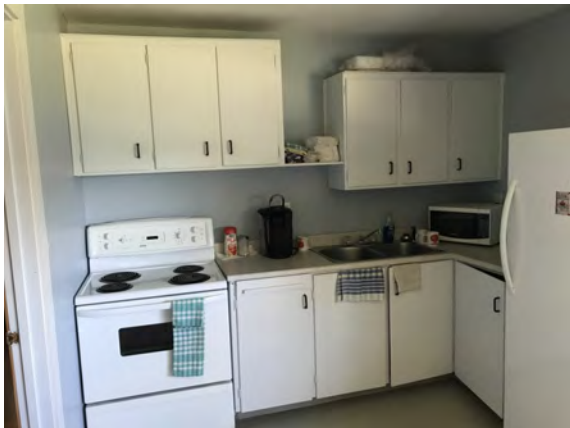
Moberly Lake Fire Hall - C103009

No major deficiencies were observed or reported. The components have surpassed their expected useful life, however, the Remaining Useful Life has been extended to a later year based on the absence of significant deficiencies.

Recommendations #1 - Cabinets - Kitchens	
Type	Life Cycle Replacement
Year	2027
Cost	\$11,202.00

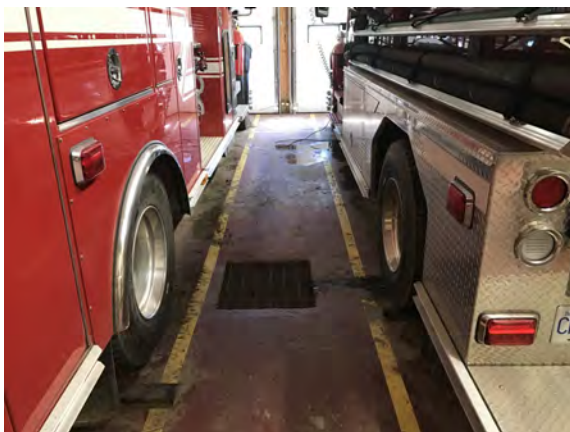
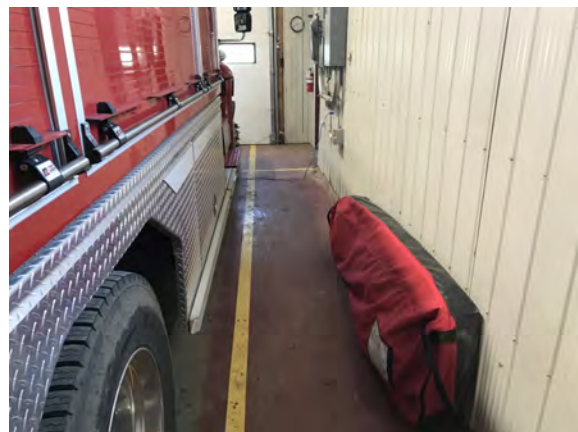
Moberly Lake Fire Hall - C302007

No major deficiencies were observed or reported.

Recommendations #1 - Painted / Sealed Concrete Floor	
Type	Life Cycle Replacement
Year	2027
Cost	\$19,566.16

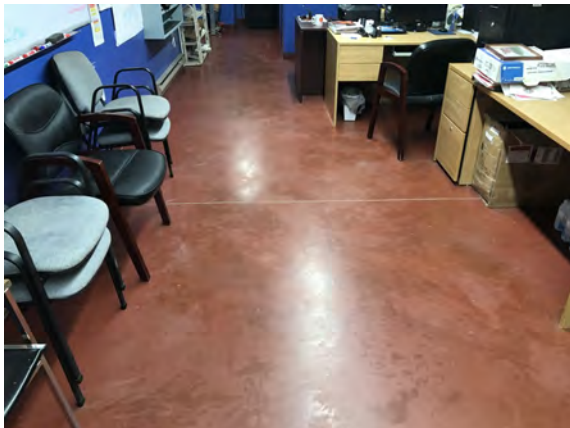
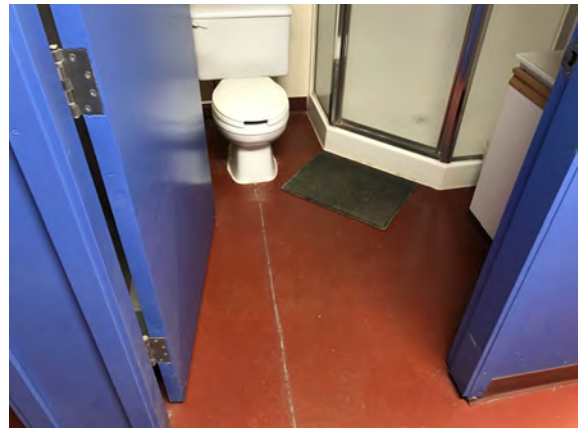
Moberly Lake Fire Hall - C302023

The flooring has exceeded its expected useful life and is exhibiting wear and tear that is consistent with age including separating at seams, lifting, and worn finishes in high traffic areas. Lifecycle replacement is recommended.

Recommendations #1 - Vinyl Sheet Floor	
Type	Life Cycle Replacement
Year	2024
Cost	\$33,157.92

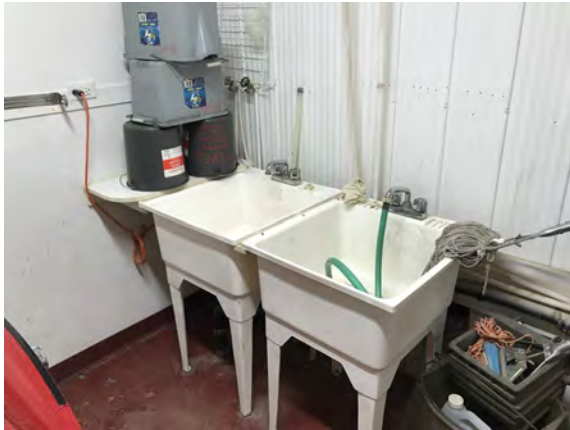
Moberly Lake Fire Hall - D201016

No major deficiencies were observed or reported. The cost factor has been decreased to account for the type of sinks.

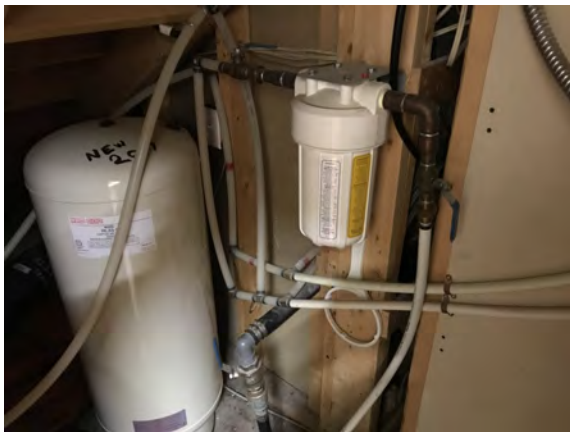
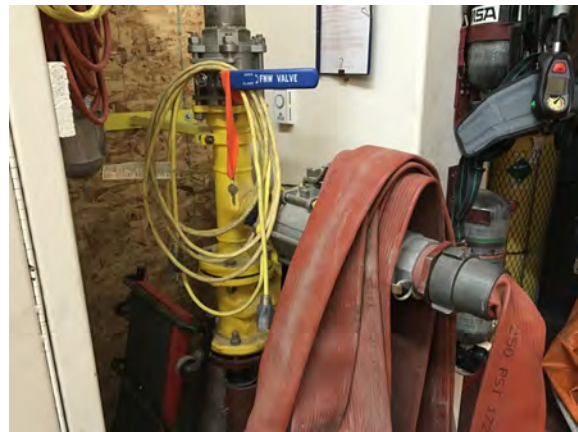
Moberly Lake Fire Hall - D202001

No major deficiencies were observed or reported. A large portion of the domestic water piping was replaced in 2017. The components have surpassed their expected useful life, however, the Remaining Useful Life has been extended to a later year based on the absence of significant deficiencies.
