PEACE RIVER REGIONAL DISTRICT

Rural Budgets Administration Committee Meeting Agenda

November 25, 2021, Immediately Following EADC
1981 Alaska Avenue, Dawson Creek, BC

**Facility Condition Assessment Report
Charlie Lake Fire Hall**

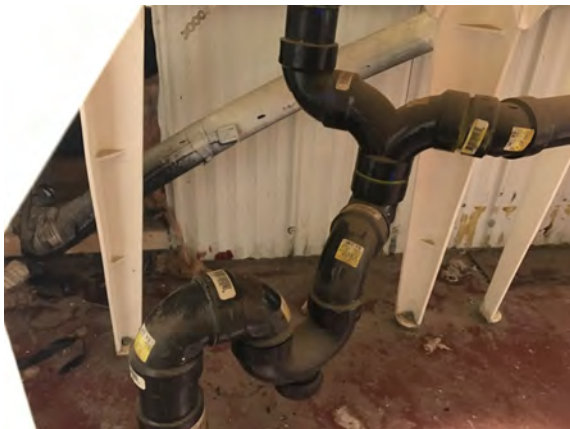
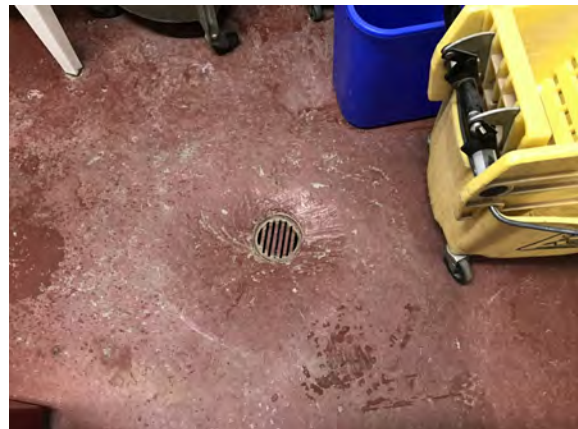
Moberly Lake Fire Hall - D203001

No major deficiencies were observed or reported.

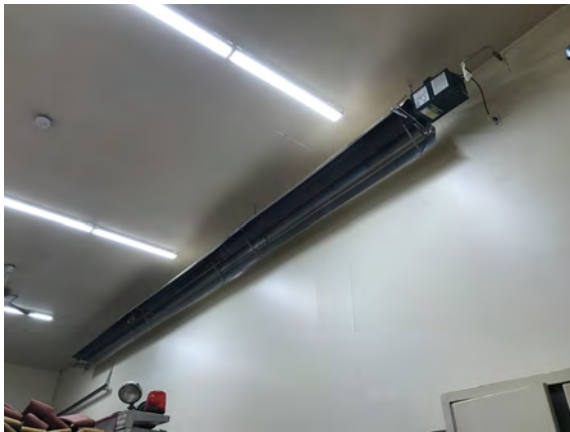
Moberly Lake Fire Hall - D302032

No major deficiencies were observed or reported, however, the equipment has exceeded its expected useful life and therefore has a higher likelihood of failure. Lifecycle replacement is recommended.

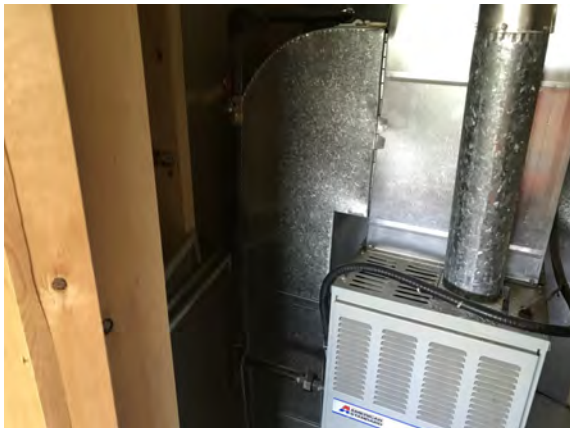
Moberly Lake Fire Hall - D304001

No major deficiencies were observed or reported. There was a noted lack of make-up air and exhaust systems present in vehicle bays. It is recommended to consult with local authorities having jurisdiction to ensure that existing infrastructure provides adequate airflow/air exchange in vehicle bays.

Recommendations #1 - Air Distribution Systems	
Type	Life Cycle Replacement
Year	2049
Cost	\$17,923.20

Replace Air Distribution Systems

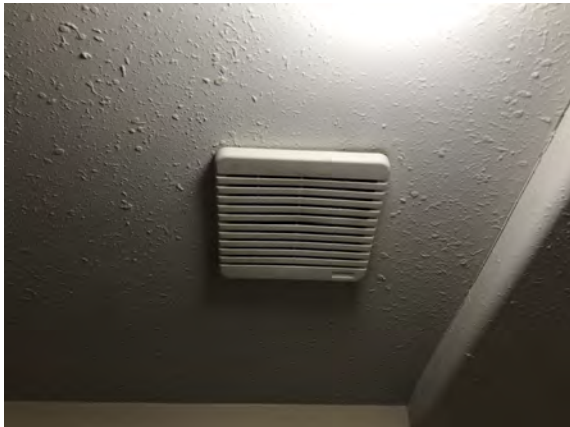
Moberly Lake Fire Hall - D304033

No major deficiencies were observed or reported.

Recommendations #1 - Exhaust Fan - Ceiling (Residential)	
Type	Life Cycle Replacement
Year	2028
Cost	\$3,734.00

Replace Exhaust Fan - Ceiling (Residential)

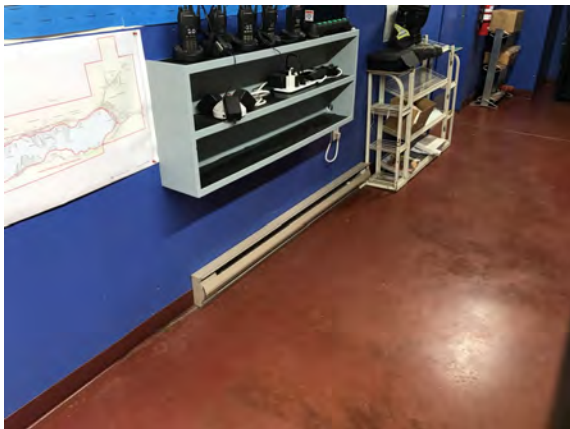
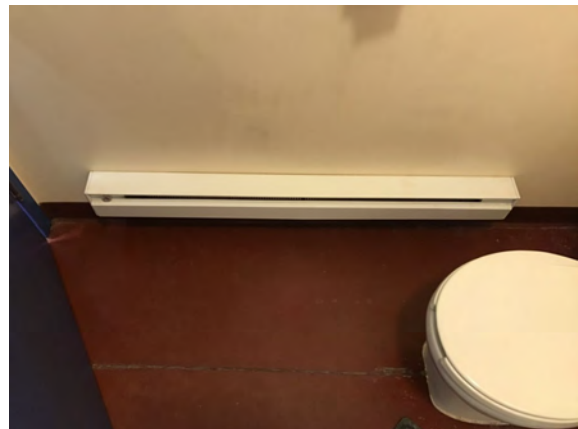
Moberly Lake Fire Hall - D305010

No major deficiencies were observed or reported, however, the baseboards have exceeded their expected useful life and should therefore be replaced.

Recommendations #1 - Electric Baseboard Heaters	
Type	Life Cycle Replacement
Year	2022
Cost	\$2,240.40

Replace Electric Baseboard Heaters

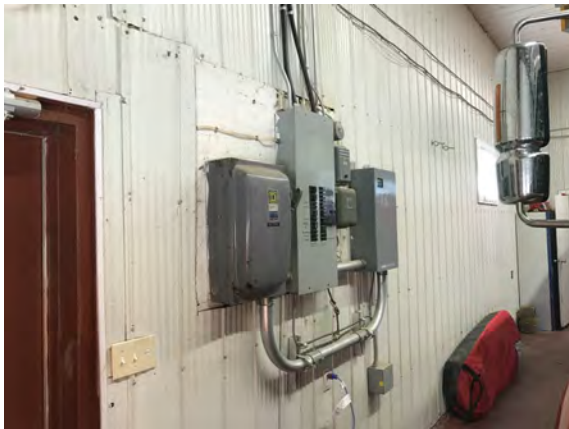
Moberly Lake Fire Hall - D501005

No major deficiencies were observed or reported, however, it is recommended to include breaker schedules in the panels as a maintenance activity. The component has surpassed its expected useful life, however, the Remaining Useful Life has been extended to a later year based on the absence of significant deficiencies.

Recommendations #1 - Panelboards up to 400A	
Type	Life Cycle Replacement
Year	2027
Cost	\$9,335.00

Replace Panelboards up to 400A

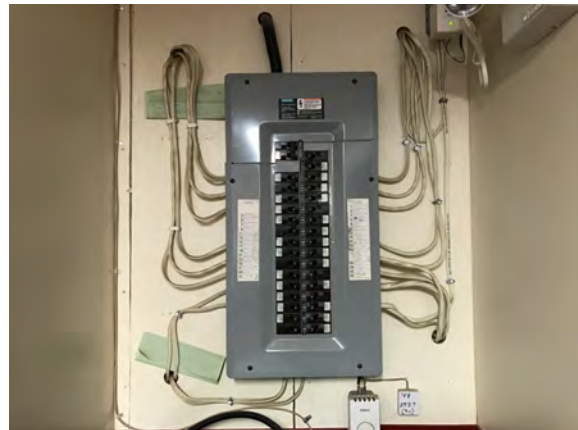
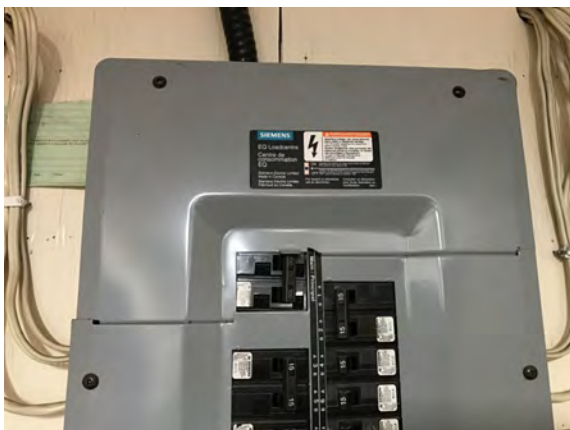
Moberly Lake Fire Hall - D501005

No major deficiencies were observed or reported, however, the panel is blocked by server equipment. Server equipment should be relocated as a maintenance activity.

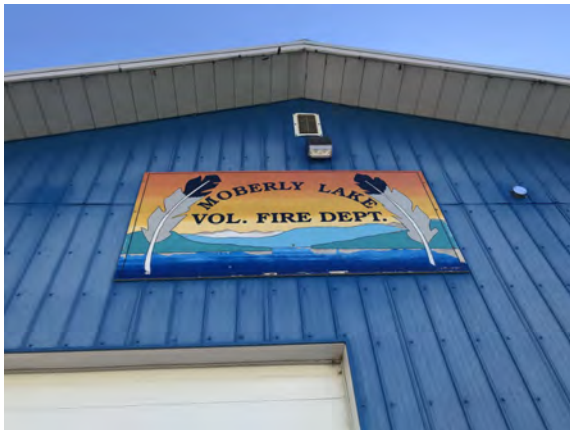
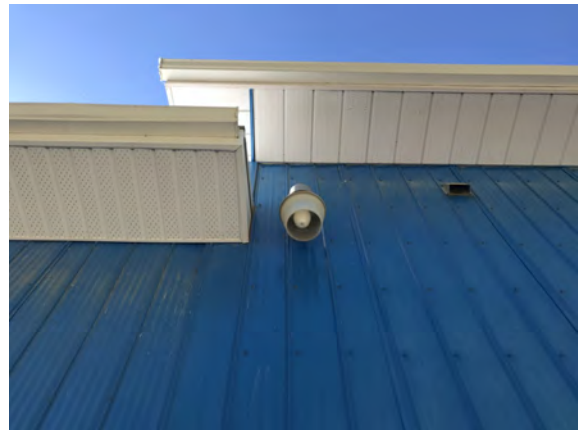
Moberly Lake Fire Hall - D502041

No major deficiencies were observed or reported, however, the remaining incandescent fixtures should be replaced with LED as a routine maintenance activity.

Recommendations #1 - Exterior Lighting	
Type	Life Cycle Replacement
Year	2039
Cost	\$3,734.00

Replace Exterior Lighting

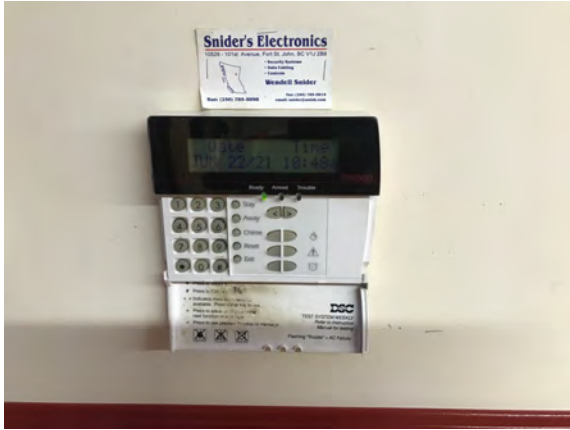
Moberly Lake Fire Hall - D503008

No major deficiencies were observed or reported. The difficulty factor has been increased to account for the smoke detectors included in the system.

Recommendations #1 - Security Systems - Intrusion Alarm Systems	
Type	Life Cycle Replacement
Year	2030
Cost	\$11,482.05

Replace Security Systems - Intrusion Alarm Systems

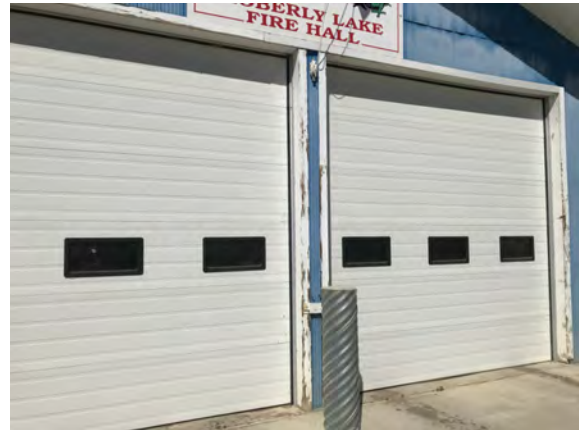
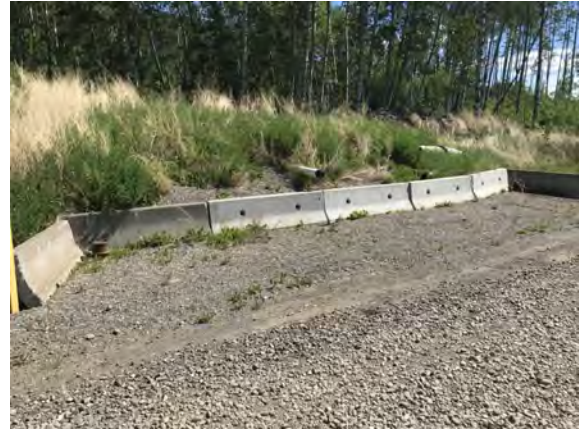
Moberly Lake Fire Hall - G201005

No major deficiencies were observed or reported. It is recommended to paint the barriers with exterior grade high visibility paint to help with visibility. The cost to paint the barriers is presumed to fall below the cost threshold for repair recommendations (\$5,000) and should be completed as a routine maintenance activity.

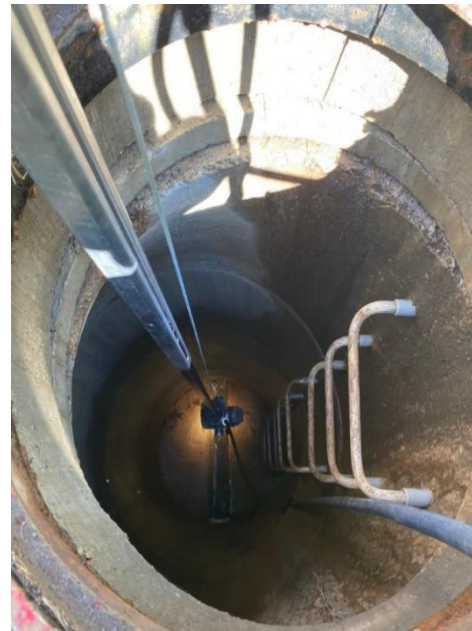
Figure 2 : Manhole

From an operation and maintenance standpoint, the inspection results confirmed that the inspected manholes are in good condition. Only 2 manholes (6%) have grades 4 and 5 O&M deficiencies.

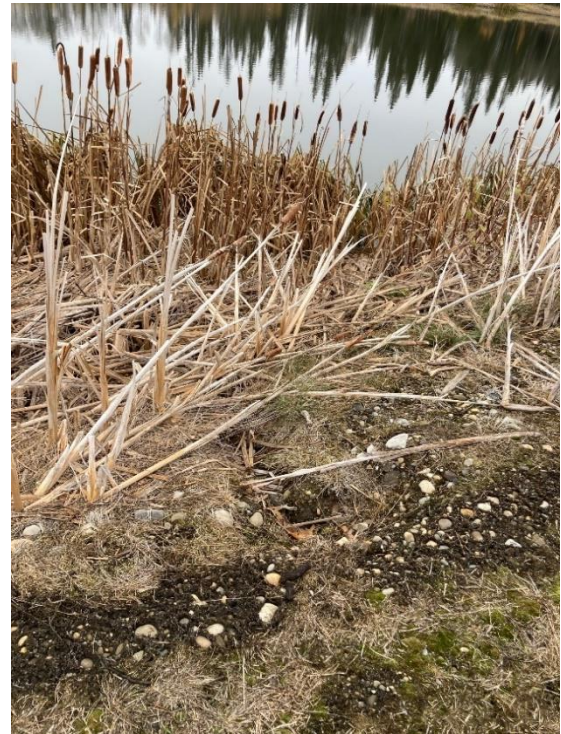
Figure 4: Crevasses between Cell 3 & 5

Repeated overflowing of lagoon 3 has created crevasses as well as a slight subsidence of the road. It is advisable to proceed to a sludge measurement on cells 1, 2 and 3 to evaluate if the design capacity is still maintained and prevent further overflow. In addition, the level of pond 3 should be lowered regularly in anticipation of the high rainfall seasons.

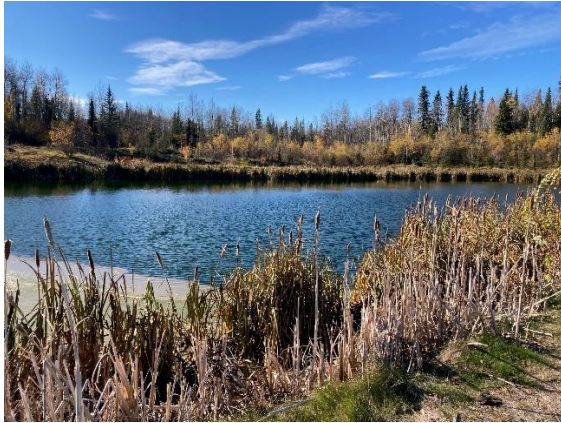
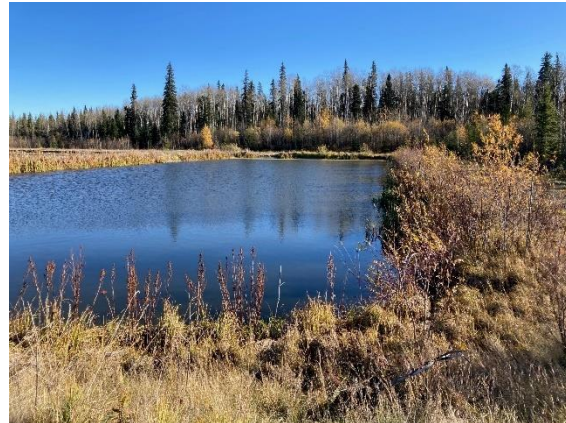
Figure 6 : Cell 3 and Cell 4

The berms of the different cells are in average to poor condition. In addition to muskrat burrows and uncontrolled vegetation, there is a strong degradation of the berm slope, especially on the eastern side of lagoon 5. The clay layer is uneven and may result in infiltration and increase risk of collapsing from the surrounding roads.

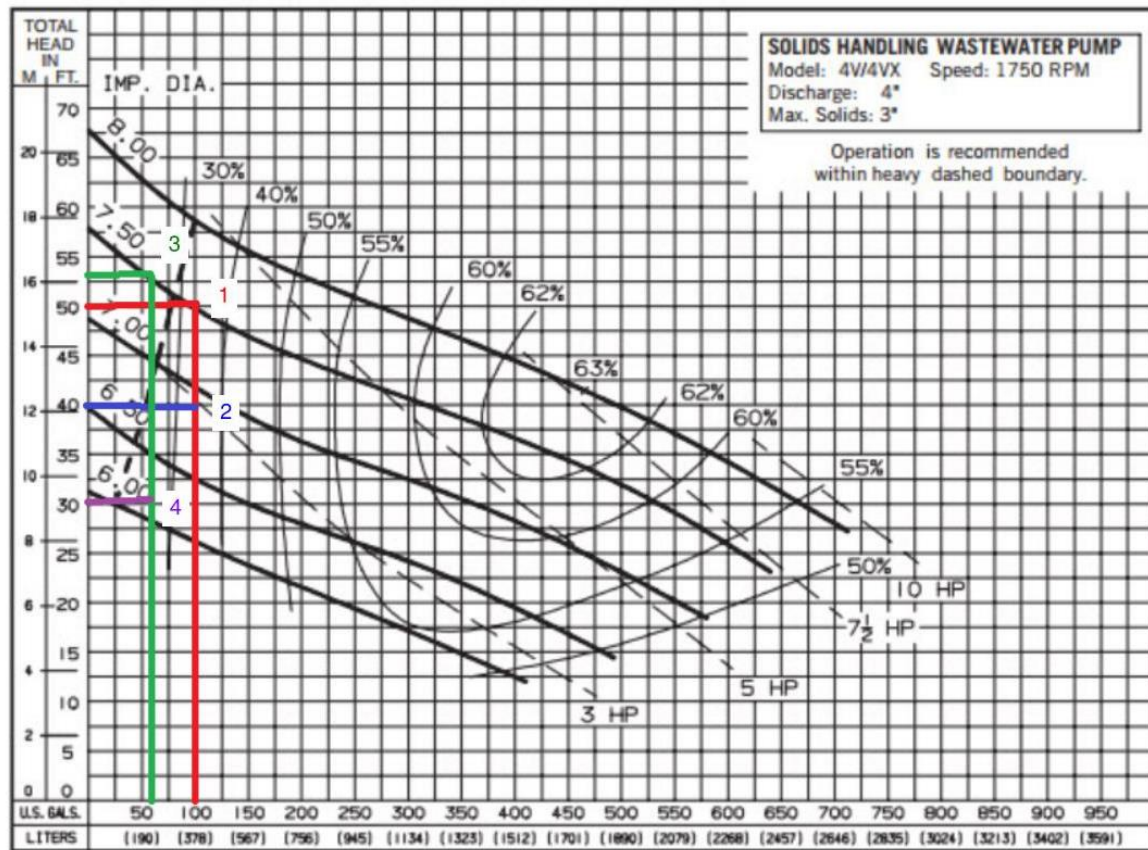
Figure 5: Pump Curve Comparison – Harper Lift Station

The total pressure head gap between points 3 and 4 and the performance gap between points 1 and 4 could be caused by:

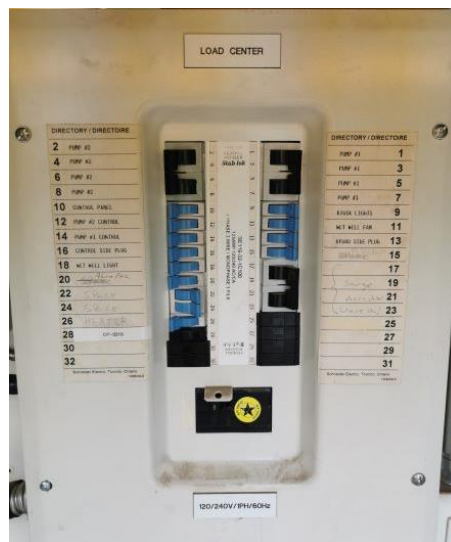
Figure 12: Electrical Panel with Federal Pioneer Breakers

The power breaker panel is located inside the cabinet next to the PCL panel ([Figure 12](#)). Federal Pioneer breakers are a known fire hazard and do not operate correctly under some conditions. This panel and all associated circuit breakers should be replaced with a currently available panelboard.
