PEACE RIVER REGIONAL DISTRICT

Electoral Area Directors Committee Meeting Agenda

Subject: North Peace Airport Subdivision Water and Sewer Condition Assessment

Condition Assessment Report

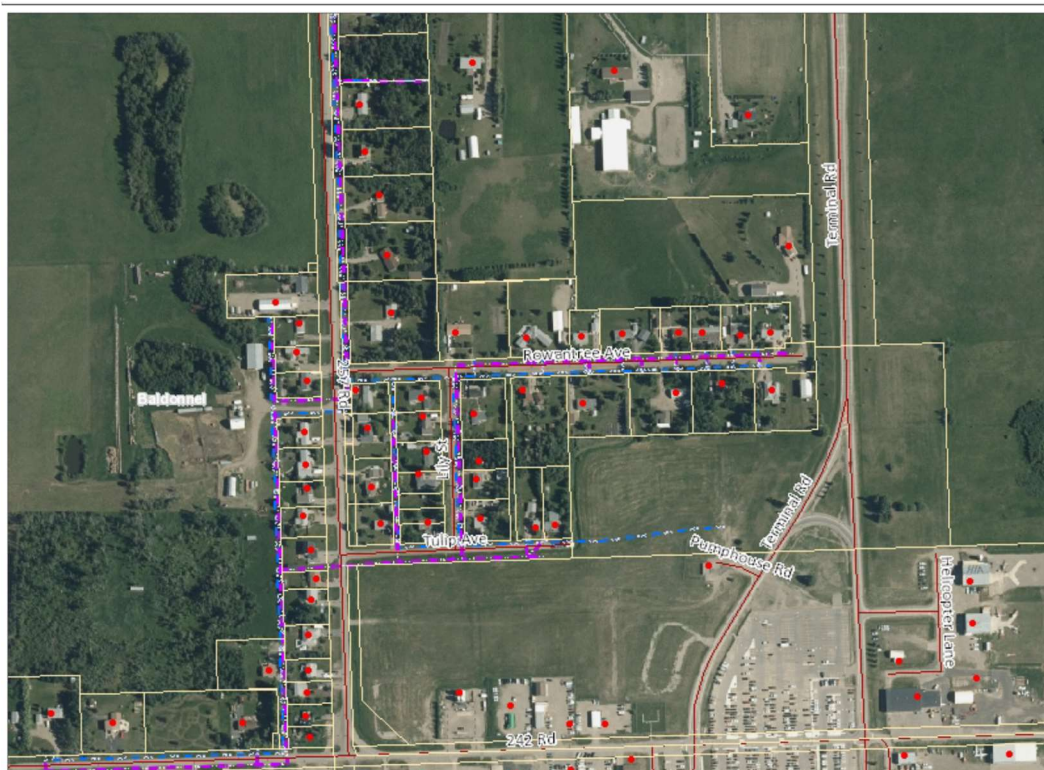
The YXJ Subdivision watermain network is comprised of approximately 2.3 kilometres of 150-millimetre Asbestos Cement Pipe (ACP) and the sewer network is approximately 2.2 kilometres of 200-millimetre Vitrified Clay Pipe (VCP). The watermain and sewer network serves about 60 households in this neighbourhood.

Figure 2.1: Inspection Scope of the 150mm watermain network and 200mm sewer network

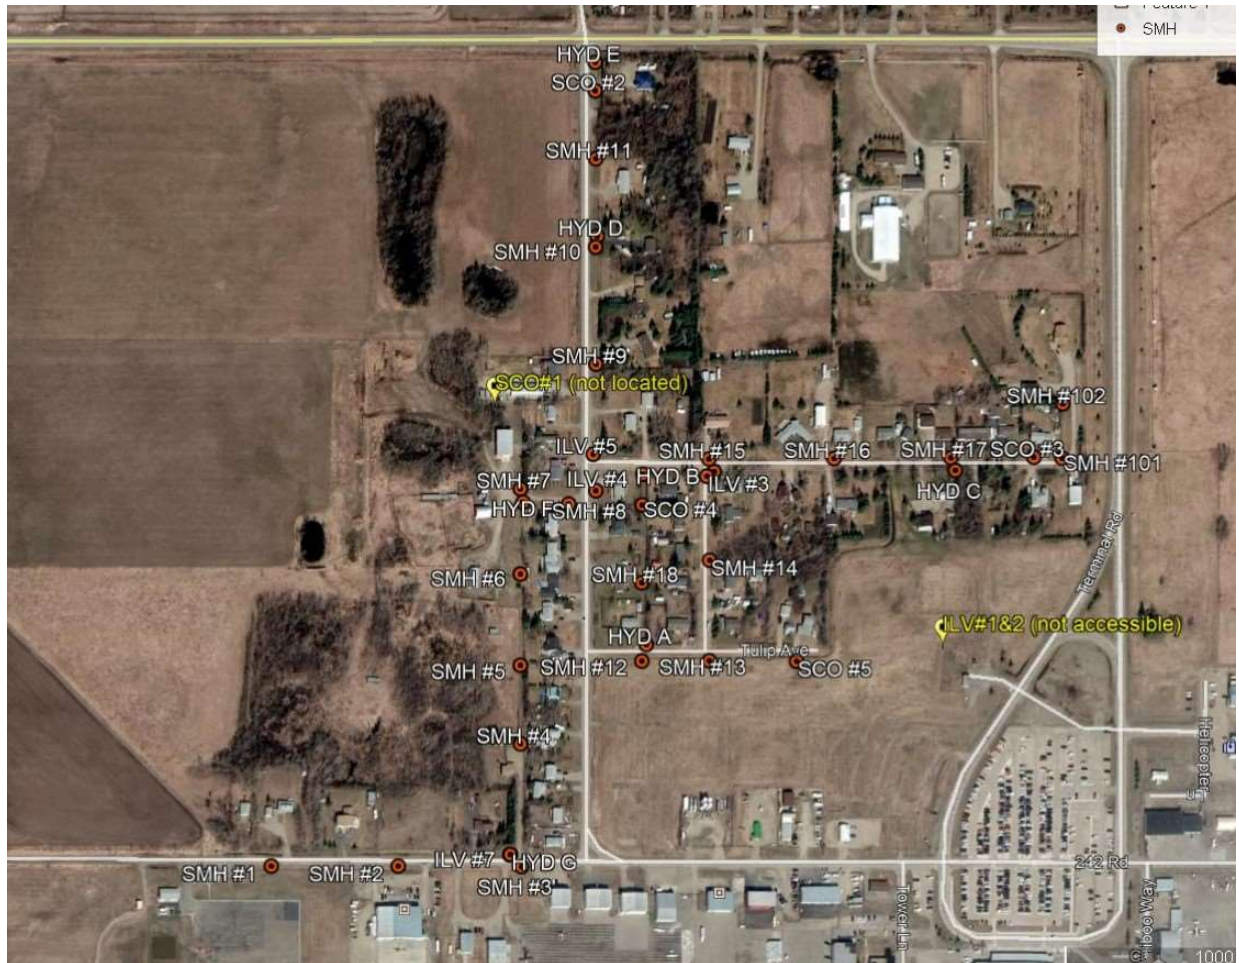
Figure 5.2: Location of Inline Valves and Hydrants

From the drawings provided, seven (7) inline valves were identified in the watermain network within the inspection limits. Inline Valves 1 and 2 could not be accessed as it is located in fence line in neighboring airport field.

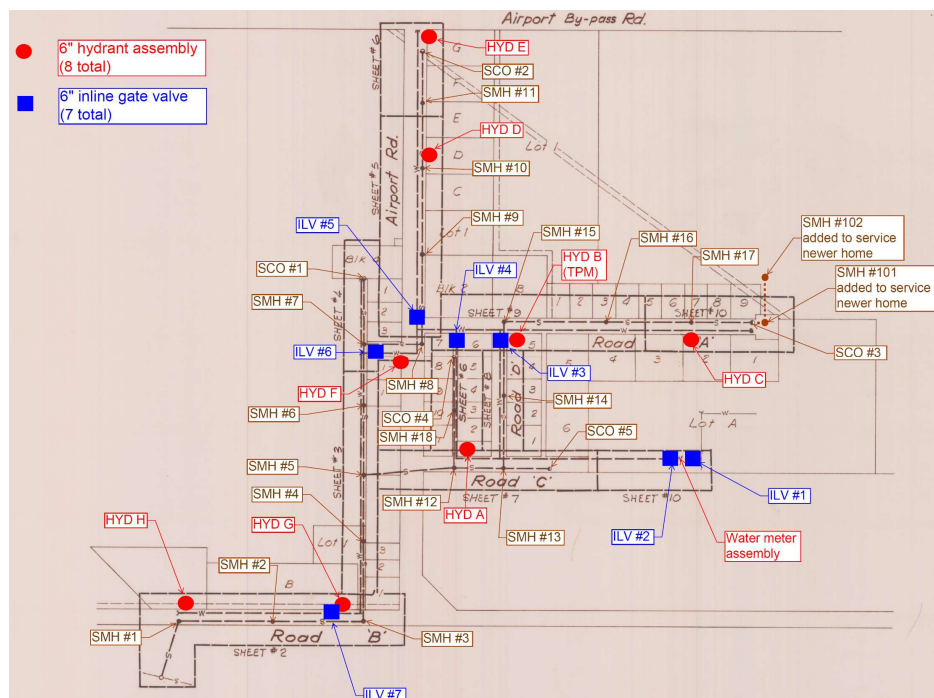
The Telog high speed pressure transducer was installed on the fire hydrant (HYD B) located at the southeast corner of Rowantree Ave. (Road A) and Lily St. (Road D). This location (see Figure 6.1) was selected because it is approximately in the middle of the YXJ Subdivision serviced by the 6-inch AC water main.

Figure 6.1: Location of Hydrants and Gate Valves in the 6-inch AC Water Mains

The transducer was activated on August 17, 2020 at 9:28 AM and was deactivated on September 15, 2020 at 11:32 AM. Pressure measurements are recorded every 4 minutes. If a transient (water hammer) event is detected, then the transducer records the pressure in micro-seconds. During the nearly one-month monitoring period 10,473 pressure measurements were recorded every 4 minutes. No significant surge pressure was detected.

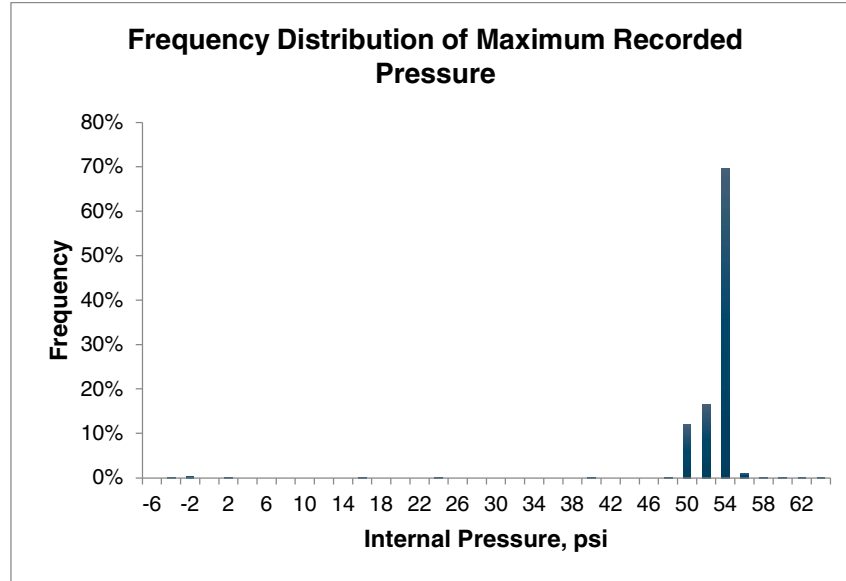
The frequency distribution of the 10,473 maximum pressure measurements can be seen in Figure 6.2 below. As expected from the graph in Appendix A, the majority of the maximum pressure measurements (applies to minimum and average too) falls into a very narrow band. In fact, 70% of all maximum pressures fall between 53 and 55 psi. This can also be observed in Figure 6.3 which shows the cumulative frequency distribution of this same data. More importantly, from a design perspective, 99.9% of all maximum pressures fall at 56 psi or below. The two maximum recorded pressures above 60 psi, which occurred at 9:00AM and 9:04AM on September 3, 2020, were probably due to some minor transient event in the system. The AWWA C401 design method incorporates a factor of safety of 4 on the working pressure to accommodate unexpected transients that may occur in a water distribution system. Consequently, for the AWWA C401 design check, a working pressure of 56 psi at the hydrant level was used. This represents the 99.9 percentile of all maximum pressure measurements in the YXJ subdivision.

Figure 6.2: Frequency Distribution of Maximum Pressure

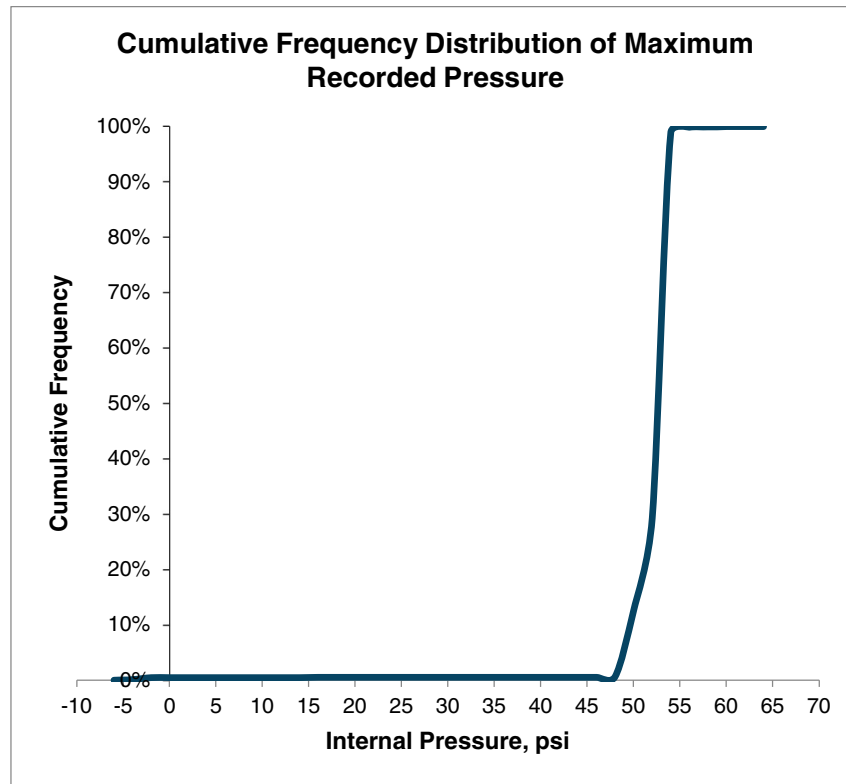
Figure 6.3: Cumulative Frequency Distribution of Maximum Pressure

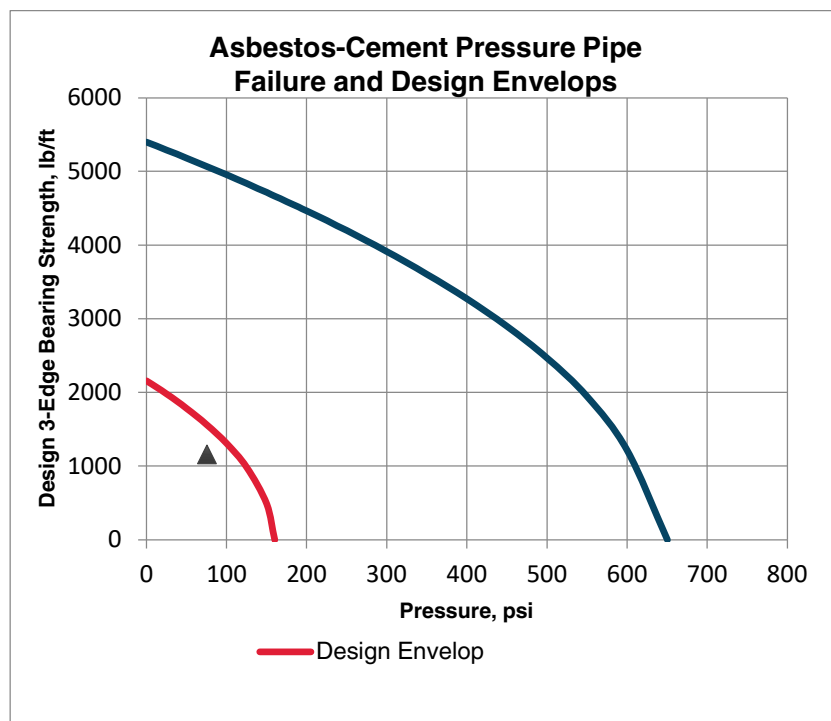
Using the AWWA C400 design (i.e., burst) internal pressure of 632 psi and a design external (crush) load of 5400 lb/ft, the failure envelop for the 6-inch Class 150 AC pipe can be calculated and plotted (blue line in Figure 7.4). Then applying the AWWA C401 recommended factors of safety of 4 for internal pressure and 2.5 for external (crush) load, the allowable or design envelope can be established (red line in Figure 7.4). Figure 7.4 shows the two curves, failure and design, for a 6-inch Class 150 AC pipe meeting the performance requirements of AWWA C400.

Superimposed on this design and failure graph in Figure 7.4 is the intersection of the maximum working pressure of 75 psi and the external load of 1,210 lb/ft. This point falls well below the design line, meaning the pipe exceeds the recommended minimum safety requirements in AWWA C401. Table 7.2 below shows the factors of safety in pressure and external crush load for the 75 psi maximum working pressure and 9 ft. of soil burial with live load.

Figure 7.4: Design and Failure Envelop for 6-in Class 150 AC Water Pipe

The 6-in Class 150 AC water pipe in the YXJ subdivision has been in service since 1977, a total of 43 years. There have been no reported failures in this piping system. Pure Technologies has assessed the condition of asbestos-cement pipes used for water pipes and sewer force mains on other projects. Although we have seen significant degrees of deterioration in some AC pipes used for sewer force mains, the condition of water main pipes has been relatively good. Unless AC water pipes are conveying “soft water” or buried in acidic sulfate bearing soils there would be little to no expectation to see significant degradation of these pipes.

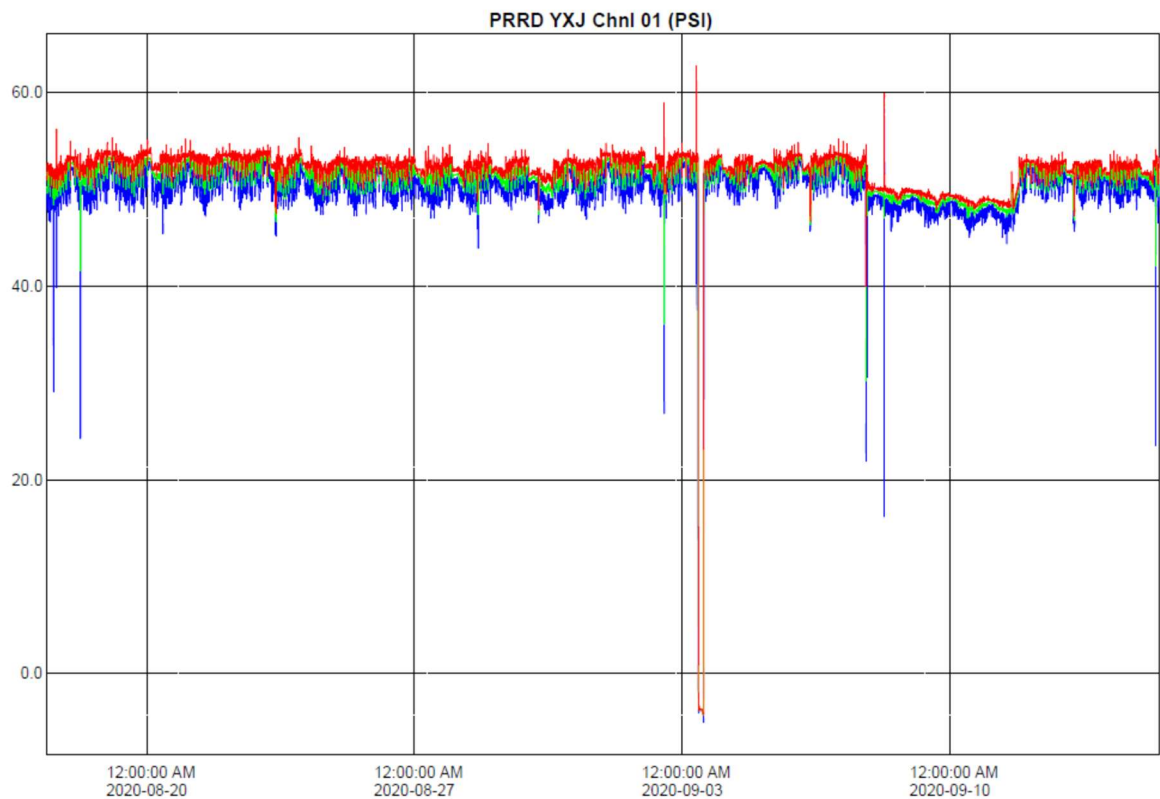
On September 3, 2020 at 10:08 AM a minimum pressure of magnitude -5.08 psi was recorded. This negative pressure lasted a duration of 3-1/2 hours, until 1:36 PM. An hour proceeding this registration of a negative pressure, the maximum pressure of 62.76 psi was recorded. This maximum pressure lasted approximately 8 minutes (2 recording cycles) before returning to a more normal level. It is suspected that the pressure to the subdivision was deactivated for that 3-1/2 hour period so maintenance or repair could be performed at some other location in the feeder system.

Figure A: Pressure Data over a 30-day monitoring period
