PEACE RIVER
REGIONAL DISTRICT

KELLY LAKE SEWER SYSTEM CONDITION ASSESSMENT

KELLY LAKE SEWER SYSTEM CONDITION ASSESSMENT NOVEMBER 2021 FINAL REPORT

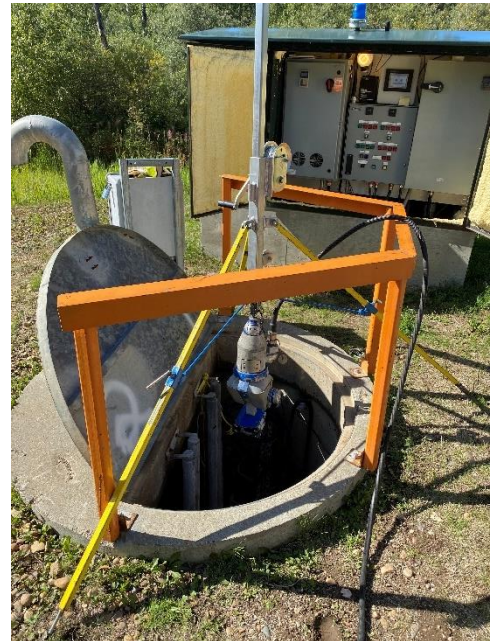
Figure 1: Zoom Inspection of Lift Station

Our crew employed a high-resolution Zoom Camera to check the pipes, valves, shut offs, and cleanouts for wall structural integrity and sewage leaks. T
