Peace River Regional District

**Facility Condition Assessment Report
Charlie Lake Fire Hall**

November 18, 2021

Prepared by:
FCAPX a Division of Roth IAMS
Project No. 21075
www.fcapx.com

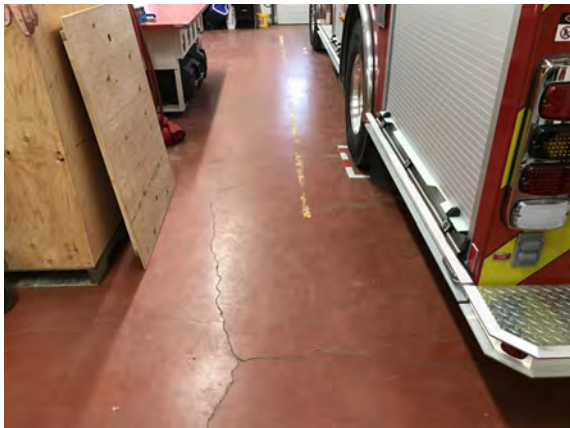
Charlie Lake Fire Hall - A103001

There are some localized cracks and uneven surfaces in the building. A repair allowance has been included herein to repair these areas. The remaining useful life has been left unchanged with the assumption that repairs are completed

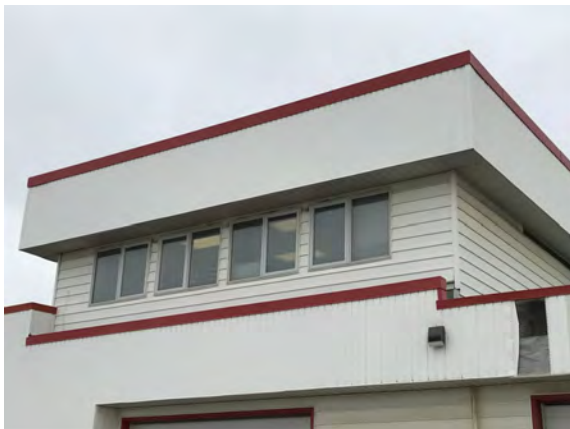
Charlie Lake Fire Hall - B103001

No major deficiencies were observed or reported during the assessment. Second floor and main wall between original building has damage due to a prior water leak. Given the nature of the component, full-scale replacement during a specific year is not expected to be required. However, a cost allowance for partial replacement and/or repairs has been carried forward in this report as a precautionary measure.

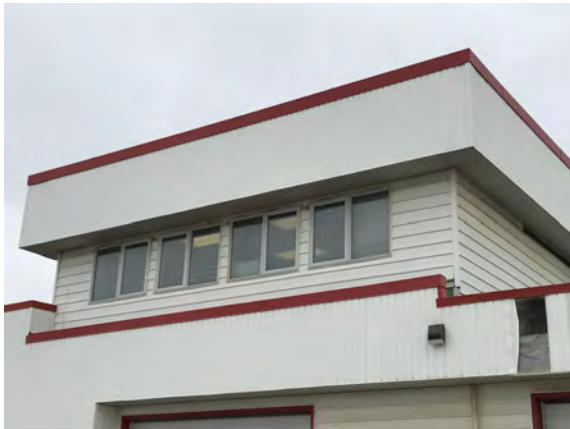
Charlie Lake Fire Hall - B201025

The window frames appeared to remain serviceable although they exhibited wear and discoloration that is generally consistent with their age. Condensation was observed between the glass panes on a few windows on the north elevation (conference room) and on the mezzanine loft, suggesting glazing unit seal failure.

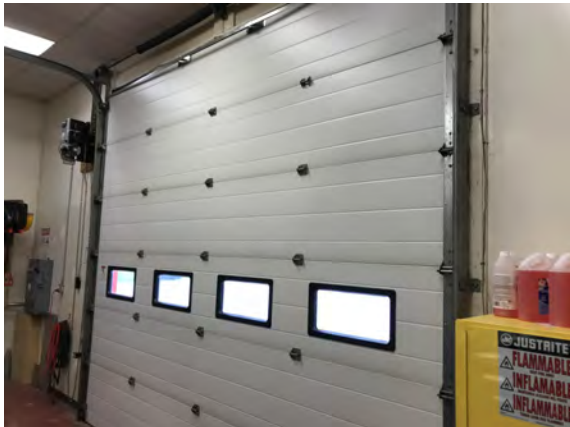
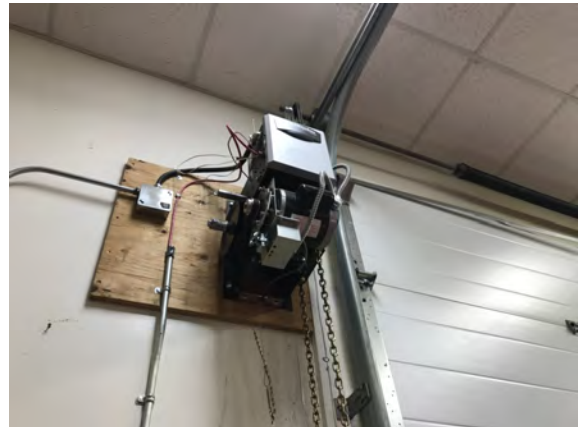
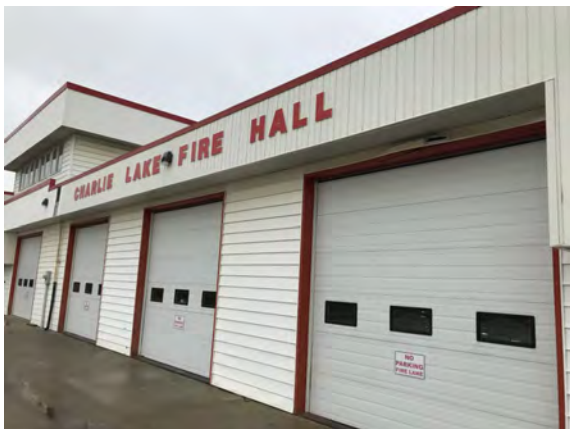
No major deficiencies were observed or reported during the assessment. Door seals were deteriorating, replace/repair as part of maintenance.

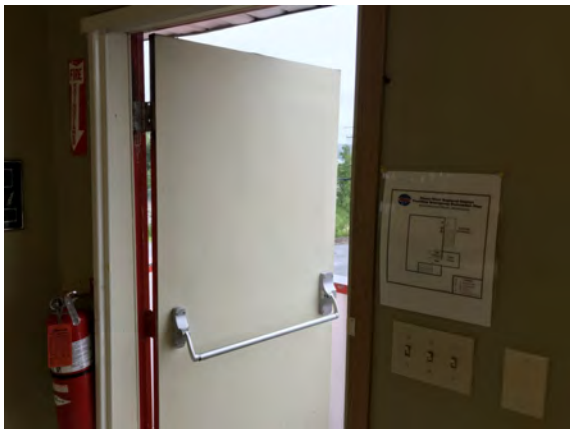
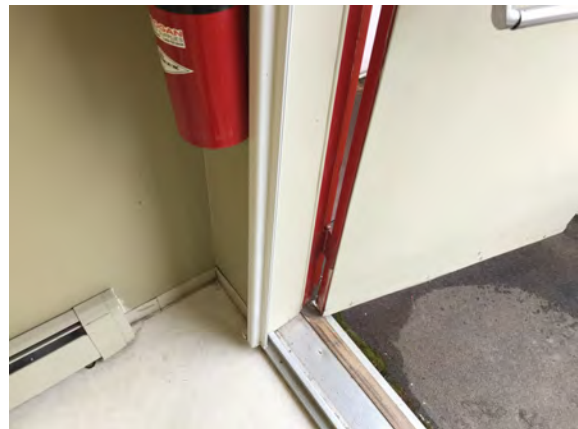
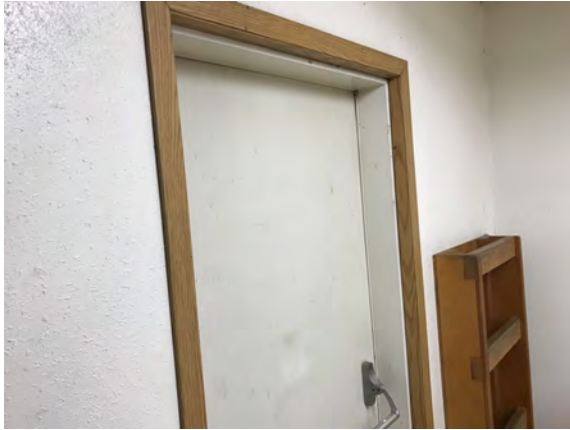
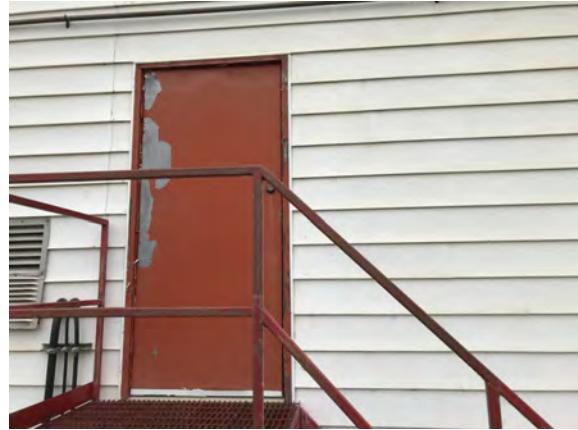
Exterior steel doors have reached the end of their expected useful life and are exhibiting wear and tear that is consistent with the age of the materials including loose hardware, difficulty latching (second floor emergency exit), and worn painted panels. Lifecycle replacement is recommended within the short-term of the evaluation period.

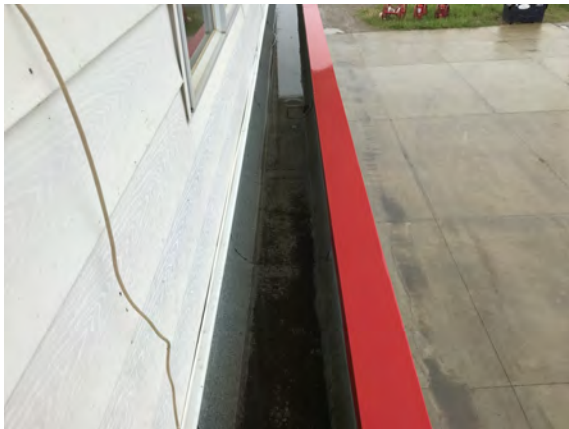
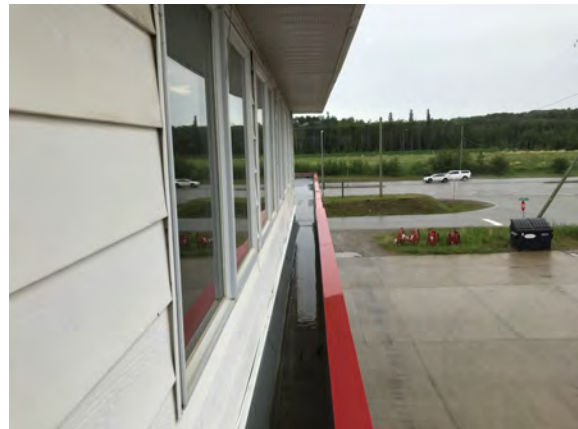
Roof access was not available during the assessment. Where visible, the gutters were observed to have inadequate drainage. It is recommended repairs be conducted in the short-term to address the drainage issues. An allowance for repairs has been provided.

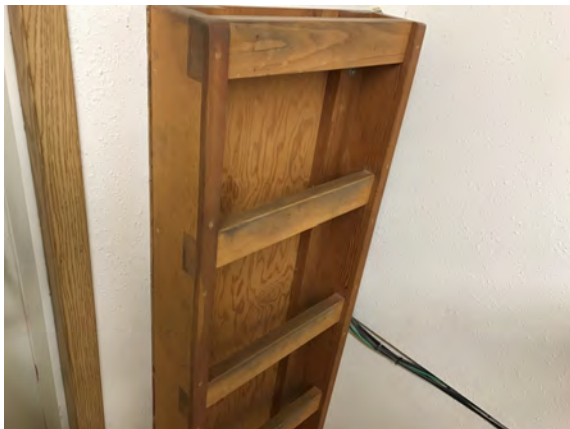
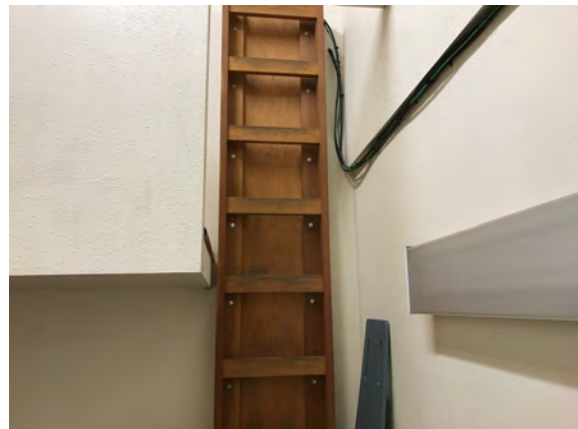
Charlie Lake Fire Hall - C201027

The ladder is not worksafe approved and should be addressed to meet current building code standards. The difficulty factor has been adjusted based on the ladder material and design.

Recommendations #1 - Access Ladders	
Type	Life Cycle Replacement
Year	2027
Cost	\$4,667.50

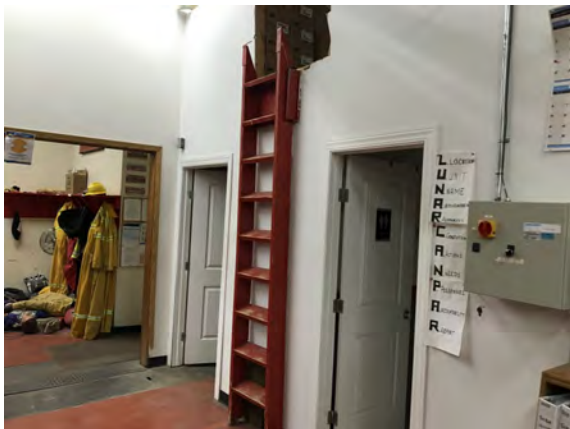
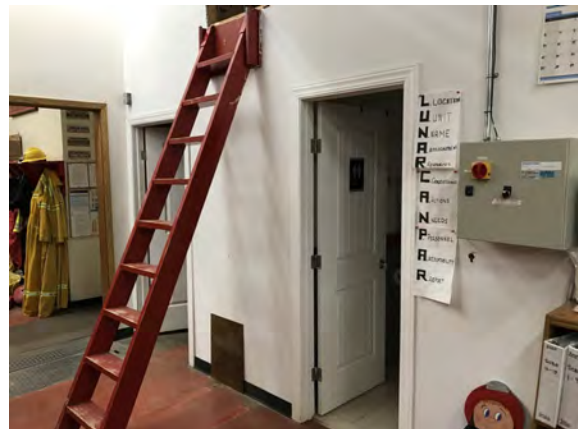
Charlie Lake Fire Hall - C201027

The ladder was observed to have worn paint finishes. No major deficiencies were observed or reported during the assessment. Renewal of paint finishes is recommended as part of routine maintenance activities. The component has exceeded its expected useful life, although its remaining useful life has been extended to a later year due to the absence of significant observed or reported deficiencies. The difficulty factor has been adjusted based on the ladder material and design.

Recommendations #1 - Access Ladders	
Type	Life Cycle Replacement
Year	2026
Cost	\$2,800.50

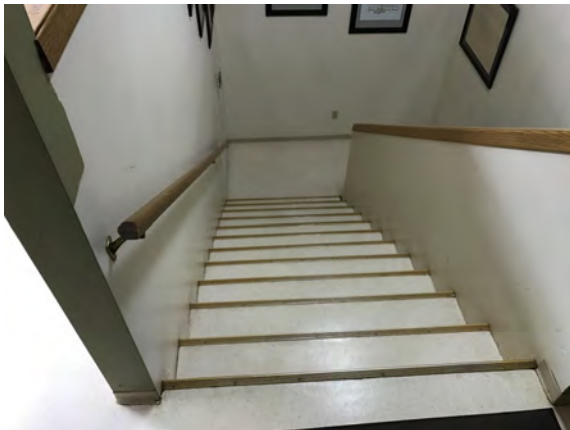
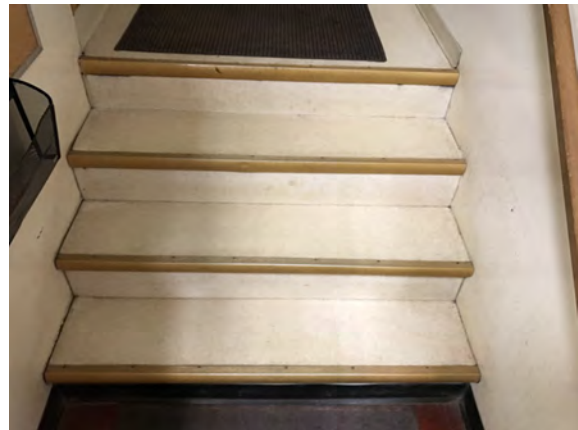
Charlie Lake Fire Hall - C202027

No major deficiencies were observed or reported during the assessment. The component has exceeded its expected useful life, although its remaining useful life has been extended beyond the short-term of the evaluation period due to the absence of significant observed or reported deficiencies.

Recommendations #1 - Vinyl Sheet	
Type	Life Cycle Replacement
Year	2027
Cost	\$3,780.68

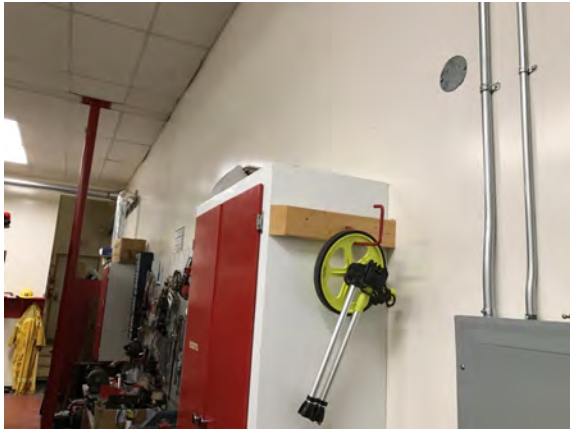
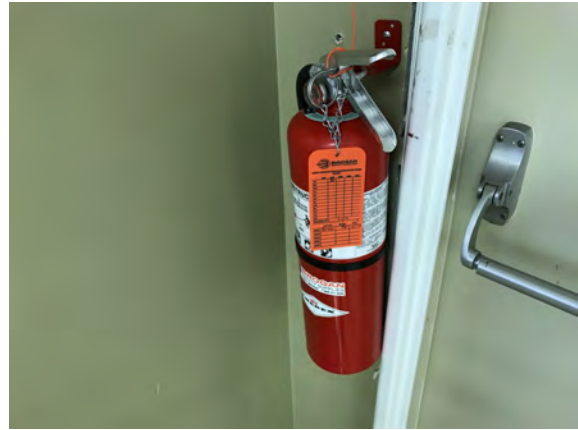
Charlie Lake Fire Hall - C301005

While the paint finish was observed to be in fair condition at the time of assessment, it is likely that it will require renewal within the short-term of the evaluation period.

Recommendations #1 - Paint Wall Covering	
Type	Life Cycle Replacement
Year	2026
Cost	\$46,600.32

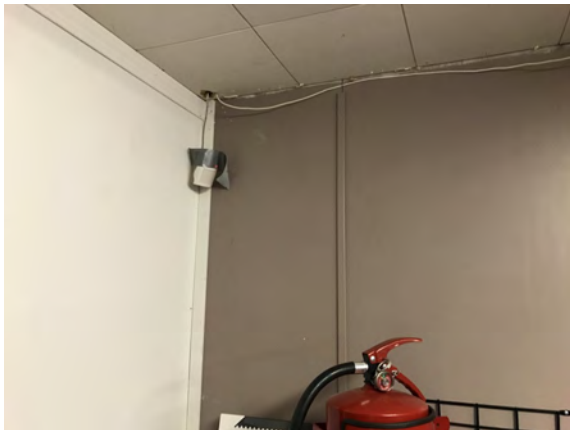
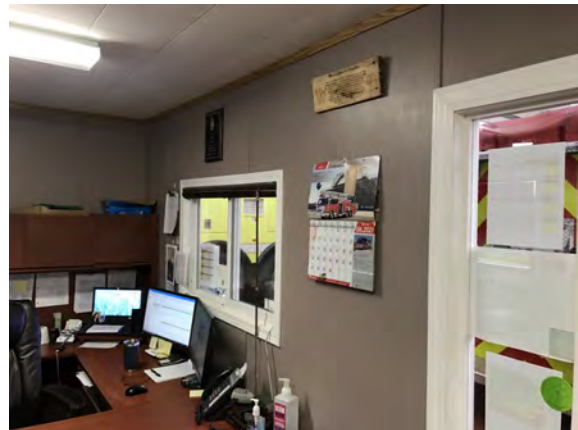
Charlie Lake Fire Hall - C301022

The component has exceeded its expected useful life, although its remaining useful life has been extended beyond the short-term of the evaluation period due to the absence of significant observed or reported deficiencies. The difficulty factor has been adjusted based on the design of the wall finish.

Recommendations #1 - Wood Wall Finish	
Type	Life Cycle Replacement
Year	2027
Cost	\$4,032.72

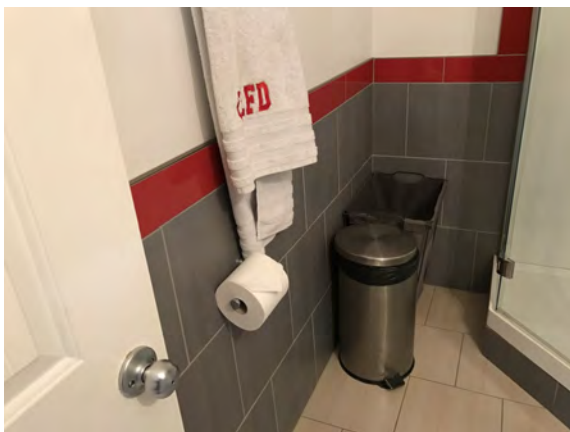
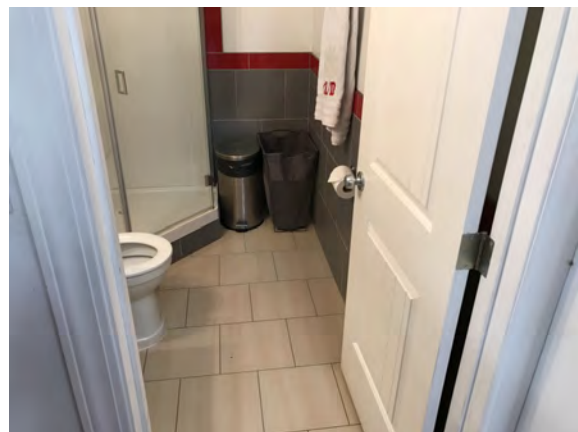
Charlie Lake Fire Hall - C301023

No major deficiencies were observed or reported during the assessment.

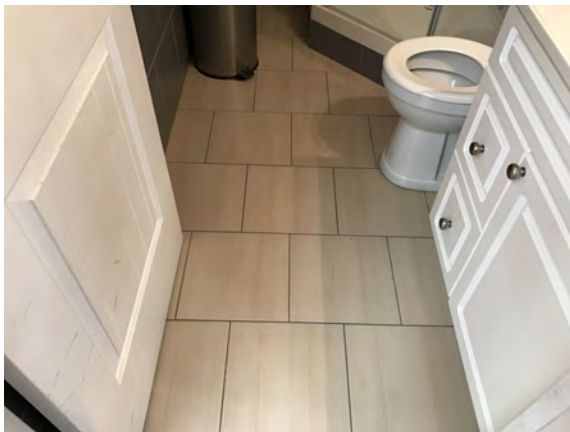
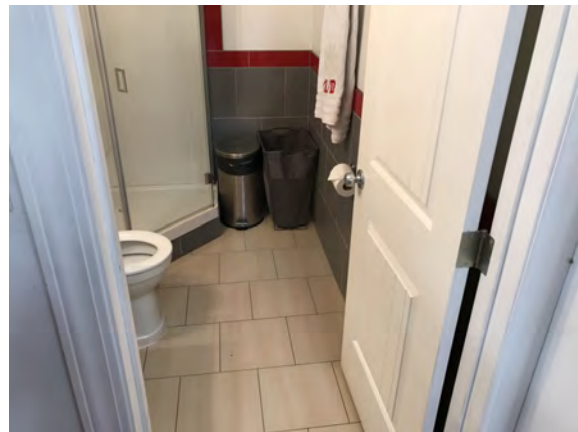
Charlie Lake Fire Hall - C302001

No major deficiencies were observed or reported during the assessment.

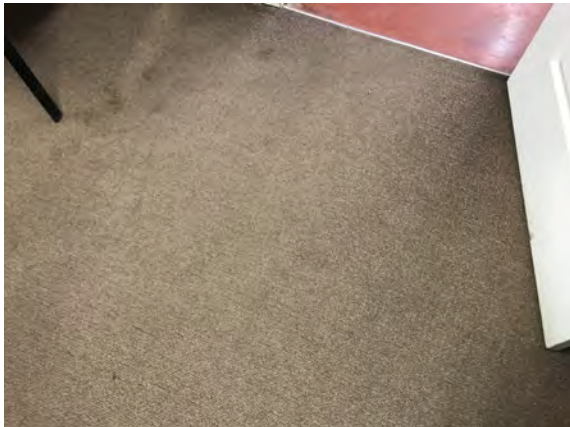
Charlie Lake Fire Hall - C302005

Carpet surfaces were noted to be worn and stained. The observed condition is consistent with the component's age. Replacement is recommended.

Recommendations #1 - Carpet Floor	
Type	Life Cycle Replacement
Year	2024
Cost	\$2,688.48

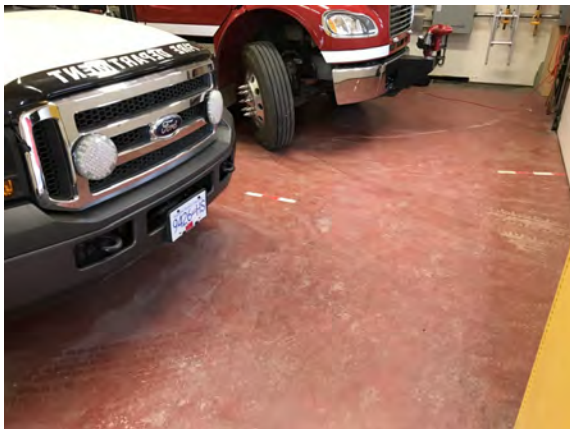
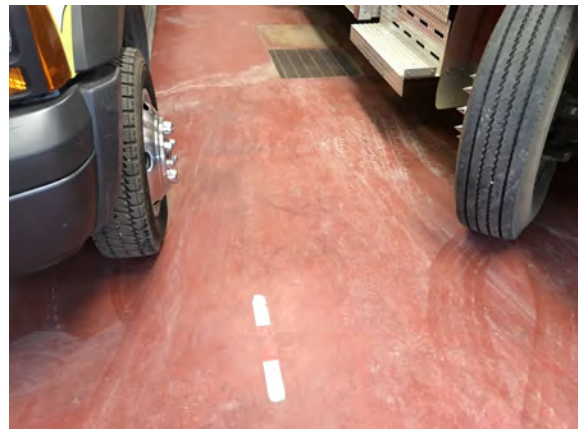
Charlie Lake Fire Hall - C302007

No major deficiencies were observed or reported during the assessment. Minor sections of damaged finish are expected to undergo repair/touch-up as a maintenance activity. The component has exceeded its expected useful life, based on the absence of significant observed or reported deficiencies, lifecycle replacement has been extended to a later year.

Recommendations #1 - Painted / Sealed Concrete Floor	
Type	Life Cycle Replacement
Year	2027
Cost	\$34,203.44

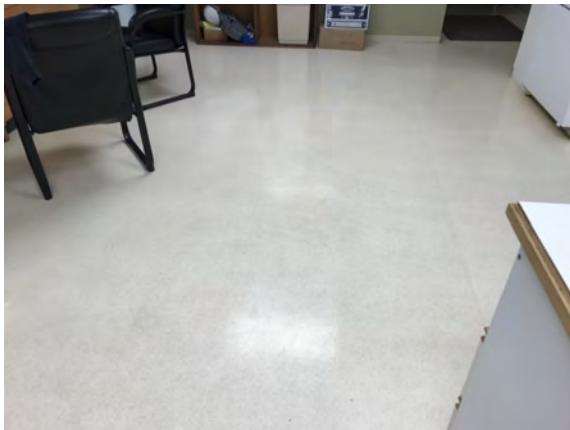
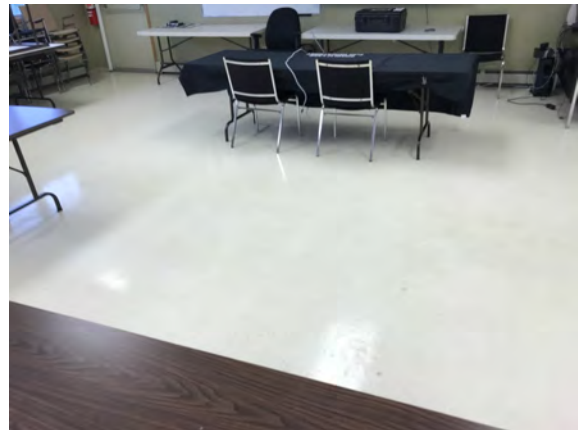
Charlie Lake Fire Hall - C302023

The component has exceeded its expected useful life, although its remaining useful life has been extended beyond the short-term of the evaluation period due to the absence of significant observed or reported deficiencies.

Recommendations #1 - Vinyl Sheet Floor	
Type	Life Cycle Replacement
Year	2027
Cost	\$31,365.60

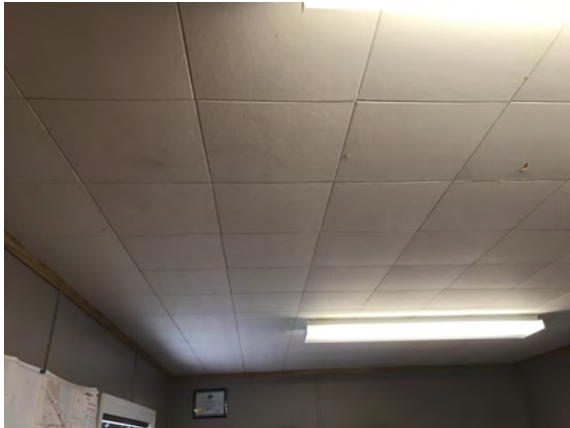
Charlie Lake Fire Hall - C303004

However, as the component has long surpassed its expected useful life and plays a critical function in building operations, short-term replacement is recommended to minimize the risk and impact of sudden failure.

Recommendations #1 - Acoustic Tile Ceiling	
Type	Life Cycle Replacement
Year	2026
Cost	\$2,091.04

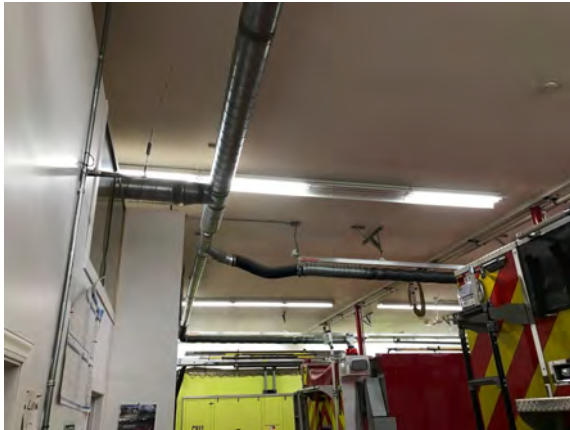
Charlie Lake Fire Hall - C303006

No major deficiencies were observed or reported during the assessment. The component has exceeded its expected useful life, although its remaining useful life has been extended beyond the short-term of the evaluation period due to the absence of significant observed or reported deficiencies.

Recommendations #1 - Painted Ceiling Structures	
Type	Life Cycle Replacement
Year	2028
Cost	\$25,652.58

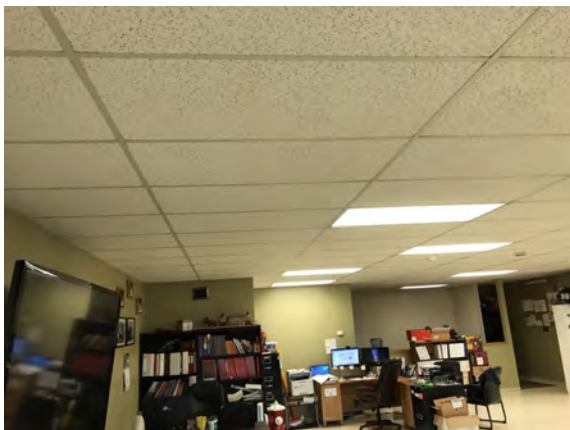
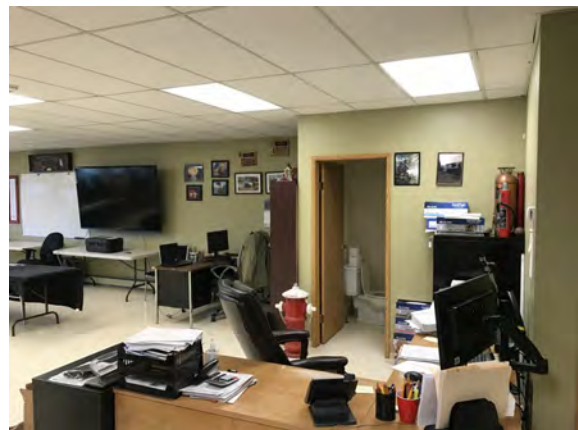
Charlie Lake Fire Hall - C303007

The component has exceeded its expected useful life, although its remaining useful life has been extended beyond the short-term of the evaluation period due to the absence of significant observed or reported deficiencies.

Recommendations #1 - Suspended Acoustic Ceiling Panels	
Type	Life Cycle Replacement
Year	2027
Cost	\$25,540.56

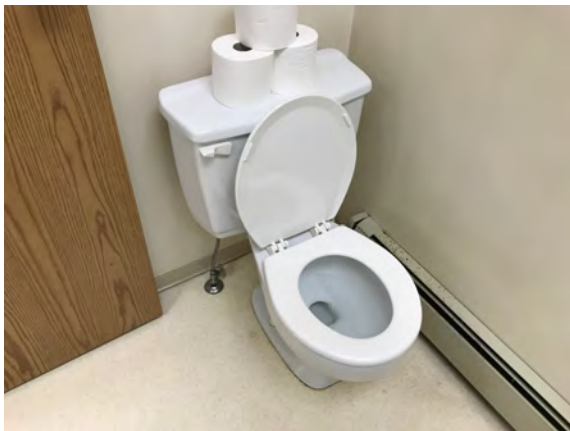
Charlie Lake Fire Hall - D201001

No major deficiencies were observed or reported during the assessment. The component will reach its expected useful life, although its remaining useful life has been extended beyond the short-term of the evaluation period due to the absence of significant observed or reported deficiencies.

Recommendations #1 - Water Closets	
Type	Life Cycle Replacement
Year	2027
Cost	\$1,867.00

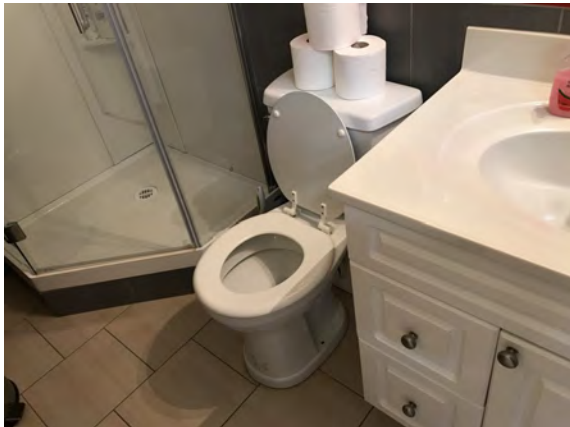
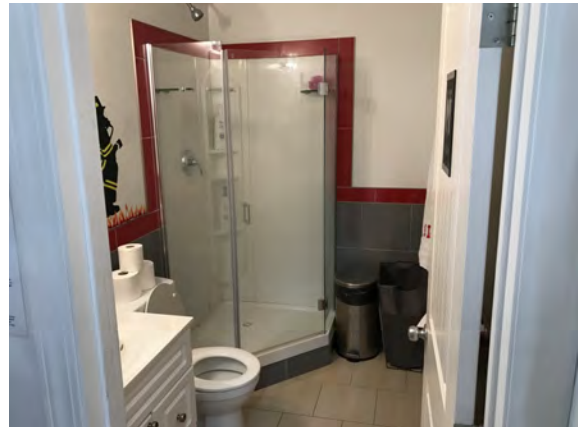
Charlie Lake Fire Hall - D201001

No major deficiencies were observed or reported during the assessment.

Recommendations #1 - Water Closets	
Type	Life Cycle Replacement
Year	2049
Cost	\$3,734.00

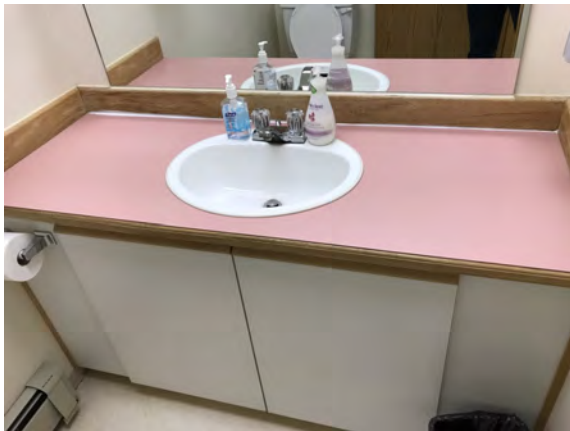
Charlie Lake Fire Hall - D201003

No major deficiencies were observed or reported during the assessment. The component will reach its expected useful life, although its remaining useful life has been extended beyond the short-term of the evaluation period due to the absence of significant observed or reported deficiencies.

Recommendations #1 - Lavatories	
Type	Life Cycle Replacement
Year	2027
Cost	\$1,867.00

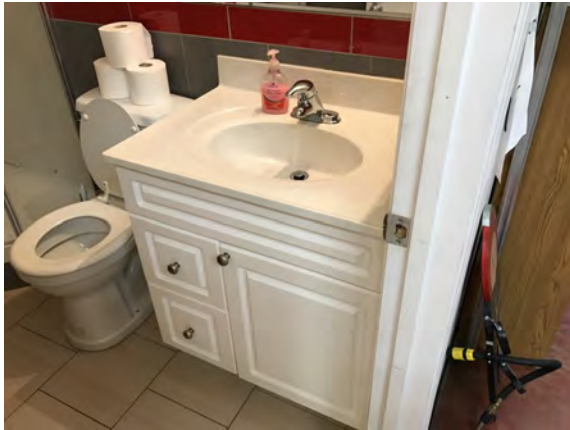
Charlie Lake Fire Hall - D201003

No major deficiencies were observed or reported during the assessment.

Recommendations #1 - Lavatories	
Type	Life Cycle Replacement
Year	2049
Cost	\$3,734.00

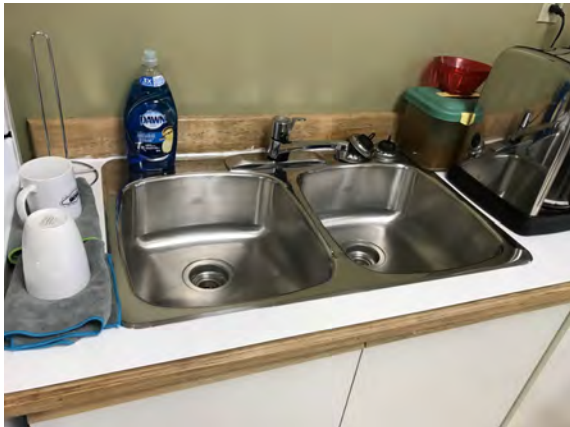
Charlie Lake Fire Hall - D201004

No major deficiencies were observed or reported during the assessment.

Recommendations #1 - Sinks	
Type	Life Cycle Replacement
Year	2035
Cost	\$1,867.00

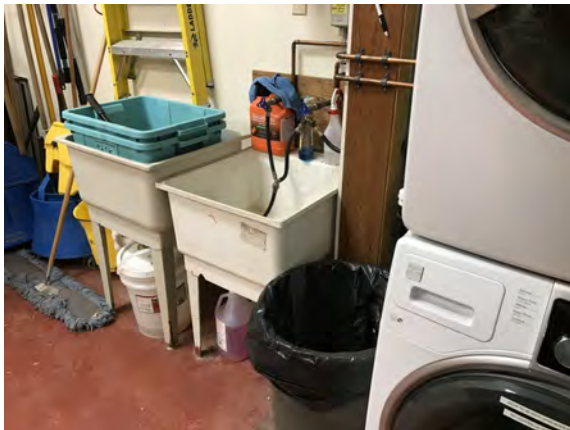
Charlie Lake Fire Hall - D201004

No major deficiencies were observed or reported during the assessment. The difficulty factor has been adjusted based on the component design.

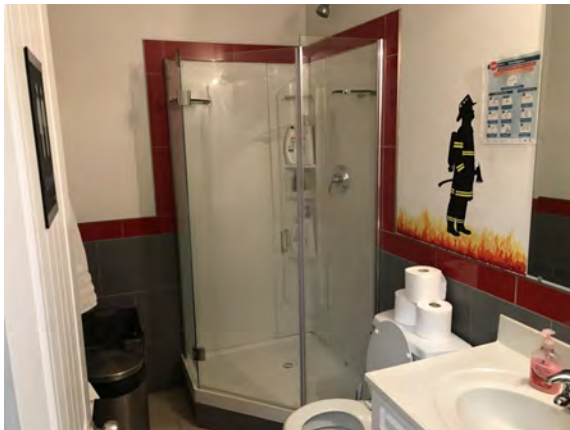
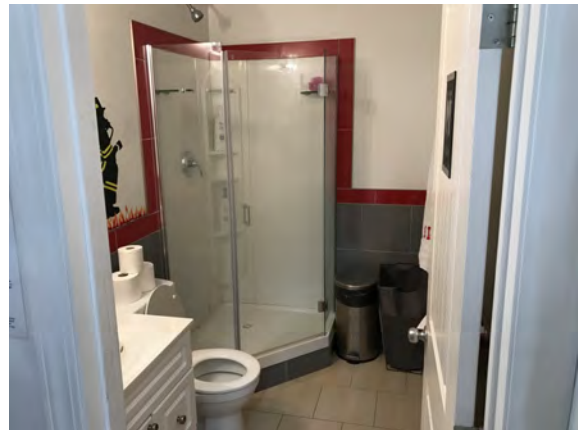
Charlie Lake Fire Hall - D201012

No major deficiencies were observed or reported during the assessment.

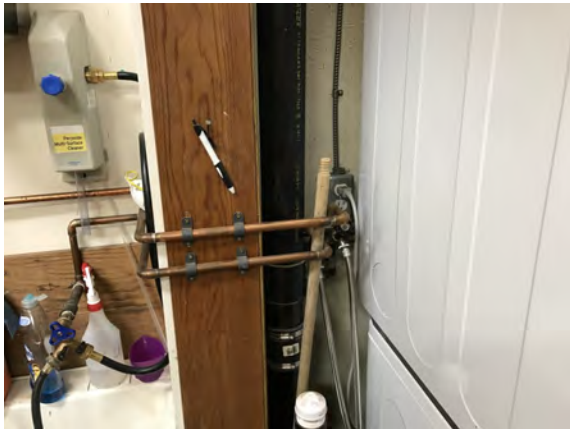
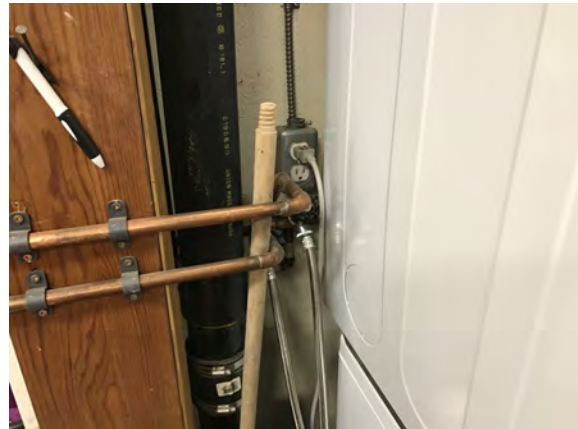
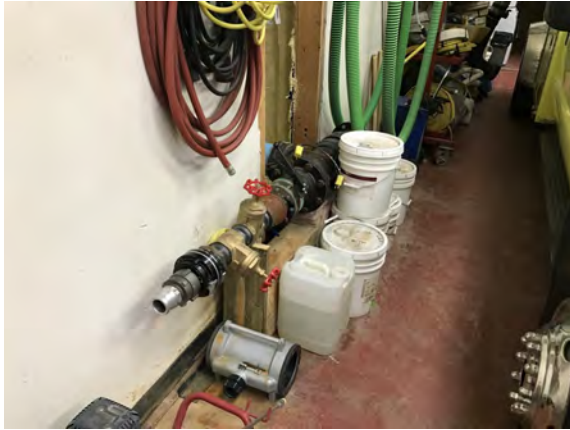
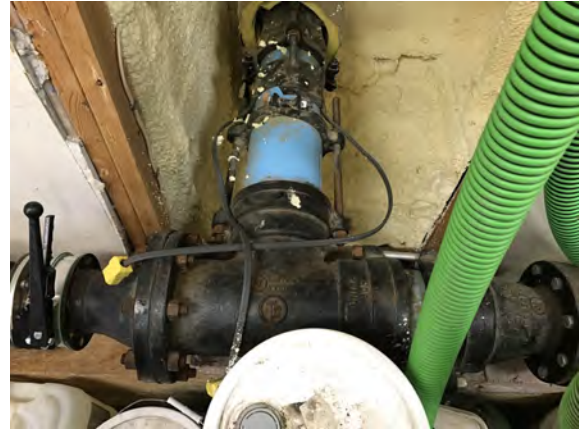
Charlie Lake Fire Hall - D202001

Original pipe runs were presumably repaired or replaced as part of renovation activities performed subsequent to the building's construction. For reporting purposes, an average installation year of 1987 has been assumed. Repair allowance for moving domestic piping away from electrical outlets. No major deficiencies were observed or reported during the assessment.

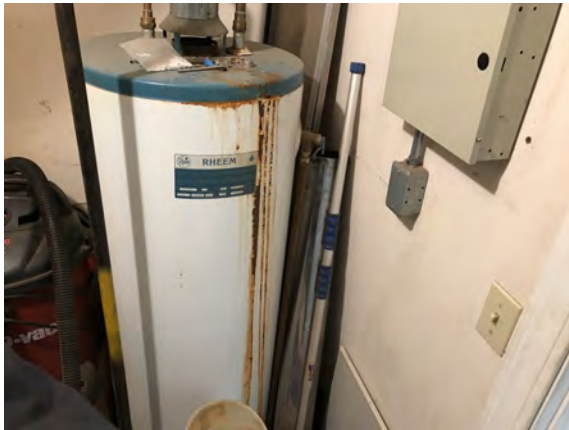
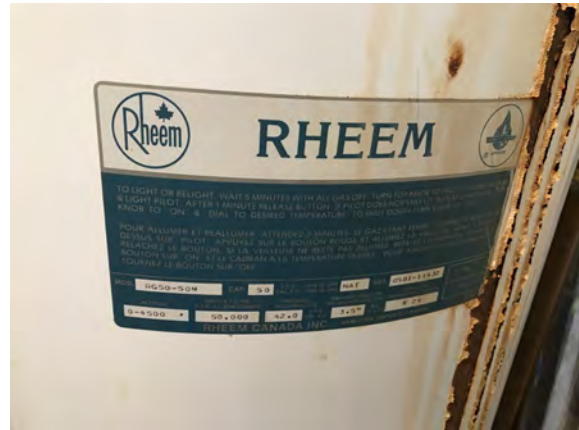
Charlie Lake Fire Hall - D202034

The water heater exhibited corrosion on its housing, and a generally worn/dated appearance. The water heater is also reportedly not performing as intended. Replacement is recommended immediately.

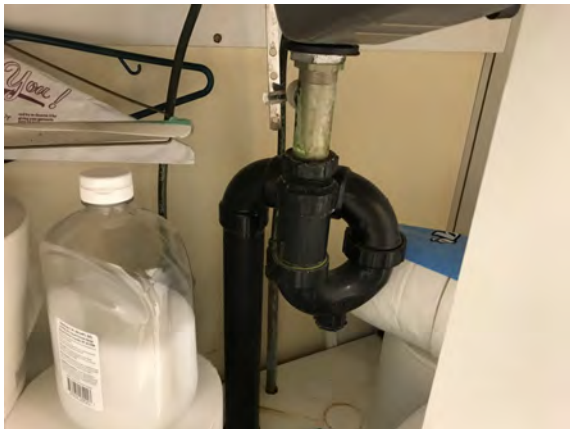
Charlie Lake Fire Hall - D203001

Original sanitary waste and vent lines were presumably repaired or replaced as part of renovation activities performed subsequent to the building's construction. For reporting purposes, an average installation year of 1987 has been assumed. No major deficiencies were observed or reported during the assessment.

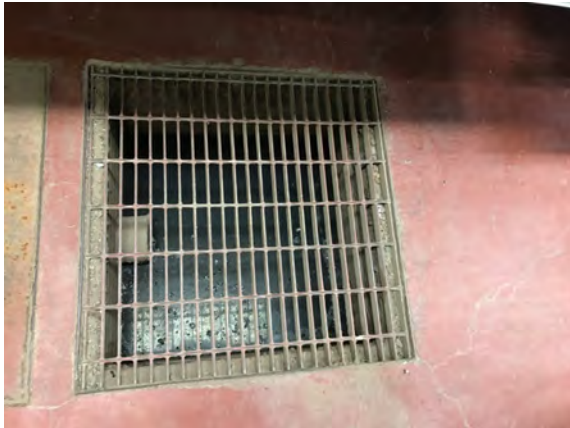
Charlie Lake Fire Hall - D203007

No major deficiencies were observed or reported. The component has exceeded its expected useful life, although its remaining useful life has been extended to a later year due to the absence of significant observed or reported deficiencies.

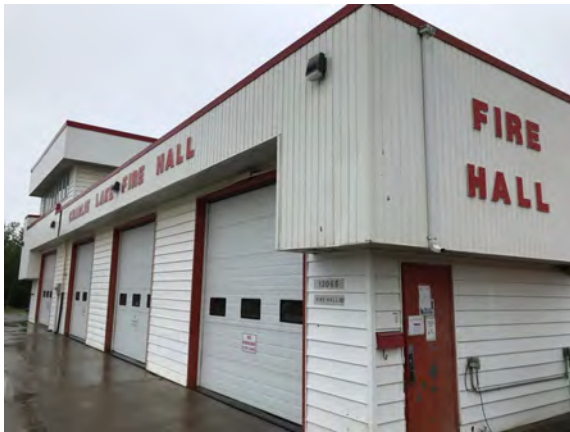
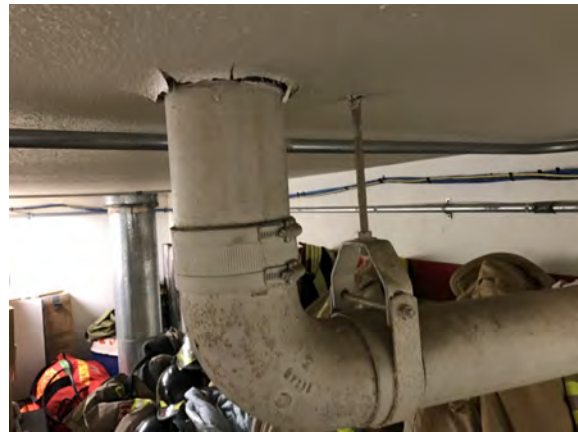
Charlie Lake Fire Hall - D204001

No major deficiencies were observed or reported during the assessment.

Recommendations #1 - Rain Water Drainage Piping and Fittings	
Type	Life Cycle Replacement
Year	2037
Cost	\$34,950.24

Replace Rain Water Drainage Piping and Fittings

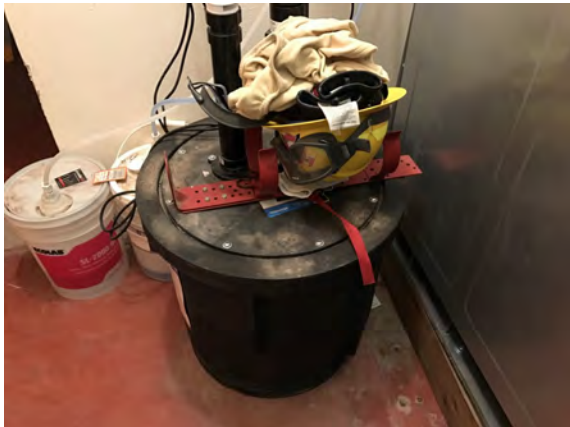
Charlie Lake Fire Hall - D204005

No major deficiencies were observed or reported during the assessment.

Recommendations #1 - Sump Pump	
Type	Life Cycle Replacement
Year	2034
Cost	\$5,601.00

Replace Sump Pump

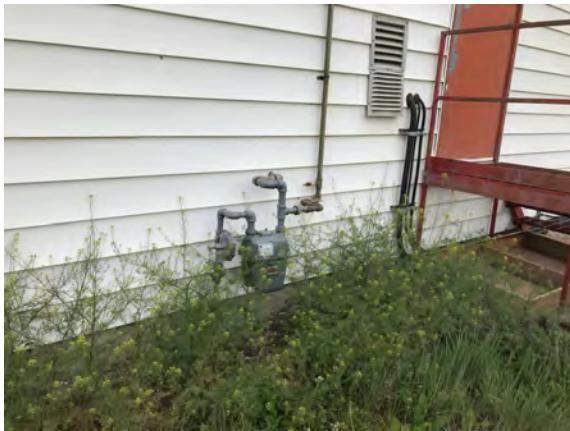
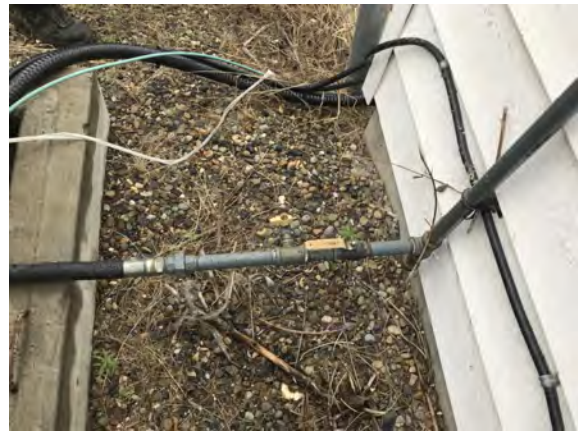
Charlie Lake Fire Hall - D301002

No major deficiencies were observed or reported during the assessment. Periodic refinishing of external pipe runs is expected to be performed as a maintenance activity to address surface corrosion and wear.

Recommendations #1 - Gas Supply Systems	
Type	Life Cycle Replacement
Year	2027
Cost	\$23,300.16

Replace Gas Supply Systems

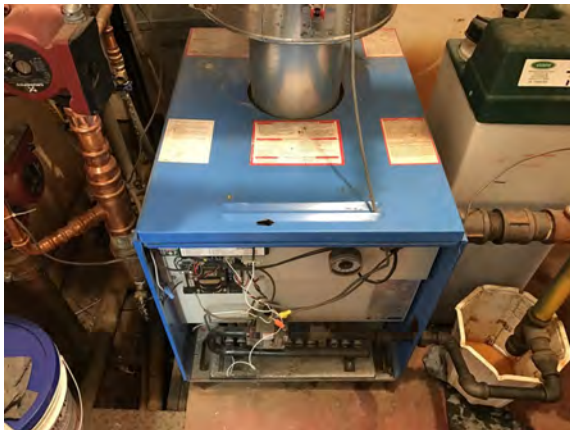
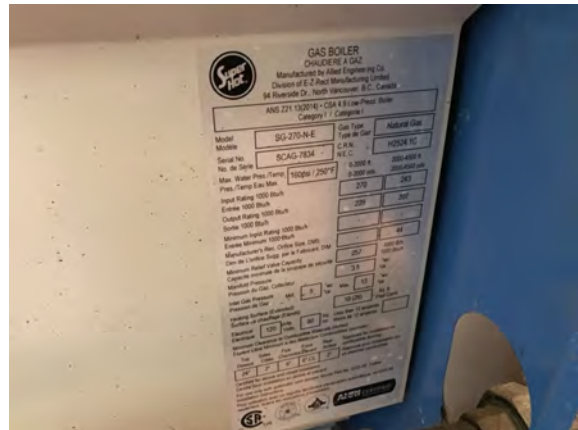
Charlie Lake Fire Hall - D302002

No major deficiencies were observed or reported during the assessment. Supports for the boiler's chimney are missing/damaged, replace as part of maintenance.

Recommendations #1 - Hot Water Boilers less than 1000 MBH	
Type	Life Cycle Replacement
Year	2040
Cost	\$37,806.75

Replace Hot Water Boilers less than 1000 MBH

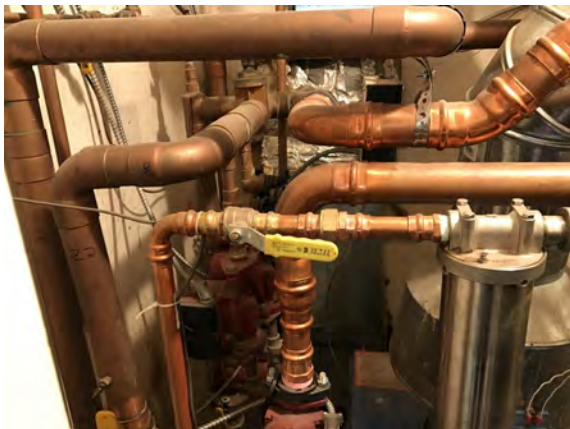
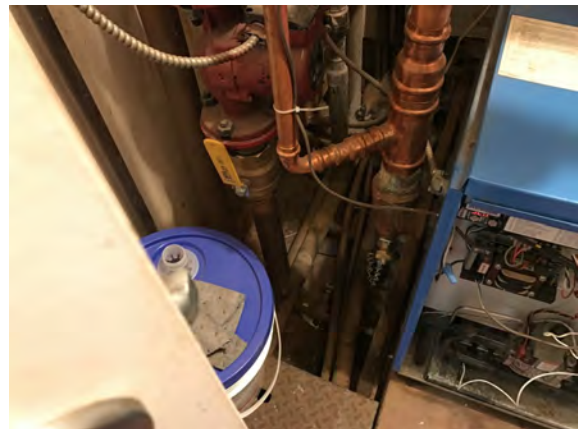
Charlie Lake Fire Hall - D304003

The piping has reported leaks and glycol is added monthly. Given the nature of the component, full-scale replacement is not expected to be required. However, a cost allowance for partial replacement and study has been carried forward in this report as a precautionary measure.

Recommendations #1 - Study - Heating Water Distribution Systems	
Type	Engineering Study
Year	2022
Cost	\$5,000.00

Based on the limited understanding of the component condition, further investigation is recommended to confirm performance and remaining useful life of the heating water piping. The scope of the investigation should include potential remedial options, a renewal schedule, and a cost to address the deficiencies and mitigate further deterioration.

Recommendations #2 - Repair - Heating Water Distribution Systems	
---	--

Type	Repair
Year	2022
Cost	\$13,500.00

Budgetary repair allowance to undertake a remedial action to address the observed deficiencies and mitigate further deterioration.

Recommendations #3 - Heating Water Distribution Systems	
--	--

Type	Life Cycle Replacement
Year	2032
Cost	\$104,850.72

Replace Heating Water Distribution Systems

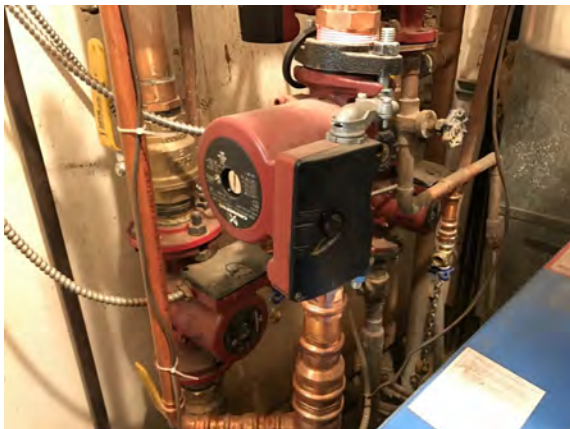
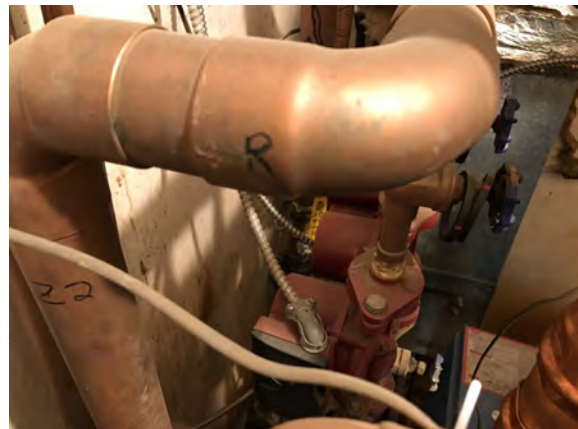
Charlie Lake Fire Hall - D202007

No major deficiencies were observed or reported during the assessment.

Recommendations #1 - HVAC Pumps (Up to 10 HP)	
Type	Life Cycle Replacement
Year	2030
Cost	\$37,340.00

Replace HVAC Pumps (Up to 10 HP)

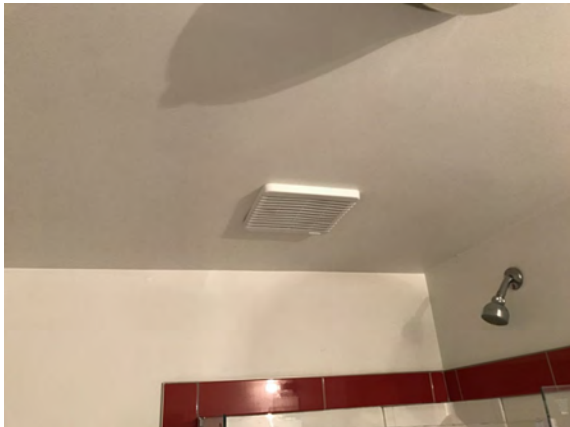
Charlie Lake Fire Hall - D304033

No major deficiencies were observed or reported during the assessment.

Recommendations #1 - Exhaust Fan - Ceiling (Residential)	
Type	Life Cycle Replacement
Year	2039
Cost	\$3,734.00

Replace Exhaust Fan - Ceiling (Residential)

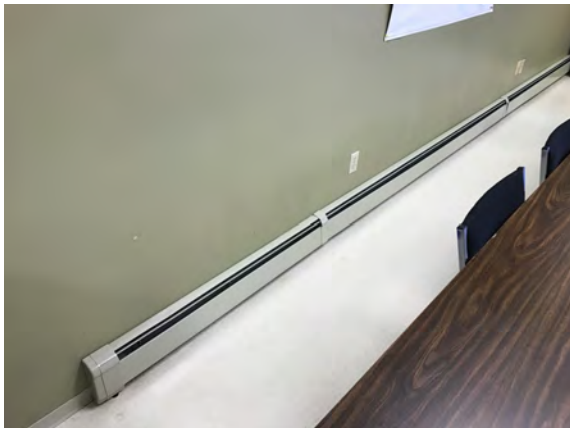
Charlie Lake Fire Hall - D305004

The component has exceeded its expected useful life, although its remaining useful life has been extended beyond the short-term of the evaluation period due to the absence of significant observed or reported deficiencies.

Recommendations #1 - Fin Tube Radiation Units	
Type	Life Cycle Replacement
Year	2027
Cost	\$25,092.48

Replace Fin Tube Radiation Units

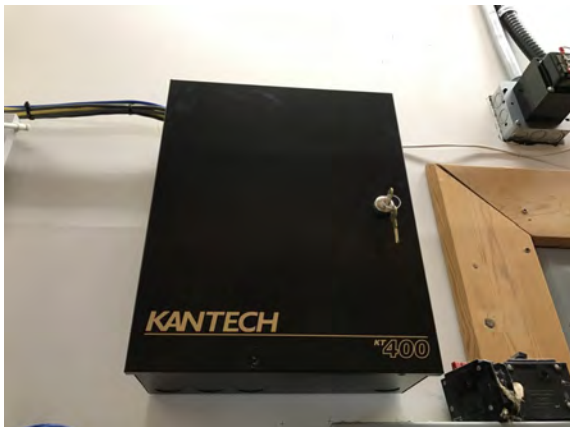
Charlie Lake Fire Hall - D305033

No major deficiencies were observed or reported during the assessment.

Recommendations #1 - Access Control Systems	
Type	Life Cycle Replacement
Year	2040
Cost	\$14,002.50

Replace Access Control Systems

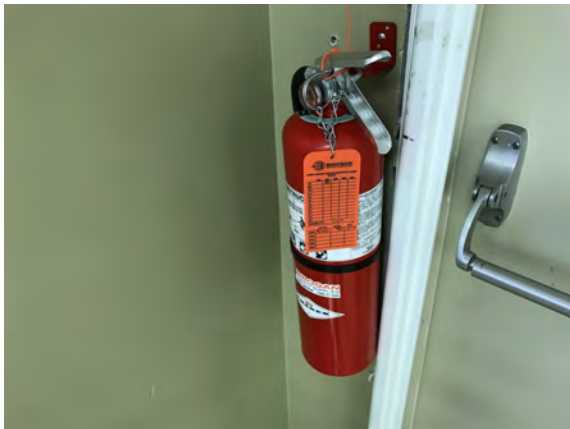
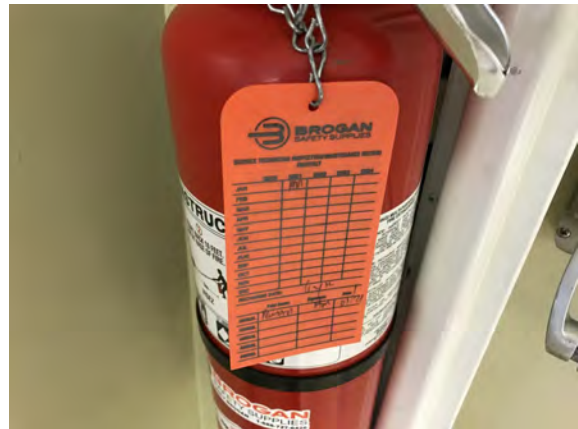
Charlie Lake Fire Hall - D403002

No major deficiencies were observed or reported during the assessment. Annual inspection appeared to be current. However, as the component has long surpassed its expected useful life and plays a critical function in building safety, short-term replacement is recommended to minimize the risk and impacts of sudden failure.

Recommendations #1 - Fire Extinguishers	
Type	Life Cycle Replacement
Year	2024
Cost	\$1,165.01

Replace Fire Extinguishers

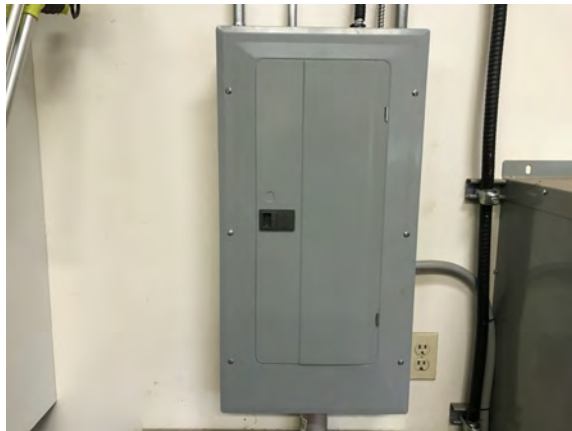
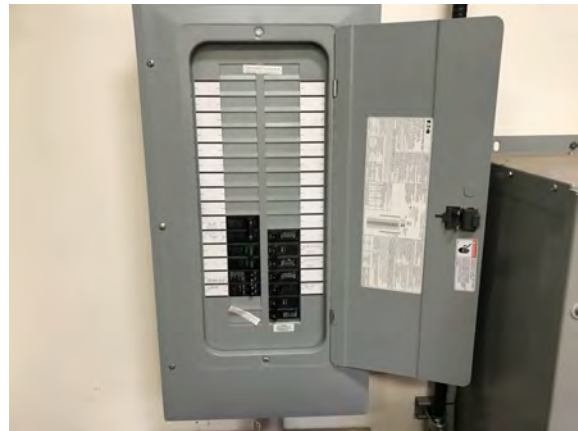
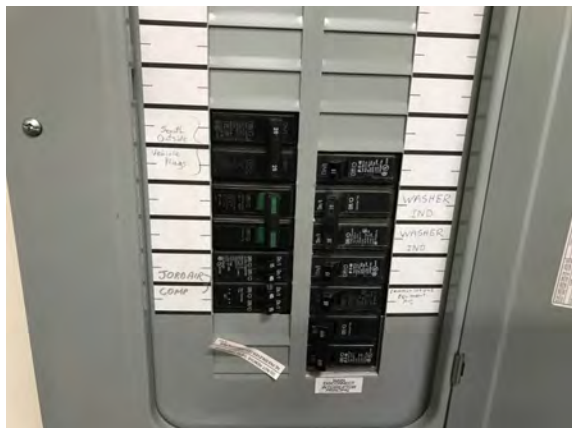
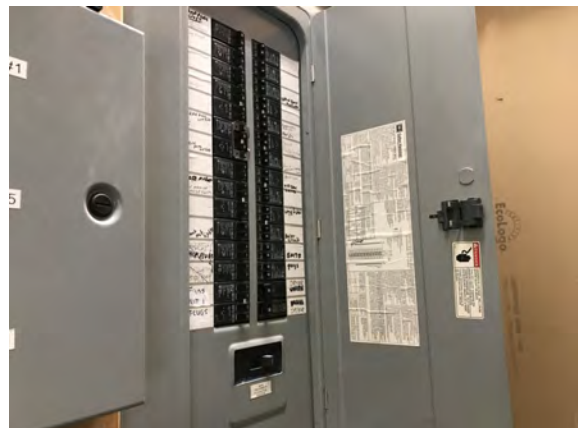
Charlie Lake Fire Hall - D501005

No major deficiencies were observed or reported during the assessment. The difficulty factor has been adjusted based on the panel sizes/amperages.

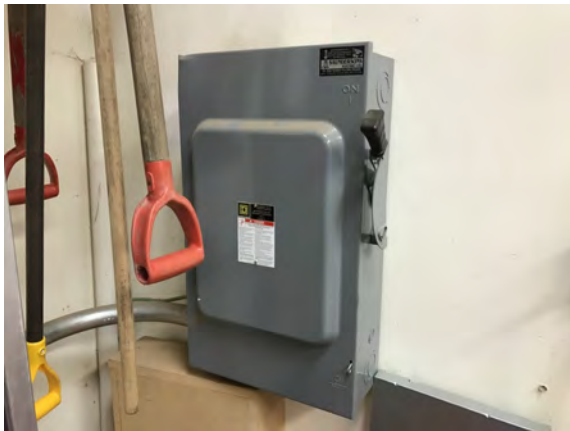
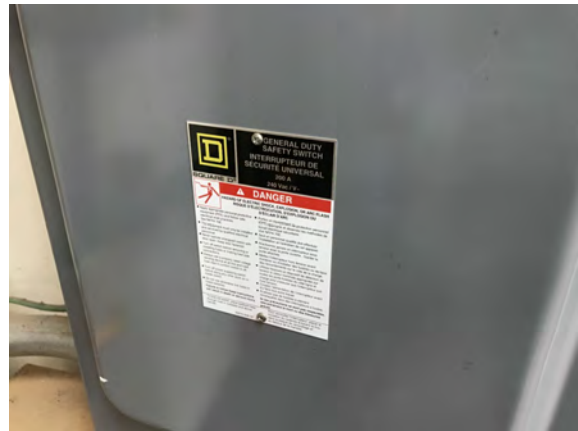
Charlie Lake Fire Hall - D501025

No major deficiencies were observed or reported during the assessment. The difficulty factor has been adjusted based on the switch amperage.

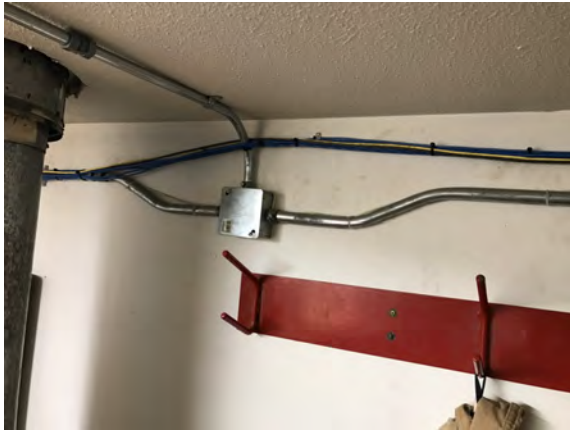
Charlie Lake Fire Hall - D502001

No major deficiencies were observed or reported during the assessment.
