Peace River Regional District

**Facility Condition Assessment Report
Charlie Lake Fire Hall**

November 18, 2021

Prepared by:
FCAPX a Division of Roth IAMS
Project No. 21075
www.fcapx.com

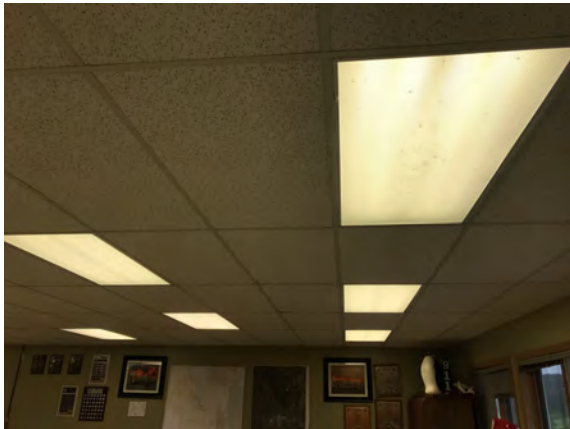
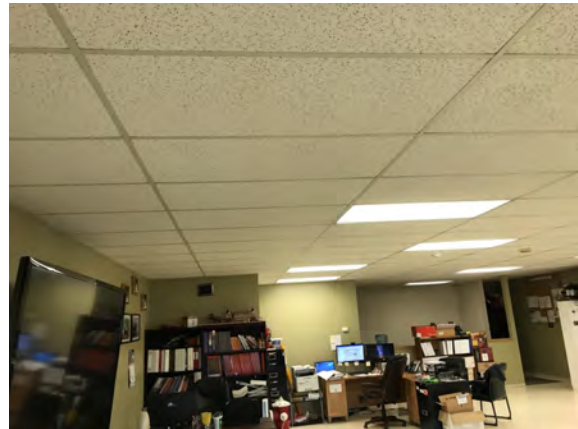
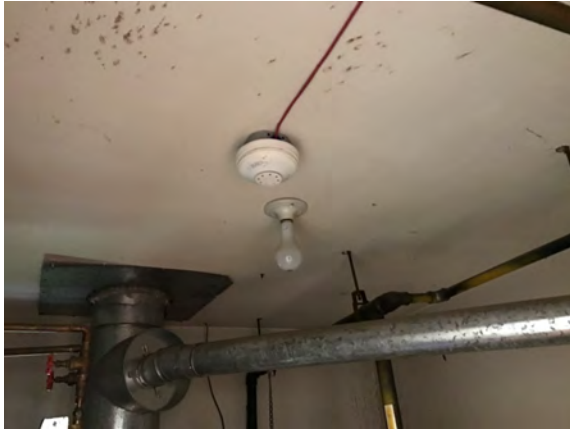
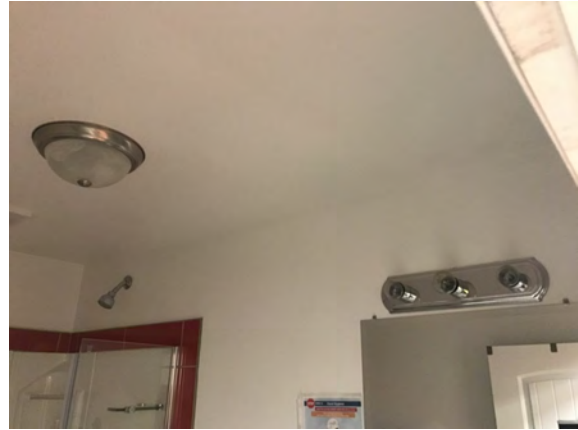
Charlie Lake Fire Hall - D502002

No major deficiencies were observed or reported during the assessment. Replace fluorescent fixtures with LED in future upgrade.

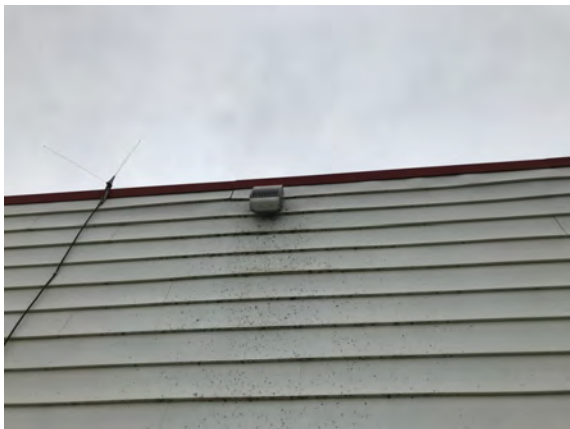
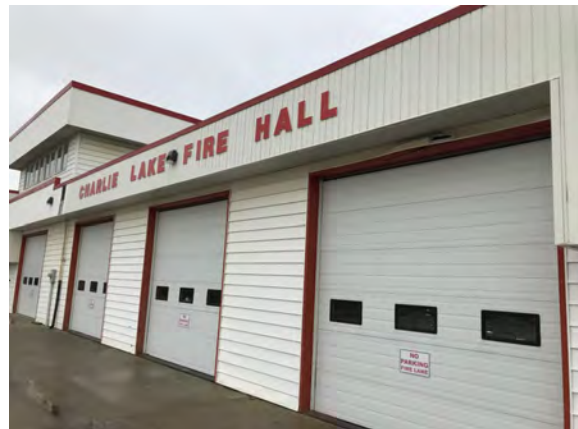
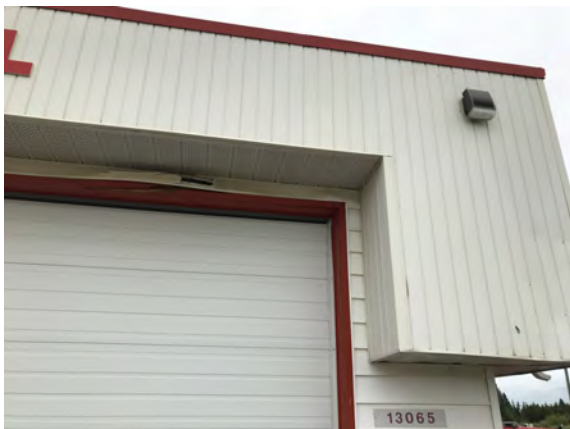
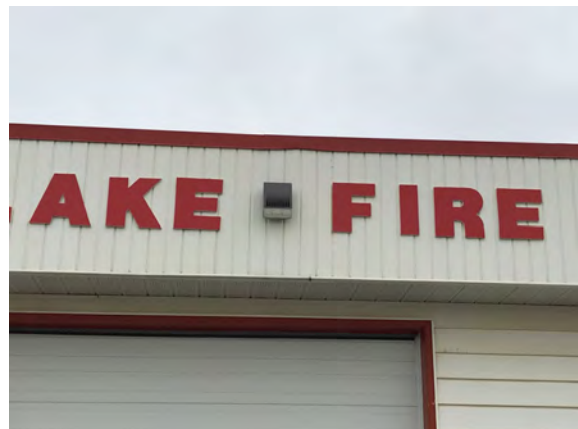
Charlie Lake Fire Hall - D502041

No major deficiencies were observed or reported during the assessment.

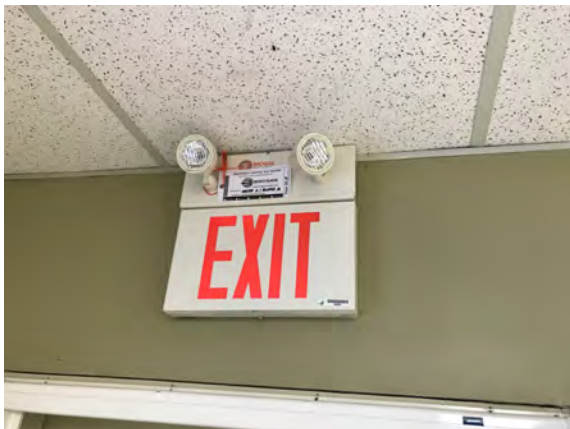
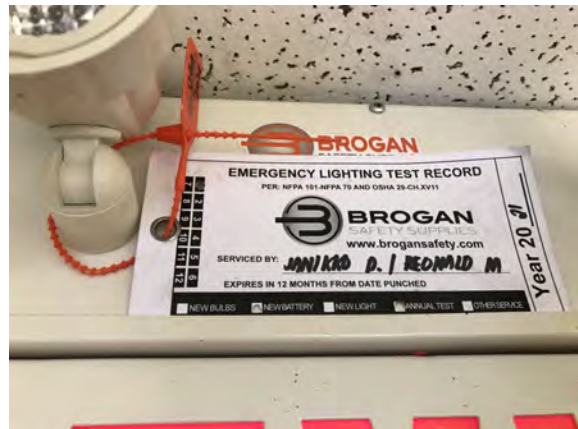
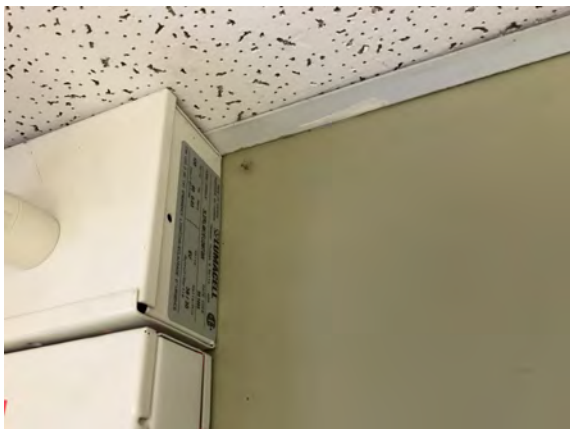
Charlie Lake Fire Hall - D502053

No major deficiencies were observed or reported during the assessment.

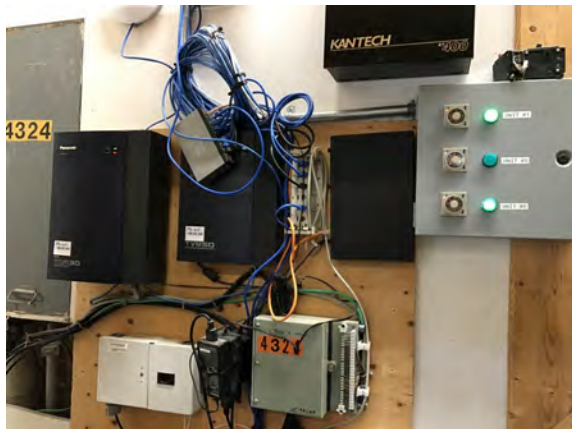
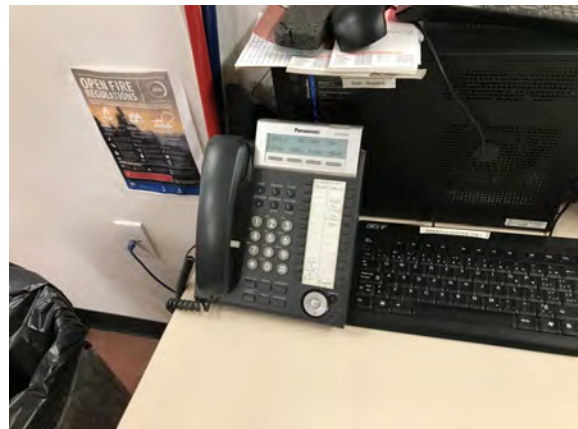
Charlie Lake Fire Hall - D503002

No major deficiencies were observed or reported during the assessment.

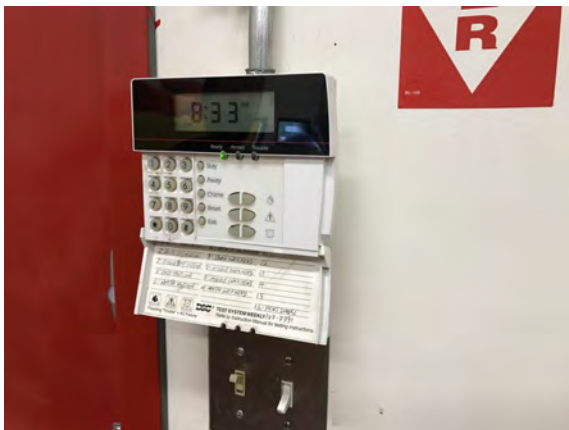
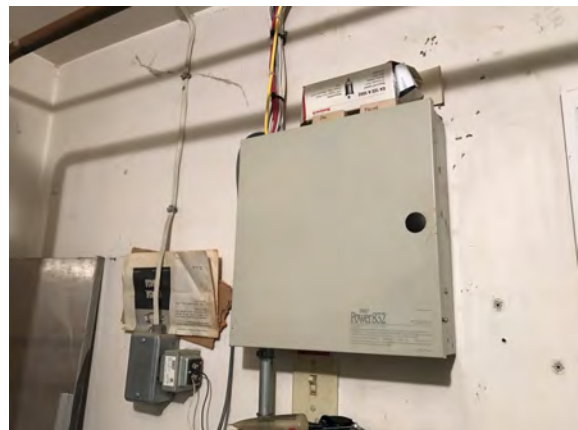
Charlie Lake Fire Hall - D503008

No major deficiencies were observed or reported during the assessment.

Recommendations #1 - Security Systems - Intrusion Alarm Systems	
Type	Life Cycle Replacement
Year	2030
Cost	\$11,650.08

Replace Security Systems - Intrusion Alarm Systems

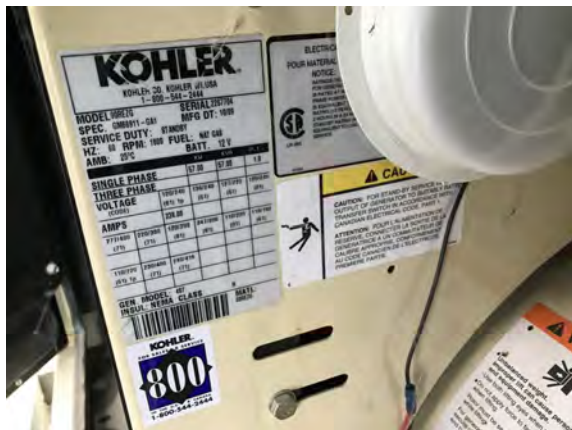
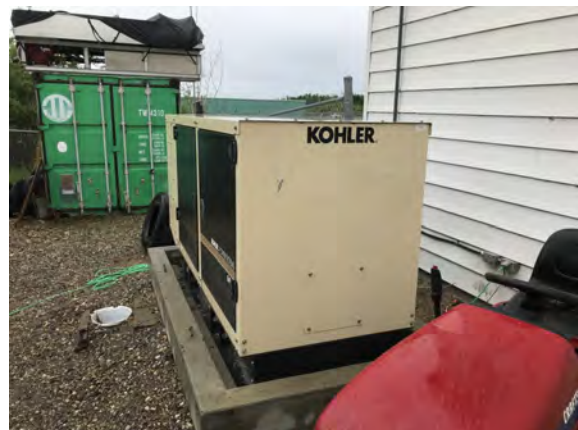
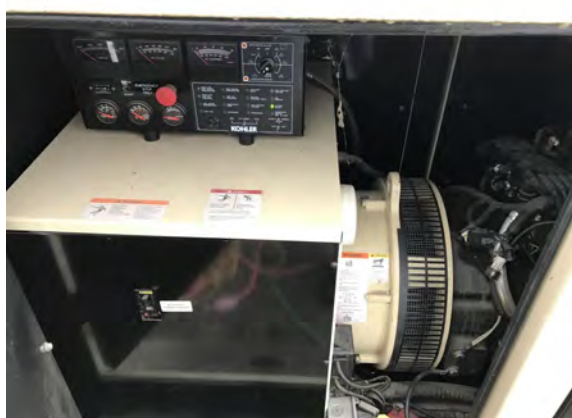
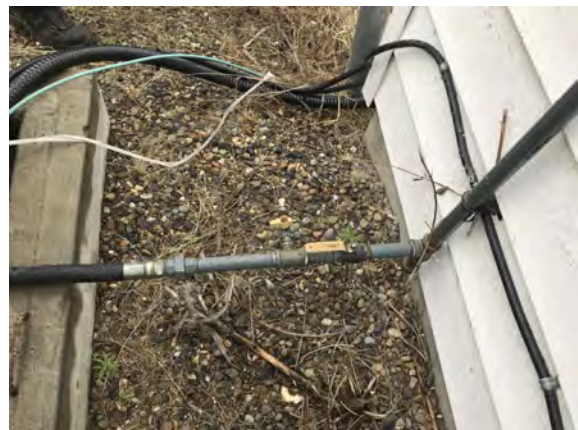
Charlie Lake Fire Hall - D509002

No major deficiencies were observed or reported during the assessment.

Recommendations #1 - Emergency Power Generator Systems Natural Gas	
Type	Life Cycle Replacement
Year	2040
Cost	\$63,851.40

Replace Emergency Power Generator Systems Natural Gas

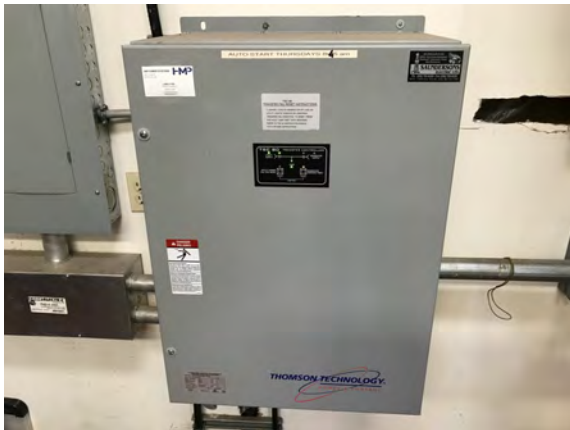
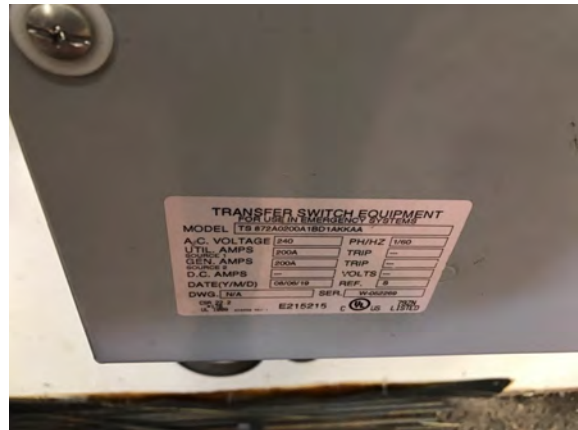
Charlie Lake Fire Hall - D509031

No major deficiencies were observed or reported during the assessment.

Recommendations #1 - Automatic Transfer Switches (ATSs) up to 400A	
Type	Life Cycle Replacement
Year	2050
Cost	\$14,002.50

Replace Automatic Transfer Switches (ATSs) up to 400A

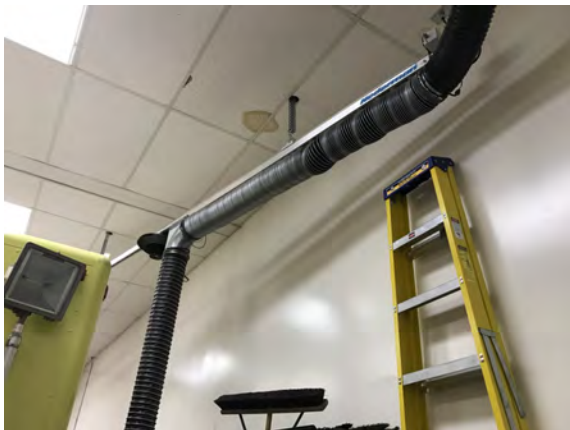
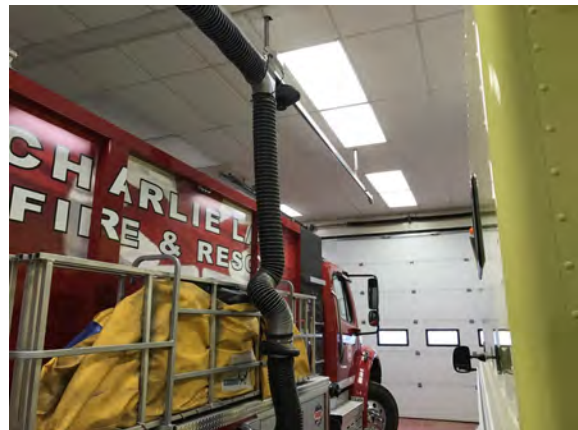
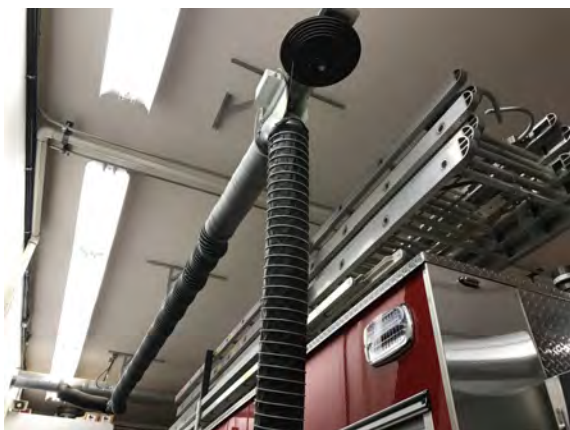
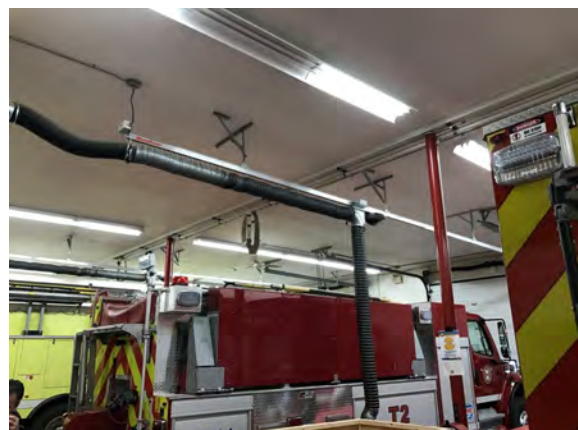
Charlie Lake Fire Hall - E102010

No major deficiencies were observed or reported during the assessment.

Recommendations #1 - Vehicle Exhaust Systems	
Type	Life Cycle Replacement
Year	2035
Cost	\$70,012.50

Replace Vehicle Exhaust Systems

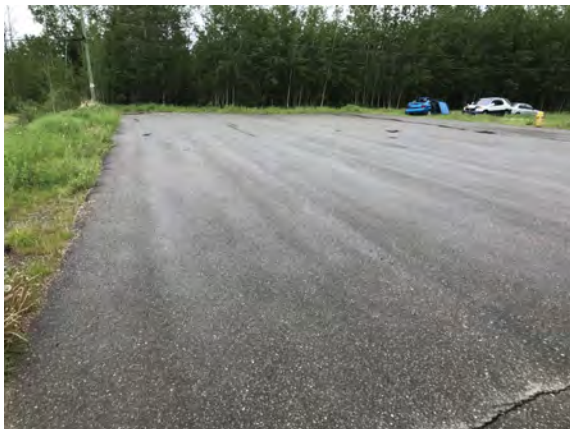
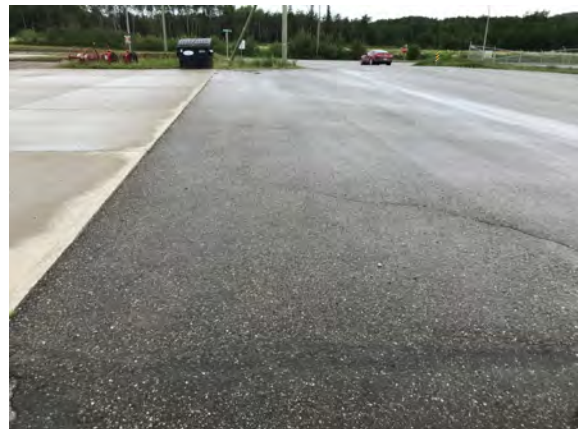
Charlie Lake Fire Hall - G202021

No major deficiencies were observed or reported during the assessment.

Recommendations #1 - Asphalt Paved Surfaces - Parking Area	
Type	Life Cycle Replacement
Year	2035
Cost	\$116,220.75

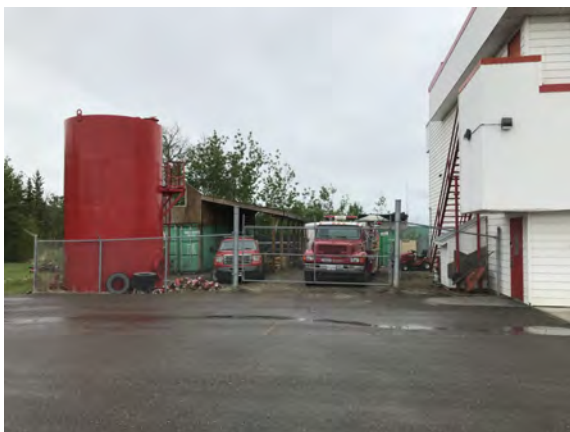
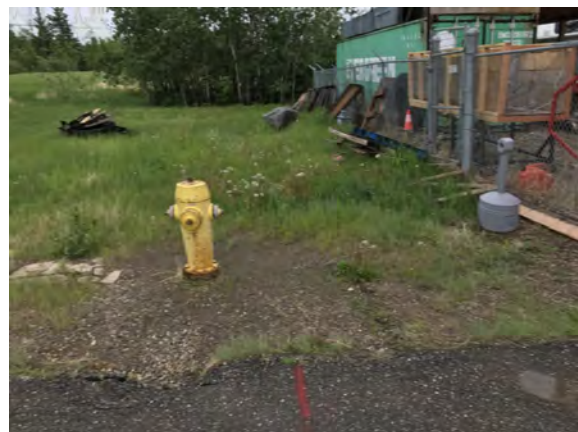
Charlie Lake Fire Hall - G204021

No major deficiencies were observed or reported during the assessment.

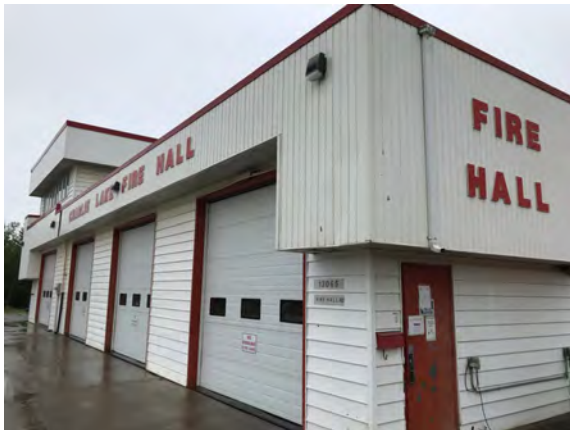
Charlie Lake Fire Hall - G204081

No major deficiencies were observed or reported during the assessment. Difficulty factor adjusted to reflect size of sign.

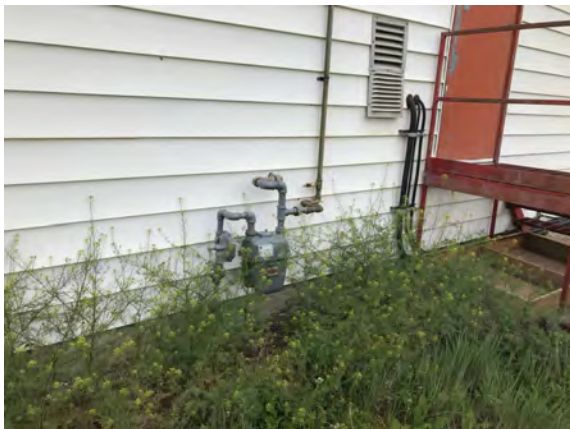
Charlie Lake Fire Hall - G306006

No major deficiencies were observed or reported during the assessment.

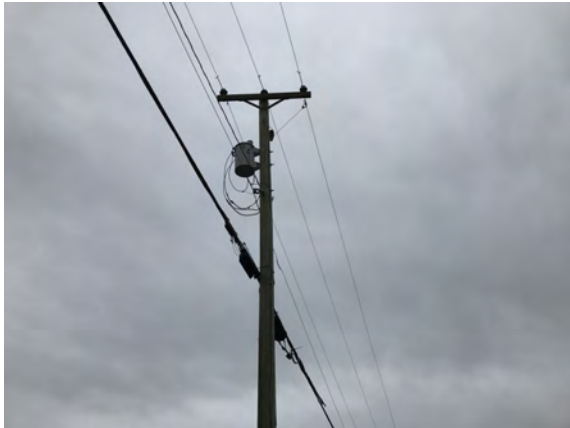
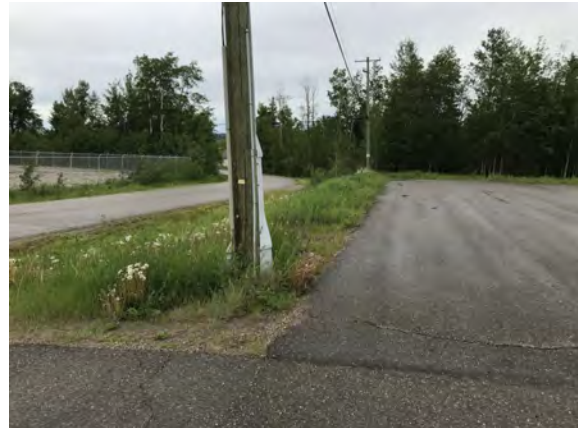
Charlie Lake Fire Hall - G401011

No major deficiencies were observed or reported during the assessment.
