**Peace River Regional District**

**Facility Condition Assessment Report  
Moberly Lake Fire Hall**

**November 17, 2021**

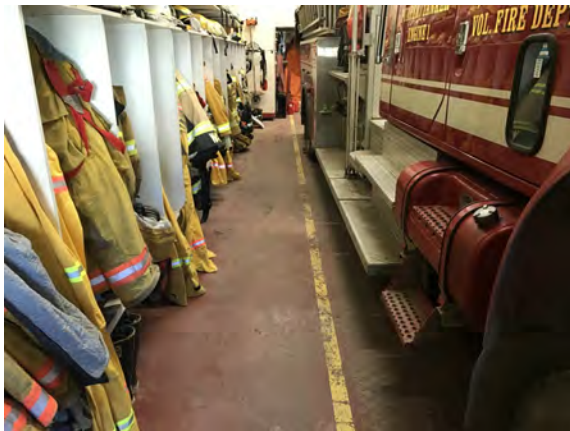
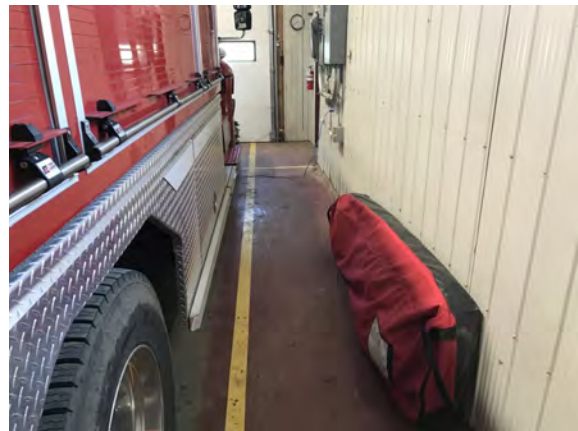
Moberly Lake Fire Hall - A103001

No major deficiencies were observed or reported. It is understood that the original building was constructed in 1983, and the west addition was constructed in 1999. As the remaining useful life falls outside the evaluation window for the oldest installed section, this system has been combined using the oldest known install date (1983).

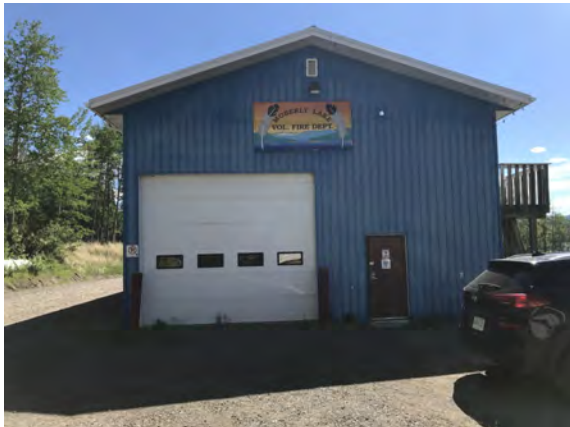
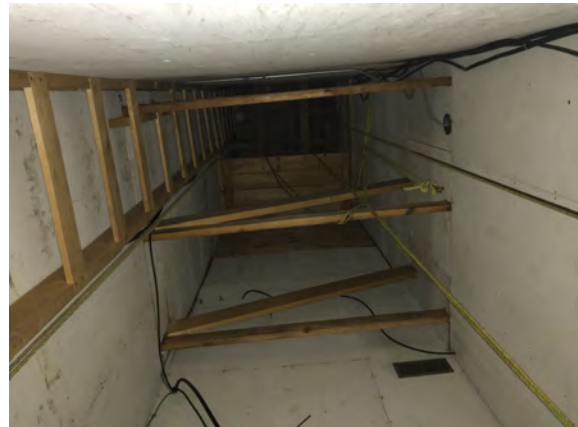
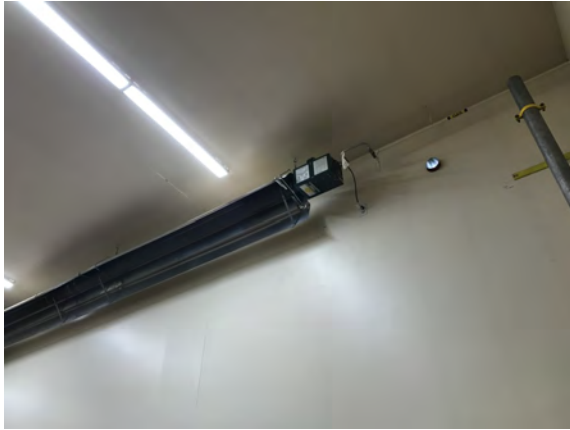
Moberly Lake Fire Hall - B103001

No major deficiencies were observed or reported, however, the wood ladder and wood platforms constructed within the hose tower are reportedly unsafe. As a result, the hose tower is not in use. It is recommended to provide an automated winch system for the hose drying tower to eliminate the need to climb the tower. Unsafe wood infrastructure should be removed. A cost to provide an automated hoist system has been provided. Additionally, in the 1999 vehicle bay, there is a through-wall penetration lined with galvanized ductwork that should be investigated. If used for combustion air, it is recommended to install a grill or fan as a maintenance activity. The Fire Chief indicated onsite that the tower could be removed altogether as it has not been in use for several years with no impact on operations. As the remaining useful life falls outside the evaluation window for the oldest installed section, this system has been combined using the oldest known install date (1983).

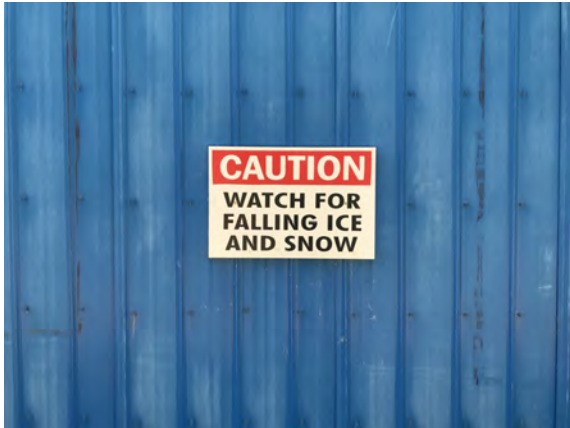
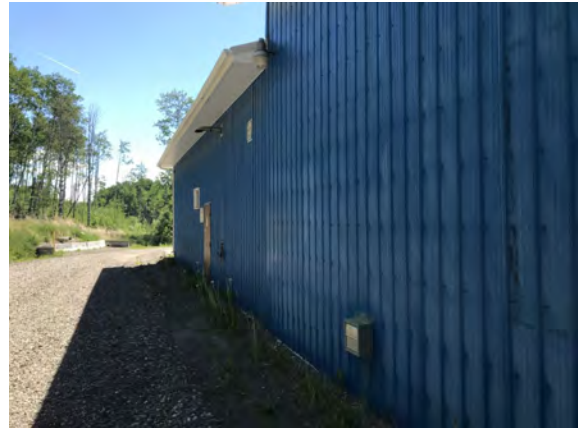
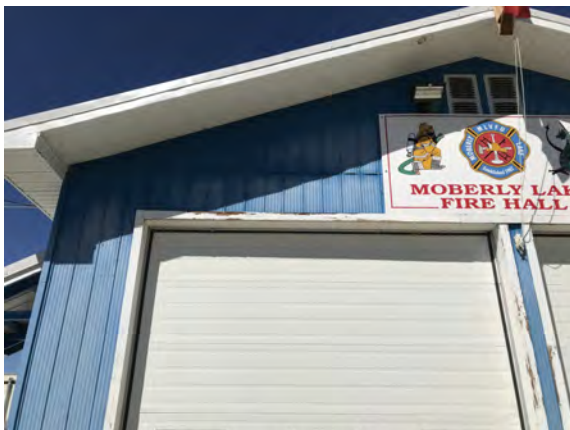
Moberly Lake Fire Hall - B201010

The paint is worn and sun-damaged. The paint is thin in spots. Lifecycle replacement is recommended to preserve the metal siding.

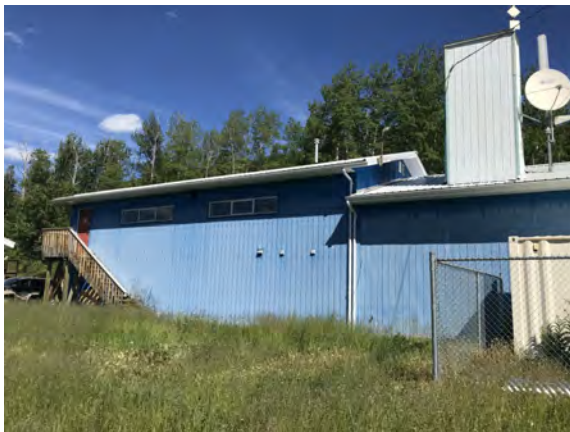
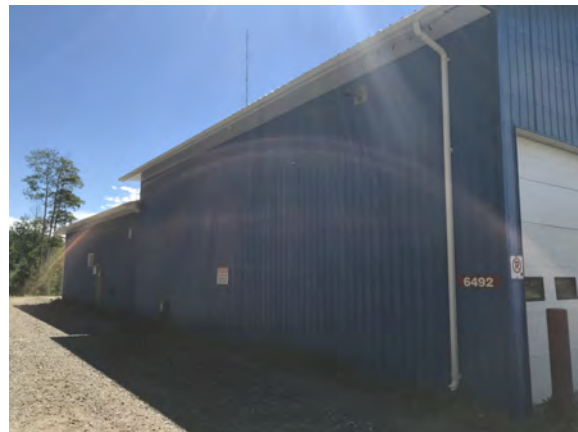
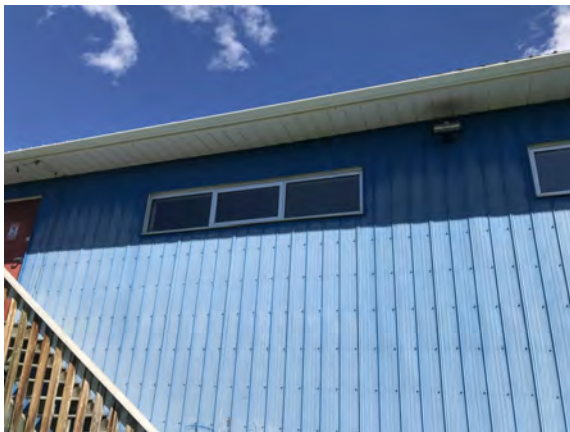
Moberly Lake Fire Hall - B201024

No major deficiencies were observed or reported.

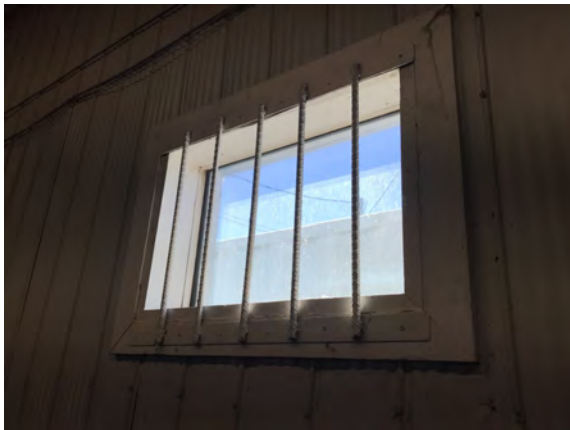
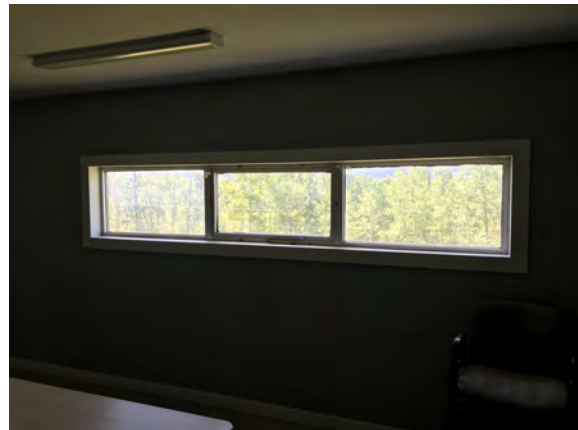
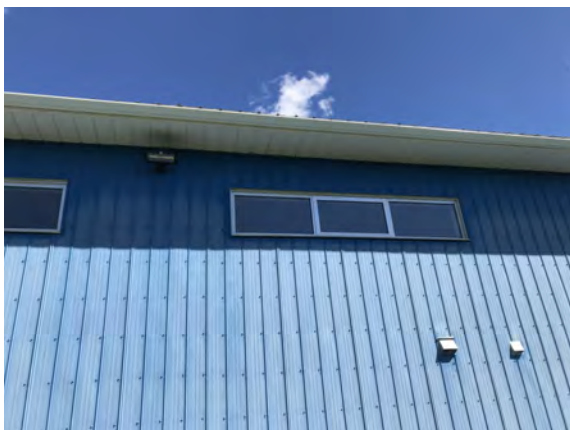
Moberly Lake Fire Hall - B202001

No major deficiencies were observed or reported.

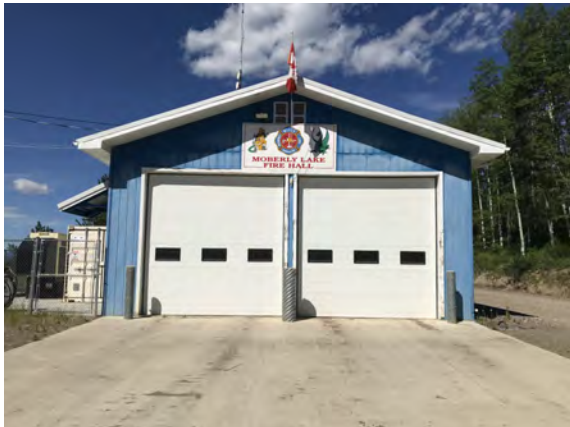
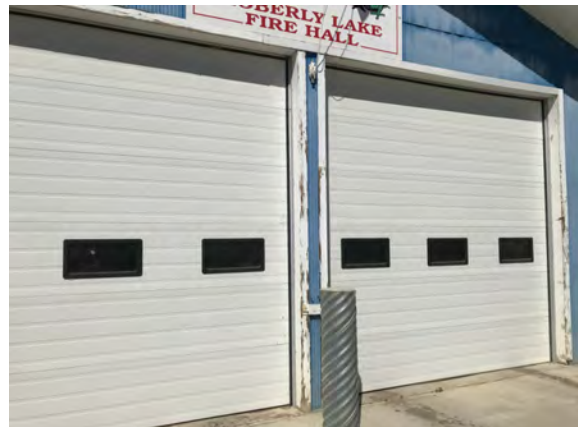
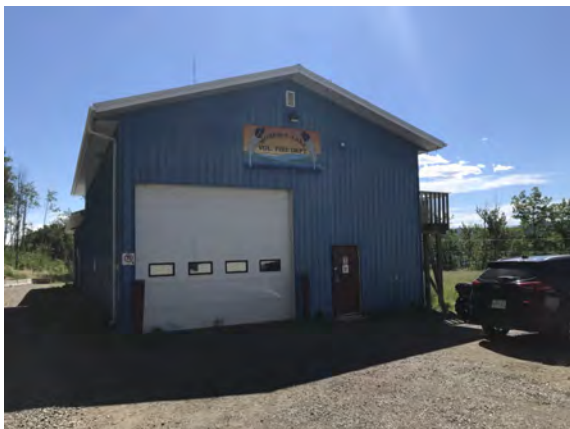
Moberly Lake Fire Hall - B203022

No major deficiencies were observed or reported.

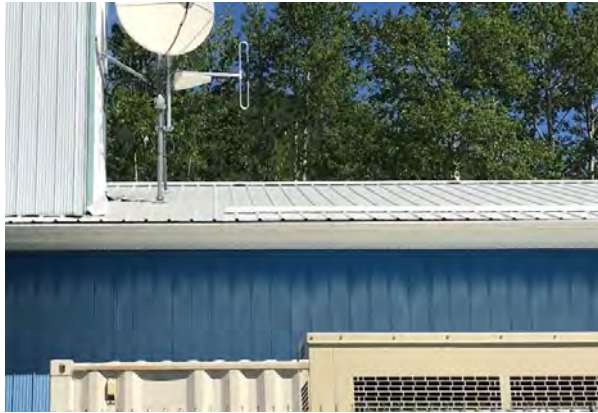
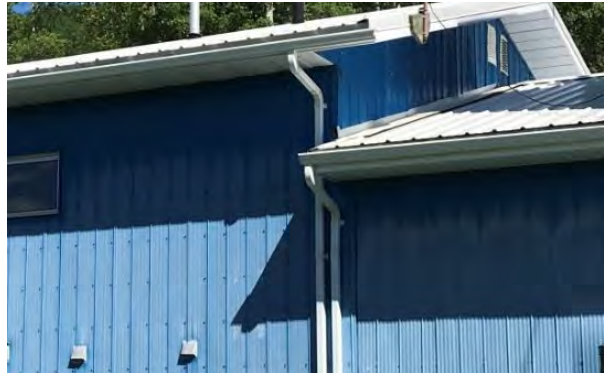
Moberly Lake Fire Hall - B301028

No major deficiencies were observed or reported.

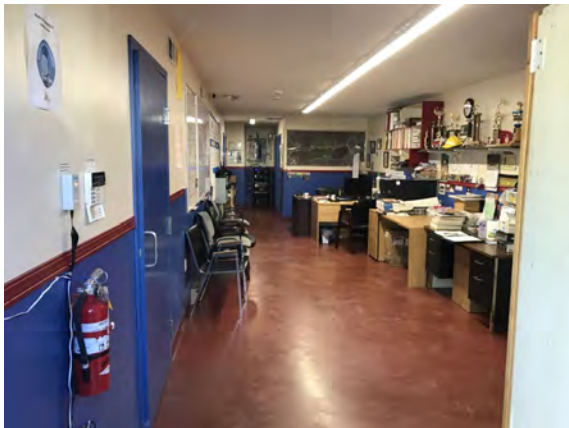
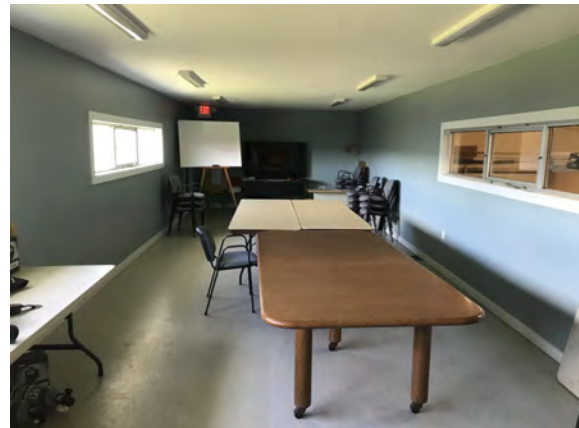
Moberly Lake Fire Hall - C101001

No major deficiencies were observed or reported. As the remaining useful life falls outside the evaluation window for the oldest installed section, this system has been combined using the oldest known install date (1983). It is recommended to conduct a Hazardous Materials Assessment based on the age of the building. A cost to complete the assessment has been provided herein.

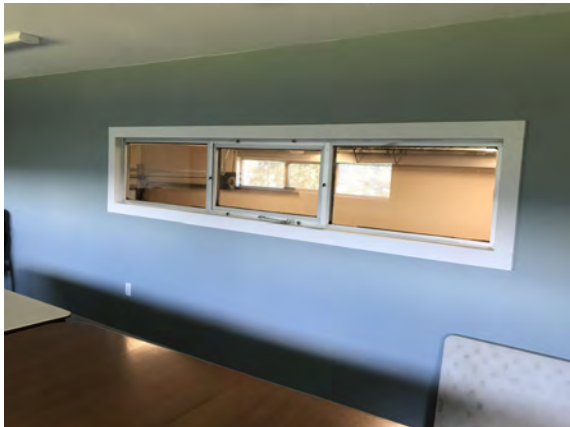
Moberly Lake Fire Hall - C101005

No major deficiencies were observed or reported.

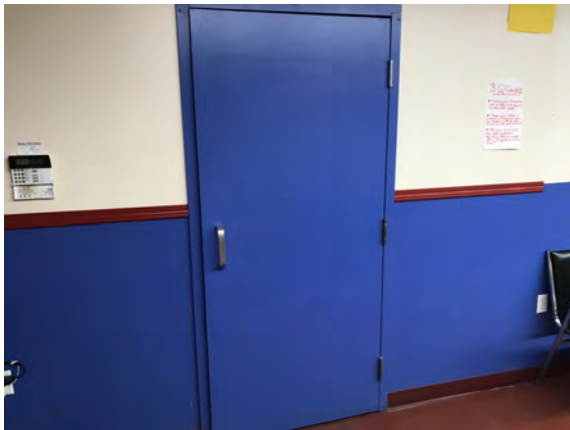
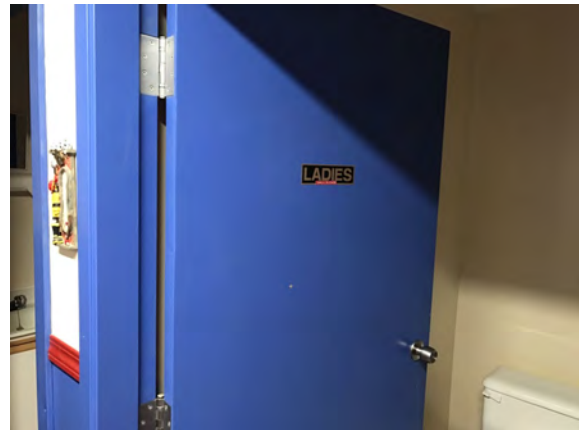
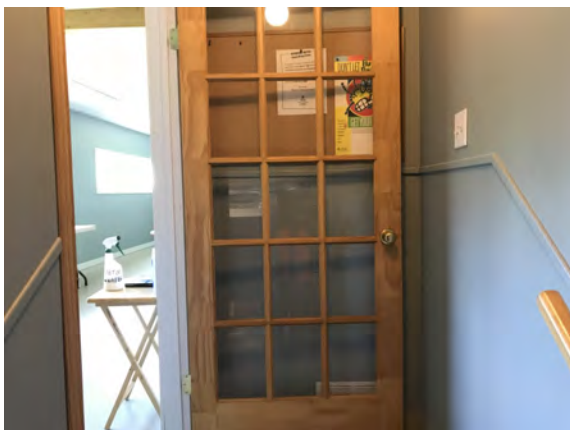
Moberly Lake Fire Hall - C102022

No major deficiencies were observed or reported during the assessment. It is assumed that the majority of interior doors were installed in 1999.

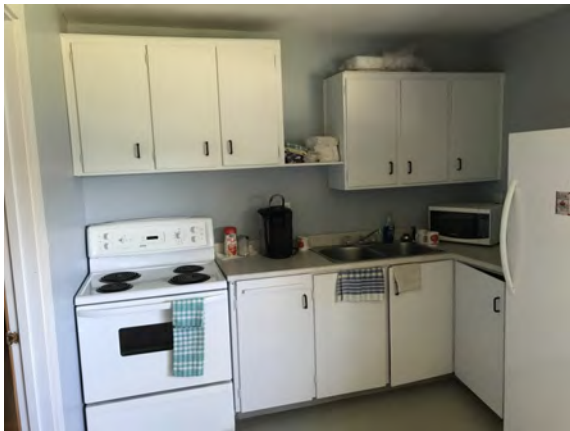
Moberly Lake Fire Hall - C103009

No major deficiencies were observed or reported. The components have surpassed their expected useful life, however, the Remaining Useful Life has been extended to a later year based on the absence of significant deficiencies.

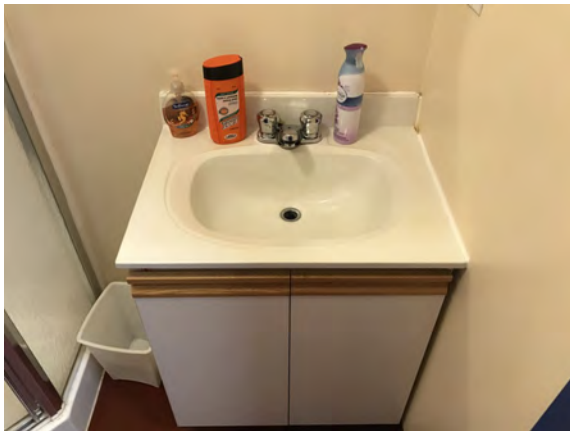
Moberly Lake Fire Hall - C103010

No major deficiencies were observed or reported during the assessment. The components have surpassed their expected useful life, however, the Remaining Useful Life has been extended to a later year based on the absence of significant deficiencies. The cost factor has been increased due to the type of vanity construction.

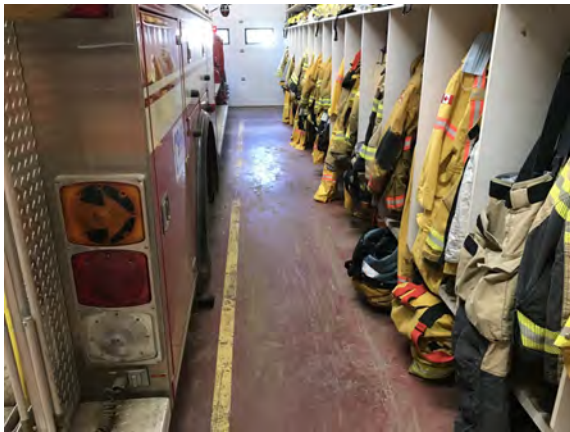
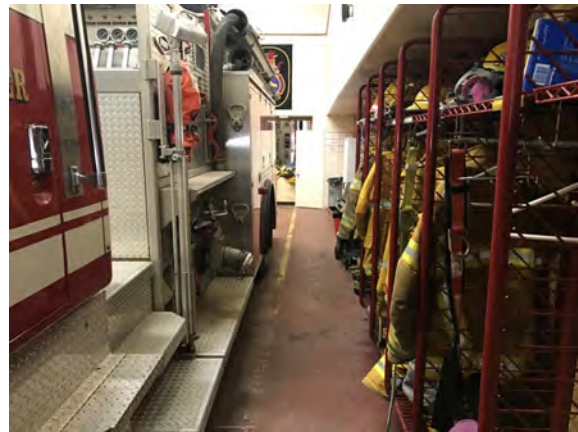
Moberly Lake Fire Hall - C103011

No major deficiencies were observed or reported. The cost factor has been increased due to the type of vanity construction.

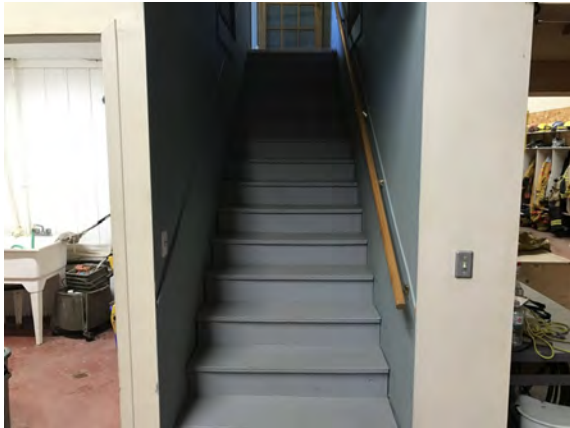
Moberly Lake Fire Hall - C201001

No major deficiencies were observed or reported during the assessment.

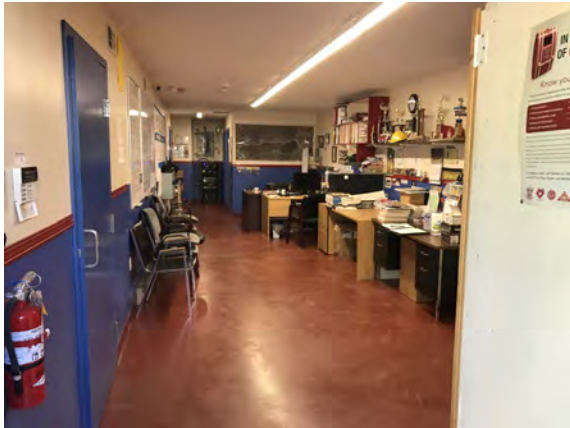
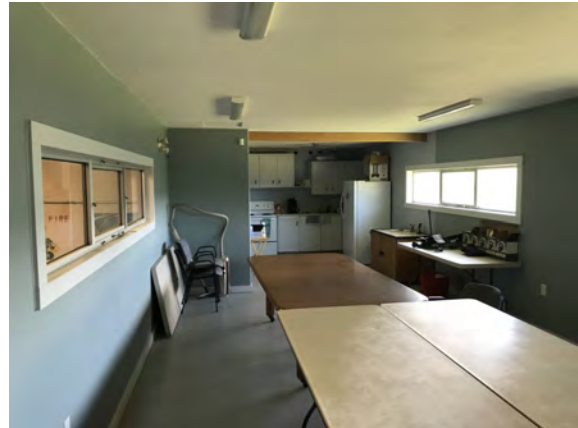
Moberly Lake Fire Hall - C301005

No major deficiencies were observed or reported.

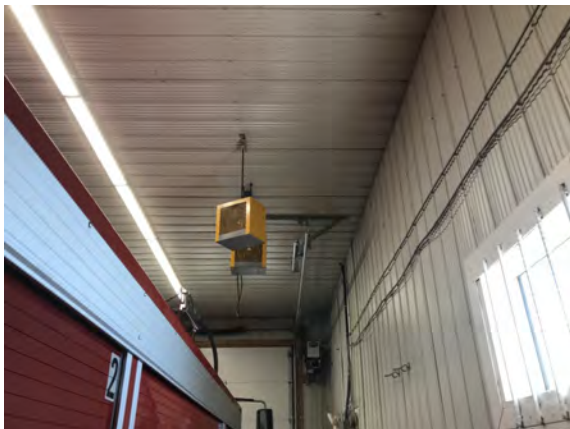
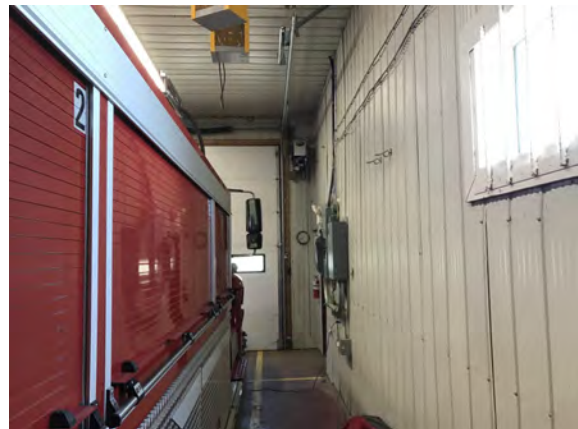
Moberly Lake Fire Hall - C301099

No major deficiencies were observed or reported. Unit cost has been determined based on \$100/SM of the vehicle bays (250 SM). The average install date is estimated circa 1999.

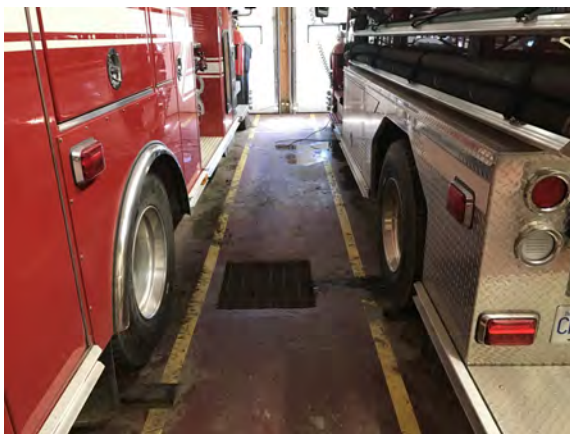
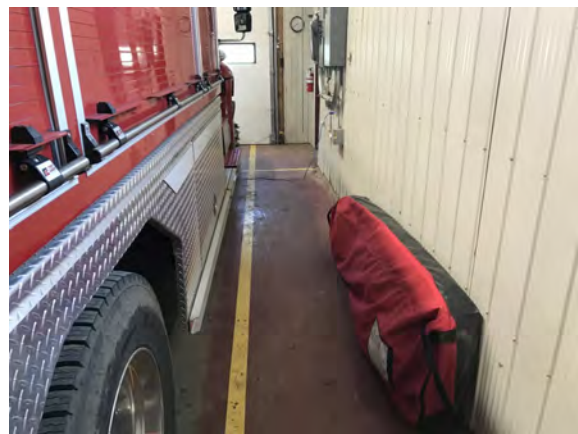
Moberly Lake Fire Hall - C302007

No major deficiencies were observed or reported.

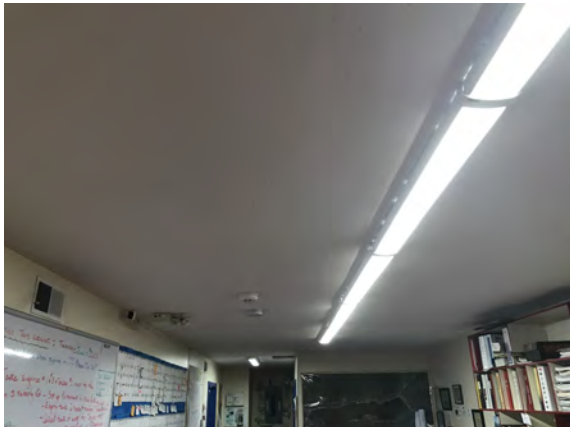
Moberly Lake Fire Hall - C303006

No major deficiencies were observed or reported.

Replace Painted Ceiling Structures

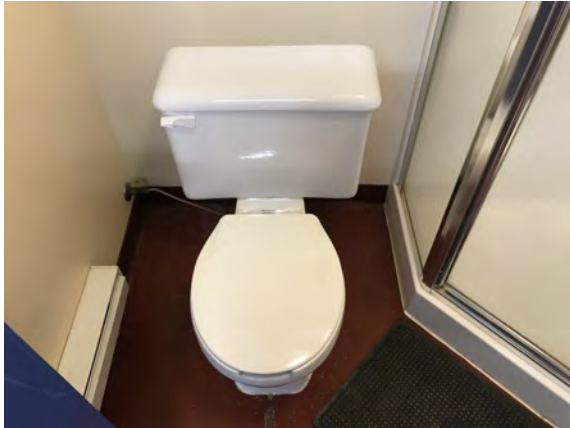
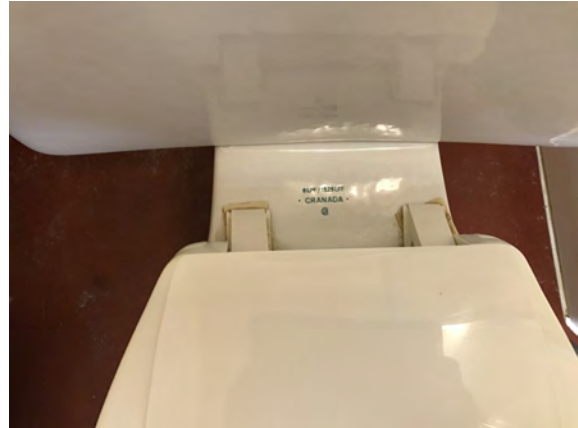
Moberly Lake Fire Hall - D201001

No major deficiencies were observed or reported.

Replace Water Closets

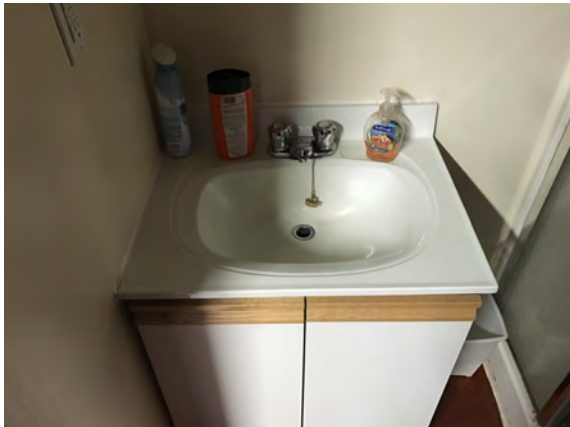
Moberly Lake Fire Hall - D201003

No major deficiencies were observed or reported.

Replace Lavatories

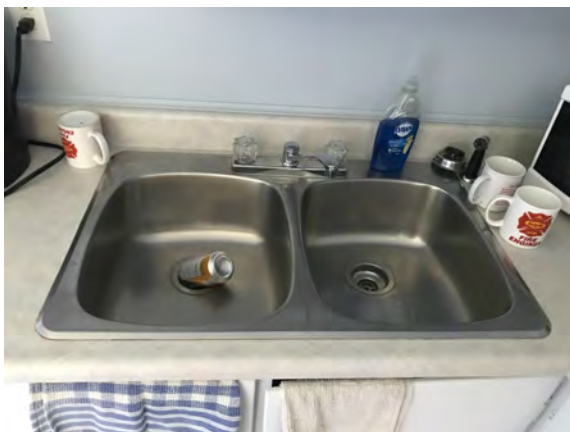
Moberly Lake Fire Hall - D201004

No major deficiencies were observed or reported.

Replace Sinks

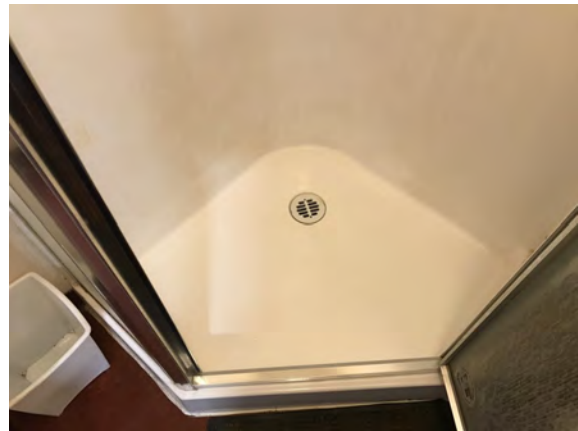
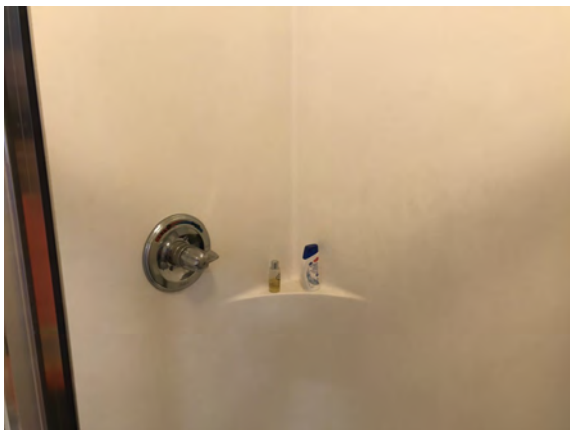
Moberly Lake Fire Hall - D201012

The components have surpassed their expected useful life, however, due to limited or less than average use, they remain in good condition. Remaining Useful Life has been extended to a later year based on the absence of significant deficiencies.

Replace Shower Assembly

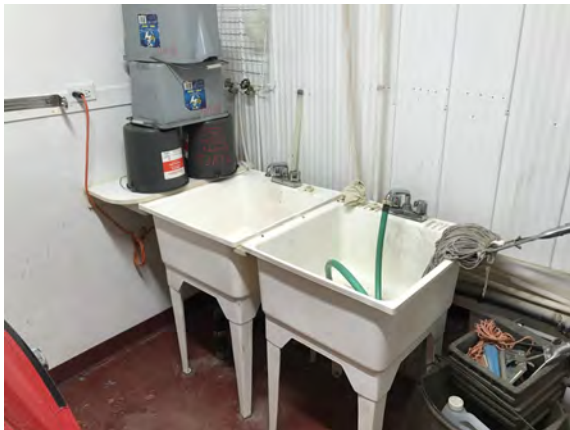
Moberly Lake Fire Hall - D201016

No major deficiencies were observed or reported. The cost factor has been decreased to account for the type of sinks.

Replace Custodial Sinks

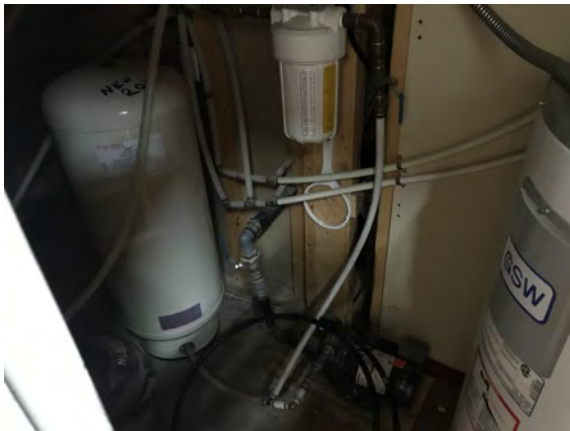
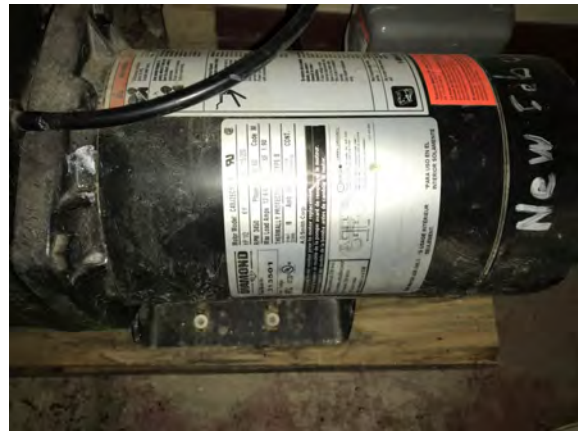
Moberly Lake Fire Hall - D202006

No major deficiencies were observed or reported. The difficulty factor has been decreased to account for the size of the pump.

Replace Domestic Water Booster Systems/Pumps

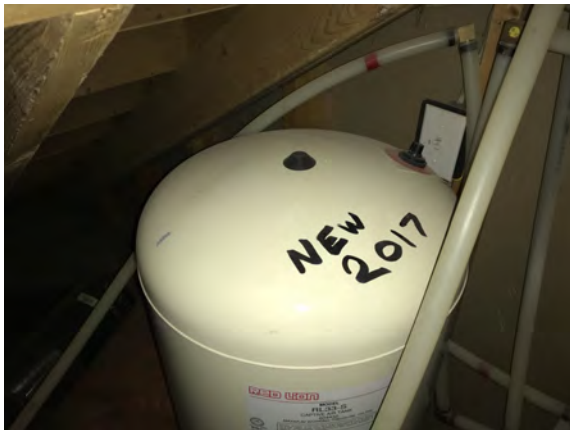
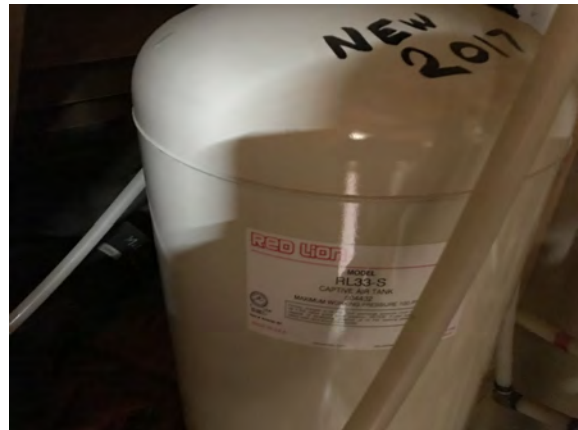
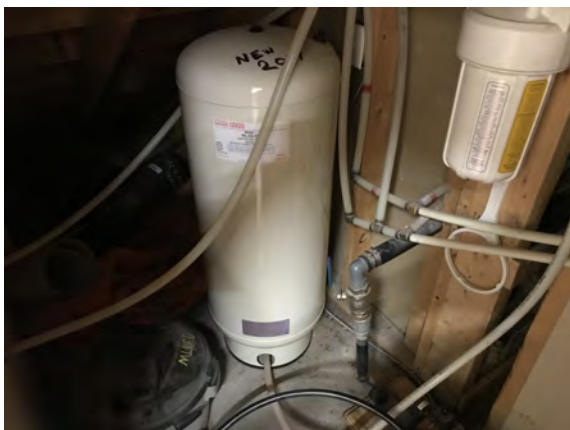
Moberly Lake Fire Hall - D202008

No major deficiencies were observed or reported. The difficulty factor has been decreased to account for the residential grade equipment.

Replace Domestic Water Expansion Tanks/Pressure Tank

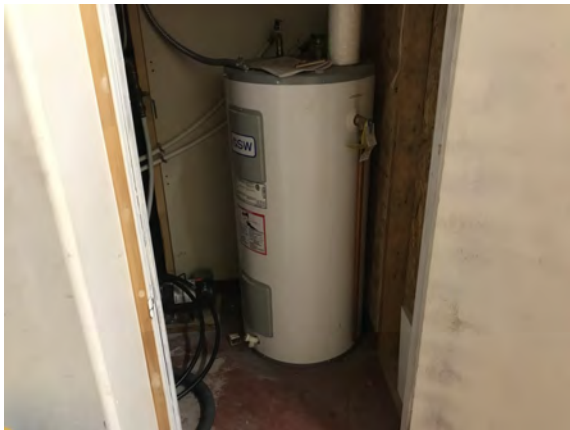
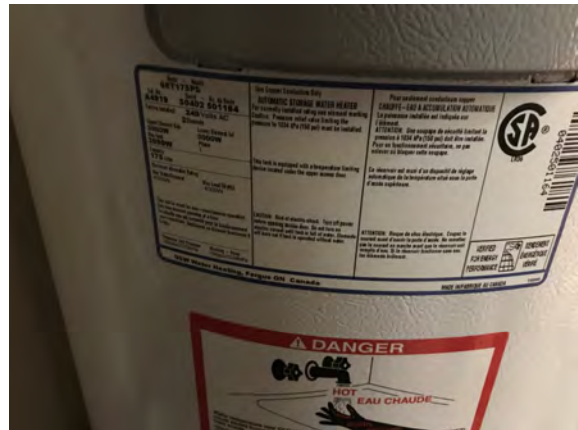
Moberly Lake Fire Hall - D202035

No major deficiencies were observed or reported.

Replace Electric Domestic Water Heaters (Residential Tank Type)

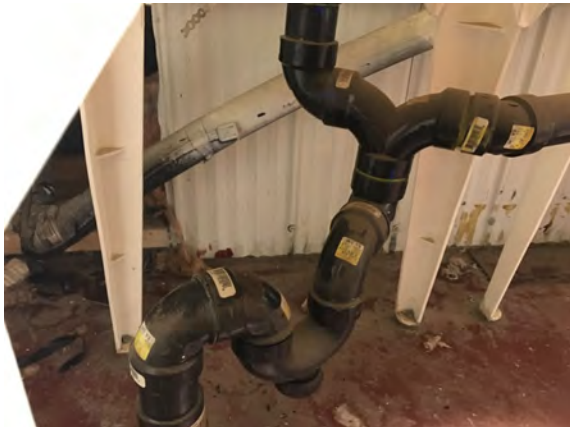
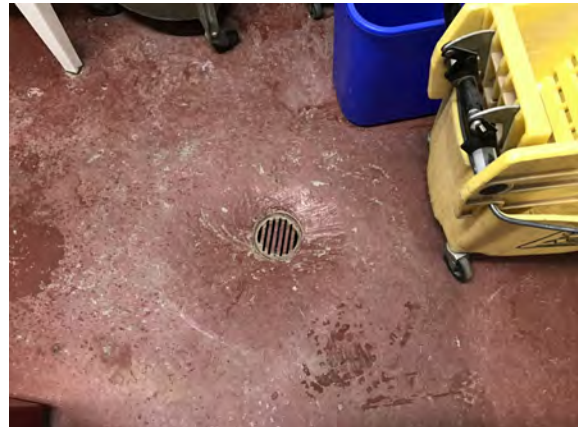
Moberly Lake Fire Hall - D203001

No major deficiencies were observed or reported.

Replace Sanitary Waste and Vent Piping

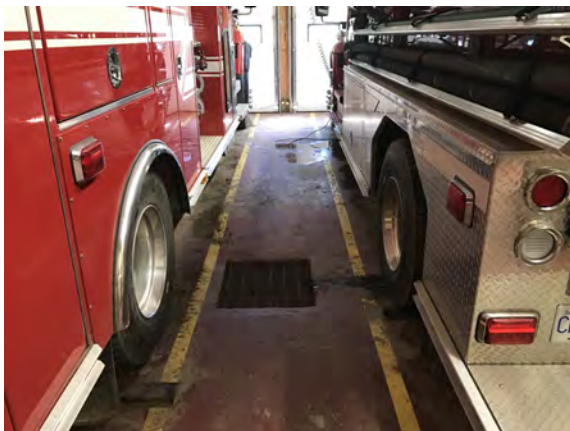
Moberly Lake Fire Hall - D203007

No major deficiencies were observed or reported. The majority of the system is concealed from view. The components are nearing their expected useful life and should therefore be inspected by a qualified tradesperson to determine piping and basin integrity. The cost to complete this inspection is presumed to fall below the cost threshold for repair recommendations (\$5,000) and therefore should be completed as a maintenance activity. In the absence of observed or reported deficiencies, the Remaining Useful Life has been extended.

Replace Interceptor Systems

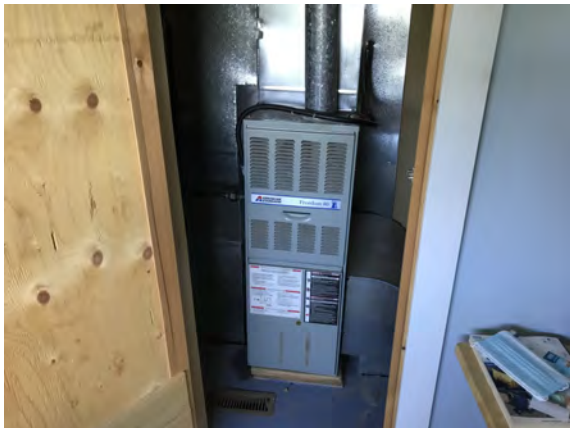
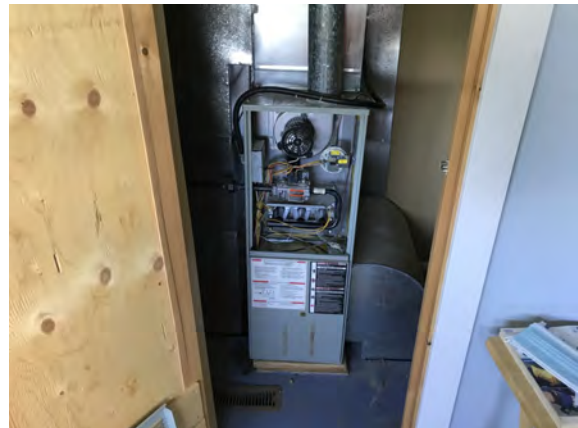
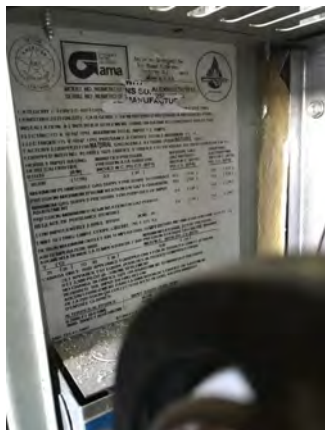
Moberly Lake Fire Hall - D302003

The furnace has exceeded its expected useful life and is exhibiting wear and tear that is consistent with age including loud operation and presumed loss of efficiency. Lifecycle replacement is recommended.

Replace Fuel Fired Forced Air Furnace

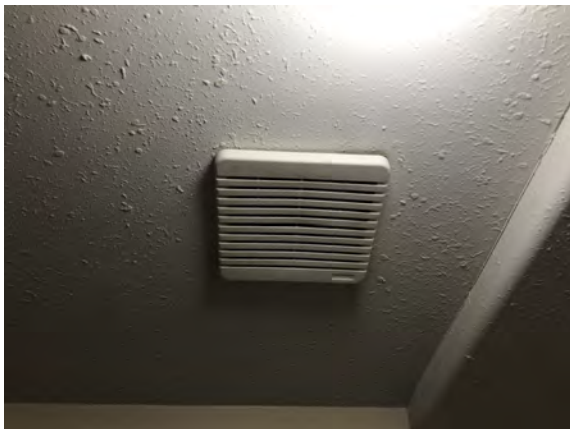
Moberly Lake Fire Hall - D304033

No major deficiencies were observed or reported.

Replace Exhaust Fan - Ceiling (Residential)

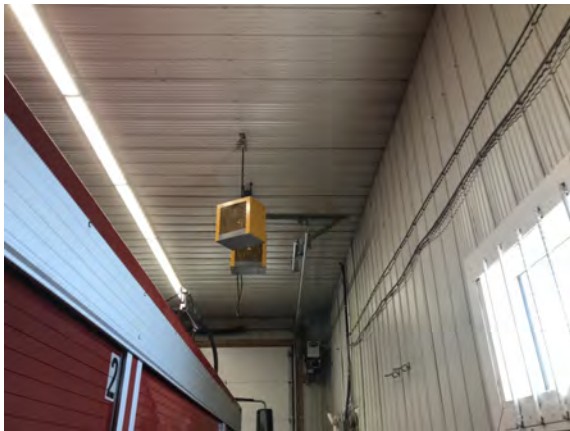
Moberly Lake Fire Hall - D305009

No major deficiencies were observed or reported. The components have surpassed their expected useful life, however, the Remaining Useful Life has been extended to a later year based on the absence of significant deficiencies, likely due to the limited use of the heater.

Replace Unit Heaters (Electric)

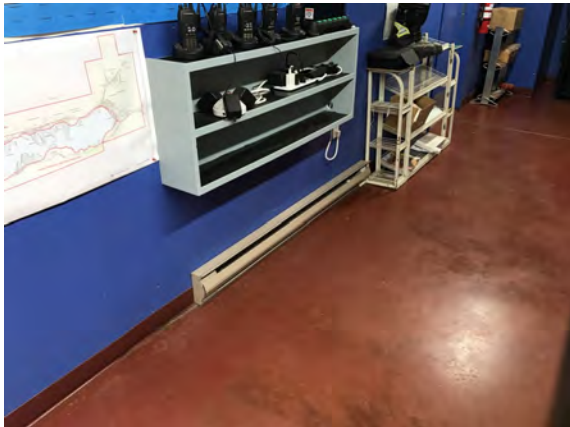
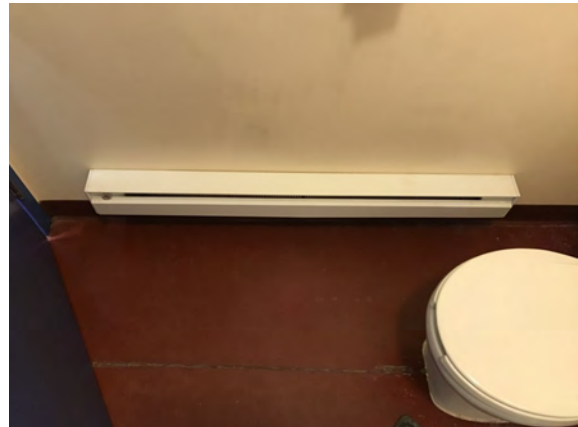
Moberly Lake Fire Hall - D305010

No major deficiencies were observed or reported, however, the baseboards have exceeded their expected useful life and should therefore be replaced.

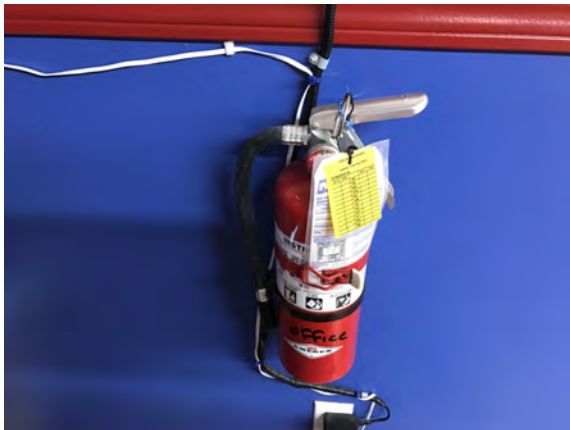
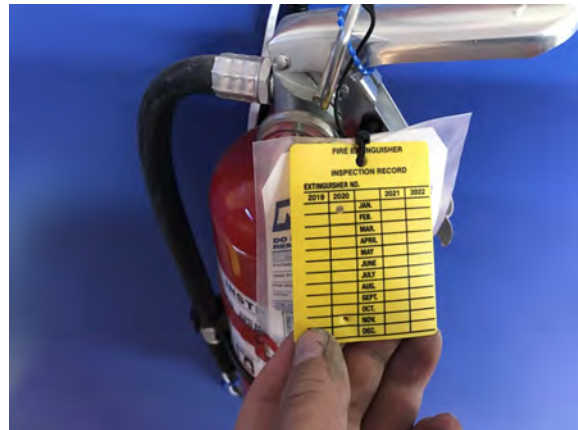
Moberly Lake Fire Hall - D403002

No major deficiencies were observed or reported. Annual inspection tags appeared to be up to date.

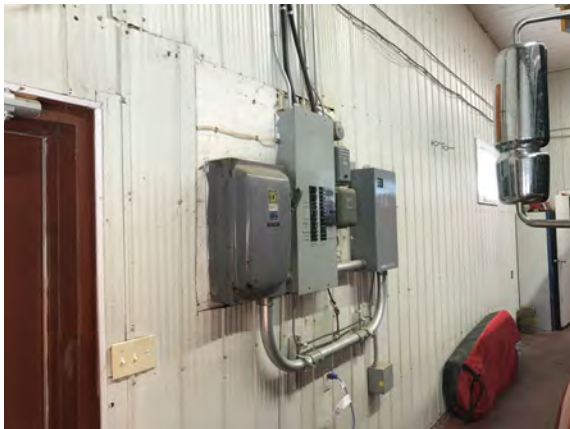
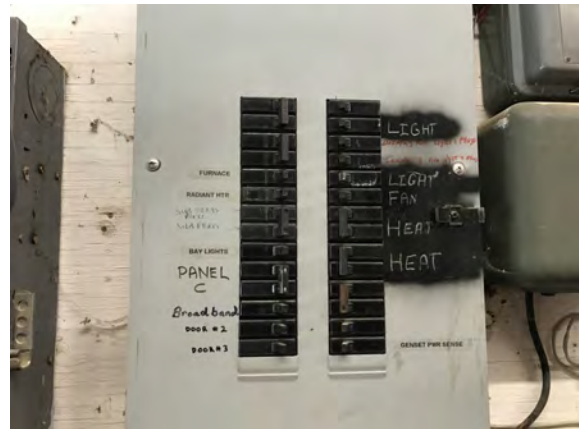
Moberly Lake Fire Hall - D501005

No major deficiencies were observed or reported, however, it is recommended to include breaker schedules in the panels as a maintenance activity. The component has surpassed its expected useful life, however, the Remaining Useful Life has been extended to a later year based on the absence of significant deficiencies.

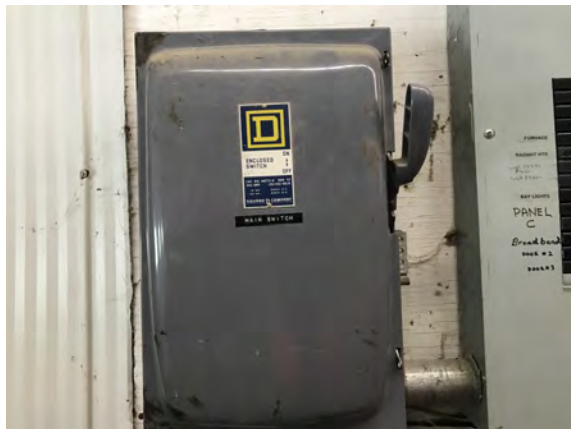
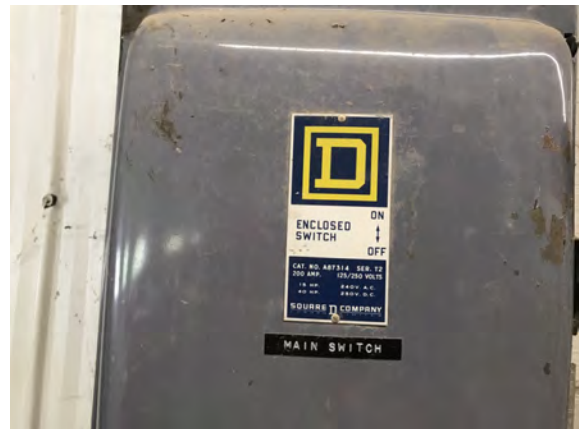
Moberly Lake Fire Hall - D501025

No major deficiencies were observed or reported during the assessment. The difficulty factor has been lowered to account for the size of the switch. The component has surpassed its expected useful life, however, the Remaining Useful Life has been extended to a later year based on the absence of significant deficiencies.

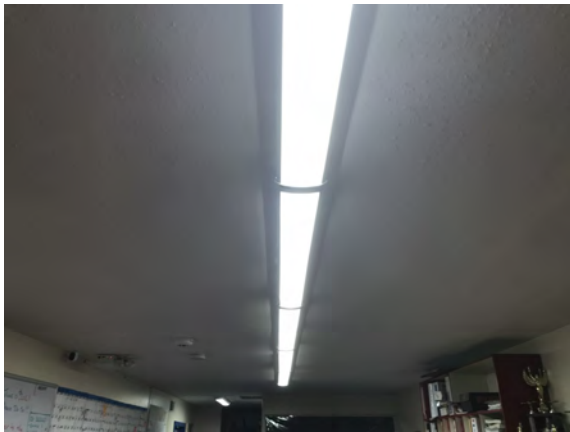
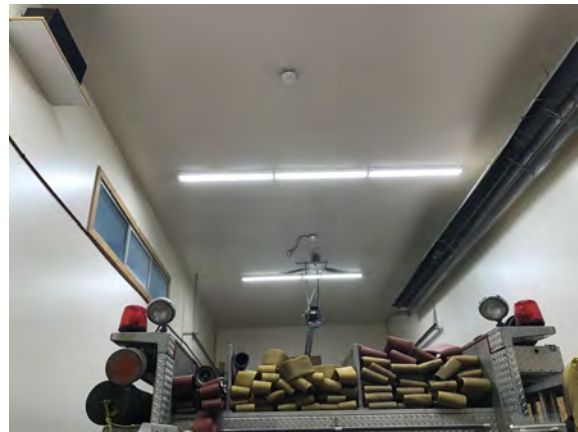
Moberly Lake Fire Hall - D502002

No major deficiencies were observed or reported.

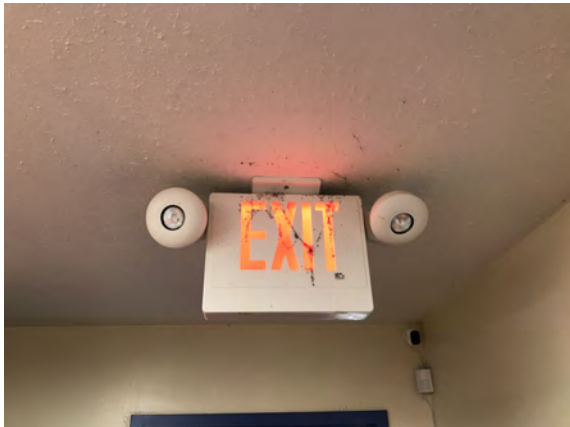
Moberly Lake Fire Hall - D502041

No major deficiencies were observed or reported.

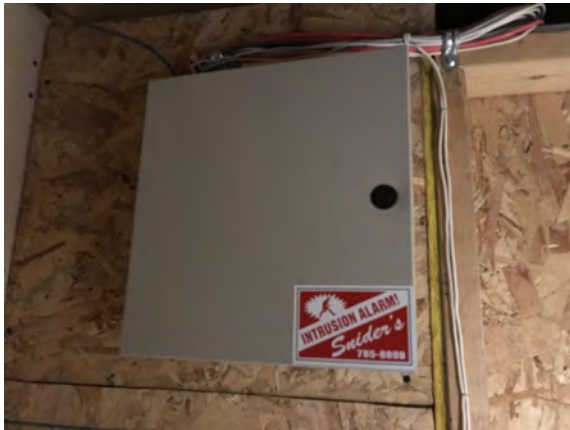
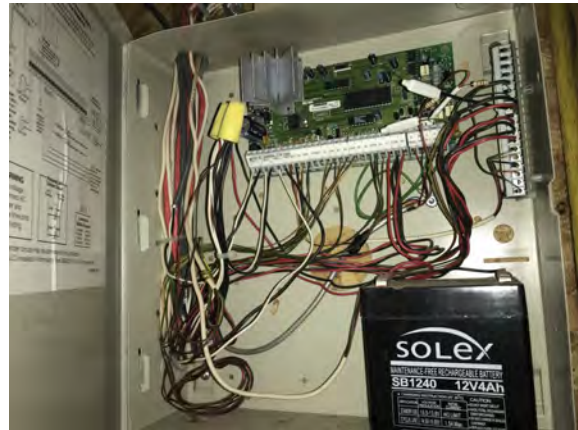
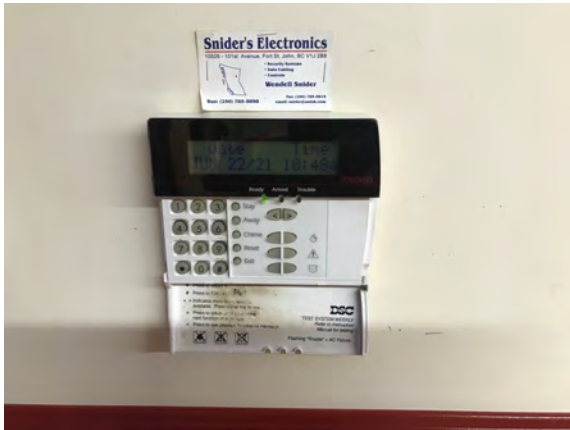
Moberly Lake Fire Hall - D503008

No major deficiencies were observed or reported. The difficulty factor has been increased to account for the smoke detectors included in the system.

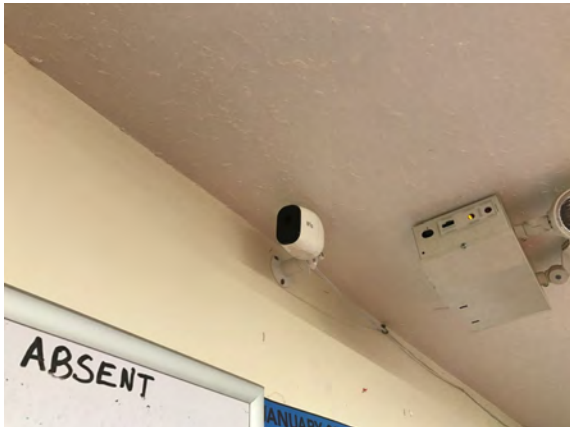
Moberly Lake Fire Hall - D503031

No major deficiencies were observed or reported.

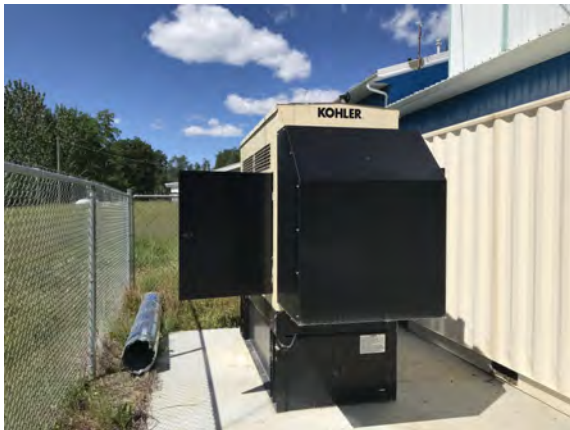
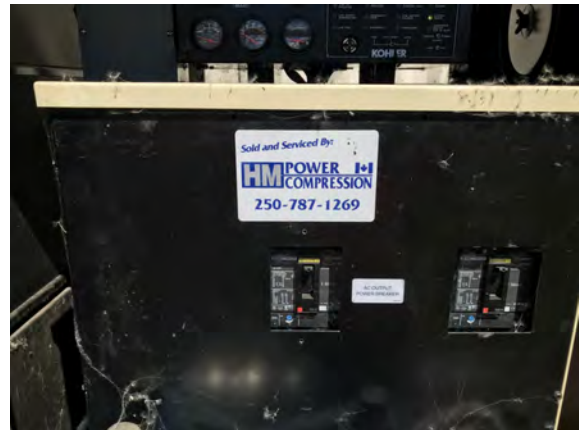
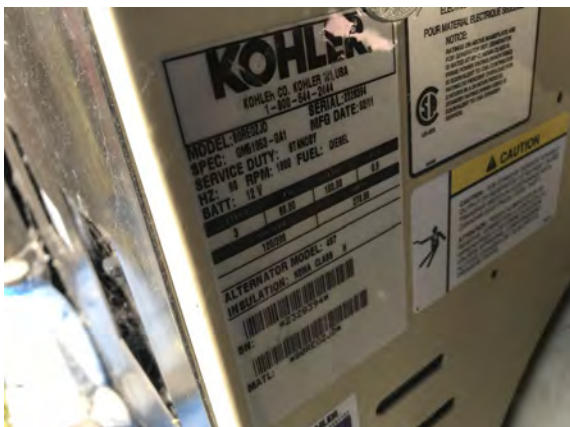
Moberly Lake Fire Hall - D509002

No major deficiencies were observed or reported.

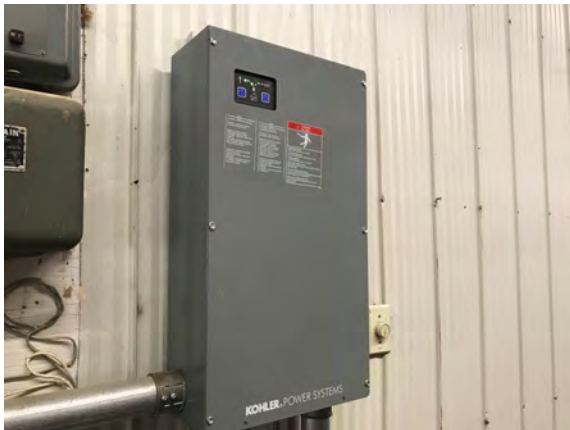
Moberly Lake Fire Hall - D509031

No major deficiencies were observed or reported.

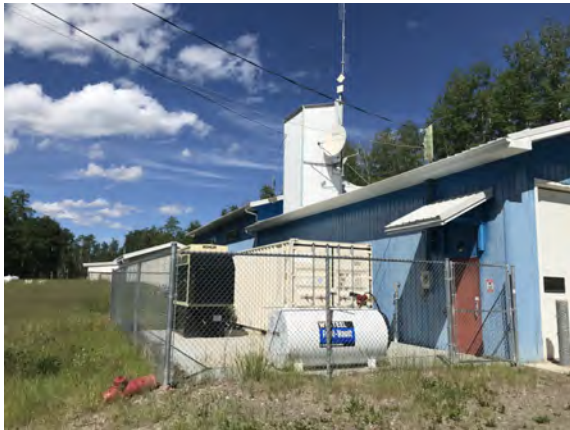
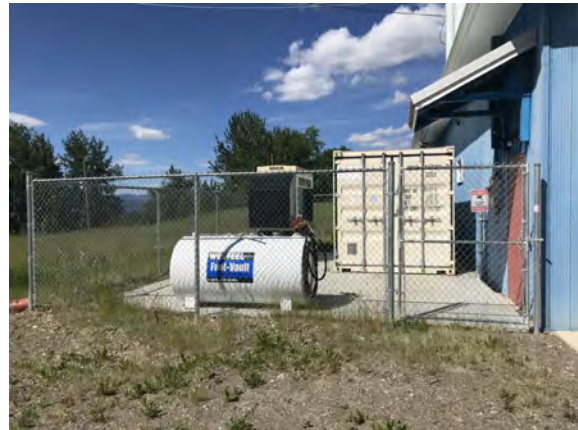
Moberly Lake Fire Hall - F101099

No major deficiencies were observed or reported.

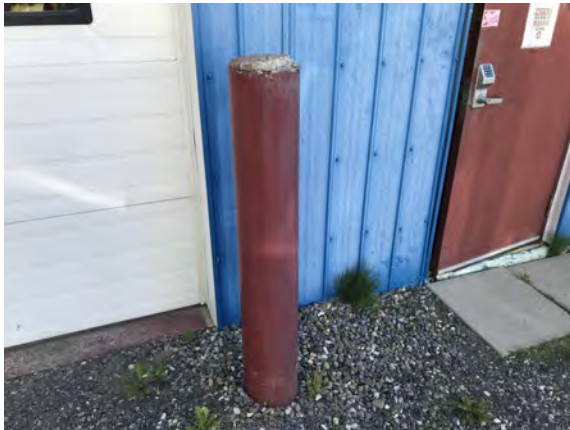
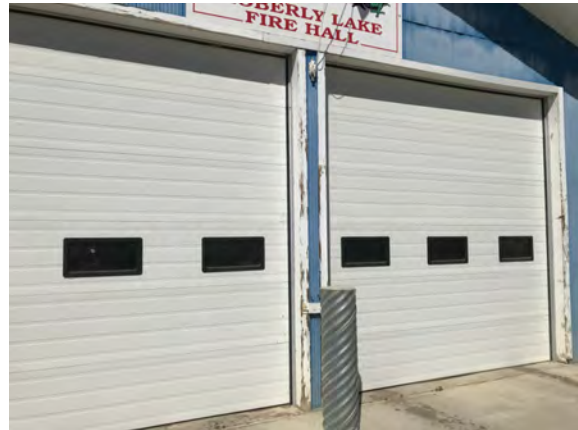
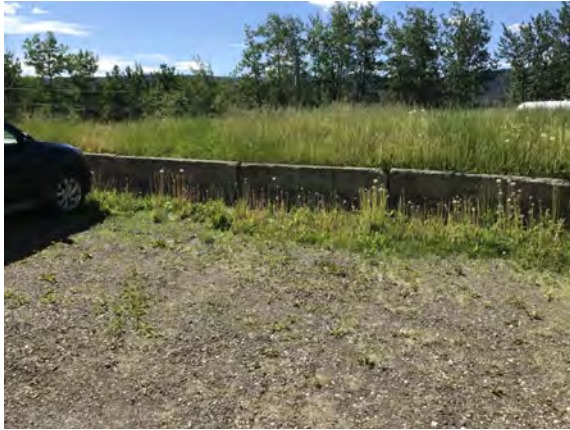
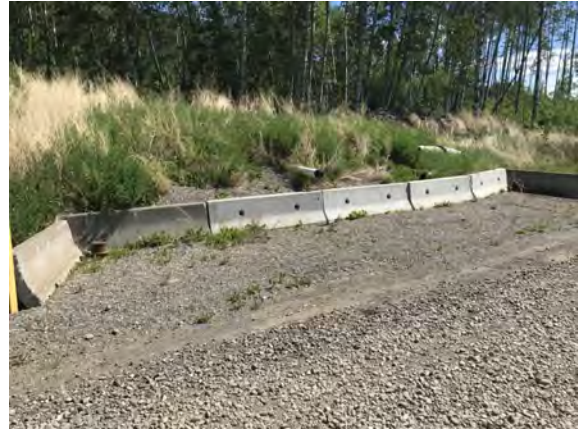
Moberly Lake Fire Hall - G201005

No major deficiencies were observed or reported. It is recommended to paint the barriers with exterior grade high visibility paint to help with visibility. The cost to paint the barriers is presumed to fall below the cost threshold for repair recommendations (\$5,000) and should be completed as a routine maintenance activity.
