**Peace River Regional District**

**Facility Condition Assessment Report  
Moberly Lake Fire Hall**

**November 17, 2021**

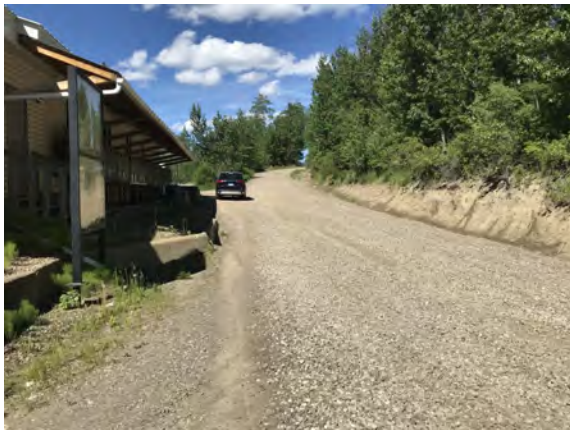
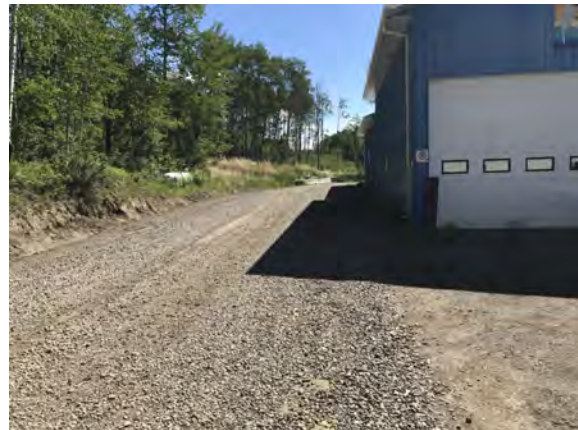
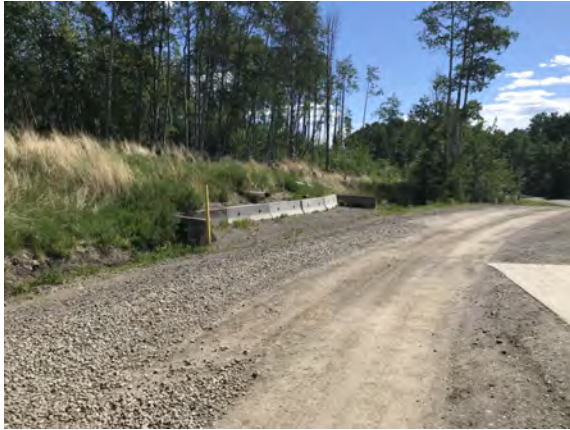
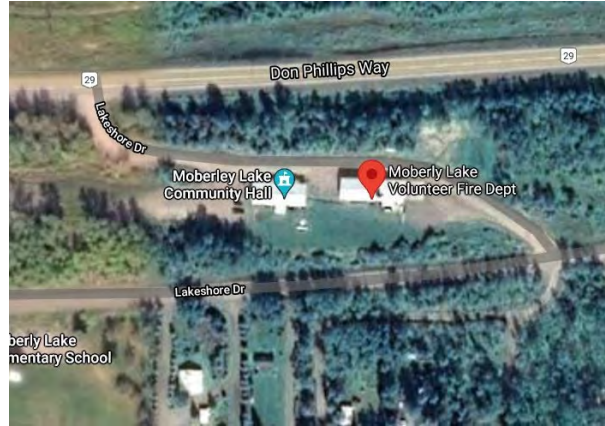
Moberly Lake Fire Hall - G201025

No major deficiencies were observed or reported, however, there are reportedly some grading issues with the roadway. At times of heavy rainfall or snowmelt, water ponds at the west entrance to the fire hall, and reportedly is not contained within the drainage ditch that runs parallel to the roadway. There is some evidence of ground heaving around the west entrance. It is recommended to undertake an engineering study to determine a solution for site ponding/heaving. A recommendation for a study and a placeholder repair have been provided herein.

Complete regrading/repairs as directed by the engineering report.

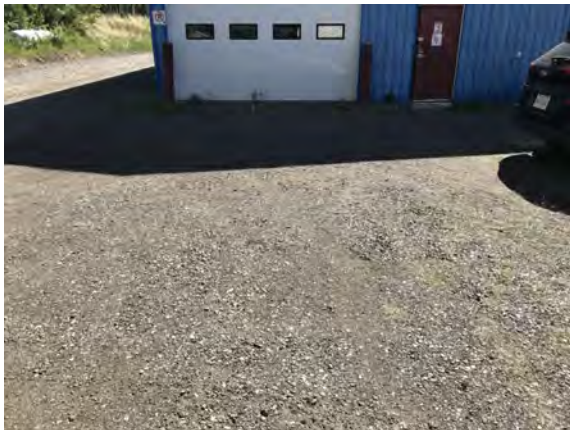
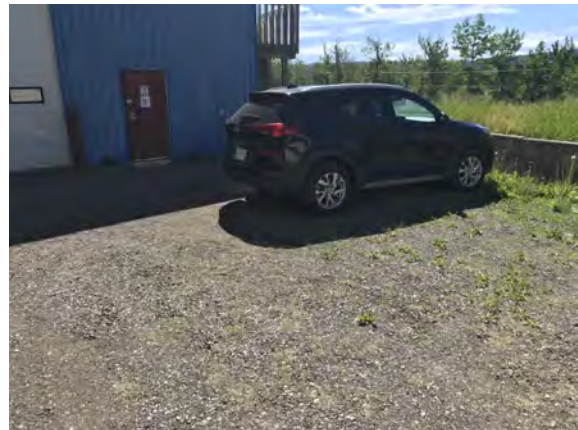
Moberly Lake Fire Hall - G202024

No major deficiencies were observed or reported during. The components have surpassed their expected useful life, however, the Remaining Useful Life has been extended to a later year based on the absence of significant deficiencies.

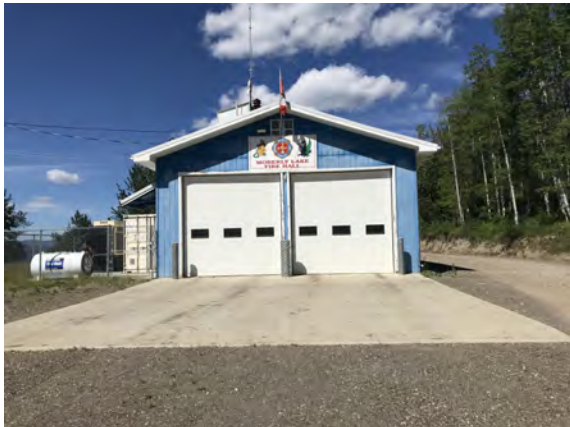
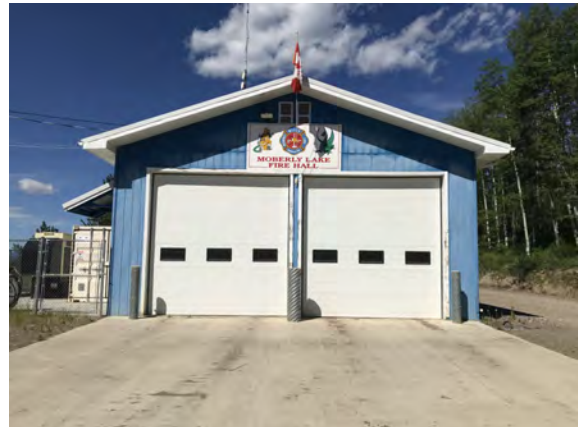
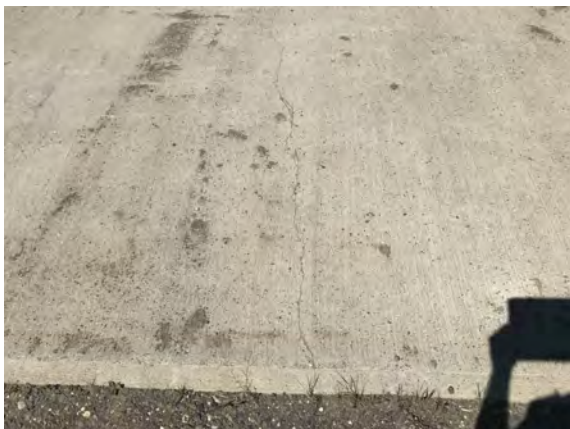
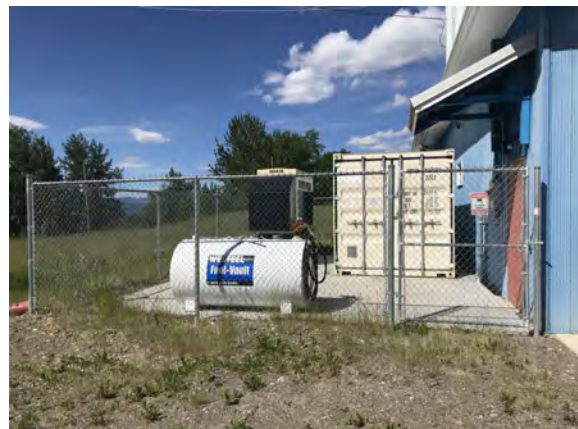
Moberly Lake Fire Hall - G203022

No major deficiencies were observed or reported.

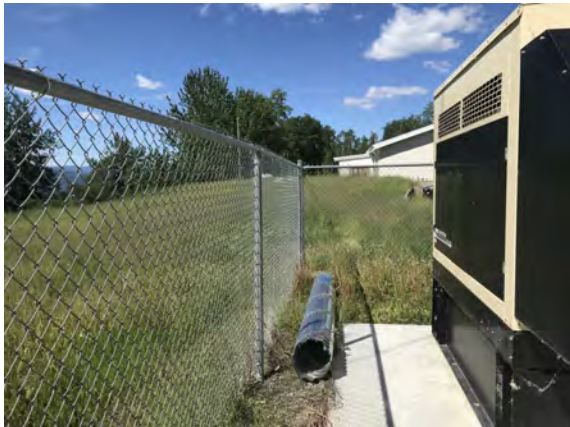
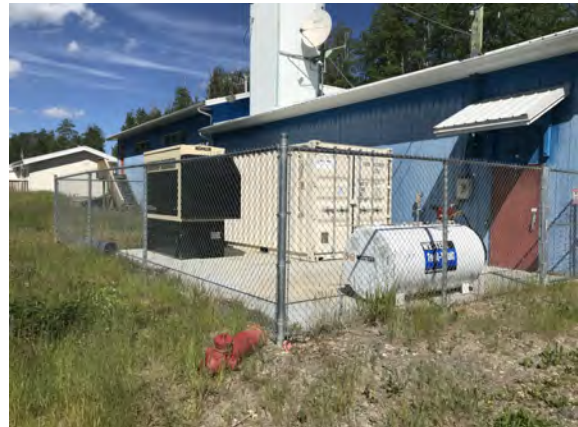
Moberly Lake Fire Hall - G204021

No major deficiencies were observed or reported.

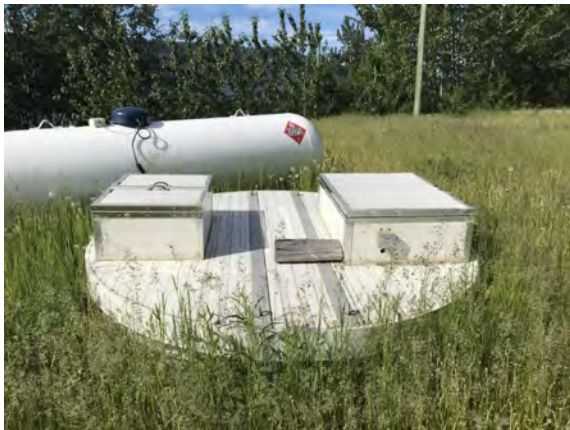
Moberly Lake Fire Hall - G301099

No major deficiencies were observed or reported. The difficulty factor has been adjusted to account for the estimated size of the tanks.

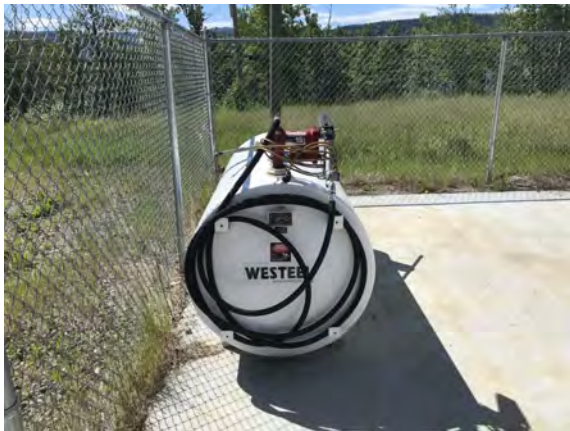
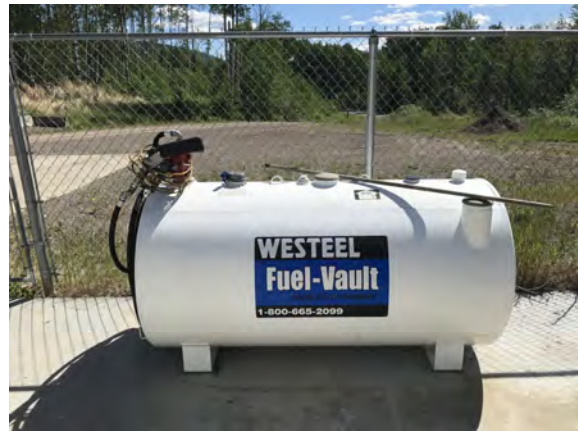
Moberly Lake Fire Hall - G306004

No major deficiencies were observed or reported.

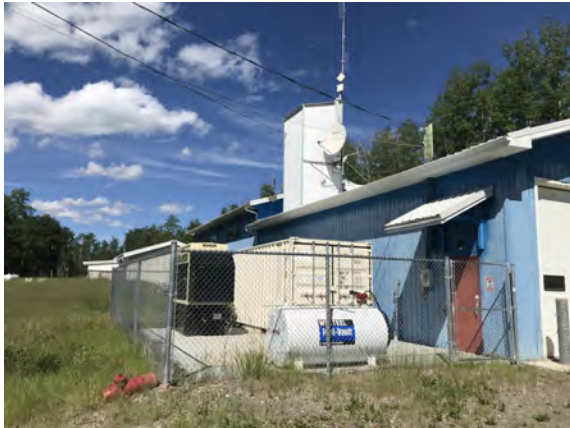
Moberly Lake Fire Hall - G401011

No major deficiencies were observed or reported.
