Peace River Regional District

**Facility Condition Assessment
Report Cache Creek Community
Hall**

November 16, 2021

Prepared by:
FCAPX a Division of Roth IAMS
Project No. 21075
www.fcapx.com

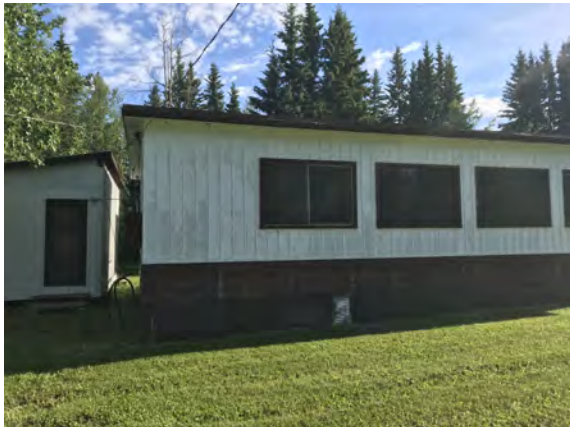
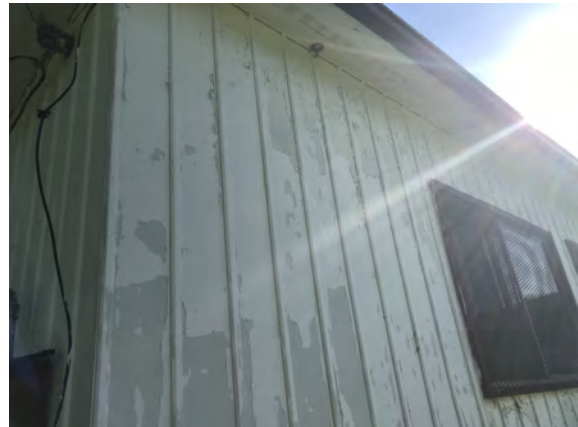
Cache Creek Community Hall - B201010

Exterior paint is peeling and flaking, particularly on the south side. Lifecycle replacement is recommended within the short-term of the evaluation period.

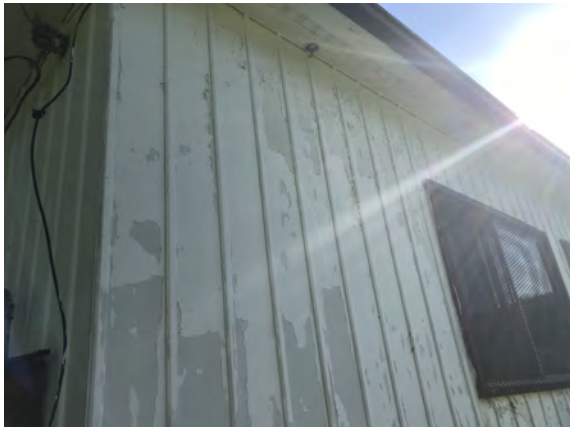
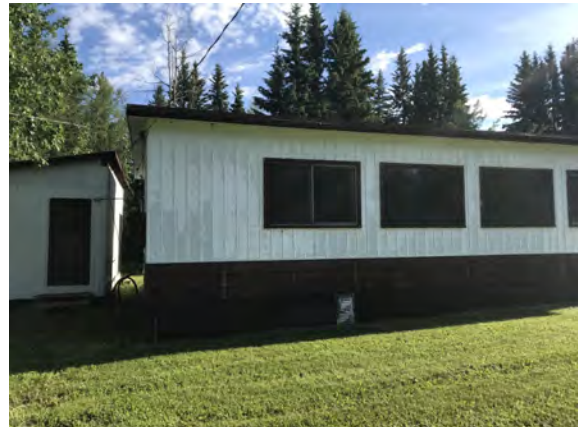
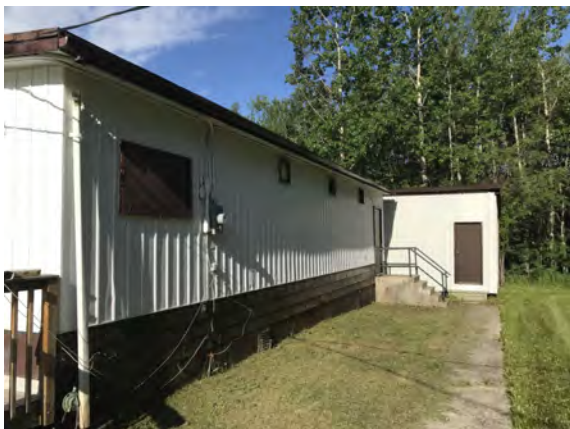
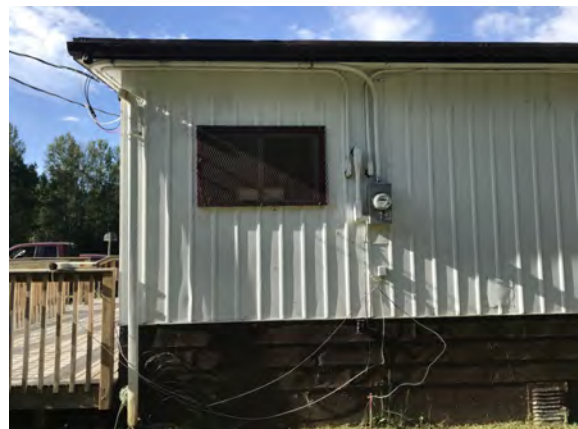
Cache Creek Community Hall - B201024

No major deficiencies were observed or reported, other than minor localized dents and deformations that are considered aesthetic in nature.

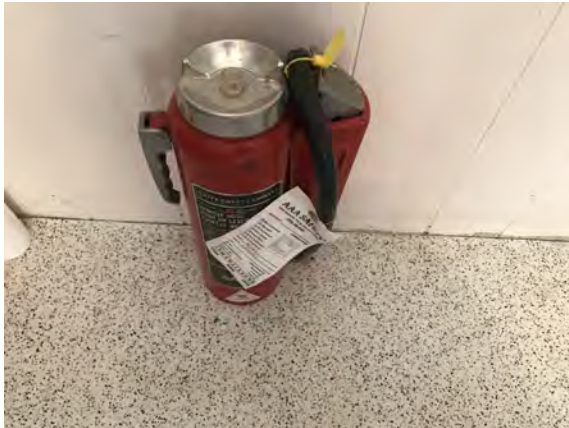
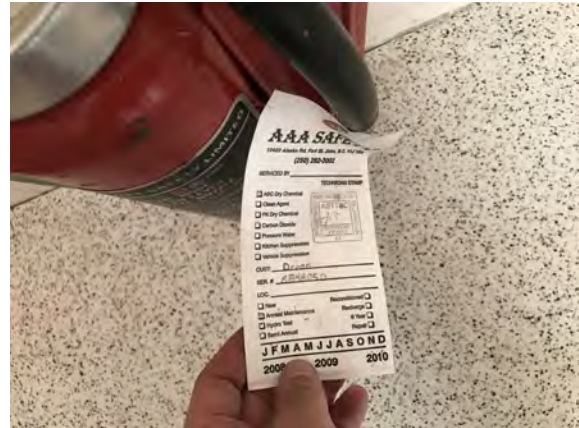
Cache Creek Community Hall - D403002

The fire extinguisher does not have up-to-date inspection tags and is not wall-mounted. Replacement is recommended.

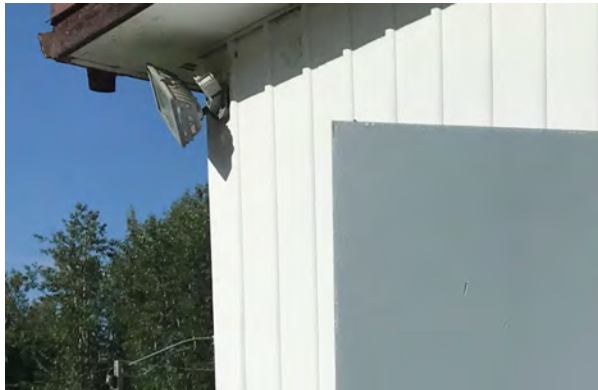
Cache Creek Community Hall - D502041

No major deficiencies were observed or reported.

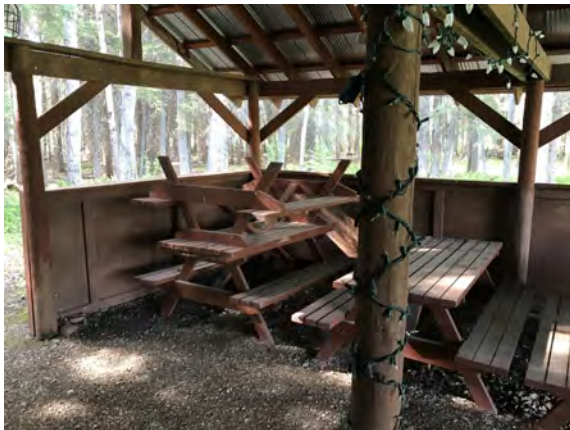
Cache Creek Community Hall - G204073

No major deficiencies were observed or reported during the assessment. The component has exceeded its expected useful life, although its remaining useful life has been extended to a later year due to the absence of significant observed or reported deficiencies.

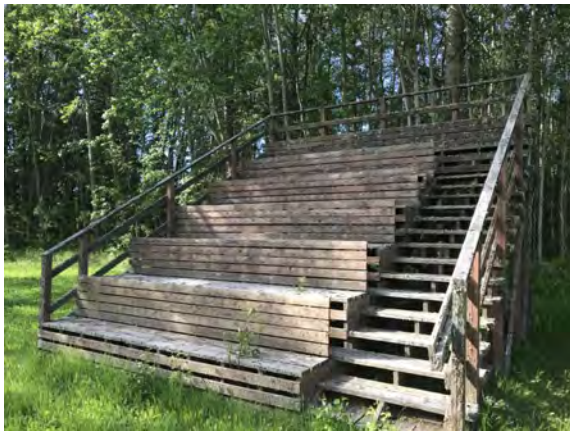
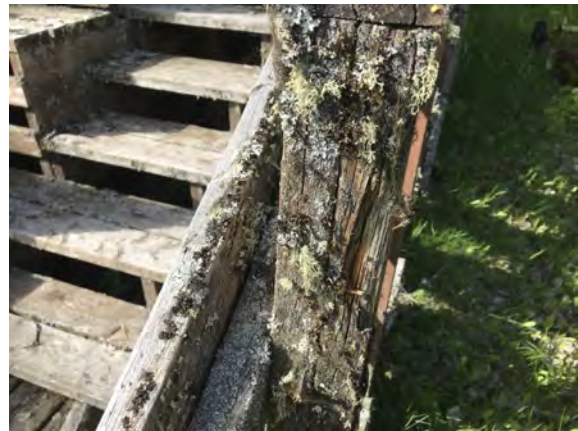
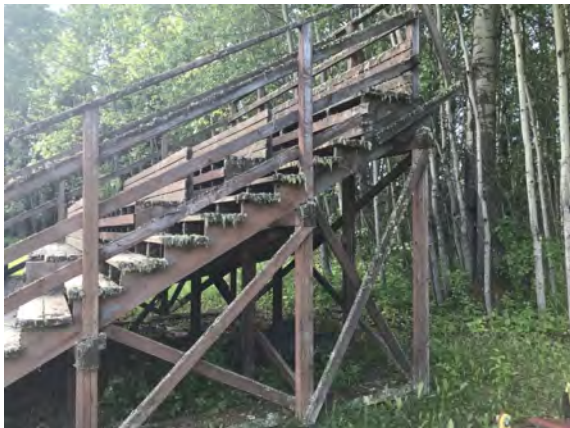
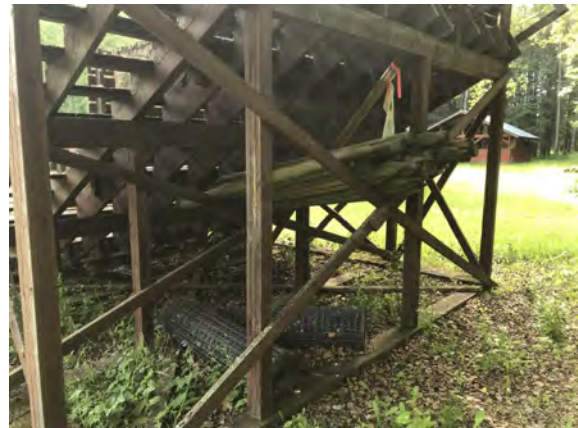
Cache Creek Community Hall - G204075

Wood was rotted and deteriorated. The structure appears to have shifted. Lifecycle replacement is recommended in the immediate term to restore safe functionality. The difficulty factor has been increased to account for the type of materials used.

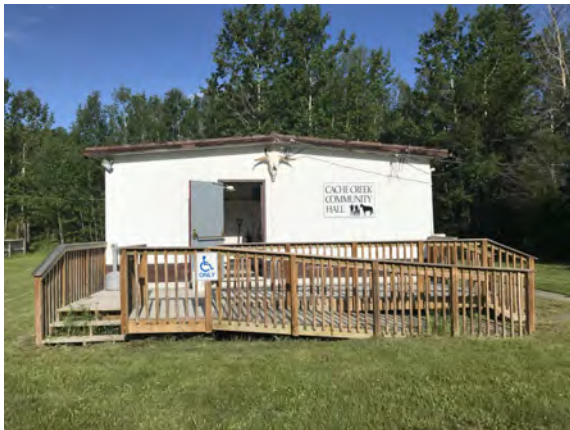
Cache Creek Community Hall - G204081

No major deficiencies were observed or reported during the assessment. The component has exceeded its expected useful life, although its remaining useful life has been extended to a later year due to the absence of significant observed or reported deficiencies.

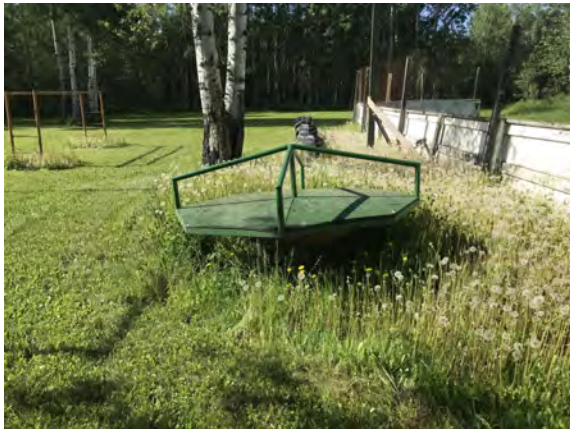
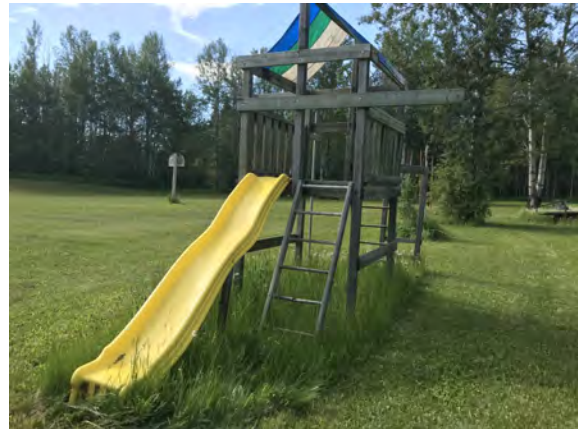
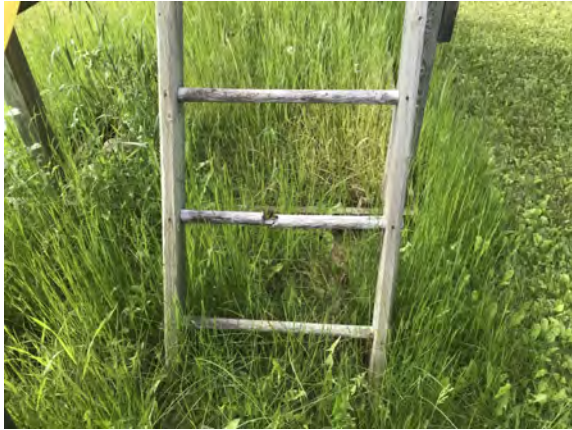
Cache Creek Community Hall - G204094

The wood-framed play equipment exhibited split wood timbers, and ladder rungs were broken. The merry-go-round was tilted at an angle. The paint finish on the monkey bars is chipped and flaking. Lifecycle replacement within the immediate term is recommended to restore safe functionality of the equipment.

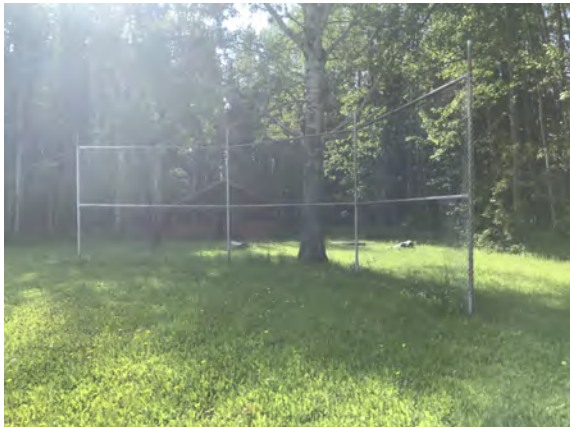
Cache Creek Community Hall - G204095

No major deficiencies were observed or reported.

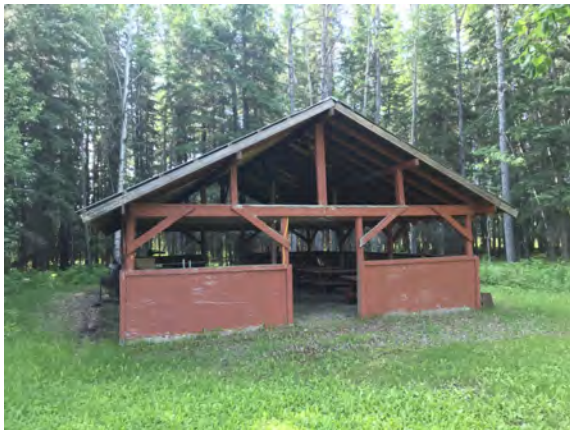
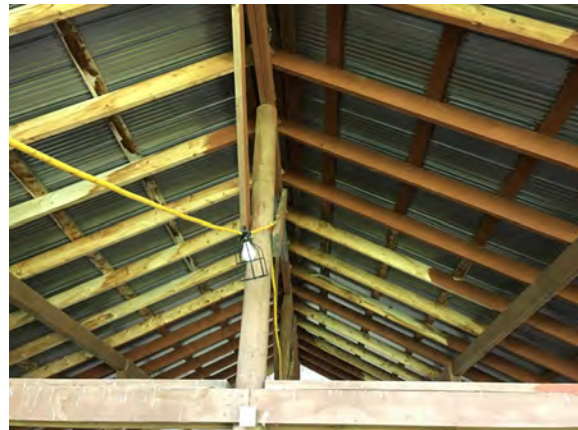
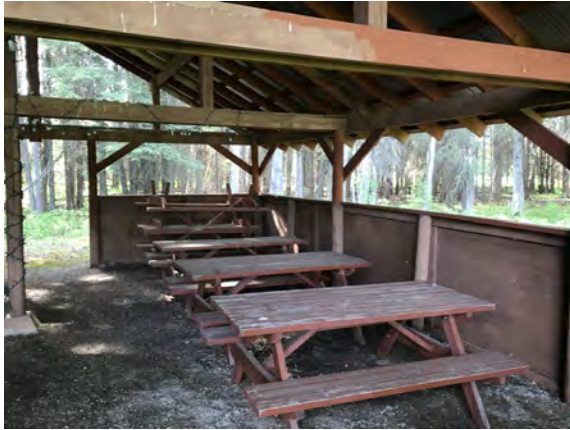
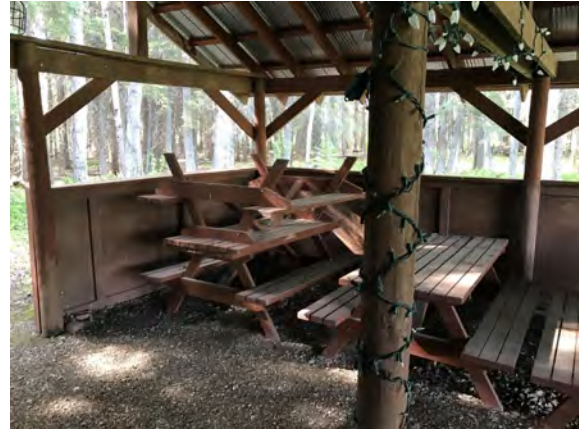
Cache Creek Community Hall - G204099

No major deficiencies were observed or reported, however, there were propane tanks stored near the cookhouse. It is unknown if tanks contain propane. Tanks should be removed to prevent vandalism or tampering. There is a propane cooktop with a range provided in the cookhouse, however, it is understood that it is no longer in use and should be removed as a maintenance activity. Repainting of half walls on the cookhouse perimeter should also be performed as part of routine maintenance. Lifecycle replacement has been deferred. The difficulty factor has been increased to account for the size and construction type.

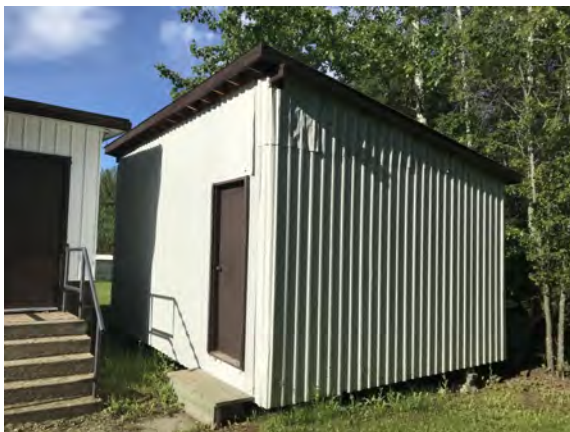
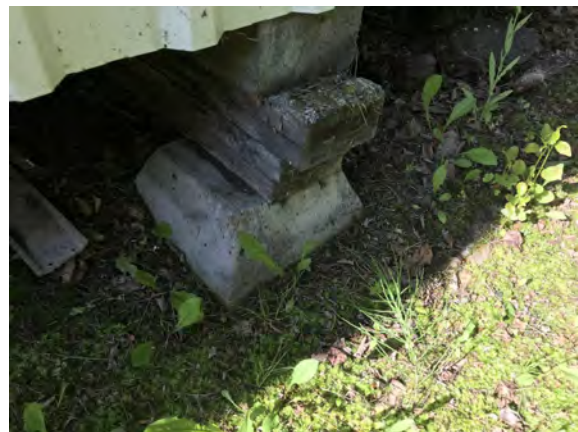
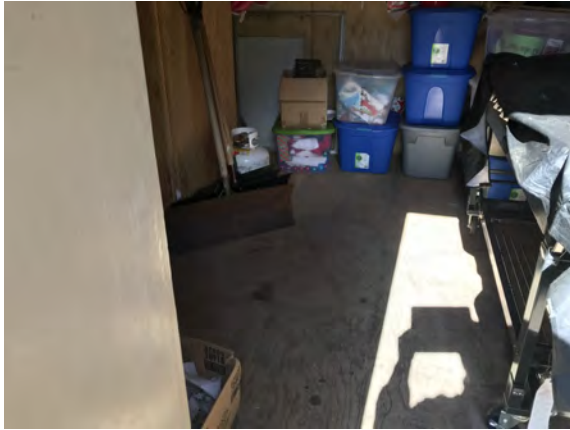
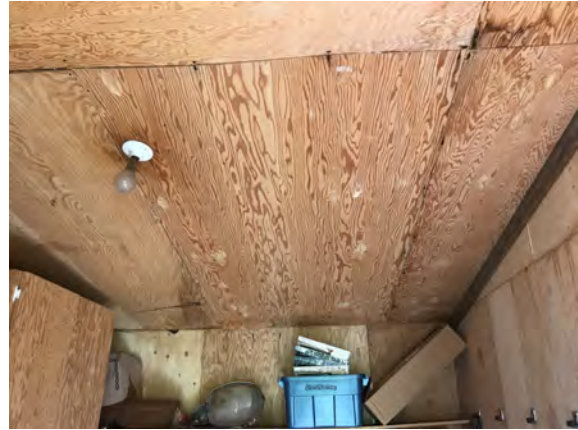
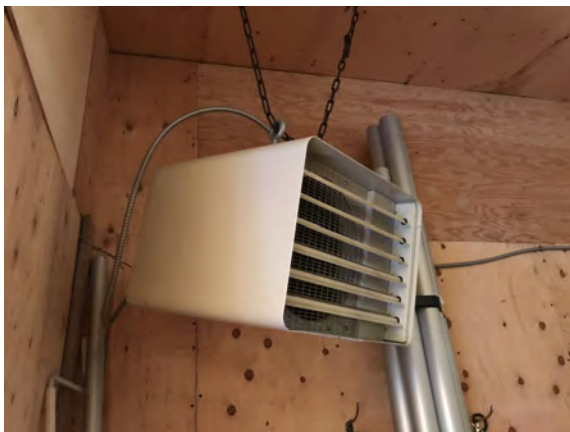
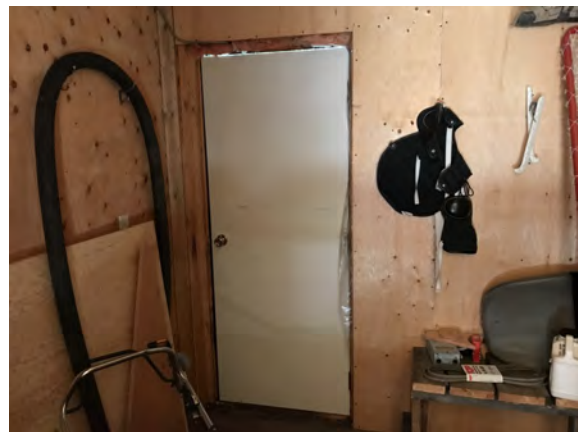
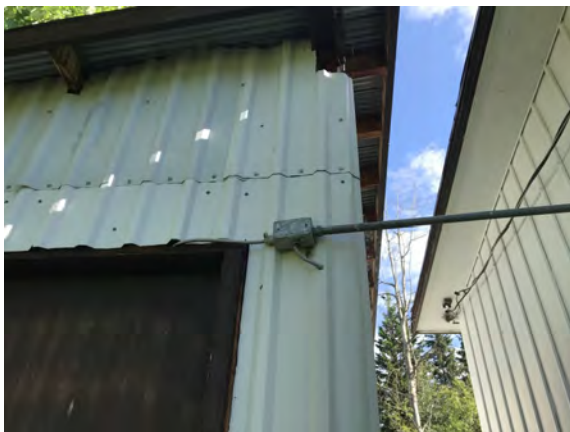
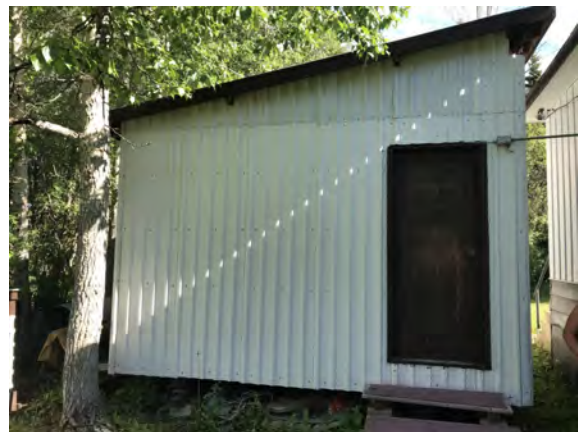
Element Description	
Name	G204099 - Other Site Development - Shed
Installation Year	1987
Condition	3 - Fair
Expected Useful Life	25 Years
Remaining Useful Life	5 Years
Renewal Year	2026
Quantity / Unit of Measure	1 / Lump Sum
Unit Cost	\$5,000.00
Difficulty / Regional / Soft Cost Factors	3.00 / 1.867 / 1
Replacement Cost	\$28,005.00

No major deficiencies were observed or reported. The components have surpassed their expected useful life, however replacement has been extended to a later year based on the absence of significant deficiencies. The difficulty factor has been increased to account for the construction type and size of the shed.

Recommendations #1 - Other Site Development	
Type	Life Cycle Replacement
Year	2026
Cost	\$28,005.00

Replace Other Site Development

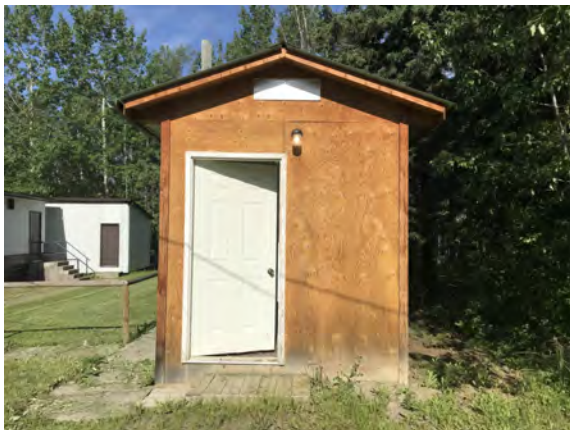
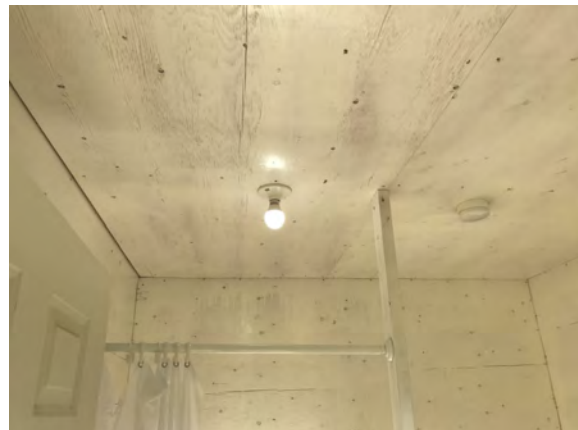
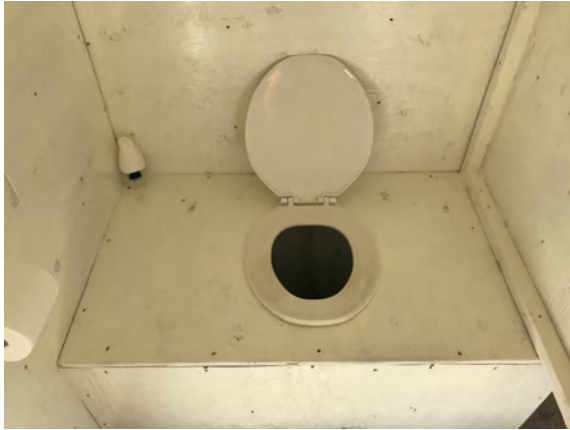
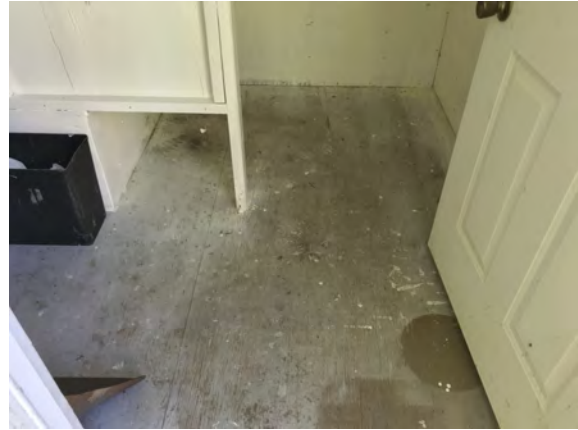
Element Description	
Name	G204099 - Other Site Development - Main Outhouse Building
Installation Year	2000
Condition	2 - Good
Expected Useful Life	25 Years
Remaining Useful Life	10 Years
Renewal Year	2031
Quantity / Unit of Measure	1 / Lump Sum
Unit Cost	\$5,000.00
Difficulty / Regional / Soft Cost Factors	2.50 / 1.867 / 1
Replacement Cost	\$23,337.50

Exterior doors were replaced in 2017. Flooring in the east-most washroom was also replaced in 2017. No major deficiencies were observed or reported. Re-sealing of exterior plywood surfaces should be performed as part of ongoing routine maintenance to preserve wood surfaces. The door to the west washroom has a hole cut for door hardware, however, hardware is not present. It is recommended to install locking hardware as a maintenance activity. Based on the absence of significant observed or reported deficiencies, lifecycle replacement has been deferred. The difficulty factor has been increased to account for the construction type and size of the building.

Recommendations #1 - Other Site Development	
Type	Life Cycle Replacement
Year	2031
Cost	\$23,337.50

Replace Other Site Development

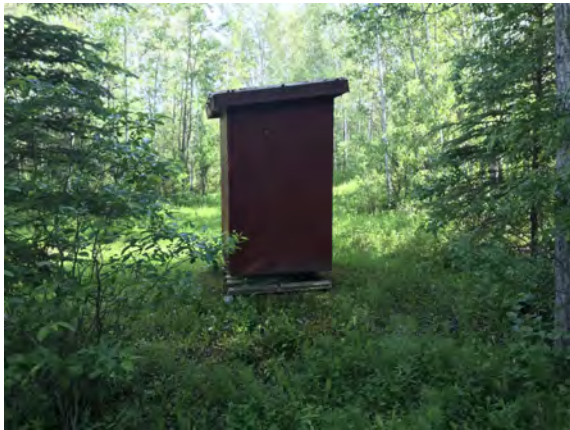
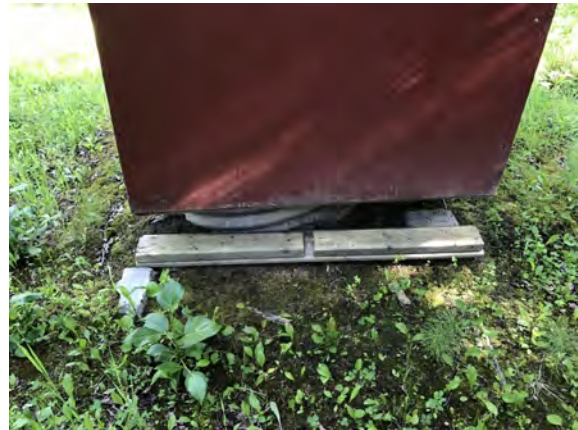
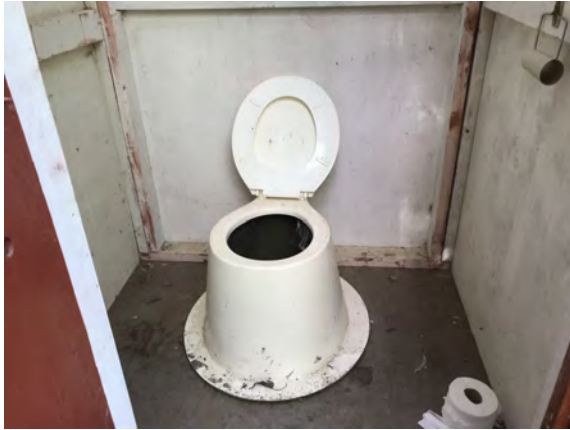
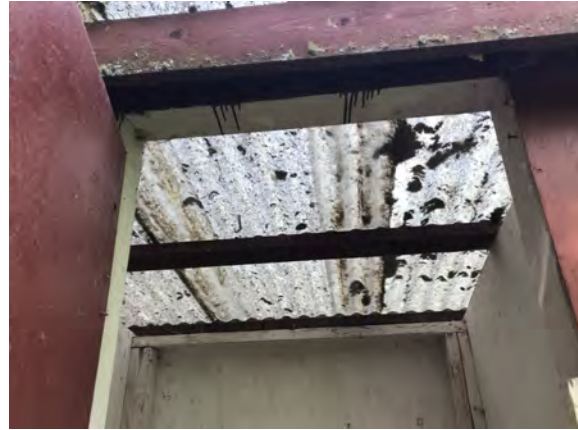
Element Description	
Name	G204099 - Other Site Development - Baseball Diamond Outhouses
Installation Year	2000
Condition	4 - Poor
Expected Useful Life	25 Years
Remaining Useful Life	0 Years
Renewal Year	2021
Quantity / Unit of Measure	2 / Lump Sum
Unit Cost	\$5,000.00
Difficulty / Regional / Soft Cost Factors	1.00 / 1.867 / 1
Replacement Cost	\$18,670.00

The ground has settled, displacing both outhouses and suspending them from grade. Wood framing and plywood cladding were deteriorated and rotting. It is understood that these outhouses are planned for removal, replacement, and relocation closer to the ball diamond, which is planned for 2021.

Recommendations #1 - Other Site Development	
Type	Life Cycle Replacement
Year	2021
Cost	\$18,670.00

Replace Other Site Development

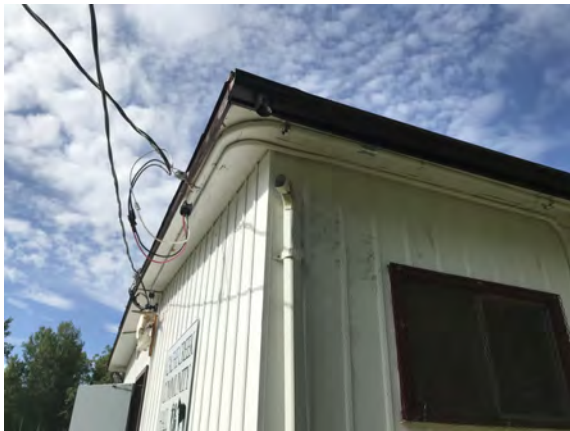
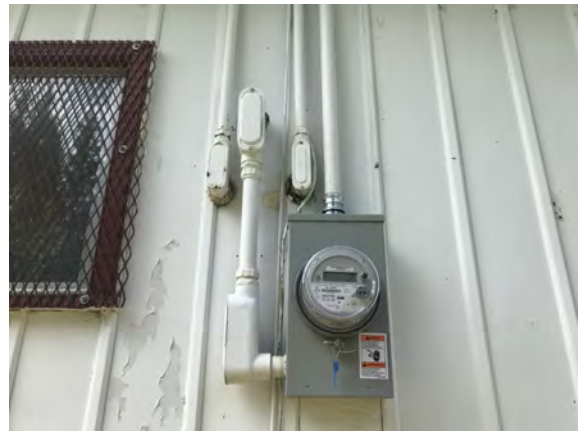
Element Description	
Name	G401011 - Electrical Service
Installation Year	2021
Condition	1 - Excellent
Expected Useful Life	50 Years
Remaining Useful Life	50 Years
Renewal Year	2071
Quantity / Unit of Measure	15 / LM
Unit Cost	\$655.00
Difficulty / Regional / Soft Cost Factors	1.00 / 1.867 / 1
Replacement Cost	\$18,343.28

No major deficiencies were observed or reported.

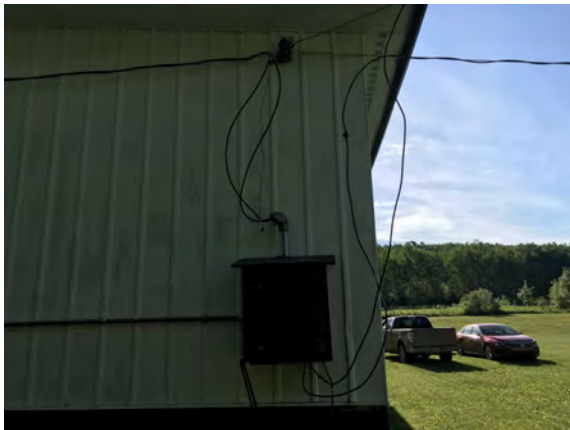
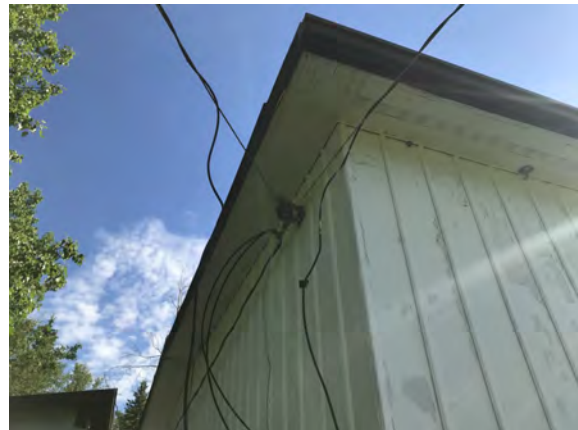
Element Description	
Name	G401021 - Site Branch Wiring and Devices
Installation Year	1987
Condition	4 - Poor
Expected Useful Life	40 Years
Remaining Useful Life	0 Years
Renewal Year	2021
Quantity / Unit of Measure	180 / LM
Unit Cost	\$65.00
Difficulty / Regional / Soft Cost Factors	1.00 / 1.867 / 1
Replacement Cost	\$21,843.90

Overhead wiring was not attached, tangled, and bunched. It is recommended to renew wiring at the time of the lifecycle replacement for the rink.

Recommendations #1 - Site Branch Wiring and Devices	
Type	Life Cycle Replacement
Year	2021
Cost	\$21,843.90

Replace Site Branch Wiring and Devices

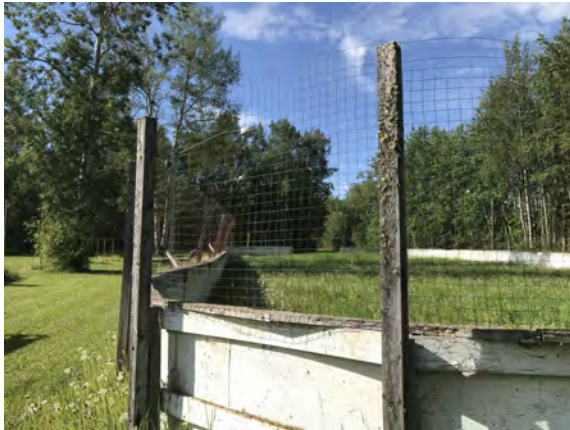
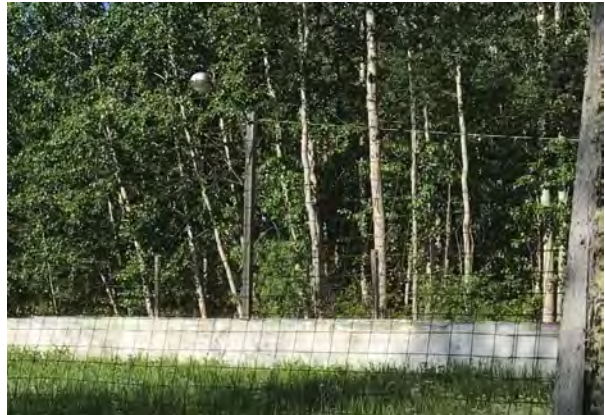
Element Description	
Name	G402016 - Pole Light Fixtures
Installation Year	1987
Condition	4 - Poor
Expected Useful Life	25 Years
Remaining Useful Life	0 Years
Renewal Year	2021
Quantity / Unit of Measure	6 / Each
Unit Cost	\$1,500.00
Difficulty / Regional / Soft Cost Factors	1.00 / 1.867 / 1
Replacement Cost	\$16,803.00

Lights are reportedly non-functional. It is recommended to replace the exterior lights at the time of lifecycle replacement for the skating rink.

Recommendations #1 - Pole Light Fixtures	
Type	Life Cycle Replacement
Year	2021
Cost	\$16,803.00

Replace Pole Light Fixtures
