Peace River Regional District

**Facility Condition Assessment Report
Golata Creek Community Hall**

November 18, 2021

Prepared by:
FCAPX a Division of Roth IAMS
Project No. 21075
www.fcapx.com

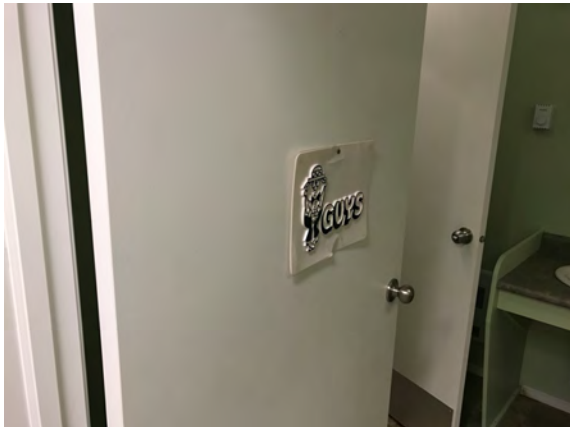
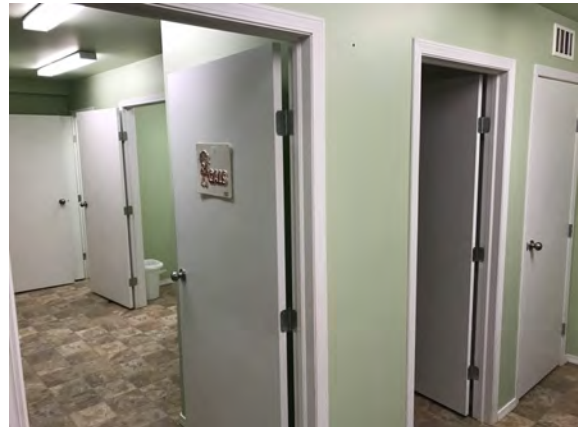
Golata Creek Community Hall - C102022

No major deficiencies were observed or reported during the assessment.

Replace Single Door - Wood

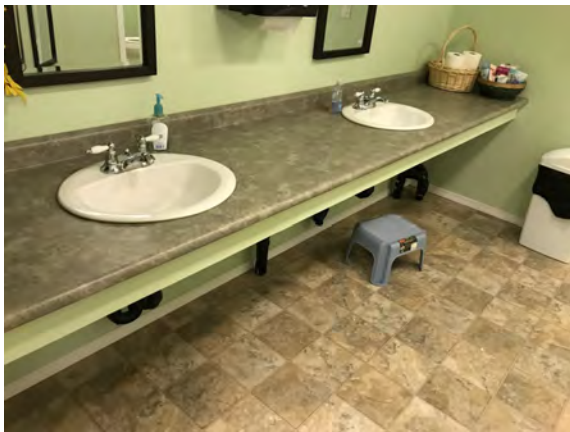
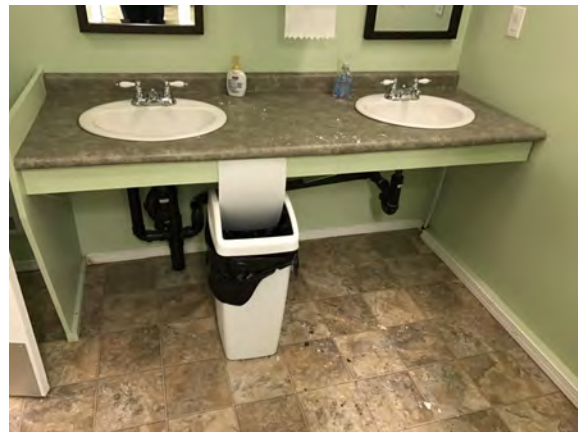
Golata Creek Community Hall - C103010

No major deficiencies were observed or reported during the assessment.

Replace Vanities

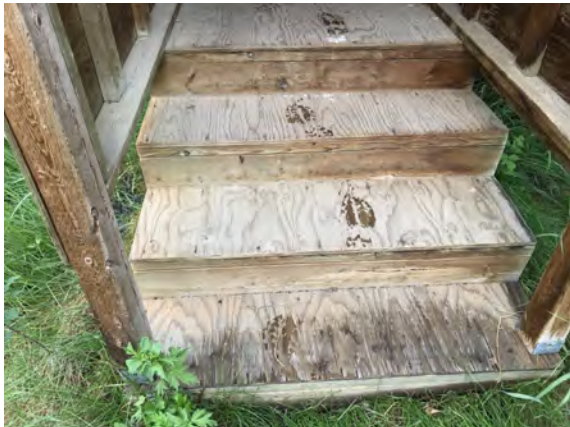
Golata Creek Community Hall - C201002

No major deficiencies were observed or reported during the assessment.

Replace Exterior Stair Construction

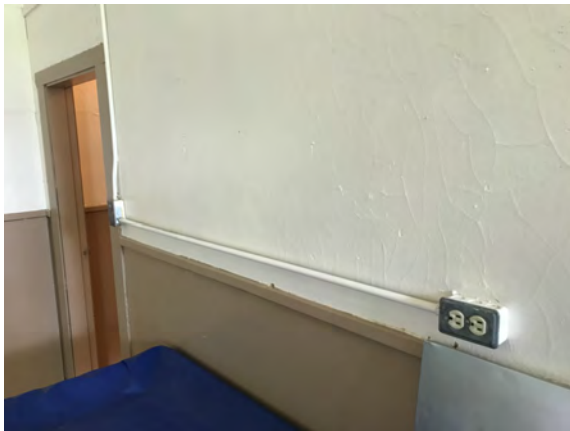
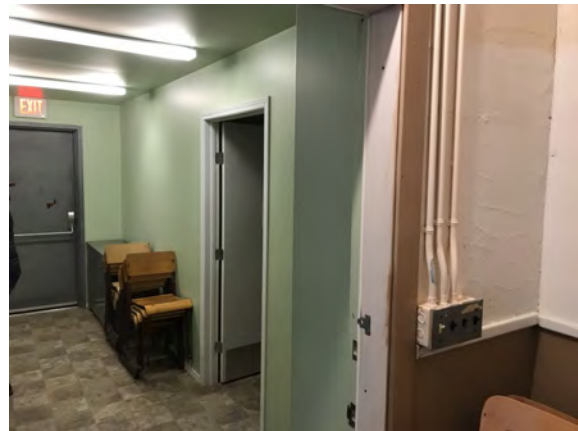
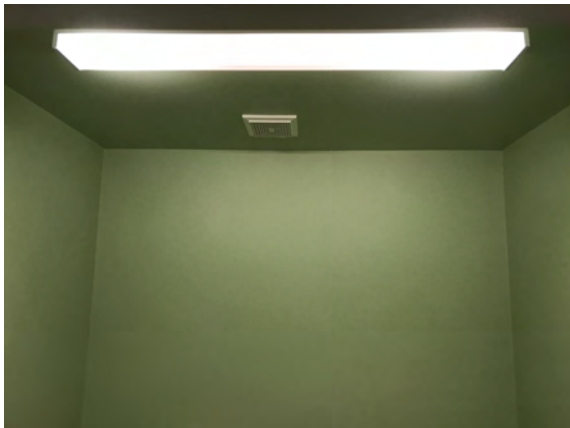
Golata Creek Community Hall - C301005

No major deficiencies were observed or reported during the assessment. The component has exceeded its expected useful life, although its remaining useful life has been extended to a later year due to the absence of significant observed or reported deficiencies.

Replace Paint Wall Covering

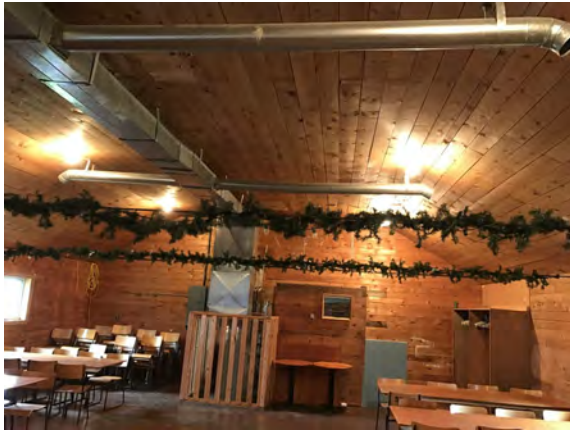
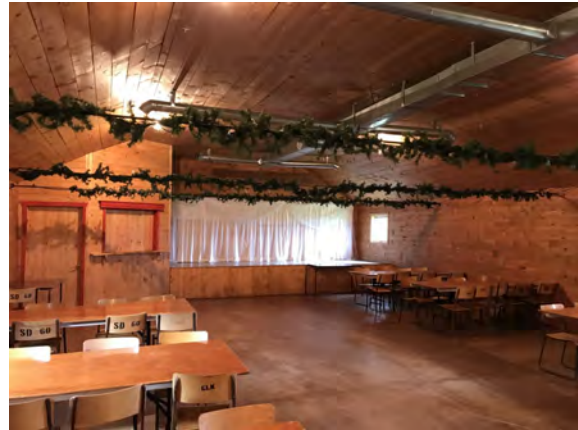
Golata Creek Community Hall - C301022

No major deficiencies were observed or reported during the assessment. The component will reach its expected useful life, although its remaining useful life has been extended to a later year due to the absence of significant observed or reported deficiencies.

Replace Wood Wall Finish

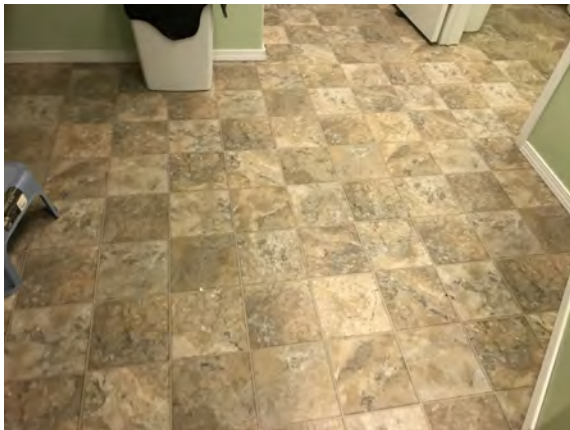
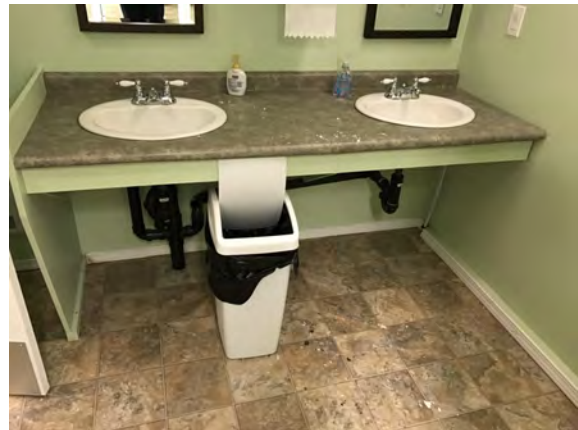
Golata Creek Community Hall - C302023

No major deficiencies were observed or reported during the assessment. The component will reach its expected useful life, although its remaining useful life has been extended to a later year due to the absence of significant observed or reported deficiencies.

Replace Vinyl Sheet Floor

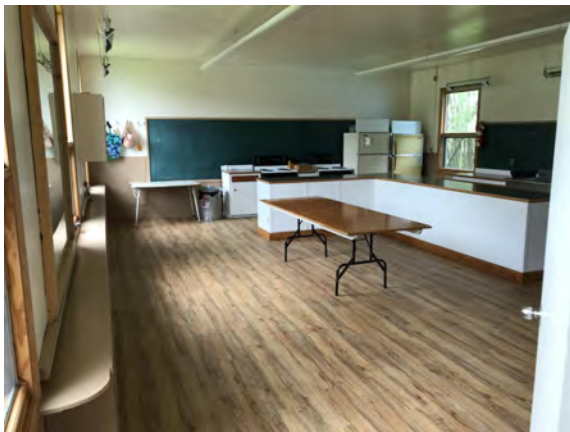
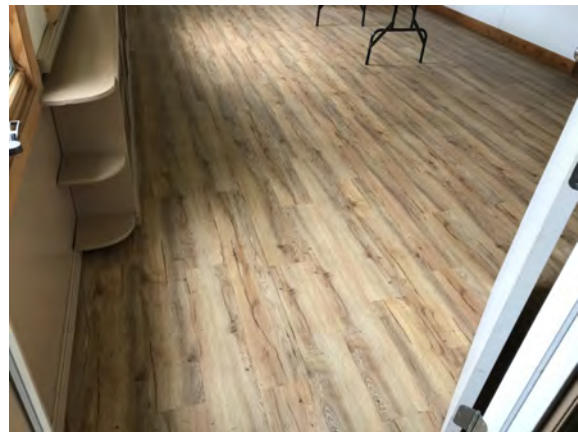
Golata Creek Community Hall - C302025

No major deficiencies were observed or reported during the assessment.

Replace Wood Laminate Floor

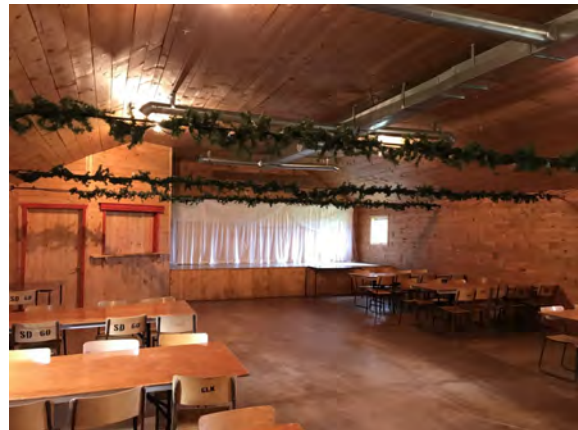
Golata Creek Community Hall - C302003

The flooring was observed to be worn. No major deficiencies were reported. The component has exceeded its expected useful life, although its remaining useful life has been extended to a later year due to the absence of significant observed or reported deficiencies.

Replace Wood Laminate Floor

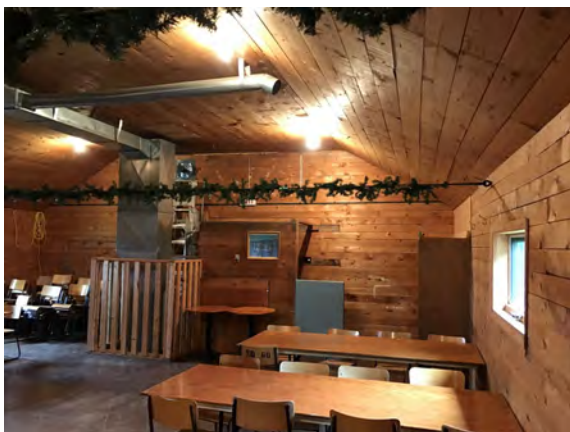
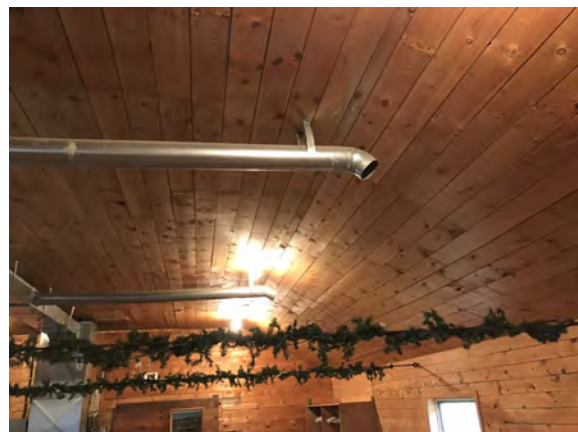
Golata Creek Community Hall - C303005

No major deficiencies were observed or reported during the assessment.

Replace Wood Ceiling

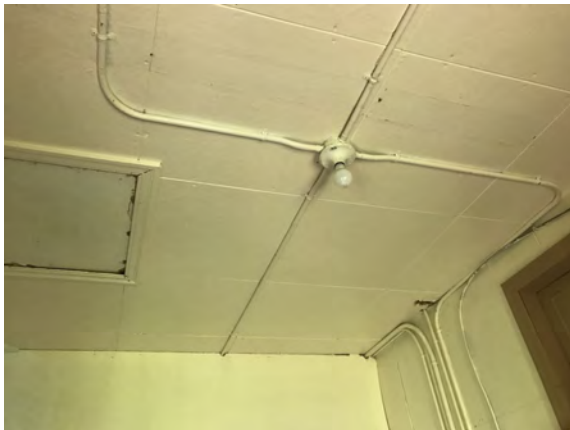
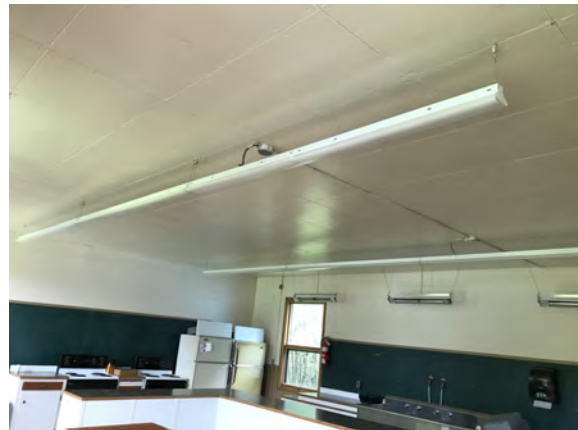
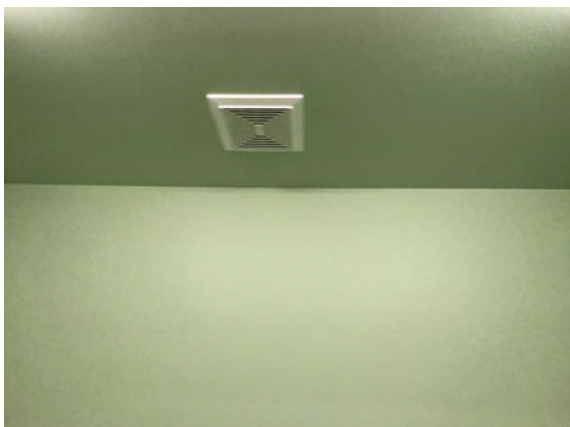
Golata Creek Community Hall - C303006

No major deficiencies were observed or reported during the assessment. The component will reach its expected useful life, although its remaining useful life has been extended to a later year due to the absence of significant observed or reported deficiencies.

Replace Painted Ceiling Structures

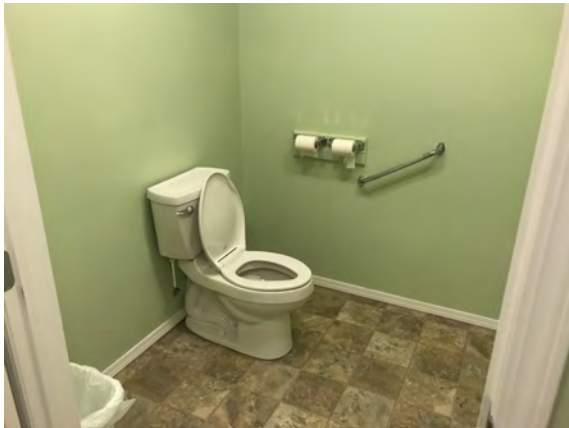
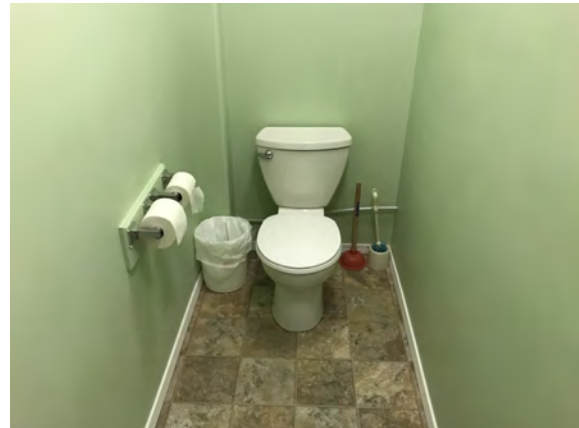
Golata Creek Community Hall - D201001

No major deficiencies were observed or reported during the assessment.

Replace Water Closets

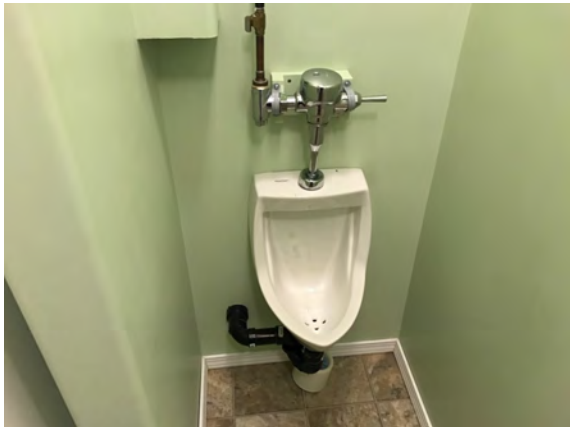
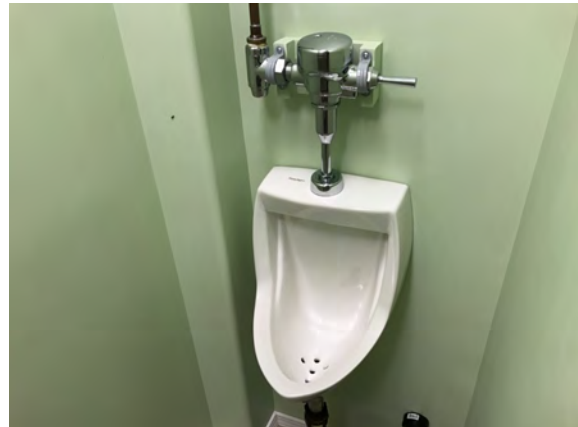
Golata Creek Community Hall - D201002

No major deficiencies were observed or reported during the assessment.

Replace Urinals

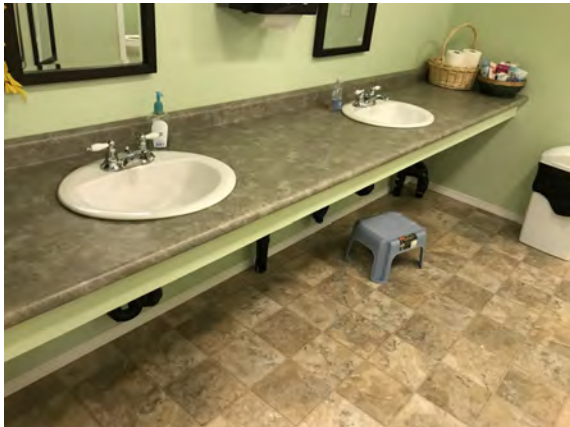
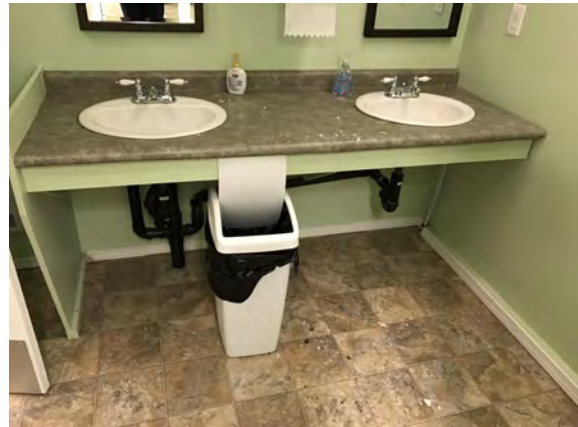
Golata Creek Community Hall - D201003

No major deficiencies were observed or reported during the assessment.

Replace Lavatories

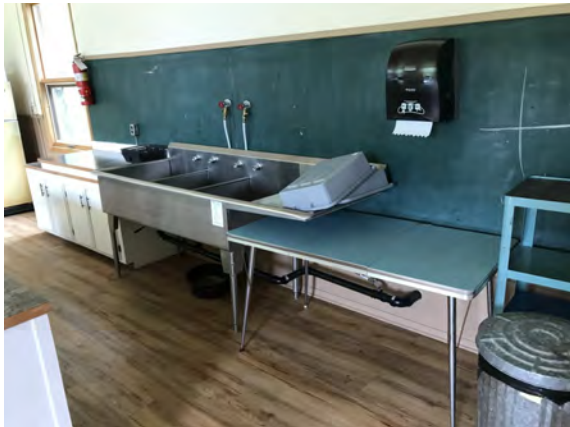
Golata Creek Community Hall - D201043

No major deficiencies were observed or reported during the assessment. The difficulty factor has been increased based on the sink design.

Replace Commercial Kitchen Sinks

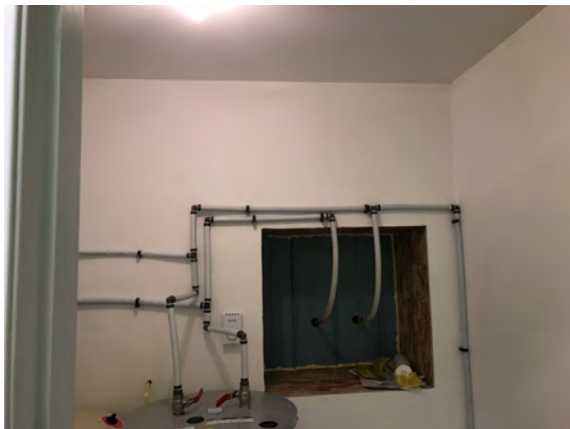
Golata Creek Community Hall - D202001

No major deficiencies were observed or reported during the assessment.

Replace Domestic Water Pipes and Fittings

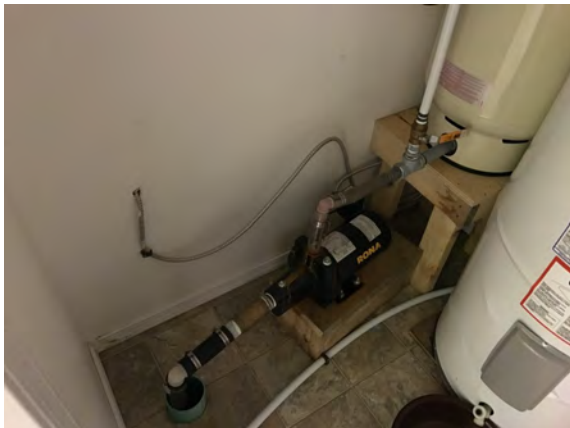
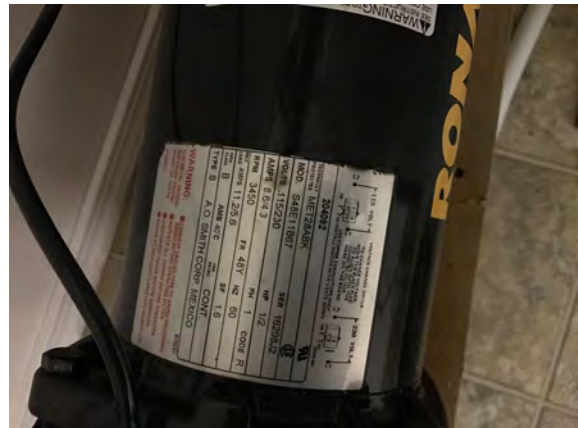
Golata Creek Community Hall - D202006

The pump is non-functioning. Replacement is recommended. The difficulty factor has been adjusted to reflect the size of the pump.

Replace Domestic Water Booster Systems/Pumps

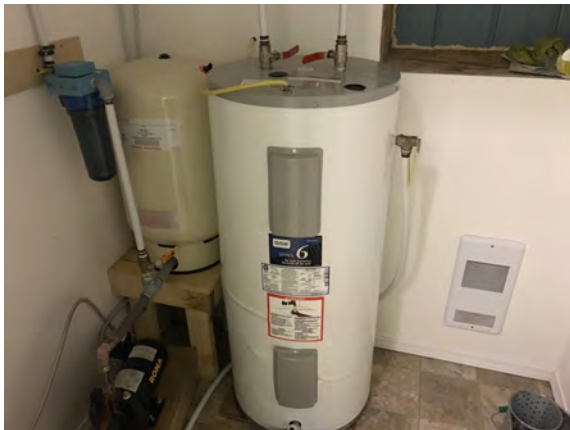
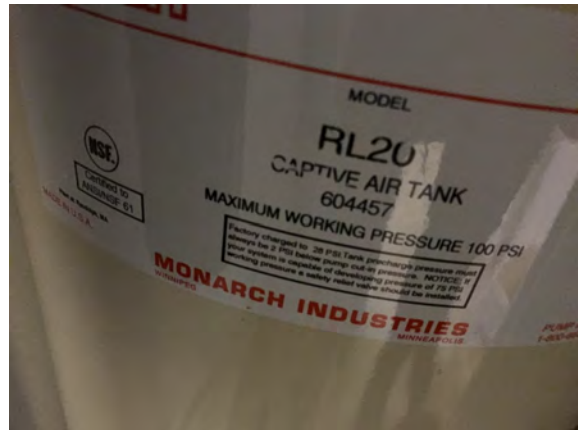
Golata Creek Community Hall - D202006

No major deficiencies were observed or reported during the assessment. The difficulty factor has been decreased as the equipment is residential-grade.

Replace Domestic Water Expansion Tanks/Pressure Tank

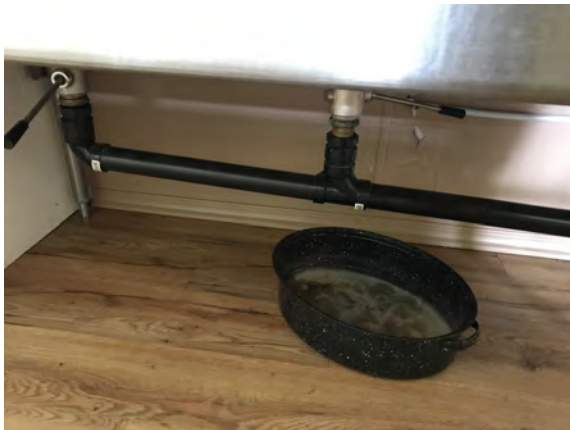
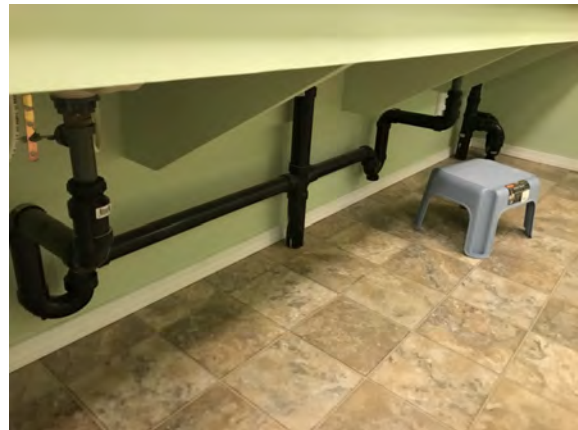
Golata Creek Community Hall - D203001

No major deficiencies were observed or reported during the assessment.

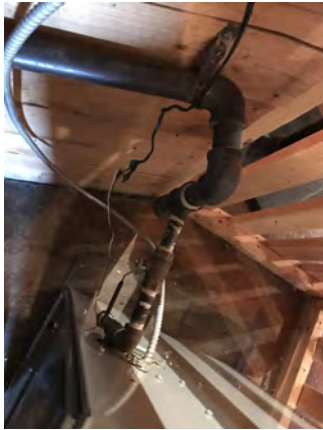
Golata Creek Community Hall - D301002

No major deficiencies were observed or reported during the assessment.

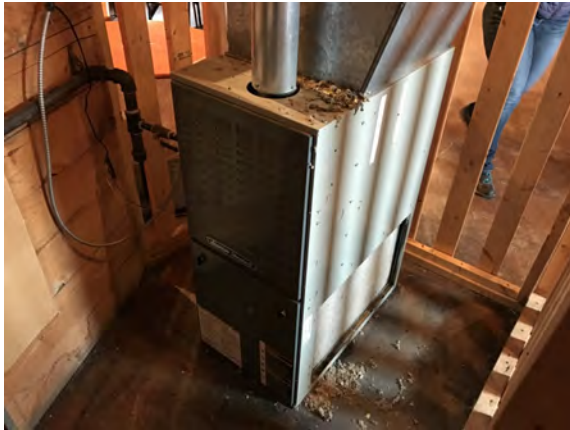
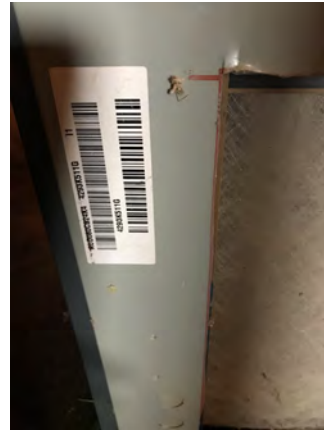
Golata Creek Community Hall - D305011

No major deficiencies were observed or reported during the assessment.

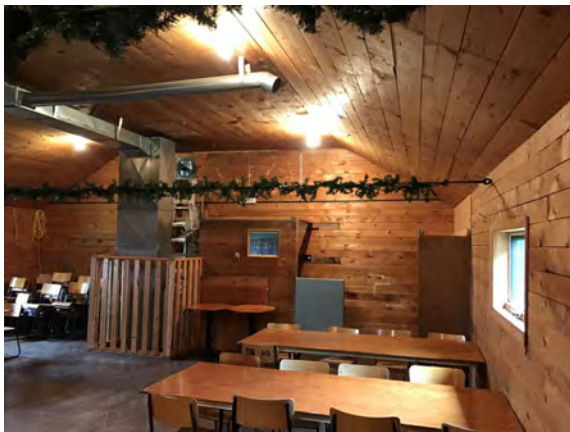
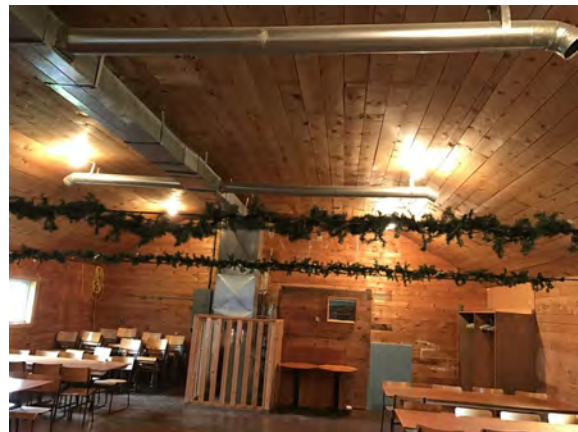
Golata Creek Community Hall - D304001

No major deficiencies were observed or reported during the assessment.

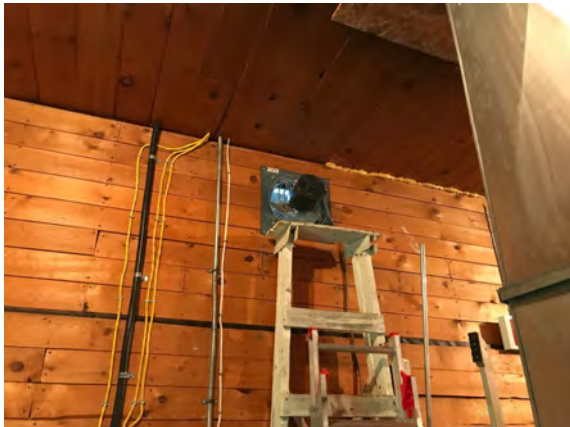
Golata Creek Community Hall - D304031

No major deficiencies were observed or reported during the assessment.

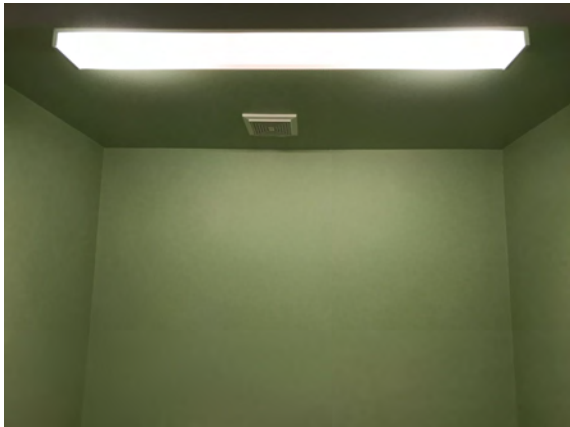
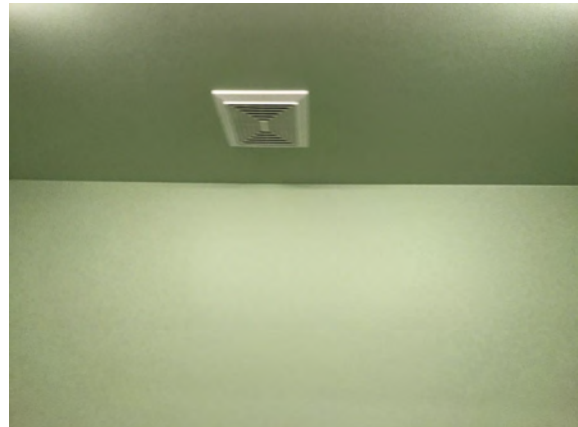
Golata Creek Community Hall - D304033

No major deficiencies were observed or reported during the assessment.

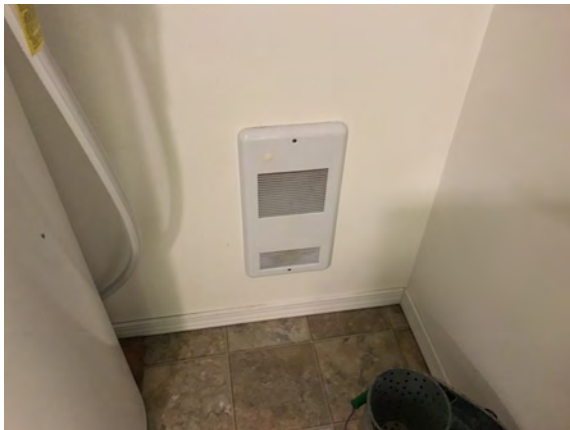
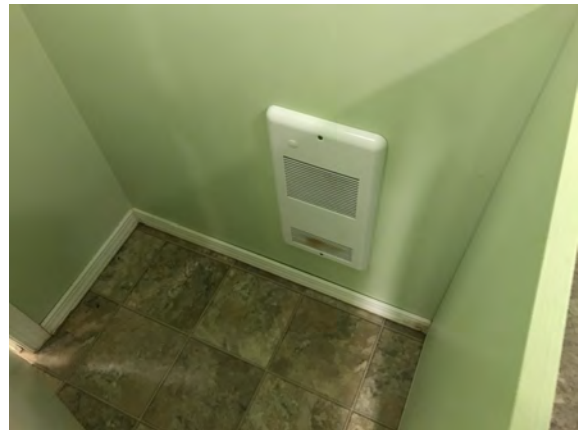
Golata Creek Community Hall - D305008

No major deficiencies were observed or reported during the assessment. Lifecycle replacement has been deferred due to the absence of major deficiencies.

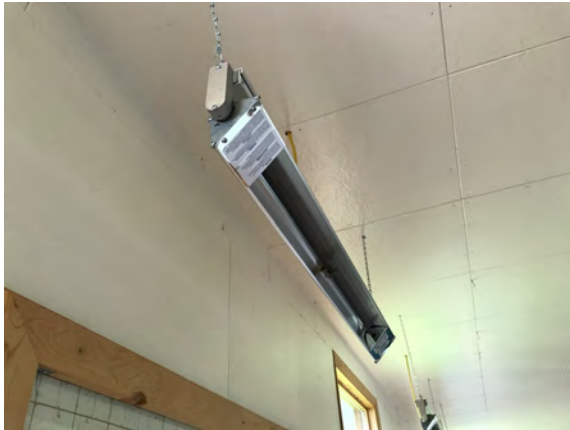
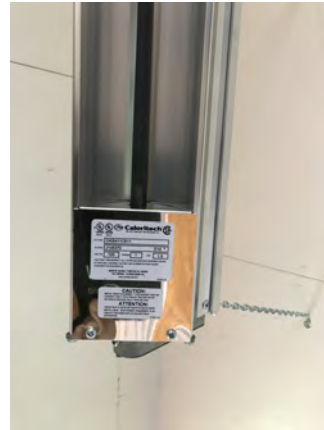
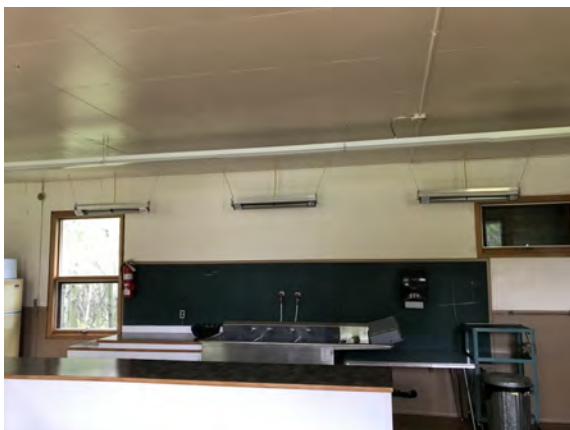
Golata Creek Community Hall - D305008

No major deficiencies were observed or reported during the assessment. Difficulty factor adjusted for heater style.

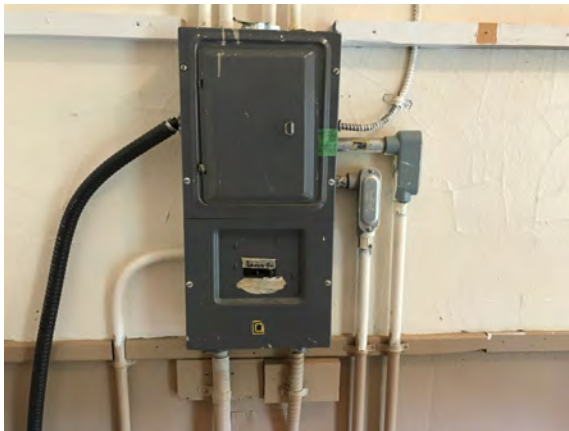
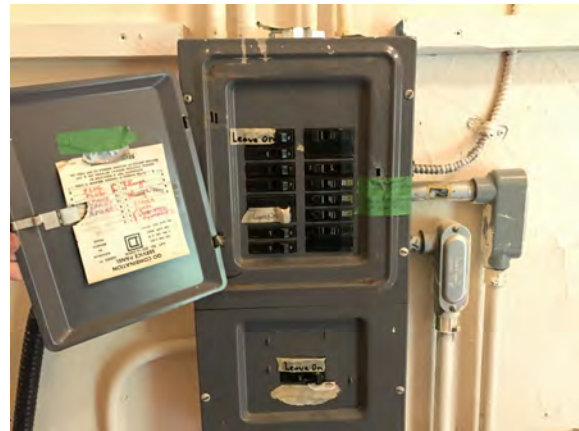
Golata Creek Community Hall - D501005

No major deficiencies were observed or reported during the assessment. Replacement has been differed.

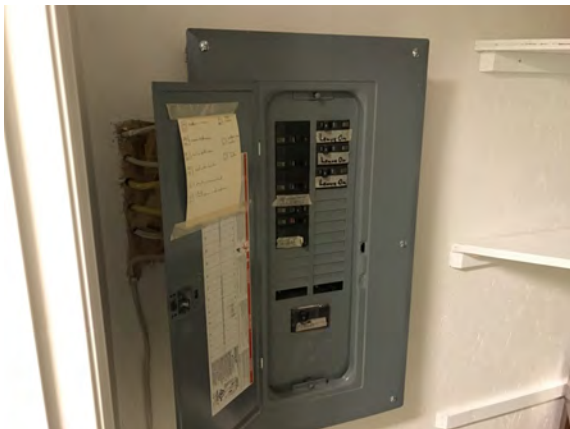
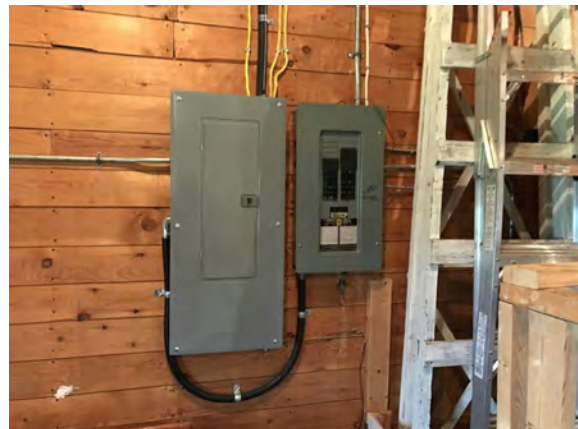
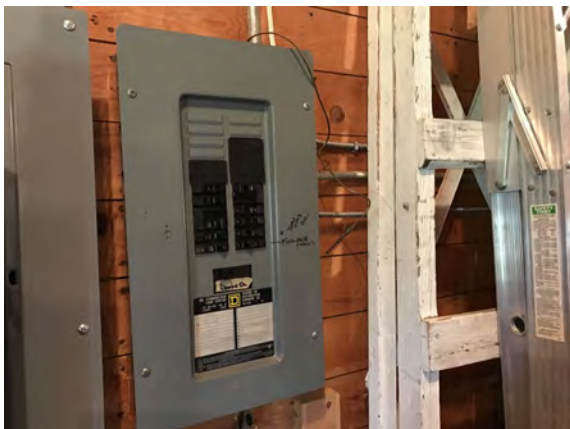
Golata Creek Community Hall - D501033

No major deficiencies were observed or reported during the assessment.

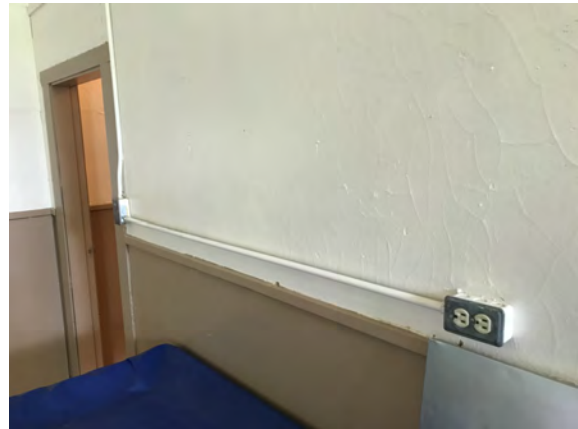
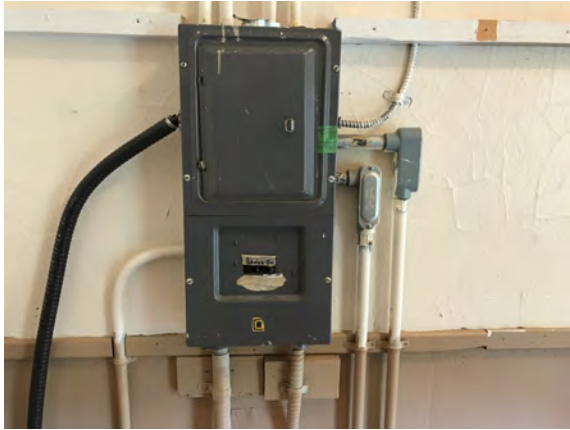
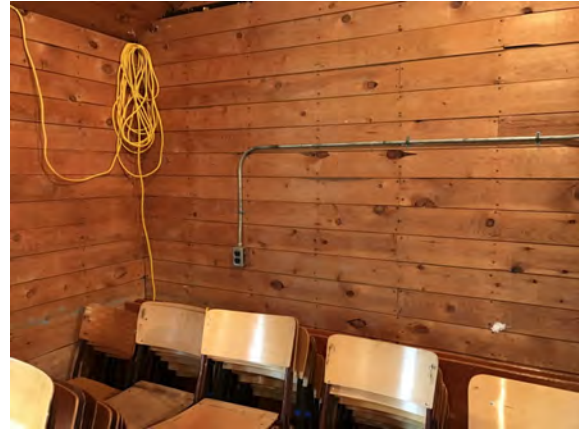
Golata Creek Community Hall - D502001

No major deficiencies were observed or reported during the assessment. Exposed wiring in the exterior canopy, install exterior junction box as part of maintenance.

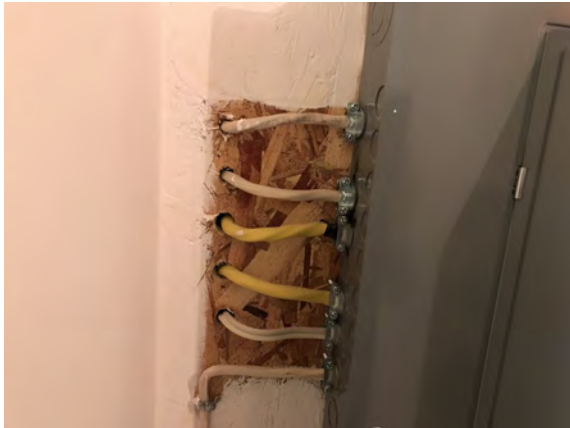
Golata Creek Community Hall - D502001

No major deficiencies were observed or reported during the assessment.

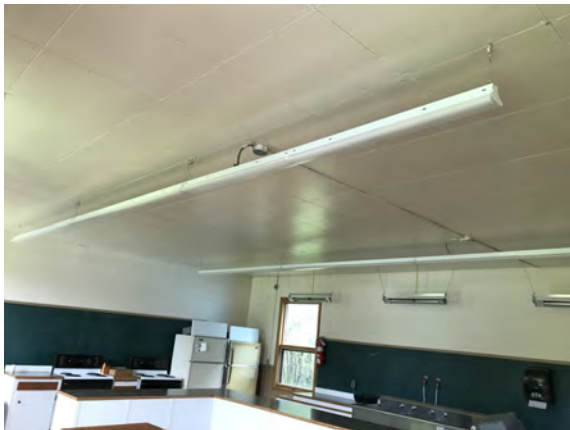
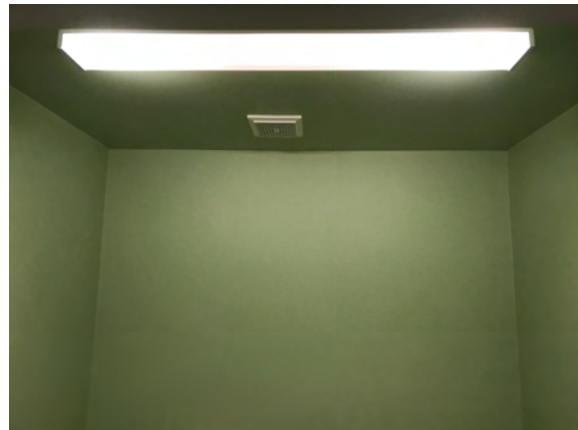
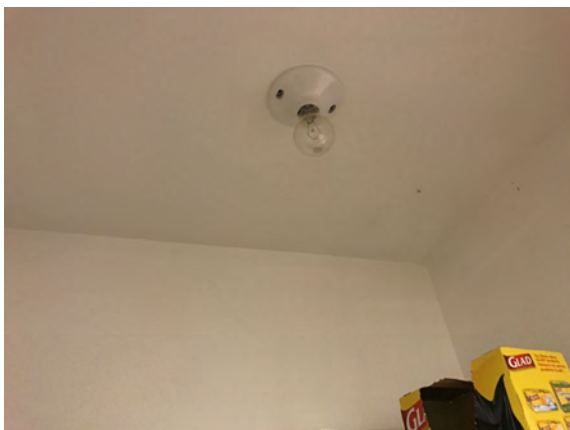
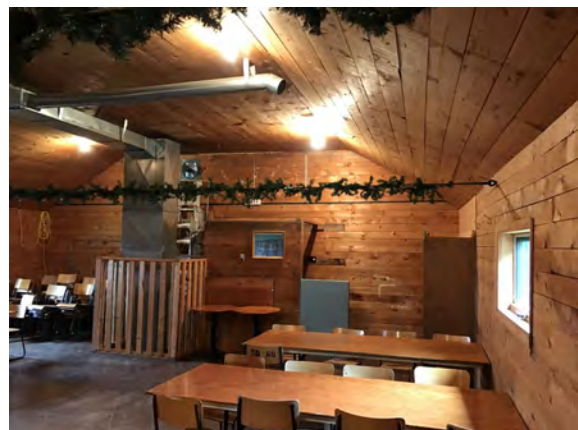
Golata Creek Community Hall - D502002

No major deficiencies were observed or reported during the assessment.

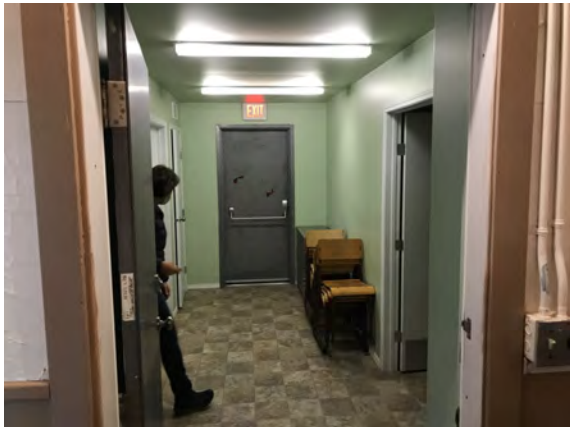
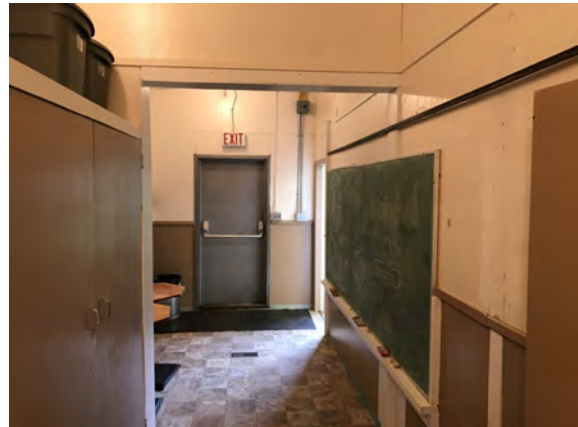
Golata Creek Community Hall - D502051

No major deficiencies were observed or reported during the assessment.

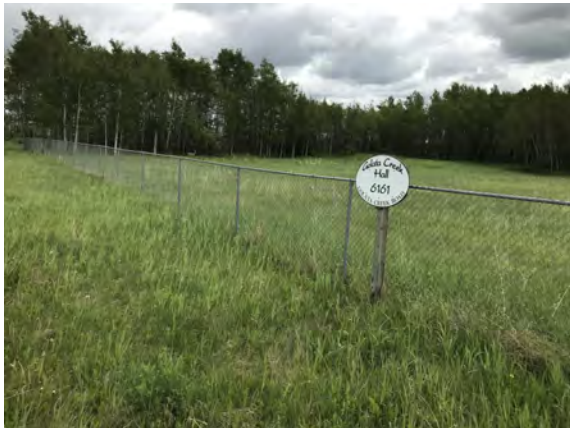
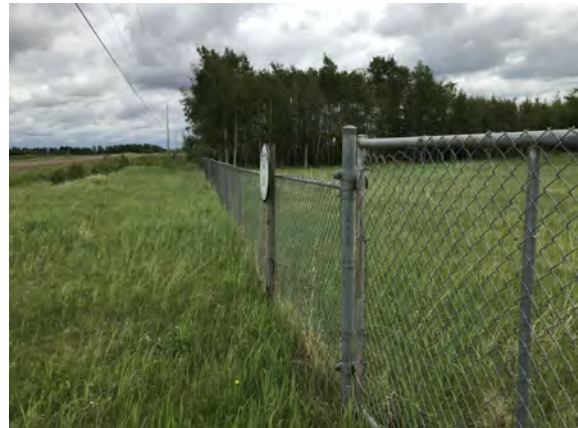
Golata Creek Community Hall - G204021

No major deficiencies were observed or reported during the assessment.

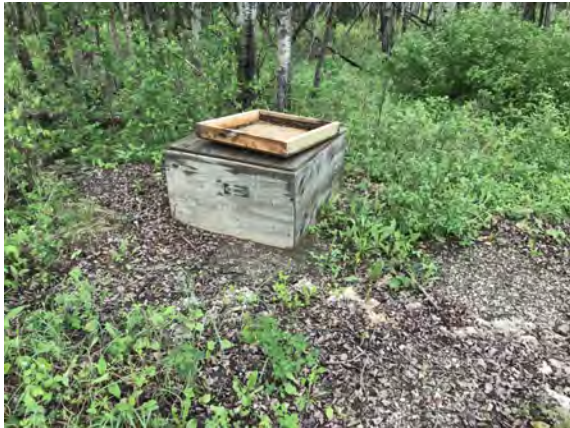
Golata Creek Community Hall - G301001

No major deficiencies were observed or reported during the assessment. The difficulty factor has been adjusted to reflect the presumed smaller size of well.

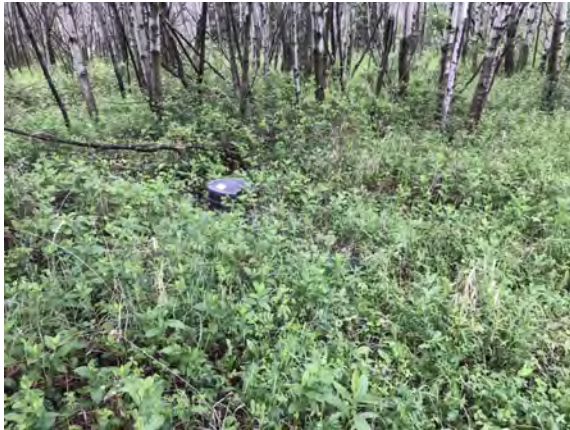
Golata Creek Community Hall - G302016

No major deficiencies were observed or reported during the assessment.

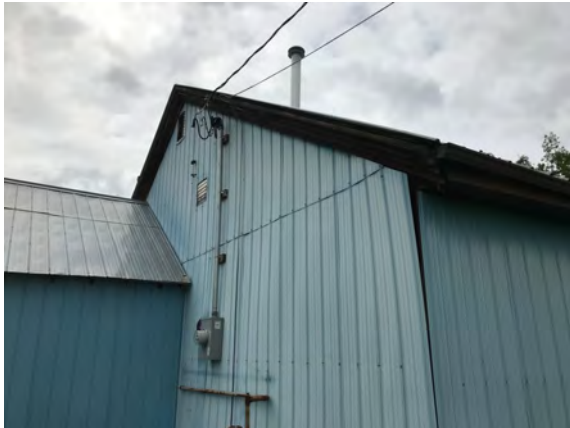
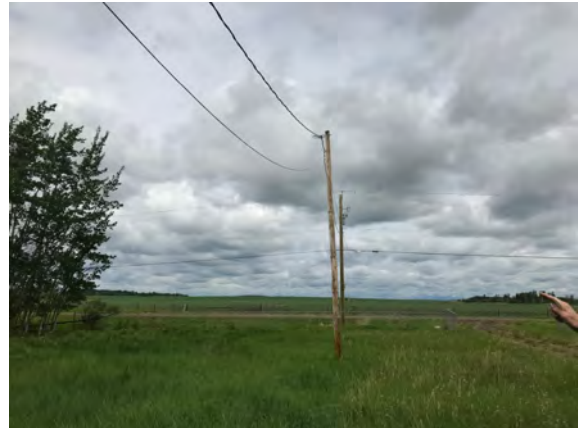
Golata Creek Community Hall - G401011

No major deficiencies were observed or reported during the assessment.
