**Peace River Regional District**

**Facility Condition Assessment Report  
North Peace Fall Fair Grounds**

**November 18, 2021**

Prepared by:  
FCAPX a Division of Roth IAMS  
Project No. 21075  
[www.fcapx.com](http://www.fcapx.com)

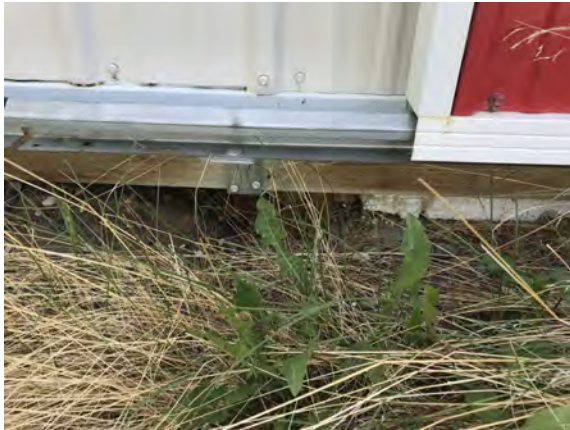
North Peace Fair Grounds - Adeline Kelly Exhibit -  
A101001

No major deficiencies were observed or reported during the assessment. Difficulty factor adjusted to reflect size of foundation.

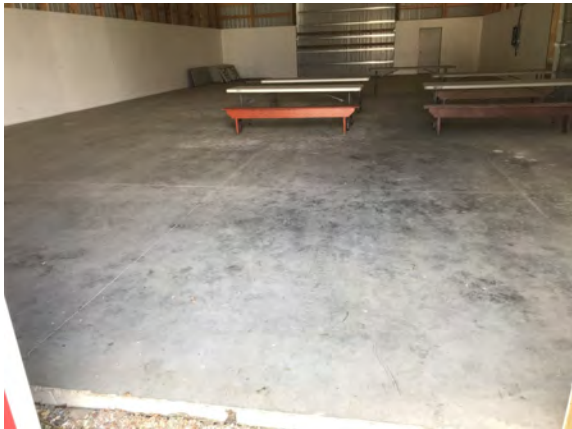
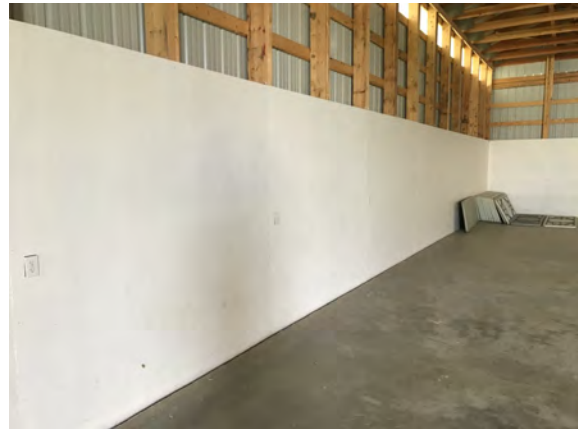
North Peace Fair Grounds - Adeline Kelly Exhibit -  
A103001

No major deficiencies were observed or reported during the assessment.

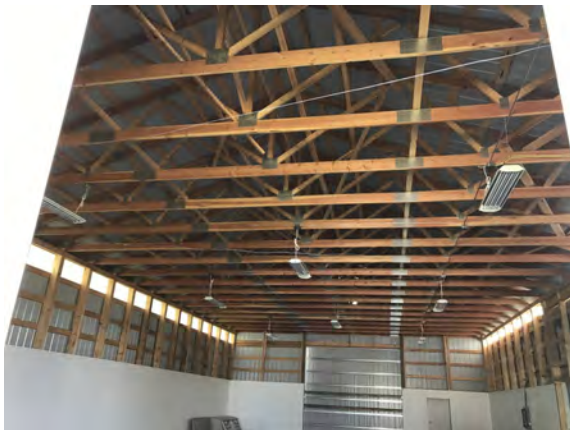
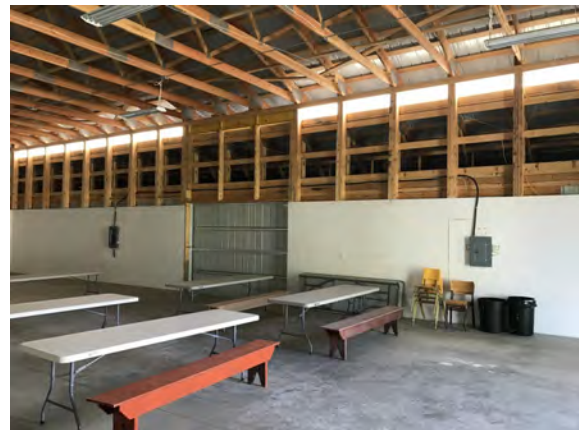
North Peace Fair Grounds - Adeline Kelly Exhibit - B103001

No major deficiencies were observed or reported during the assessment.

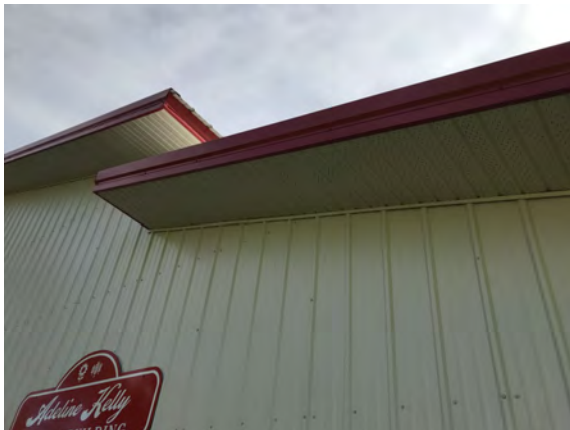
North Peace Fair Grounds - Adeline Kelly Exhibit -  
B201008

No major deficiencies were observed or reported during the assessment.

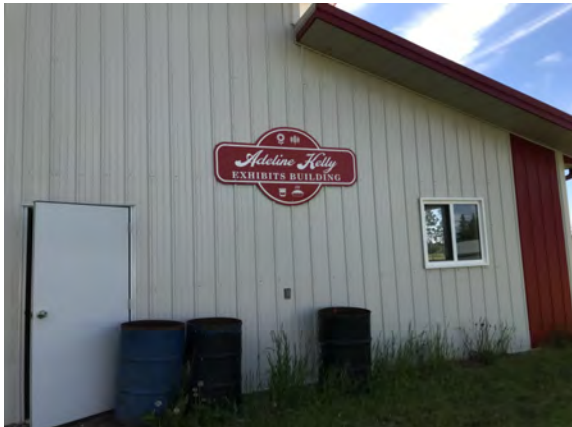
North Peace Fair Grounds - Adeline Kelly Exhibit - B201024

No major deficiencies were observed or reported during the assessment.

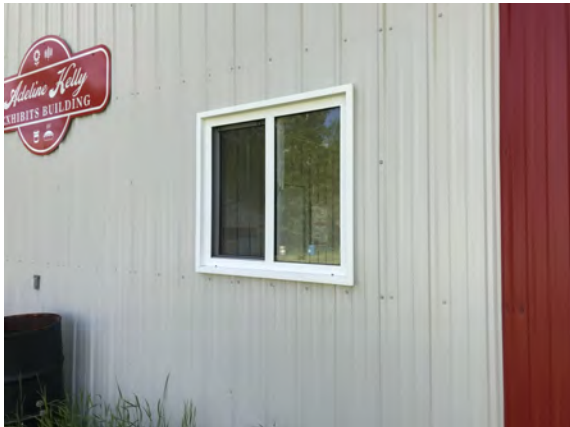
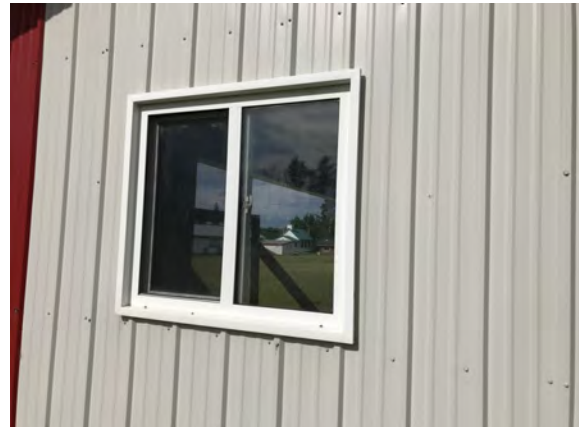
North Peace Fair Grounds - Adeline Kelly Exhibit - B202001

No major deficiencies were observed or reported during the assessment.

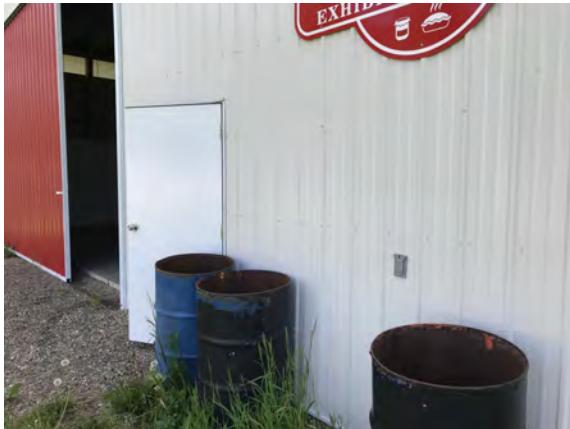
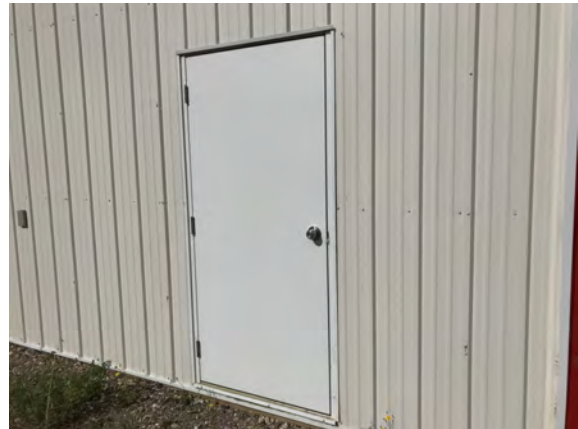
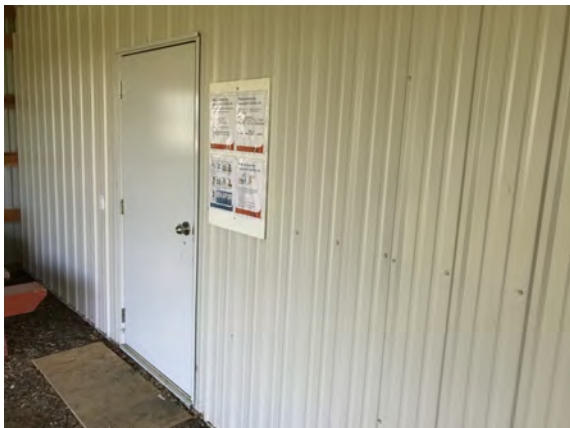
North Peace Fair Grounds - Adeline Kelly Exhibit - B203023

No major deficiencies were observed or reported during the assessment.

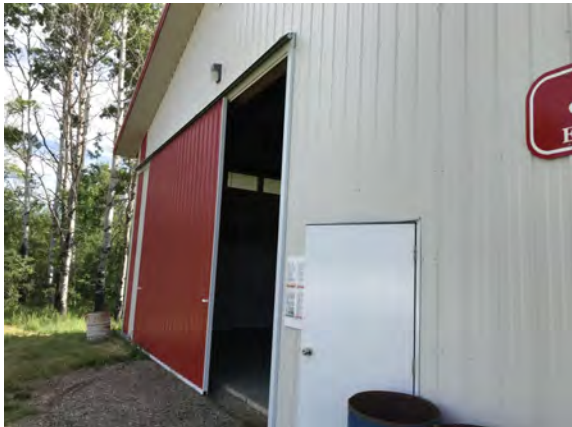
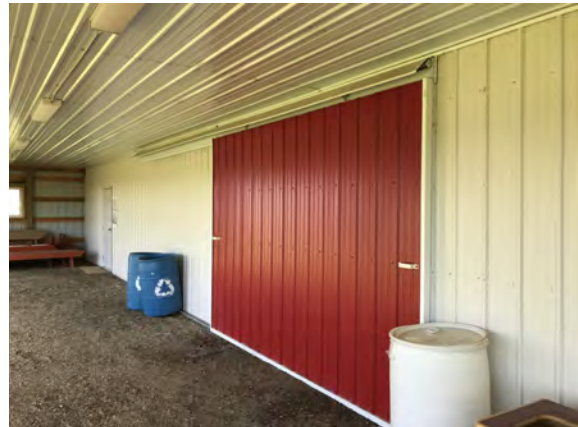
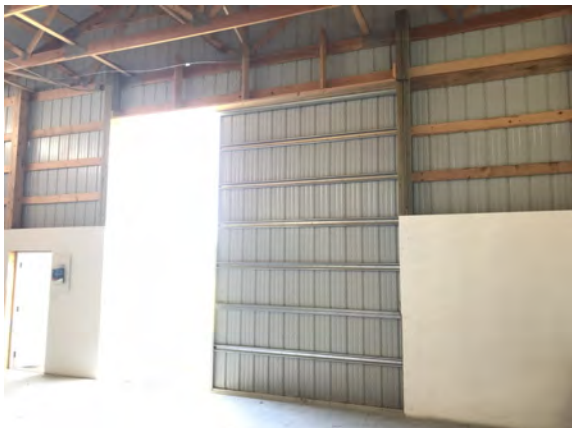
North Peace Fair Grounds - Adeline Kelly Exhibit - B203099

No major deficiencies were observed or reported during the assessment.

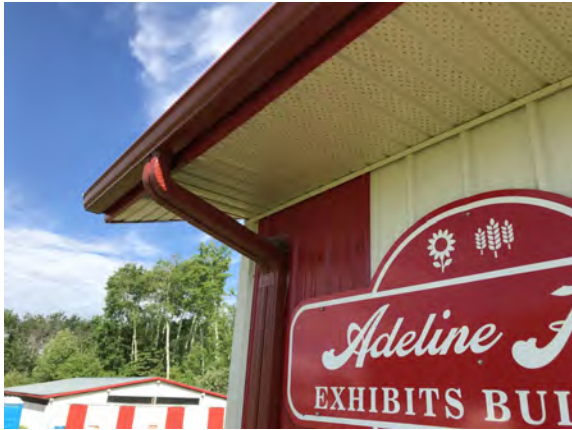
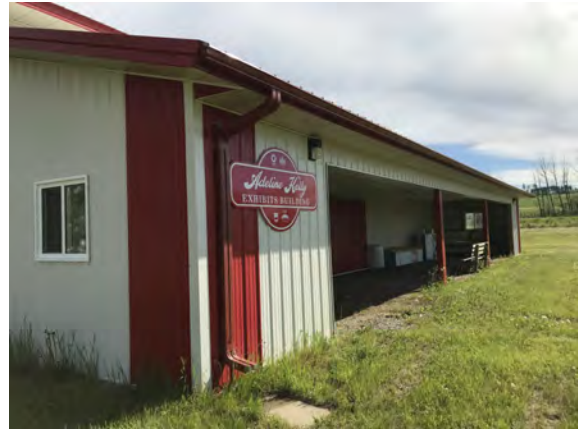
North Peace Fair Grounds - Adeline Kelly Exhibit - B301005

No major deficiencies were observed or reported during the assessment.

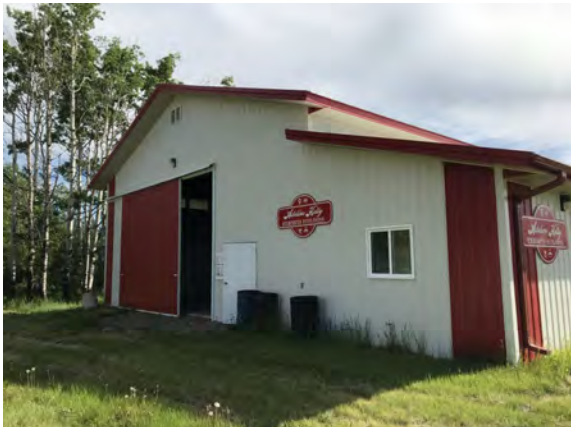
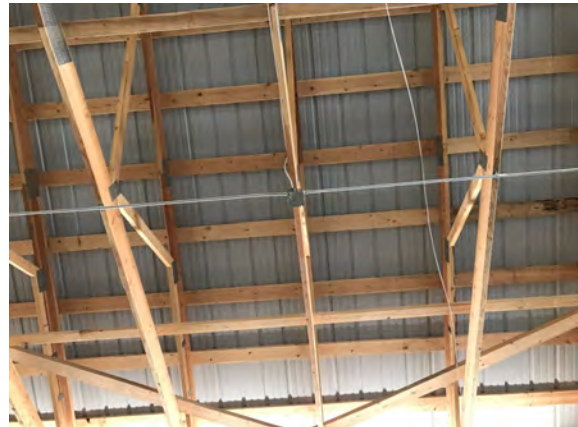
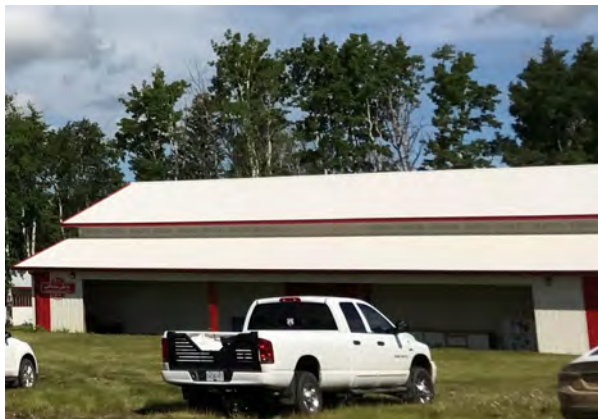
North Peace Fair Grounds - Adeline Kelly Exhibit - B301028

No major deficiencies were observed or reported during the assessment.

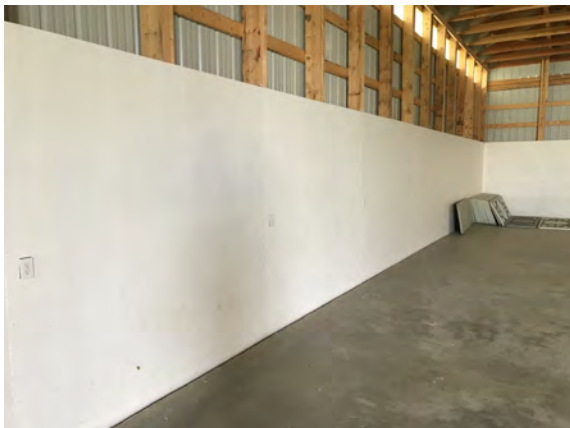
North Peace Fair Grounds - Adeline Kelly Exhibit -  
C301005

No major deficiencies were observed or reported during the assessment. The difficulty factor has been decreased based on coverage area of the wall finish.

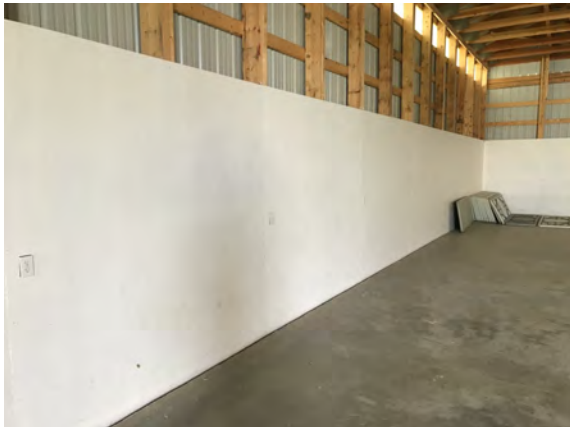
North Peace Fair Grounds - Adeline Kelly Exhibit -  
C301022

No major deficiencies were observed or reported during the assessment. The difficulty factor has been lowered based on the finish quality.

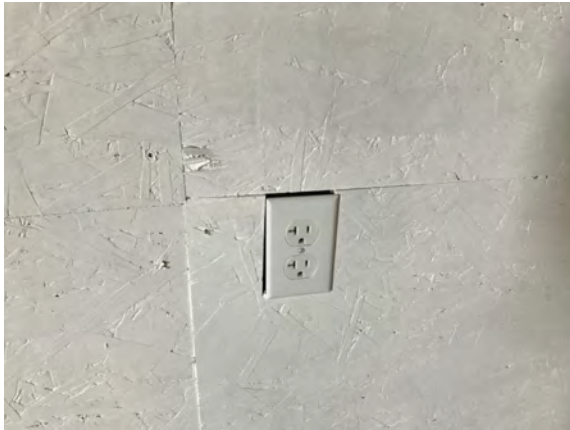
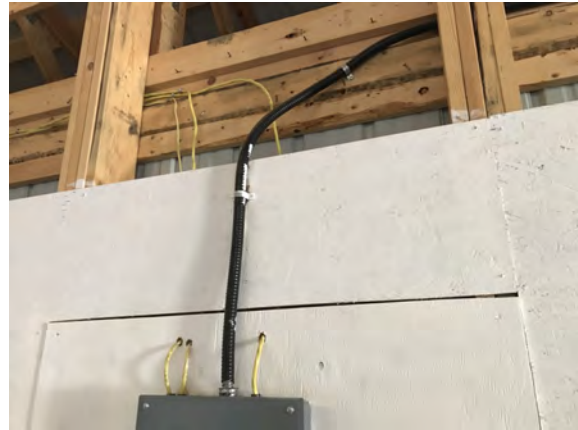
North Peace Fair Grounds - Adeline Kelly Exhibit -  
D502001

No major deficiencies were observed or reported during the assessment.

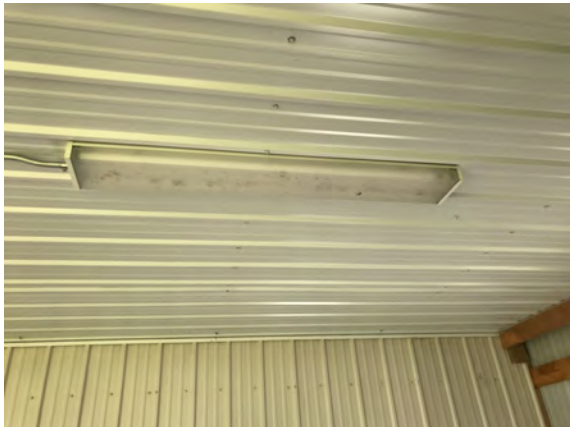
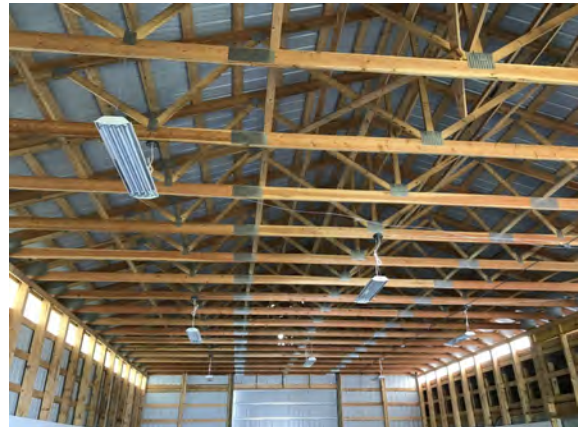
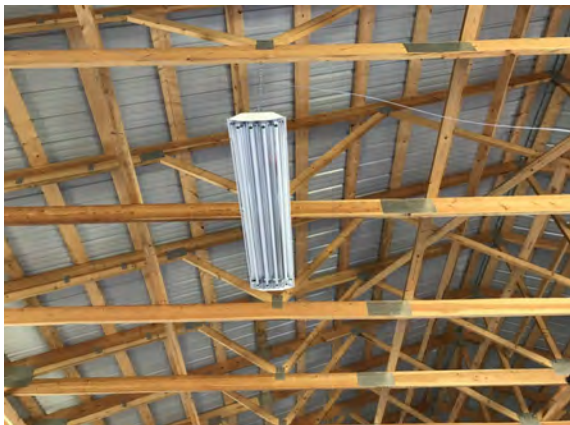
North Peace Fair Grounds - Adeline Kelly Exhibit - D502002

No major deficiencies were observed or reported during the assessment.

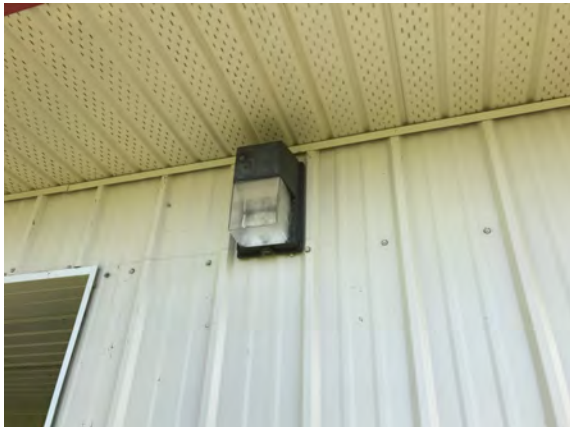
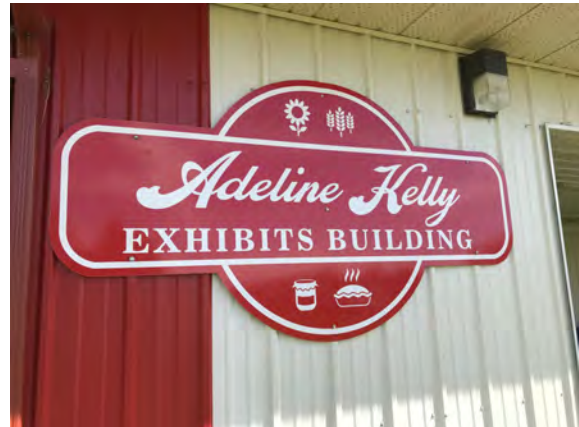
North Peace Fair Grounds - Adeline Kelly Exhibit - D502041

No major deficiencies were observed or reported during the assessment.

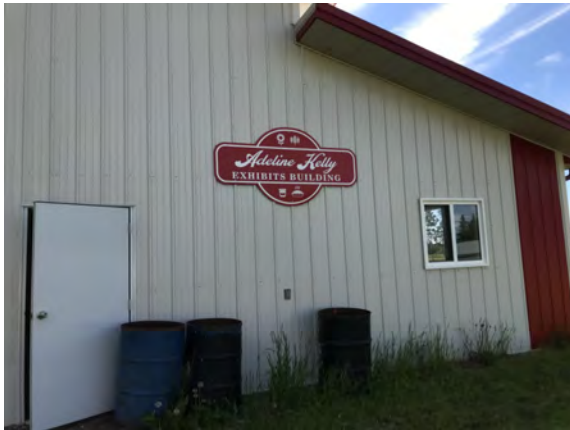
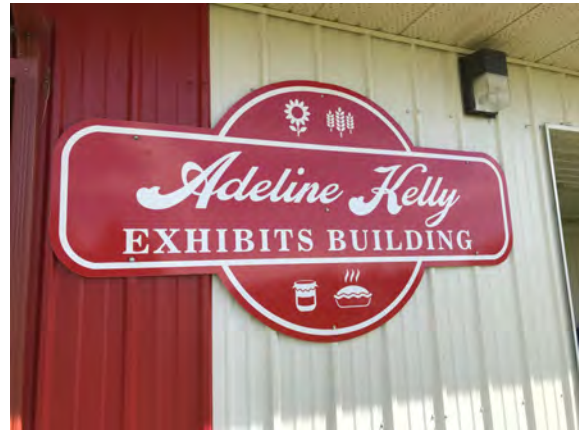
North Peace Fair Grounds - Adeline Kelly Exhibit - G204081

No major deficiencies were observed or reported during the assessment.

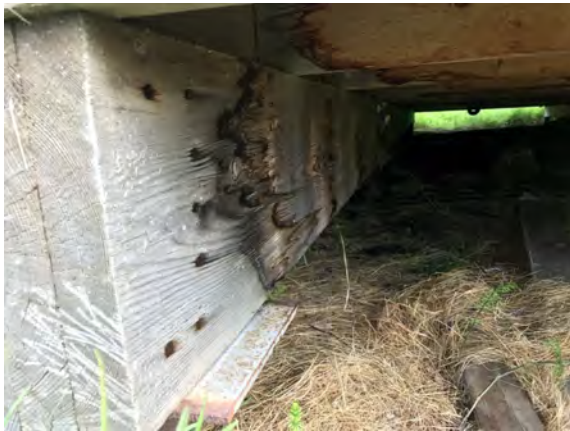
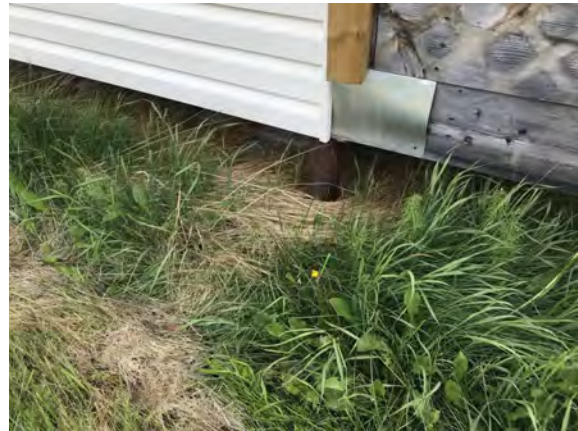
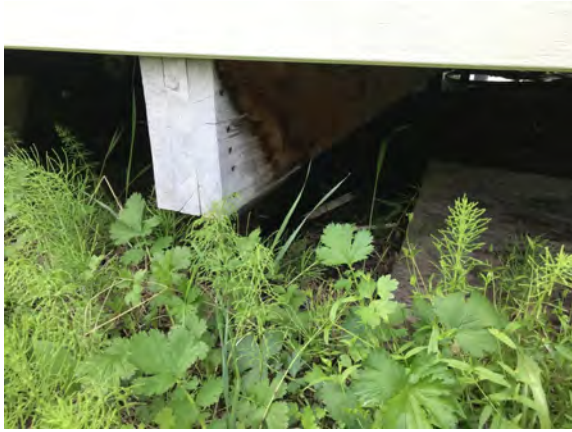
North Peace Fair Grounds - Washroom Building -  
A101001

No major deficiencies were observed or reported during the assessment. Difficulty factor adjusted to reflect size of foundation.

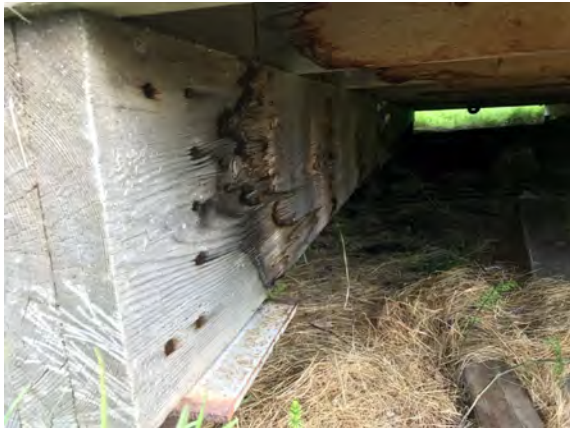
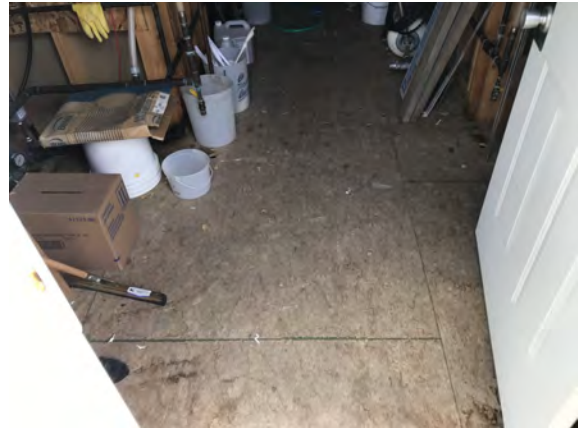
North Peace Fair Grounds - Washroom Building -  
 B101001

No major deficiencies were observed or reported during the assessment. However, weathered wood surfaces were noted at the edges of wood beams that are exposed to sunlight and external elements. The exposed wood surfaces are recommended to be sealed / stained periodically as a maintenance activity to preserve the condition of wood surfaces.

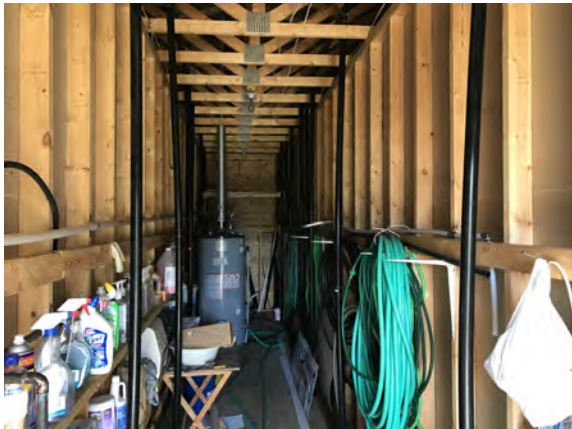
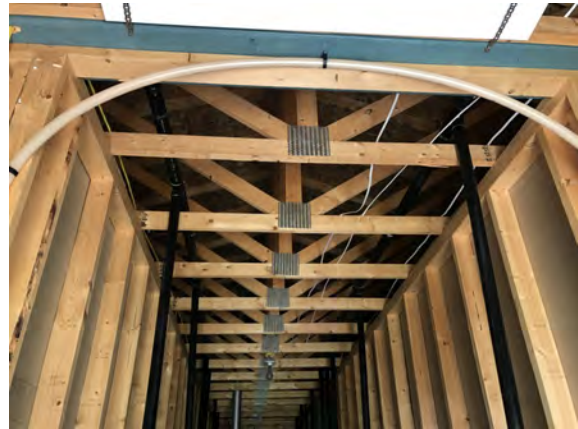
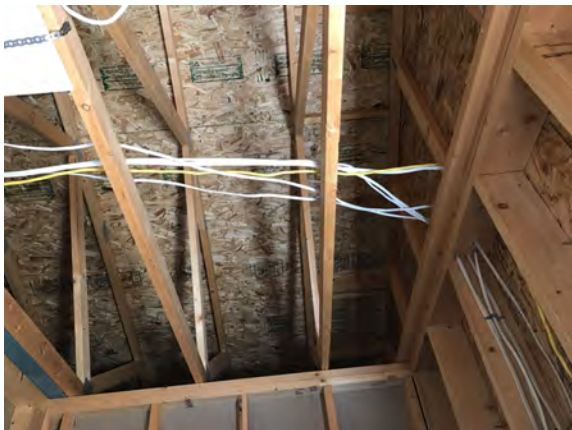
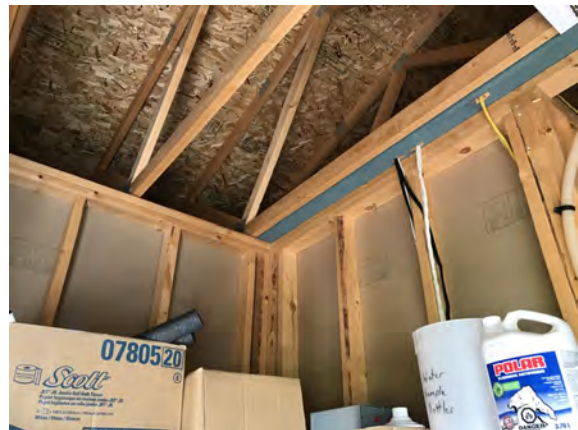
North Peace Fair Grounds - Washroom Building - B103001

No major deficiencies were observed or reported during the assessment.

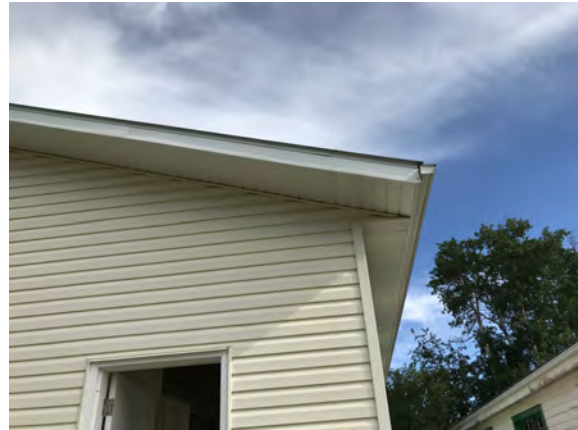
North Peace Fair Grounds - Washroom Building - B201025

No major deficiencies were observed or reported during the assessment. The component has achieved its expected useful life, although its remaining useful life has been extended to a later year due to the absence of significant observed or reported deficiencies.

<b>Recommendations #1 - Vinyl Siding</b>	
Type	Life Cycle Replacement
Year	2027
Cost	\$26,660.76

Replace Vinyl Siding

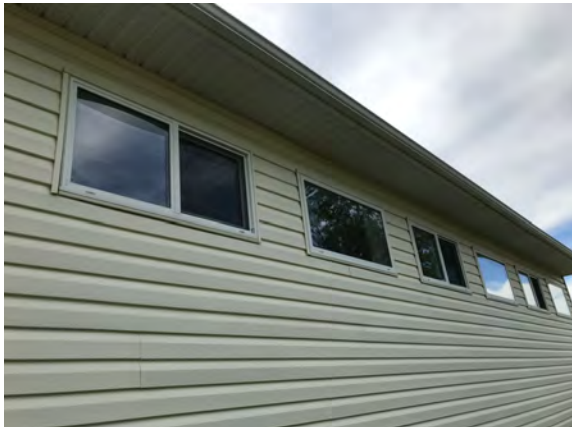
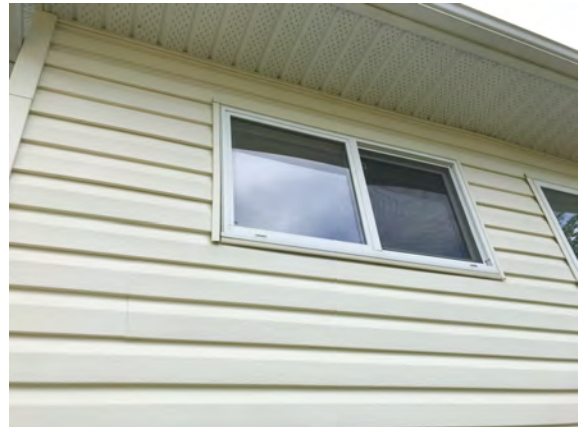
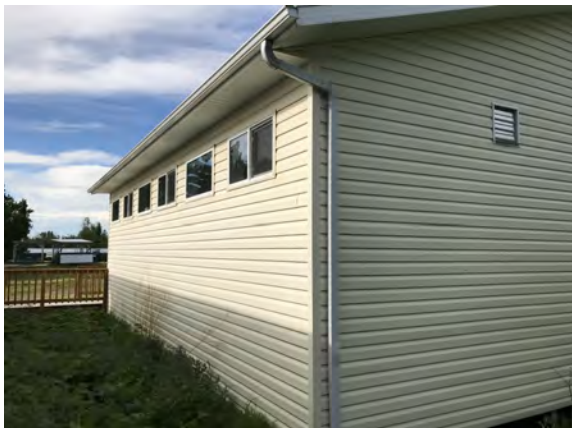
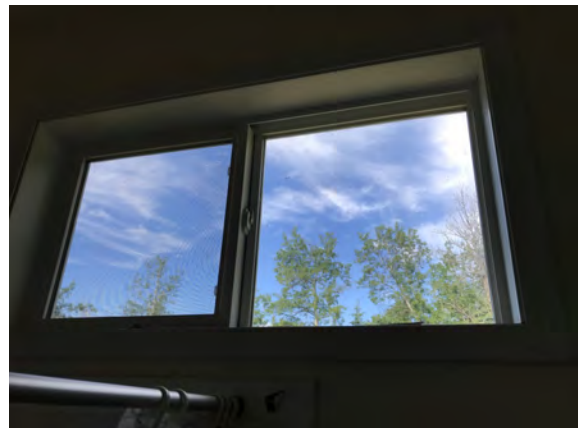
North Peace Fair Grounds - Washroom Building - B202001

No major deficiencies were observed or reported during the assessment.

<b>Recommendations #1 - Windows</b>	
Type	Life Cycle Replacement
Year	2031
Cost	\$21,283.80

Replace Windows

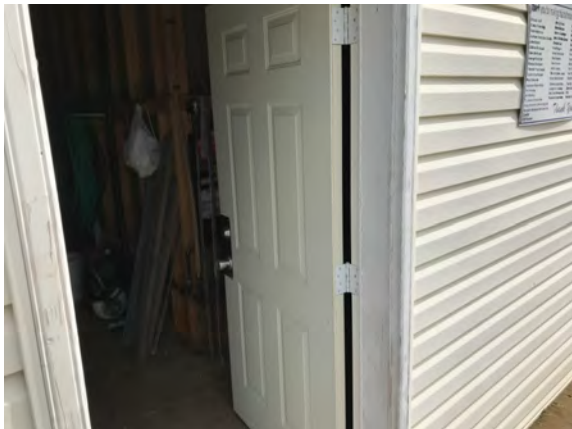
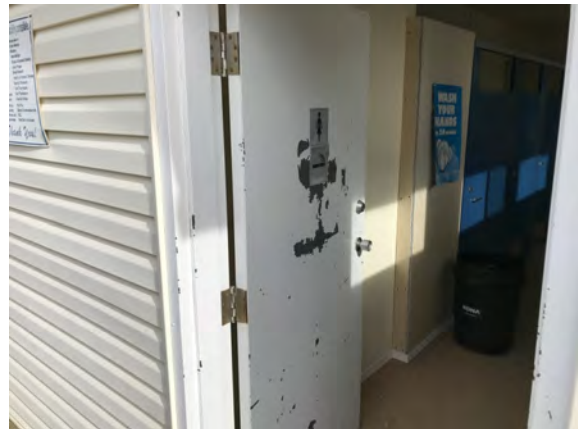
North Peace Fair Grounds - Washroom Building - B203024

No major deficiencies were observed or reported during the assessment; however, the paint is weathered and worn. The cost of refinishing door panel surfaces is expected to be minimal and may be handled as routine maintenance. The component is nearing the end of its expected useful life, although its remaining useful life has been extended to a later year due to the absence of significant observed or reported deficiencies.

<b>Recommendations #1 - Single Door - Hollow Metal</b>	
Type	Life Cycle Replacement
Year	2027
Cost	\$17,923.20

Replace Single Door - Hollow Metal

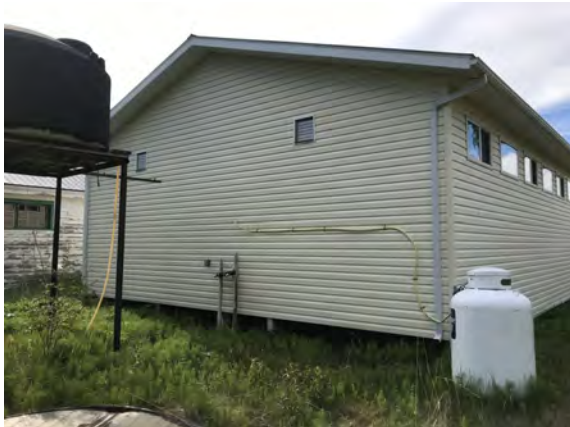
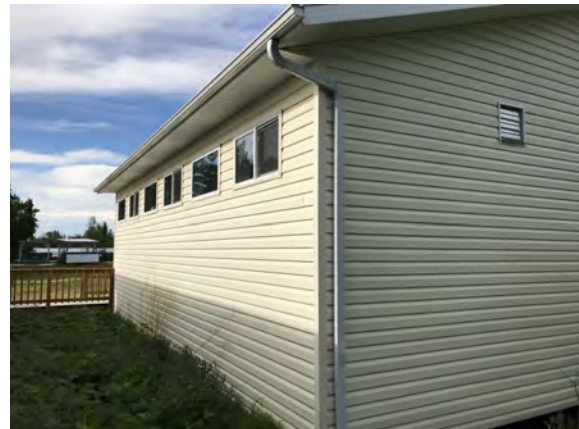
North Peace Fair Grounds - Washroom Building - B301005

No major deficiencies were observed or reported during the assessment. The component is nearing the end of its expected useful life, although its remaining useful life has been extended to a later year due to the absence of significant observed or reported deficiencies. Install splash pads at ground level, which should be installed as a maintenance activity to mitigate soil erosion and the development of negative drainage slopes.

Recommendations #1 - Gutters and Downspouts	
Type	Life Cycle Replacement
Year	2027
Cost	\$1,848.33

Replace Gutters and Downspouts

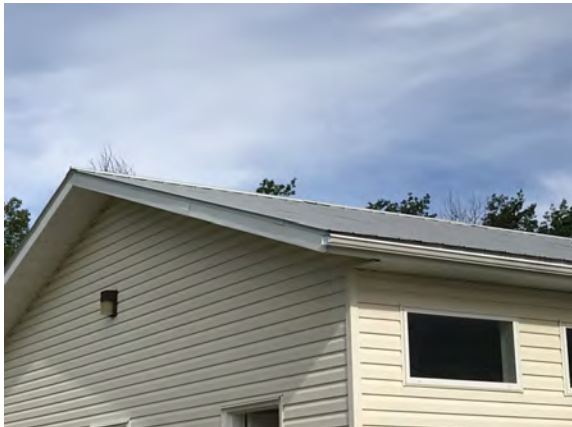
North Peace Fair Grounds - Washroom Building -  
B301027

No major deficiencies were observed or reported during the assessment.

<b>Recommendations #1 - Metal Roofing</b>	
Type	Life Cycle Replacement
Year	2036
Cost	\$67,958.80

Replace Metal Roofing

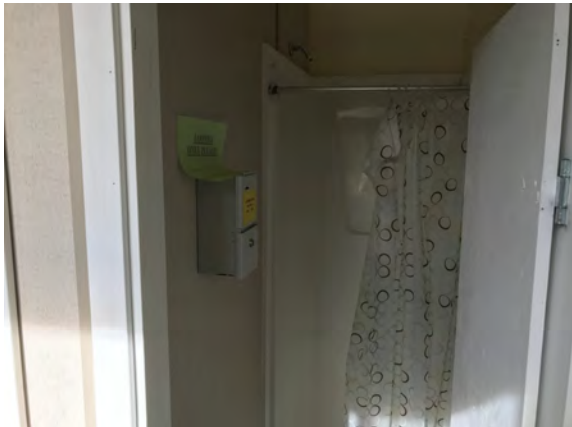
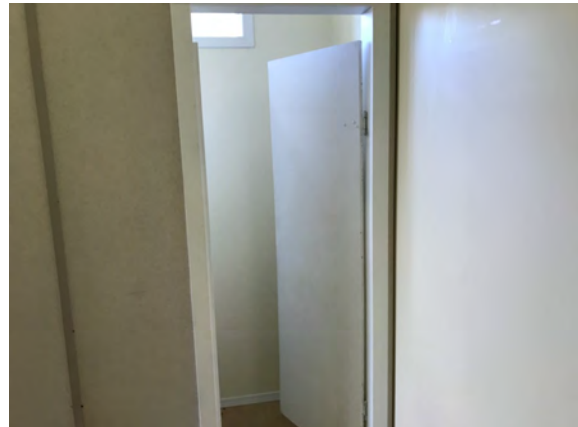
North Peace Fair Grounds - Washroom Building - C102022

No major deficiencies were observed or reported during the assessment.

Recommendations #1 - Single Door - Wood	
Type	Life Cycle Replacement
Year	2036
Cost	\$14,936.00

Replace Single Door - Wood

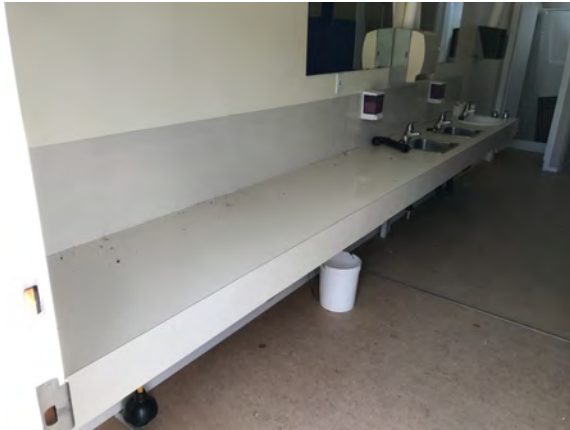
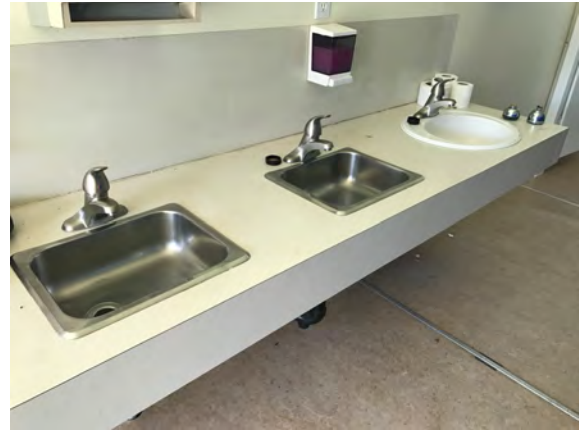
North Peace Fair Grounds - Washroom Building - C103010

No major deficiencies were observed or reported during the assessment. The component has achieved its expected useful life, although its remaining useful life has been extended to a later year due to the absence of significant observed or reported deficiencies.

<b>Recommendations #1 - Vanities</b>	
Type	Life Cycle Replacement
Year	2027
Cost	\$6,721.20

Replace Vanities

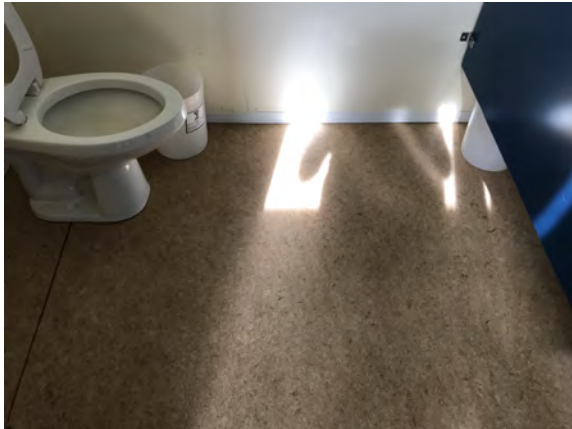
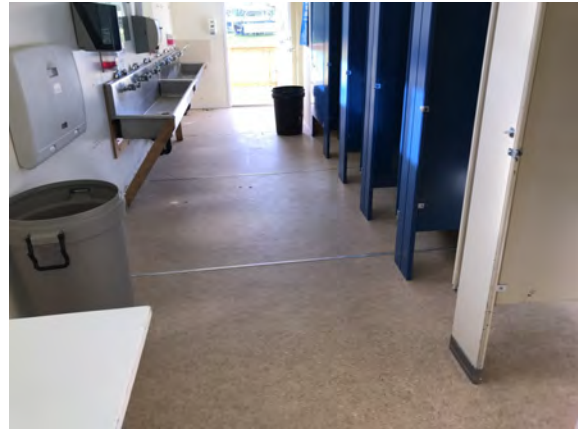
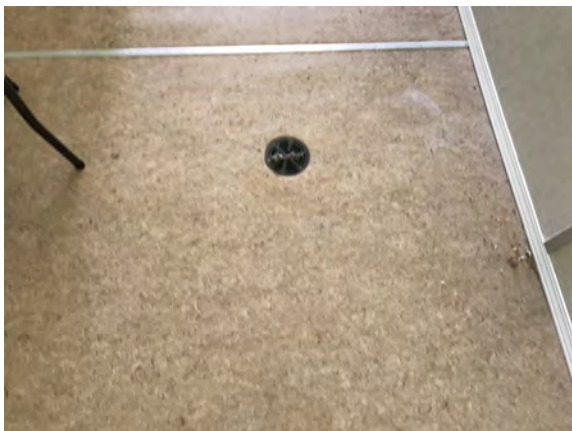
North Peace Fair Grounds - Washroom Building - C302023

No major deficiencies were observed or reported during the assessment.

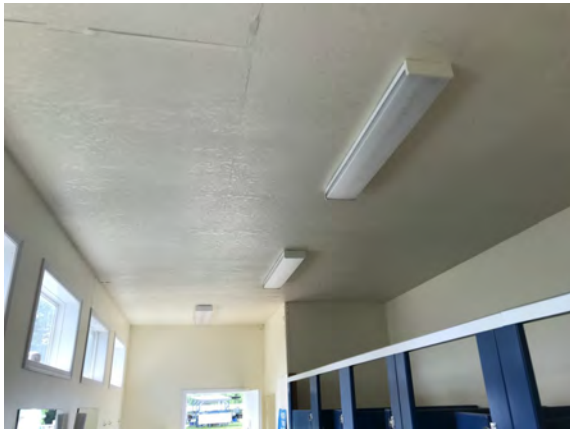
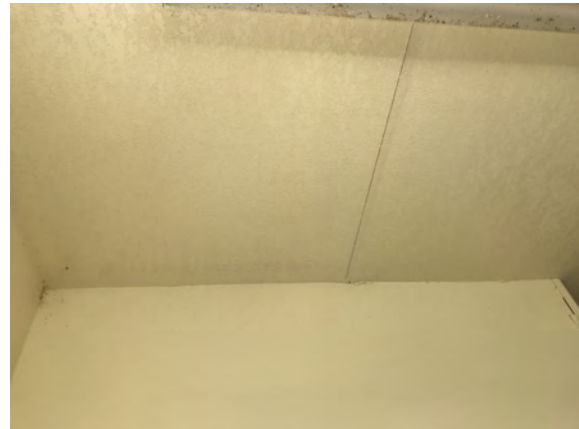
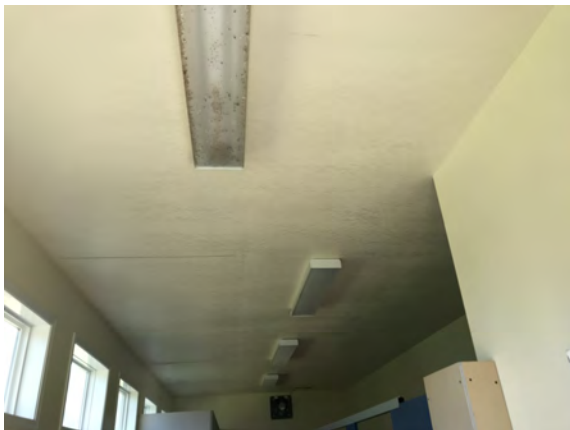
North Peace Fair Grounds - Washroom Building - C303006

No major deficiencies were observed or reported during the assessment. Lifecycle replacement has been deferred.

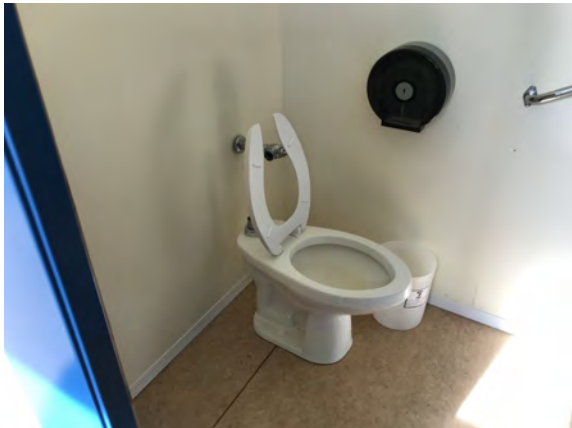
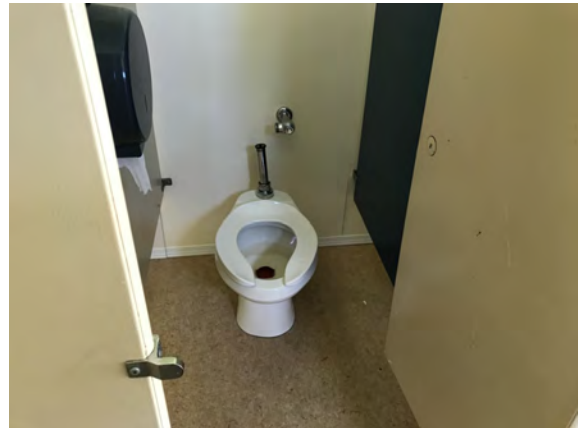
North Peace Fair Grounds - Washroom Building - D201001

No major deficiencies were observed or reported during the assessment.

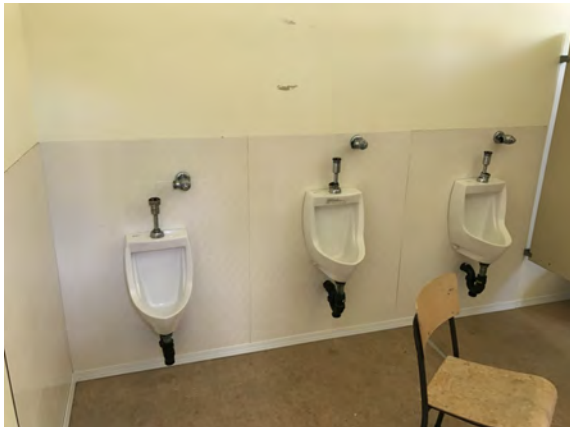
North Peace Fair Grounds - Washroom Building -  
D201002

No major deficiencies were observed or reported during the assessment.

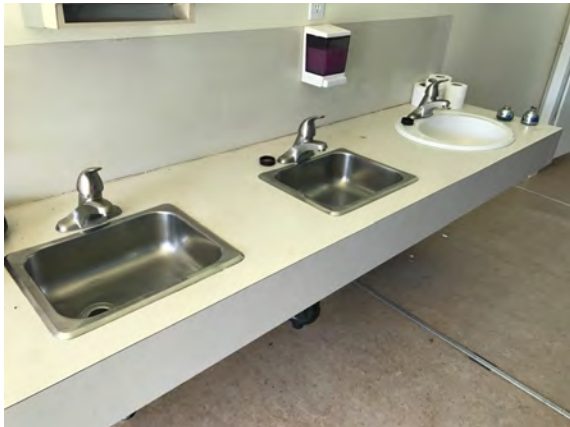
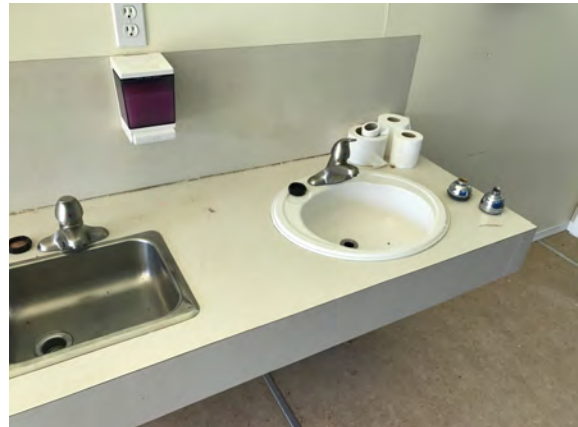
North Peace Fair Grounds - Washroom Building - D201003

No major deficiencies were observed or reported during the assessment.

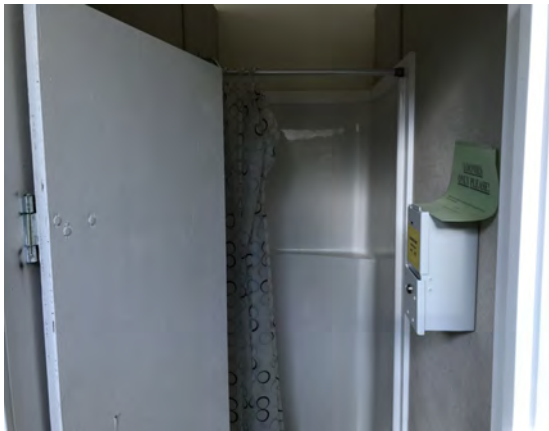
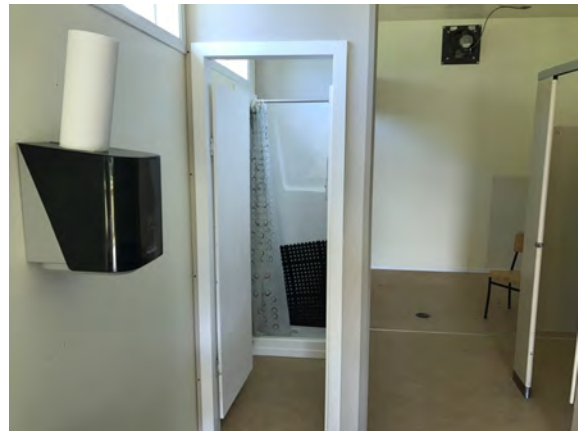
North Peace Fair Grounds - Washroom Building - D201043

No major deficiencies were observed or reported during the assessment. The component has reached its expected useful life, although its remaining useful life has been extended to a later year due to the absence of significant observed or reported deficiencies.

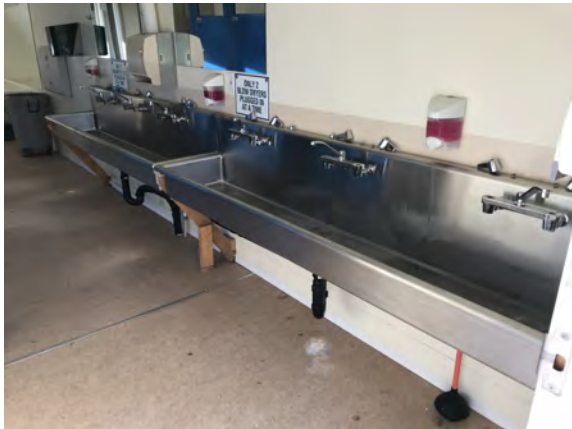
North Peace Fair Grounds - Washroom Building -  
D201003

No major deficiencies were observed or reported during the assessment.

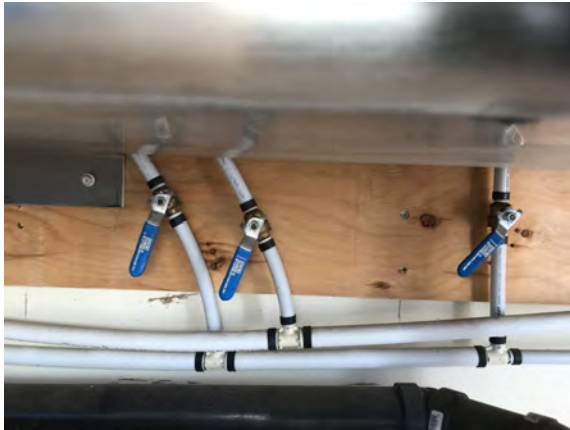
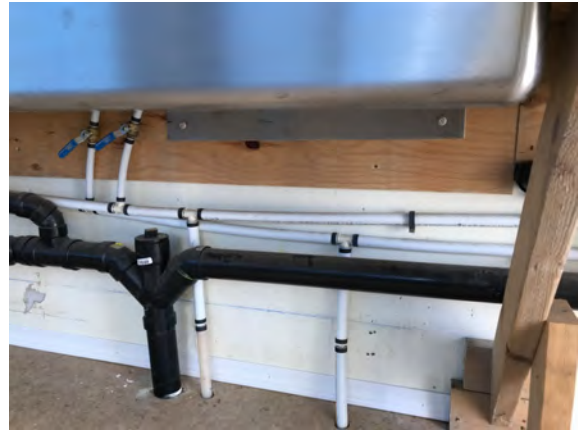
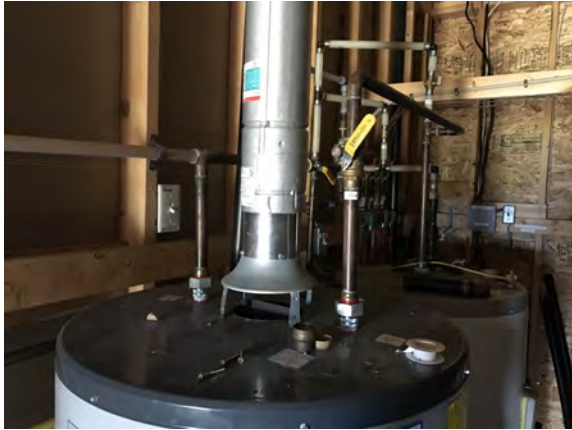
North Peace Fair Grounds - Washroom Building - D202001

No major deficiencies were observed or reported during the assessment.

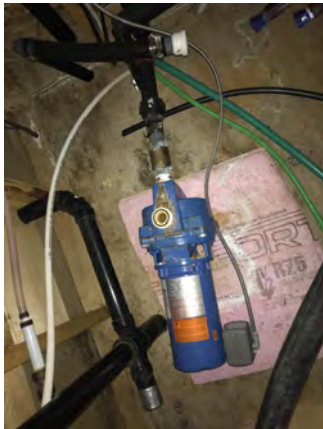
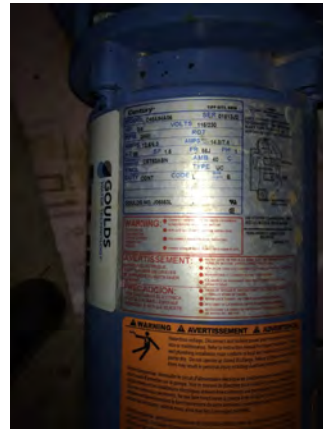
North Peace Fair Grounds - Washroom Building - D202006

No major deficiencies were observed or reported during the assessment. The difficulty factor has been lowered based on the pump size.

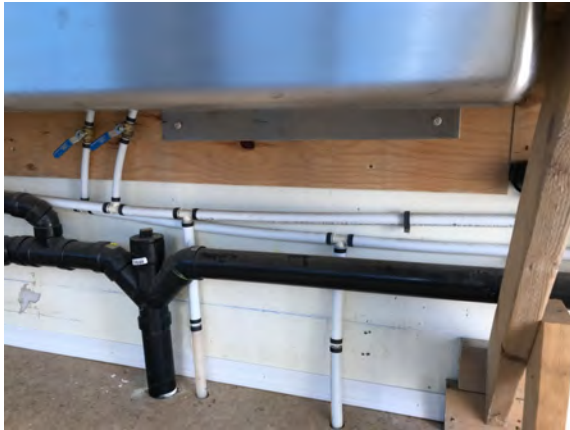
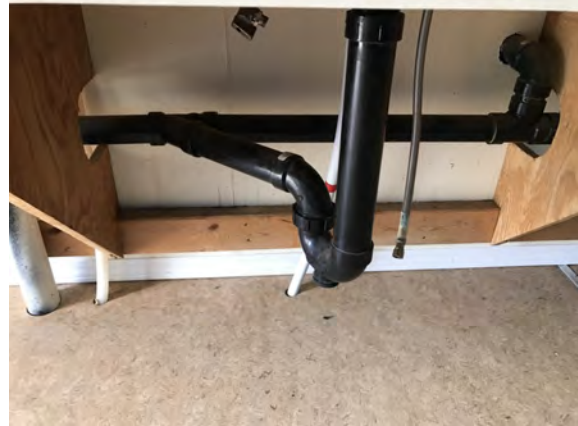
North Peace Fair Grounds - Washroom Building - D203001

No major deficiencies were observed or reported during the assessment.

Recommendations #1 - Sanitary Waste and Vent Piping	
Type	Life Cycle Replacement
Year	2046
Cost	\$9,073.62

Replace Sanitary Waste and Vent Piping

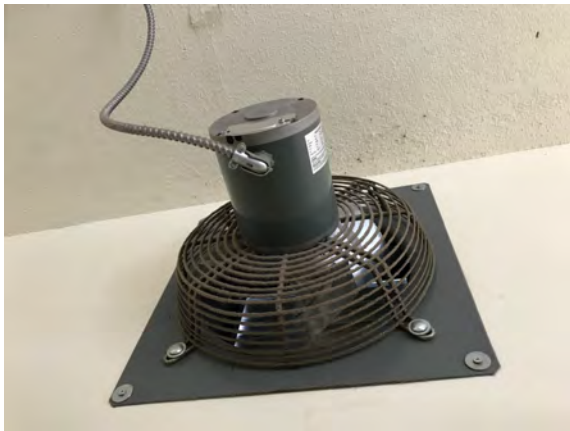
North Peace Fair Grounds - Washroom Building -  
D304031

No major deficiencies were observed or reported during the assessment. The component has achieved its expected useful life, although its remaining useful life has been extended to a later year due to the absence of significant observed or reported deficiencies.

Recommendations #1 - Exhaust Fan - Roof/Wall Mounted Small	
Type	Life Cycle Replacement
Year	2025
Cost	\$11,202.00

Replace Exhaust Fan - Roof/Wall Mounted Small

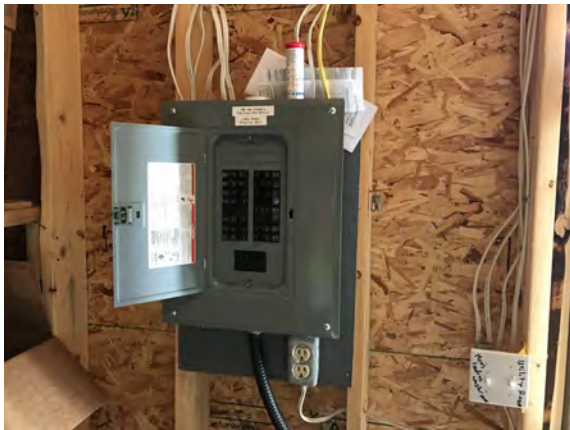
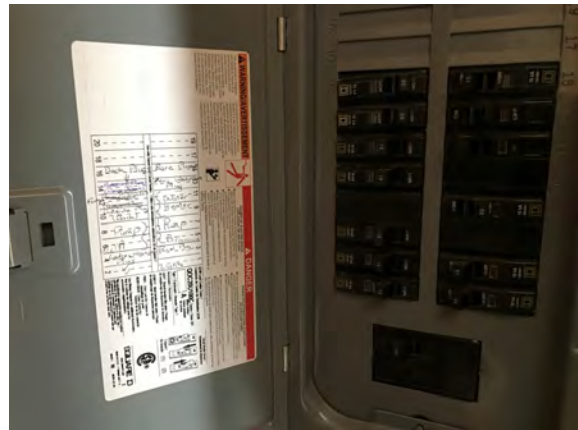
North Peace Fair Grounds - Washroom Building -  
D501033

No major deficiencies were observed or reported during the assessment.

Recommendations #1 - Panelboards Residential	
Type	Life Cycle Replacement
Year	2036
Cost	\$2,240.40

Replace Panelboards Residential

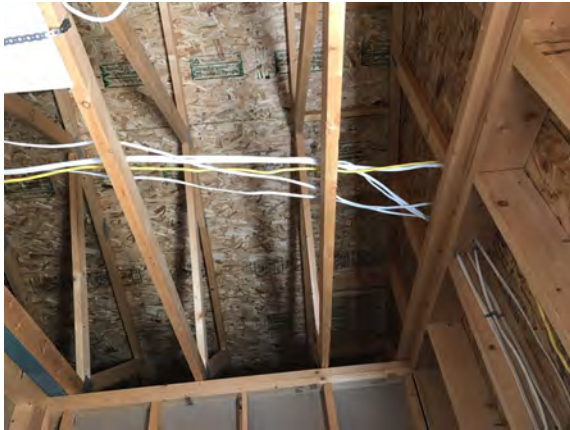
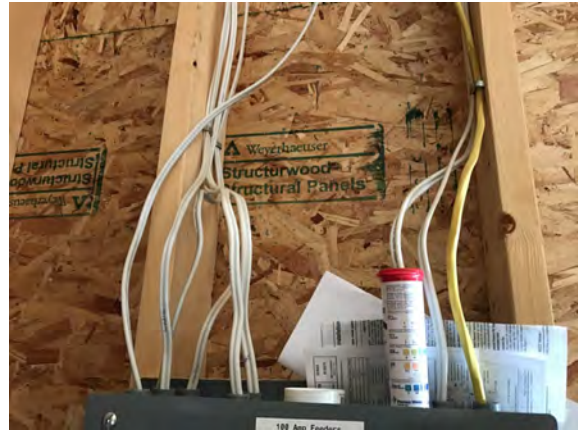
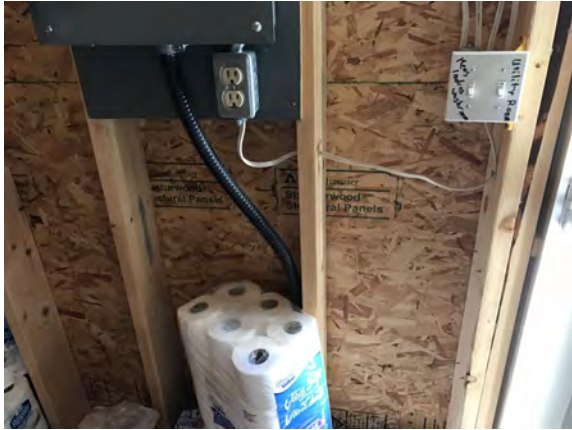
North Peace Fair Grounds - Washroom Building - D502001

No major deficiencies were observed or reported during the assessment.

<b>Recommendations #1 - Branch Wiring and Devices</b>	
Type	Life Cycle Replacement
Year	2046
Cost	\$19,155.42

Replace Branch Wiring and Devices

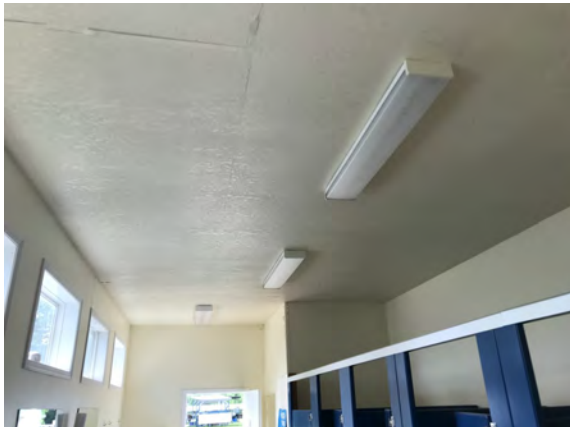
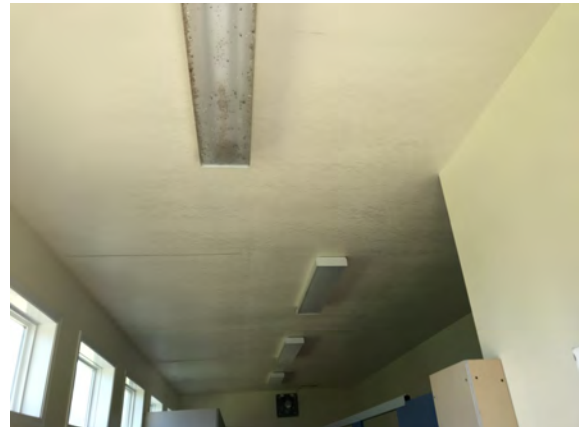
North Peace Fair Grounds - Washroom Building - D502002

No major deficiencies were observed or reported during the assessment.

<b>Recommendations #1 - Interior Lighting Residential</b>	
Type	Life Cycle Replacement
Year	2031
Cost	\$6,049.08

Replace Interior Lighting Residential

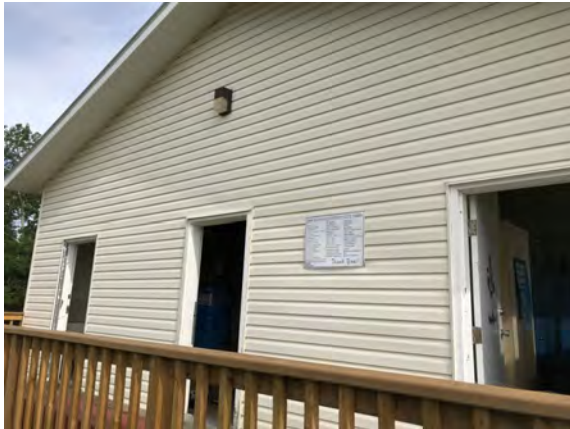
North Peace Fair Grounds - Washroom Building -  
D502041

No major deficiencies were observed or reported during the assessment.

<b>Recommendations #1 - Exterior Lighting</b>	
Type	Life Cycle Replacement
Year	2030
Cost	\$933.50

Replace Exterior Lighting
