**Peace River Regional District**

**Facility Condition Assessment Report  
North Peace Fall Fair Grounds**

**November 18, 2021**

Prepared by:  
FCAPX a Division of Roth IAMS  
Project No. 21075  
[www.fcapx.com](http://www.fcapx.com)

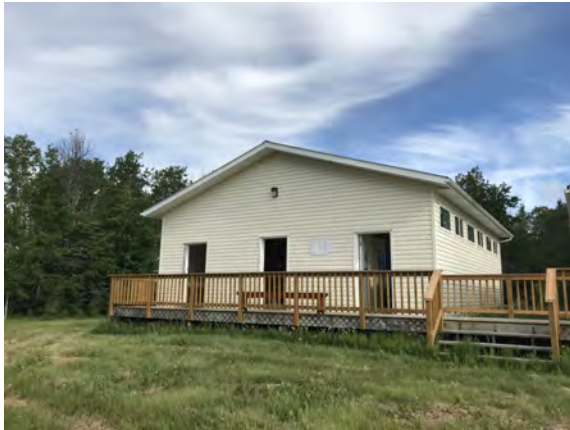
North Peace Fair Grounds - Washroom Building - G204096

There is a wood deck installed on the south elevation of the washroom building. The deck comprises a conventional wood frame with stained deck boards. A set of wood stairs is provided on the east and south sides and a sloped access ramp is installed along the east edge.

No major deficiencies were observed or reported.

<b>Recommendations #1 - Exterior Wood Decks</b>	
Type	Life Cycle Replacement
Year	2035
Cost	\$33,606.00

Replace Exterior Wood Decks

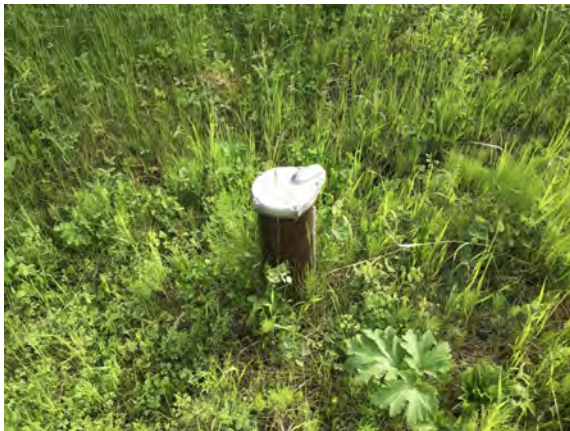
North Peace Fair Grounds - Washroom Building -  
G301001

No major deficiencies were observed or reported during the assessment. The difficulty factor has been adjusted to reflect the estimated size of the well based on the building it serves.

Recommendations #1 - Well System	
Type	Life Cycle Replacement
Year	2046
Cost	\$84,015.00

Replace Well System

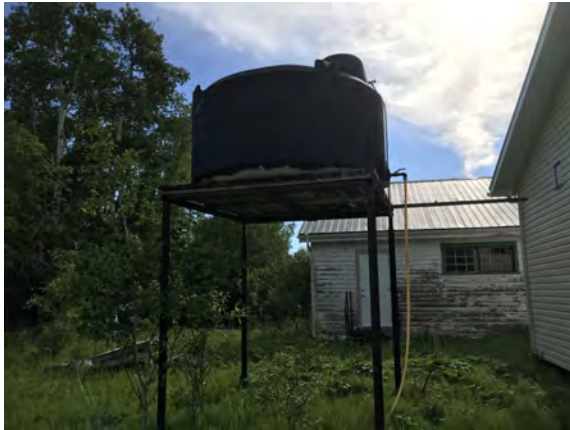
North Peace Fair Grounds - Washroom Building -  
G301099

No major deficiencies were observed or reported during the assessment. The difficulty factor has been adjusted to reflect the size of tank and assembly design.

Recommendations #1 - OtherWater Supply	
Type	Life Cycle Replacement
Year	2046
Cost	\$9,335.00

Replace OtherWater Supply

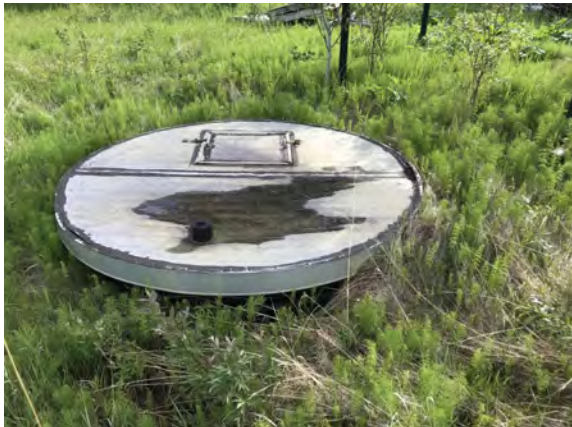
North Peace Fair Grounds - Washroom Building -  
G302016

No major deficiencies were observed or reported during the assessment.

<b>Recommendations #1 - Septic Tank (4000 Gallons)</b>	
Type	Life Cycle Replacement
Year	2046
Cost	\$49,475.50

Replace Septic Tank (4000 Gallons)

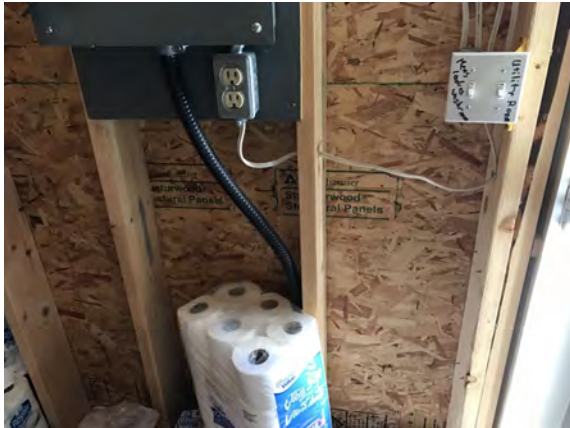
North Peace Fair Grounds - Washroom Building -  
G401010

No major deficiencies were observed or reported during the assessment.

Recommendations #1 - Electrical Service Single Phase	
Type	Life Cycle Replacement
Year	2046
Cost	\$58,530.45

Replace Electrical Service Single Phase

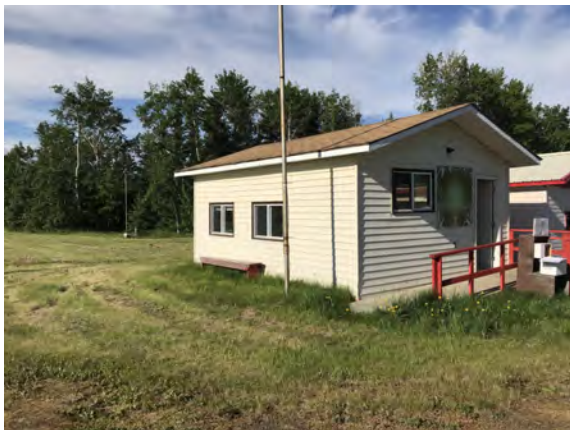
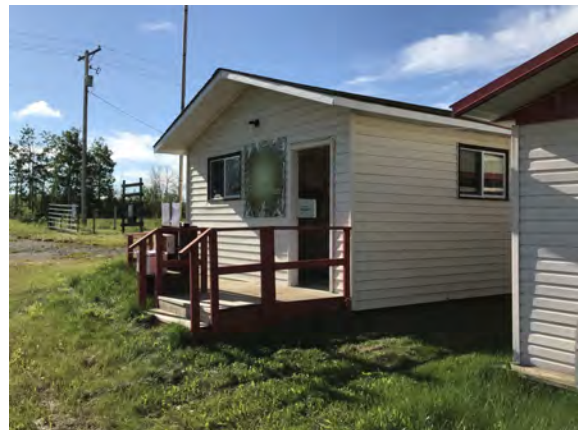
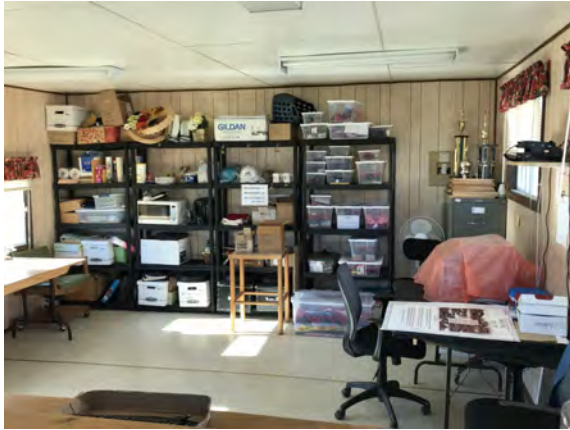
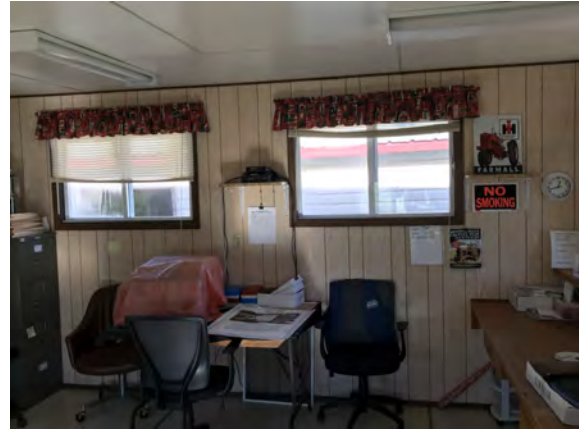
North Peace Fall Fair Grounds - B103001

Select components were observed to have been renewed subsequent to the building's construction circa 1979, although most components appeared to be original. No major deficiencies were observed or reported during the assessment. The component has exceeded its expected useful life, although its remaining useful life has been extended to a later year due to the absence of significant observed or reported deficiencies. The difficulty factor has been increased based on the structure's design and size.

<b>Recommendations #1 - Other Special Construction</b>	
Type	Life Cycle Replacement
Year	2027
Cost	\$56,010.00

Replace Other Special Construction

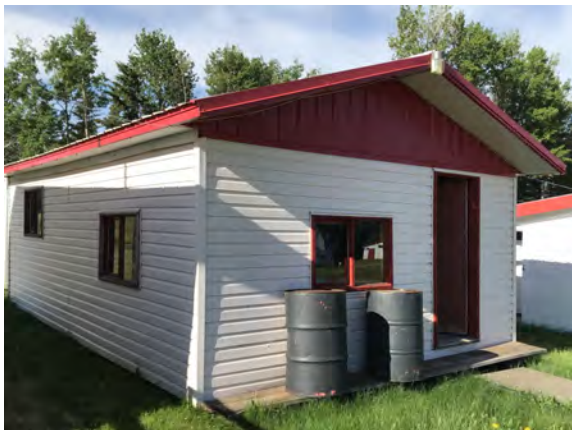
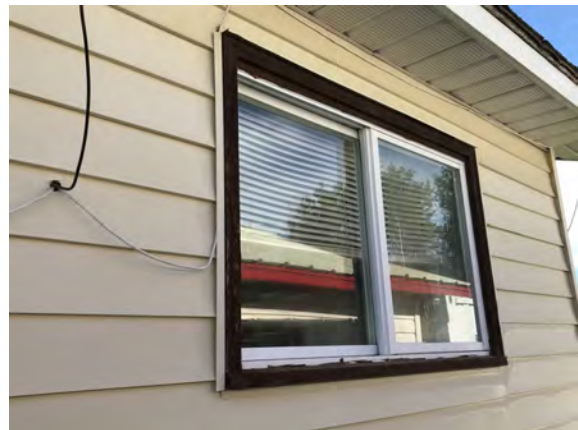
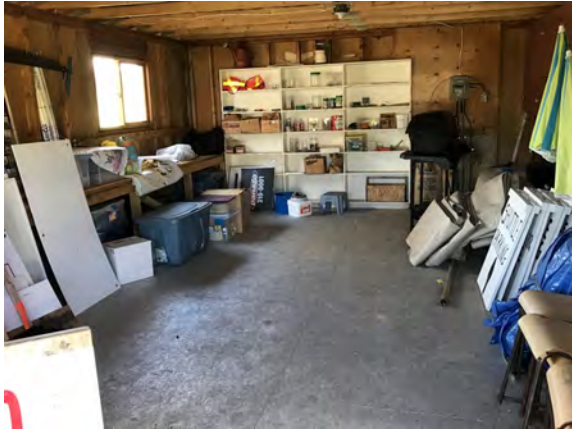
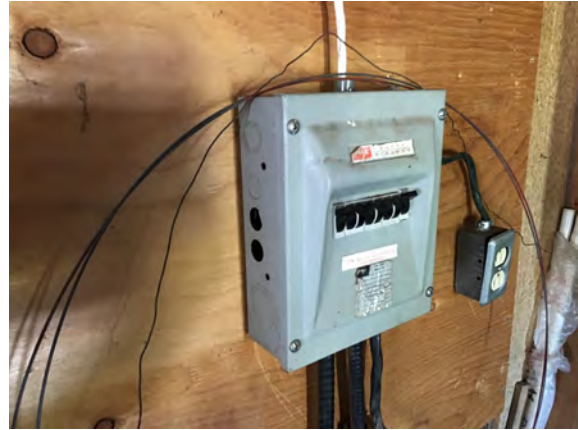
North Peace Fall Fair Grounds - B103001

Select components were observed to have been renewed subsequent to the building's construction circa 1979, although most components appeared to be original. The wood door and window has reached the end of its expected useful life and is exhibiting wear and tear that is consistent with the age of the materials. No major deficiencies were observed or reported during the assessment. The component has exceeded its expected useful life, although its remaining useful life has been extended to a later year pending the completion of repair activities recommended above. The difficulty factor has been increased based on the structure's design and size.

### Recommendations #1 - Replace Exterior Door and Window

Type	Major Repair
Year	2023
Cost	\$3,000.00

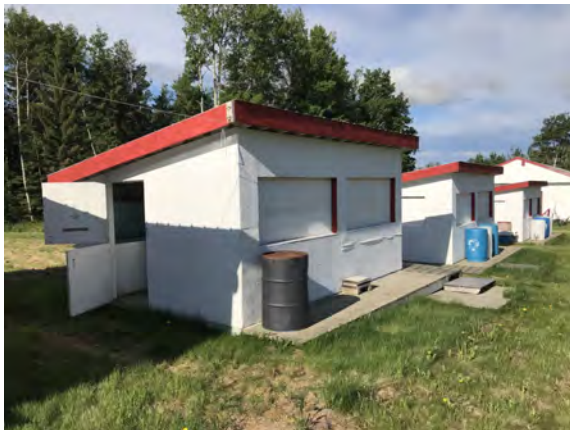
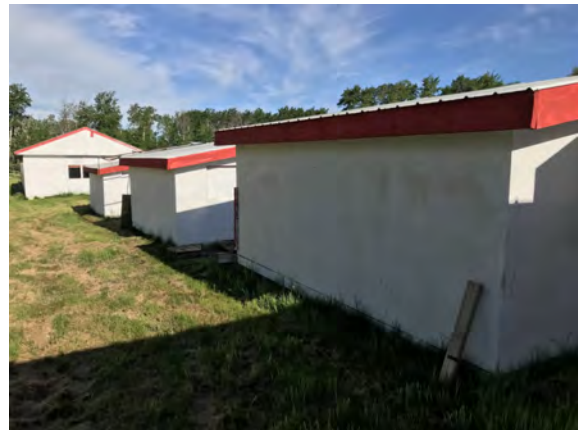
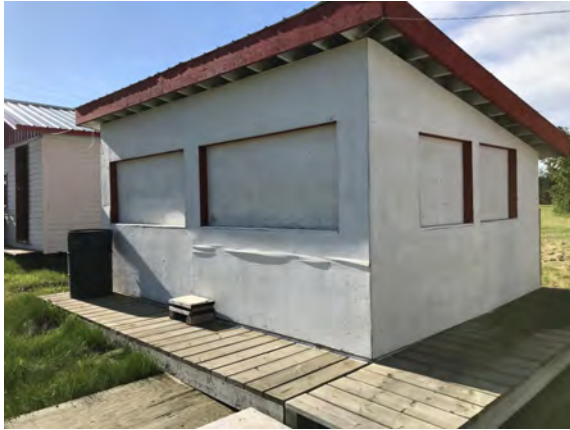
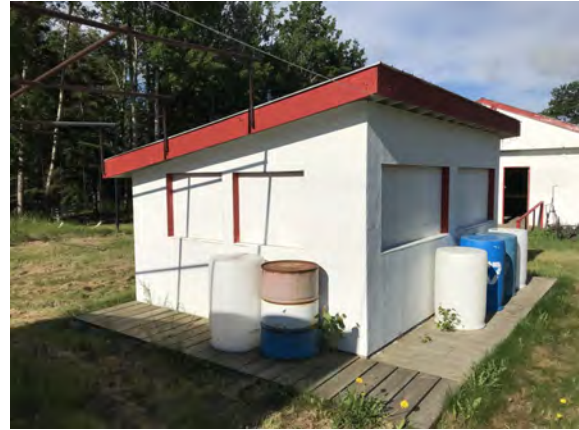
North Peace Fall Fair Grounds - B103001

Select components were observed to have been renewed subsequent to the building's construction circa 1970, although most components appeared to be original. No major deficiencies were observed or reported during the assessment. The component has exceeded its expected useful life, although its remaining useful life has been extended to a later year due to the absence of significant observed or reported deficiencies. The difficulty factor has been increased based on the structure's design and size.

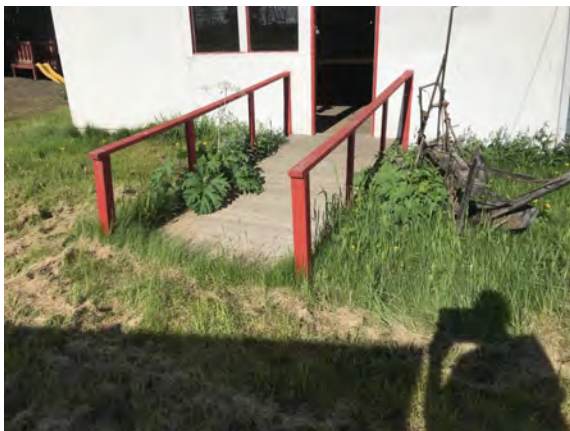
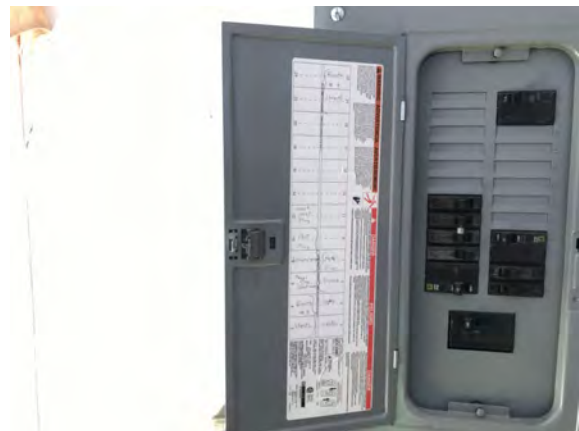
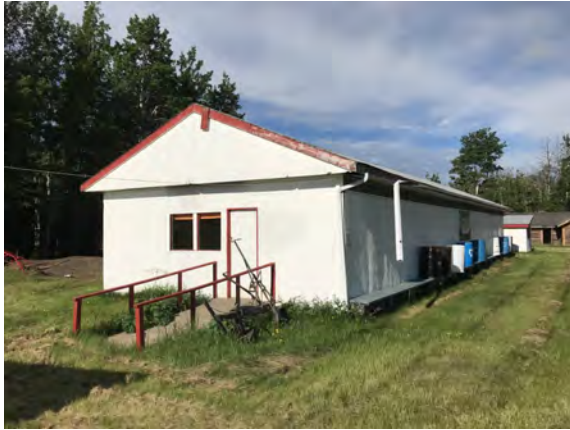
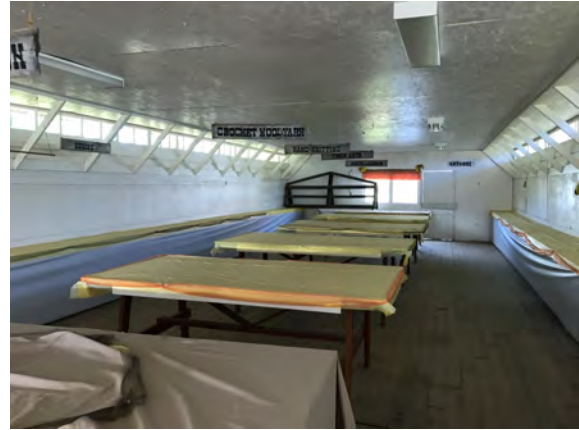
North Peace Fall Fair Grounds - B103001

Select components were observed to have been renewed subsequent to the building's construction circa 1979, although most components appeared to be original. No major deficiencies were observed or reported during the assessment. There were observed to be damaged gutters, worn painted finishes, and gaps in soffit coverage. An allowance for repairs has been provided. The component has exceeded its expected useful life, although its remaining useful life has been extended to a later year pending the completion of repair activities recommended above. The difficulty factor has been increased based on the structure's design and size.

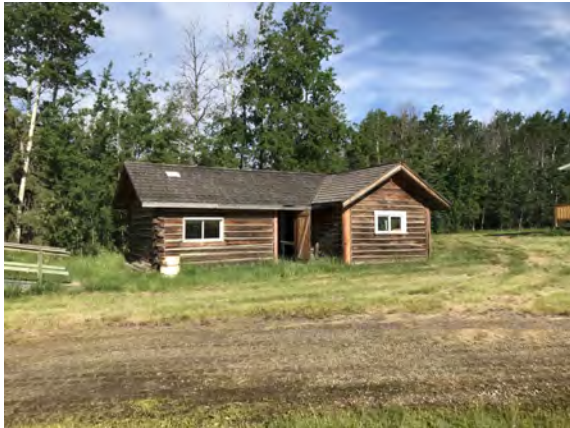
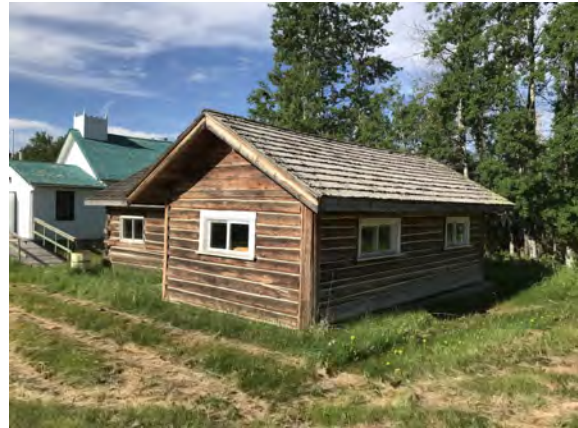
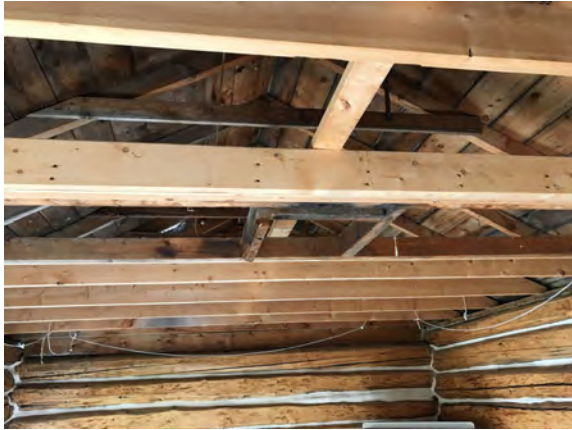
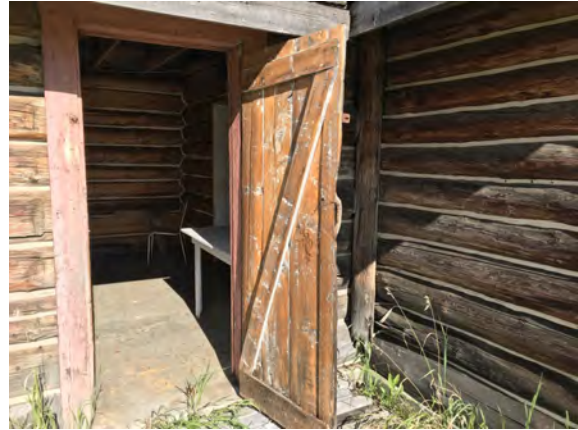
North Peace Fall Fair Grounds - B103001

Select components were observed to have been renewed subsequent to the building's construction circa 1890, although most components appeared to be original. No major deficiencies were observed or reported during the assessment. The component has exceeded its expected useful life, although its remaining useful life has been extended to a later year due to the absence of significant observed or reported deficiencies. The difficulty factor has been increased based on the structure's design and size.

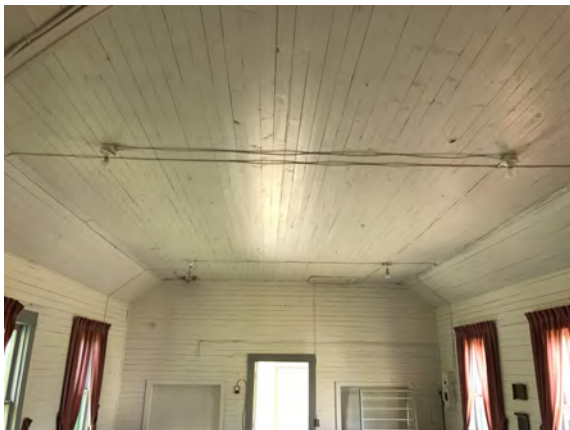
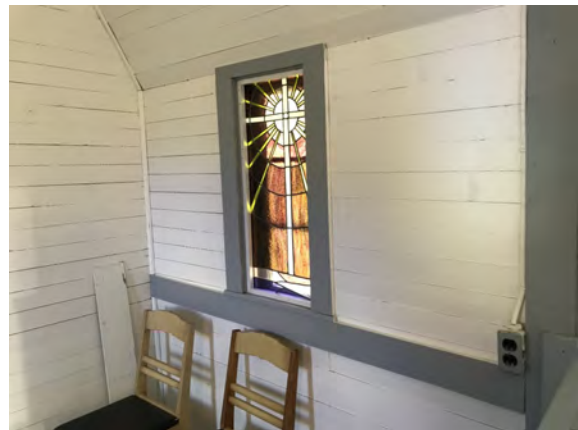
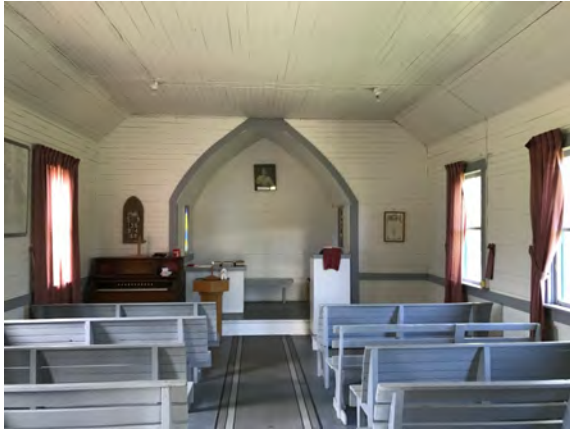
North Peace Fall Fair Grounds - B103001

Select components were observed to have been renewed subsequent to the building's construction circa 1890, although most components appeared to be original. There was observed to be worn paint finishes on the exterior, loose wood skirting, some damaged and deteriorated wood shingles, gaps in floor insulation, exposed wood sheathing around the chimney, missing splash pads, water-damaged and worn interior finishes, and dated electrical panel and distribution wiring. Repairs are recommended in the short-term and an allowance has been provided. The component has exceeded its expected useful life, although its remaining useful life has been extended to a later year pending the completion of repair activities recommended above. The difficulty factor has been increased based on the structure's design and size.

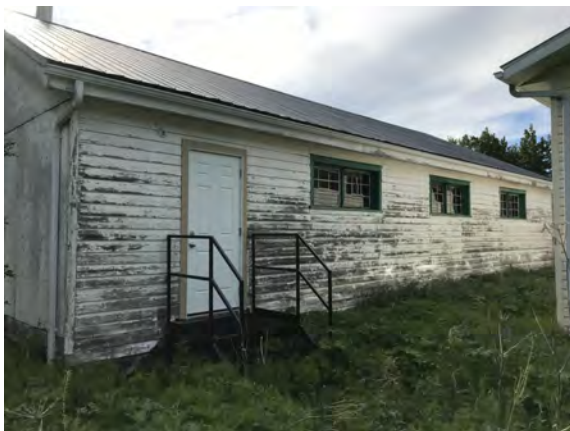
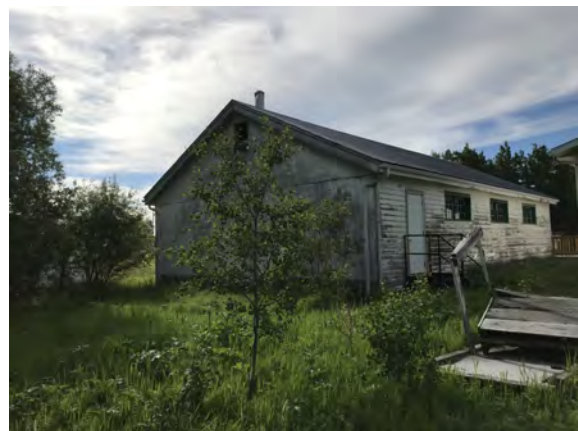
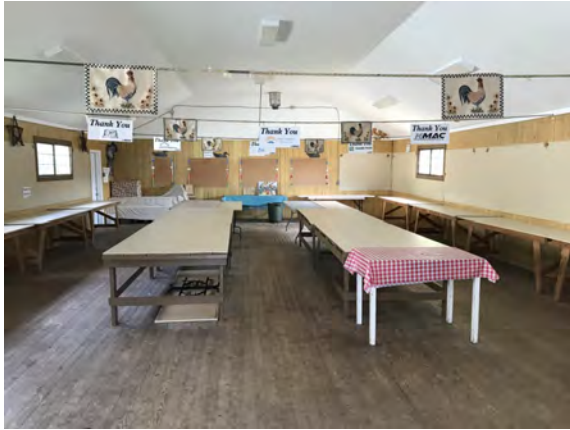
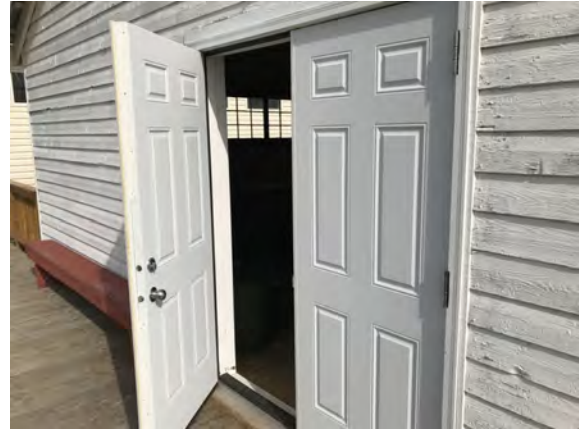
Select components were observed to have been renewed subsequent to the building's construction circa 1871, although most components appeared to be original. There is worn paint finishes, missing screens at wall openings, aged / inefficient windows, and worn wood flooring. No major deficiencies were observed or reported during the assessment. The component has exceeded its expected useful life, although its remaining useful life has been extended to a later year pending the completion of repair activities recommended above. The difficulty factor has been increased based on the structure's design and size.

Repair worn paint finishes, missing screens at wall openings, aged / inefficient windows, and worn wood flooring.

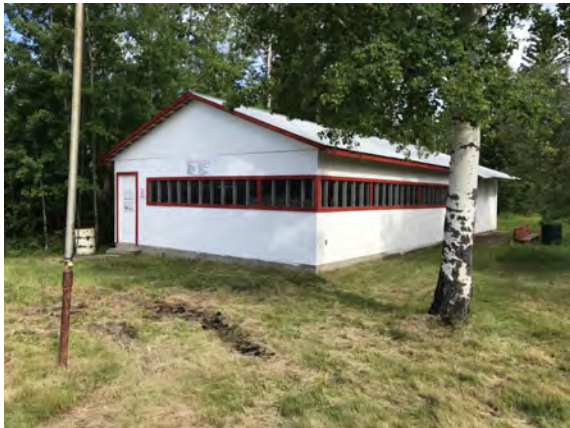
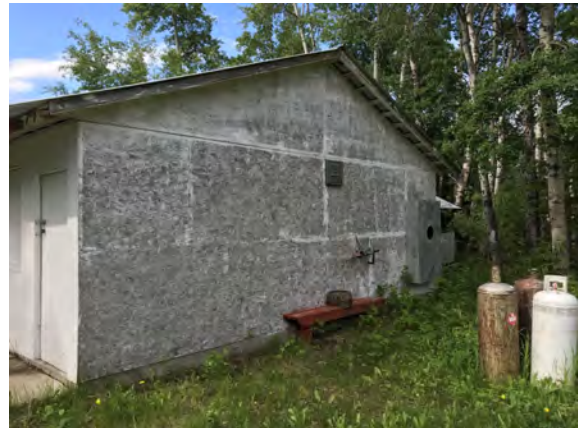
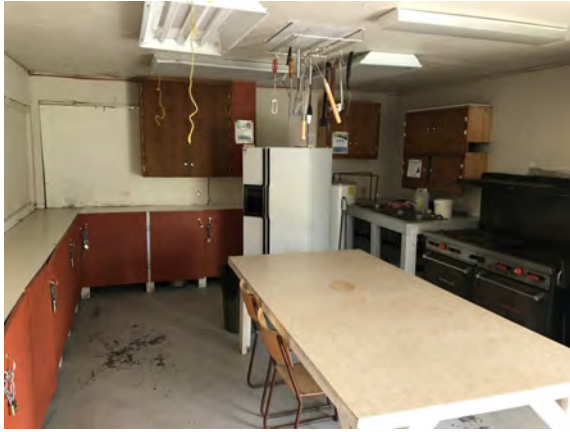
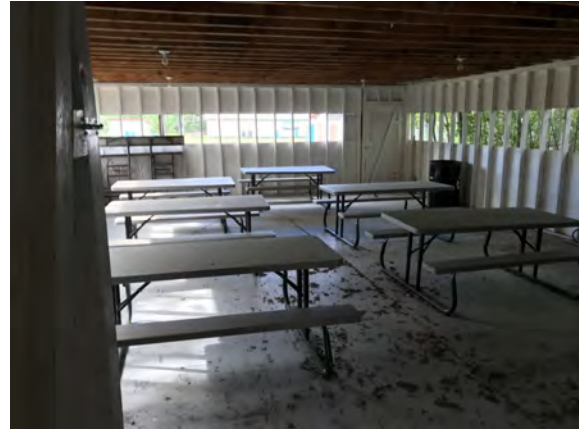
Select components were observed to have been renewed subsequent to the building's construction circa 1950, although most components appeared to be original. There were observed to be worn paint finishes, water-damaged wood sheathing, and worn paint floor finishes. Repairs are recommended in the short-term. An allowance has been provided. The component has exceeded its expected useful life, although its remaining useful life has been extended to a later year pending the completion of repair activities recommended above. The difficulty factor has been increased based on the structure's design and size.

Repair the worn paint finishes, water-damaged wood sheathing, and worn paint floor finishes.

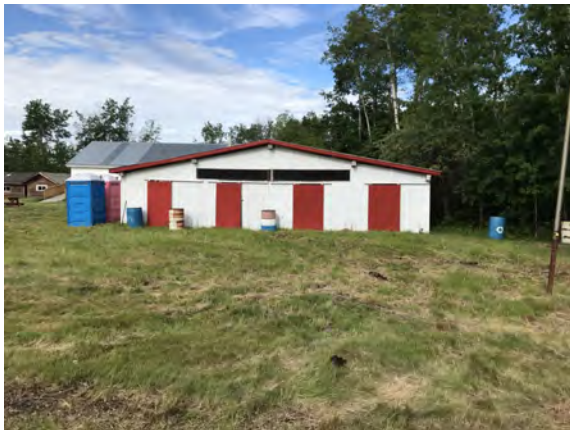
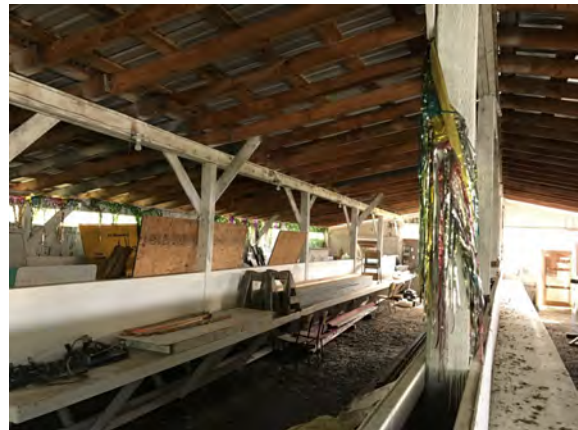
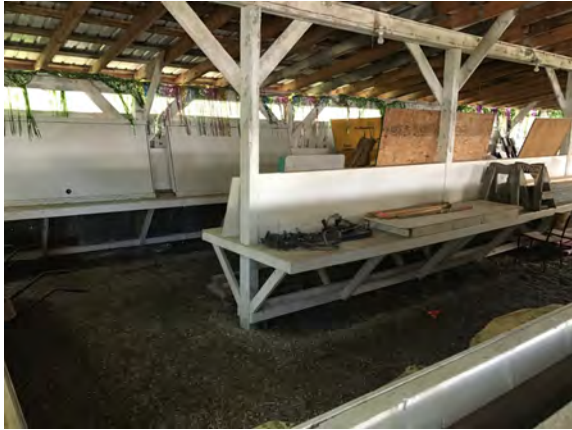
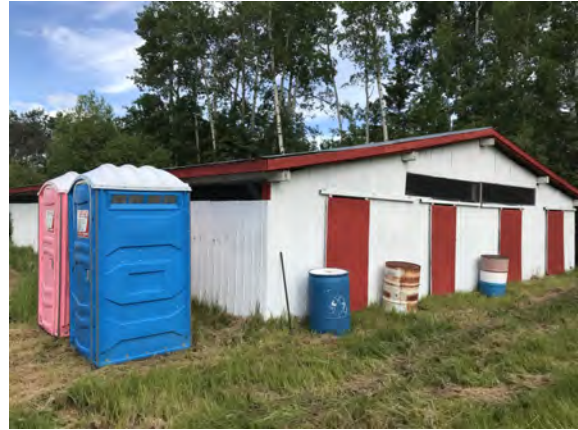
Select components were observed to have been renewed subsequent to the building's construction circa 1950, although most components appeared to be original. There is loose fascia board, worn paint finishes, and weathered surfaces on wood rafters and purlins. No major deficiencies were observed or reported during the assessment. The component has exceeded its expected useful life, although its remaining useful life has been extended to a later year pending the completion of repair activities recommended above. The difficulty factor has been increased based on the structure's design and size.

Repair loose fascia board, worn paint finishes, and weathered surfaces on wood rafters and purlins.

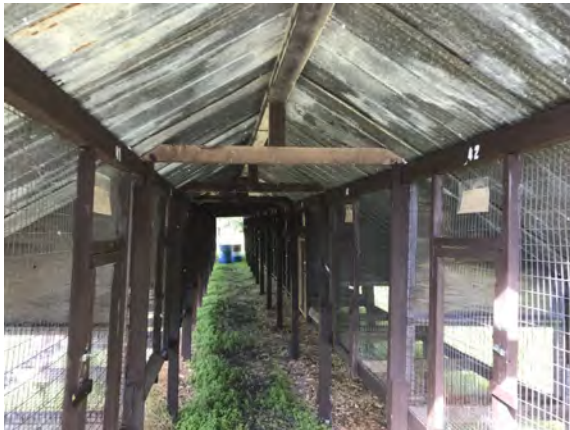
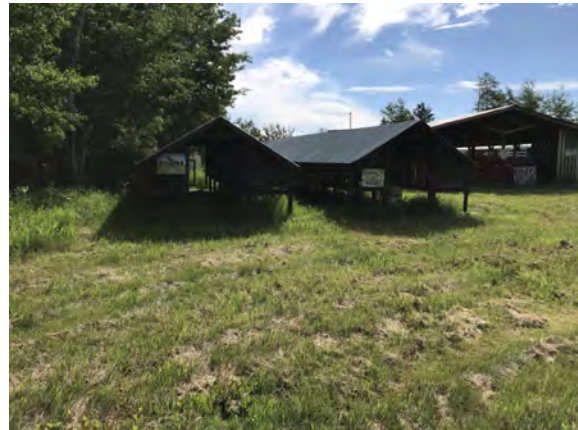
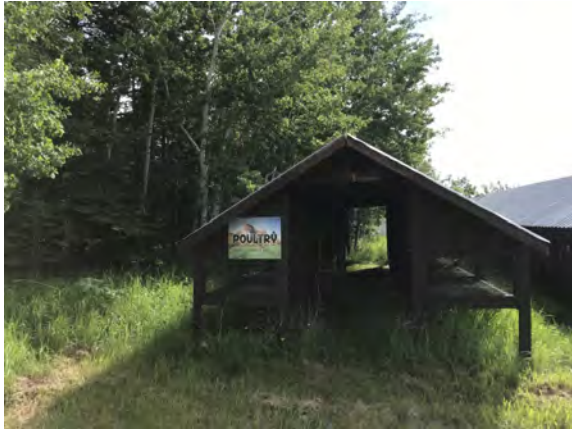
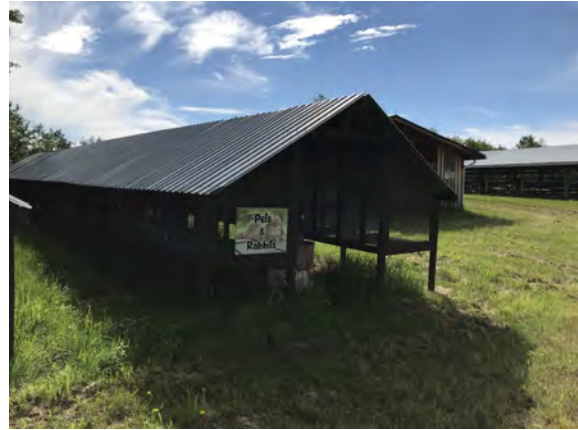
Select components were observed to have been renewed subsequent to the building's construction circa 1970, although most components appeared to be original. Weathered purlins and rafters were observed. Repairs to worn purlins and rafters is recommended as part of regular maintenance activities. No major deficiencies were observed or reported during the assessment. The component has exceeded its expected useful life, although its remaining useful life has been extended to a later year due to the absence of significant observed or reported deficiencies. The difficulty factor has been increased based on the structure's design and size.

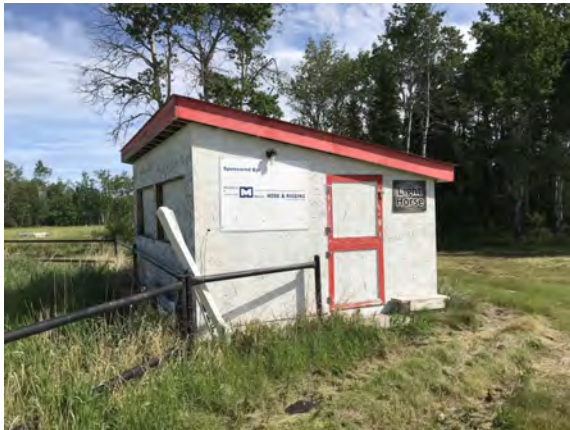
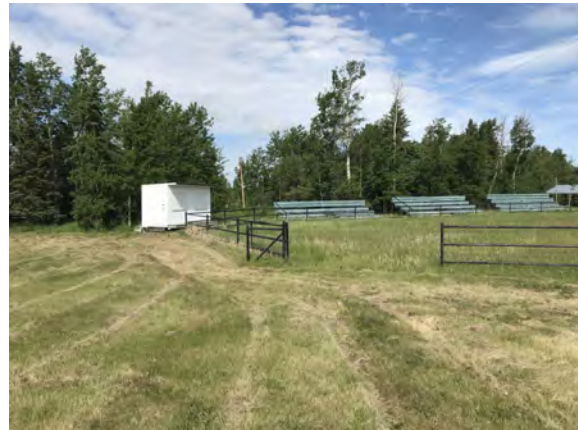
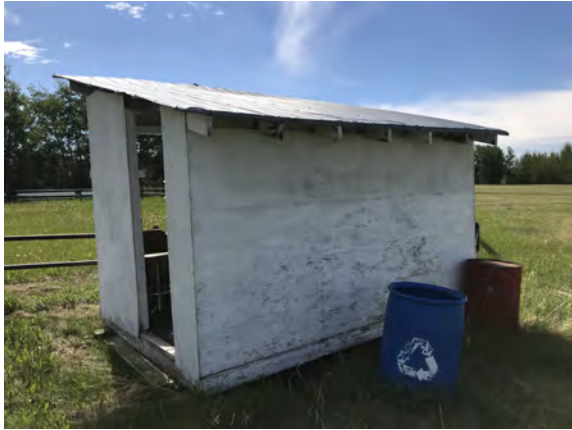
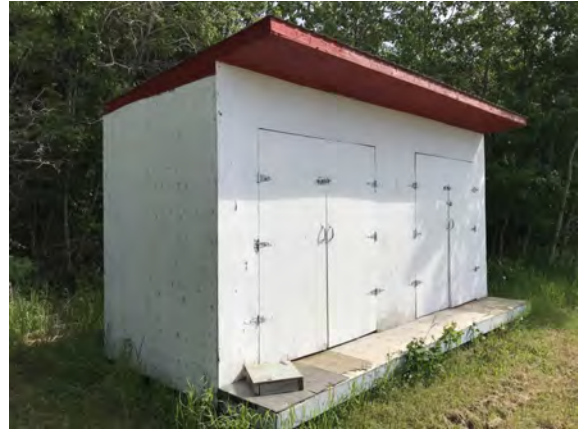
Select components were observed to have been renewed subsequent to the buildings' construction circa 1970, although most components appeared to be original. No major deficiencies were observed or reported during the assessment. Some roof panels were observed to be loose and the exterior paint finishes were worn. Repairs are recommended as part of maintenance activities. The component has exceeded its expected useful life, although its remaining useful life has been extended to a later year due to the absence of significant observed or reported deficiencies. The difficulty factor has been increased based on the structures' design and size.

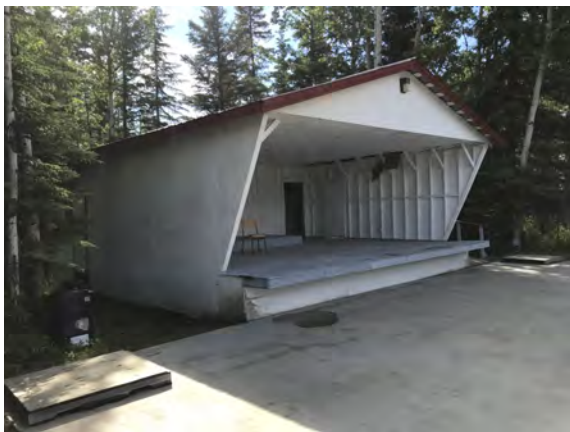
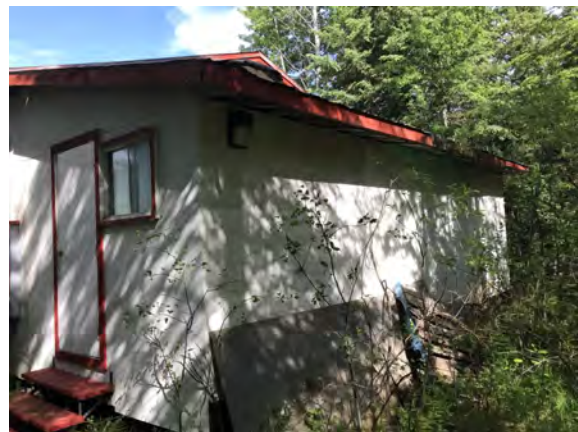
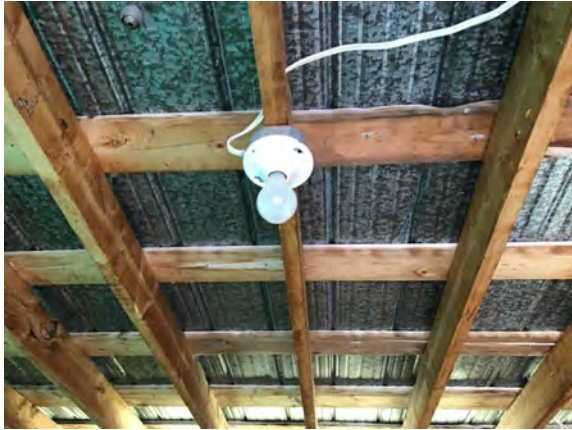
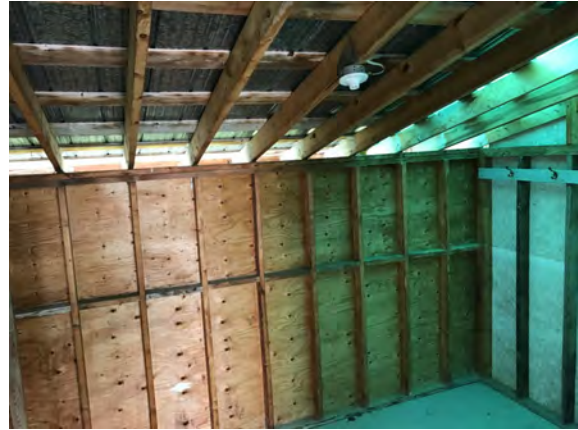
Select components were observed to have been renewed subsequent to the building's construction circa 1950, although most components appeared to be original. No major deficiencies were observed or reported during the assessment. Worn paint finishes were noted on the exterior surfaces. Renewal of paint finishes is recommended as part of regular maintenance activities. The component has exceeded its expected useful life, although its remaining useful life has been extended to a later year due to the absence of significant observed or reported deficiencies. The difficulty factor has been increased based on the structure's design and size.

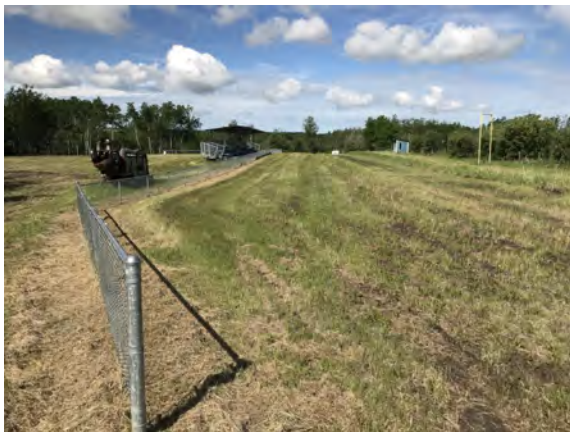
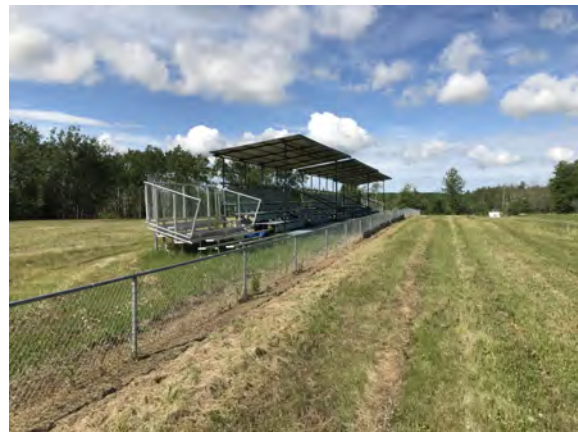
No major deficiencies were observed or reported during the assessment.

<b>Recommendations #1 - Fencing and Gates - Chain Link Fence</b>	
Type	Life Cycle Replacement
Year	2030
Cost	\$120,981.60

Replace Fencing and Gates - Chain Link Fence

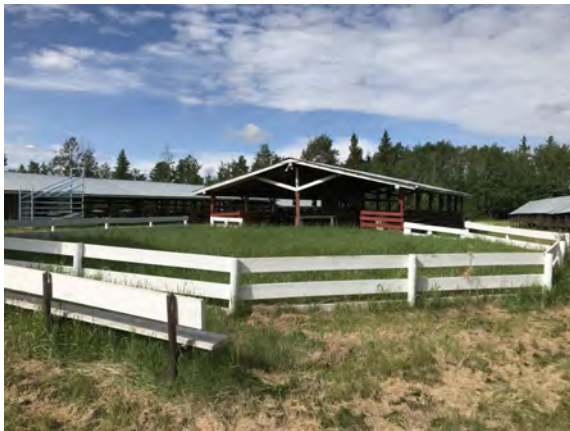
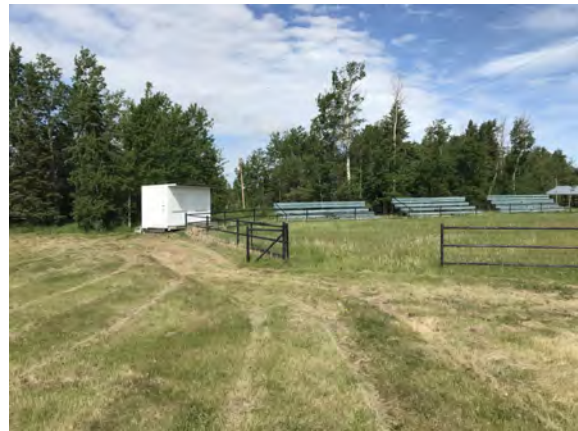
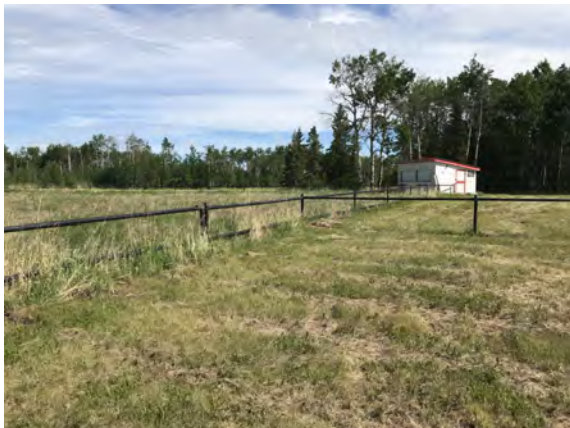
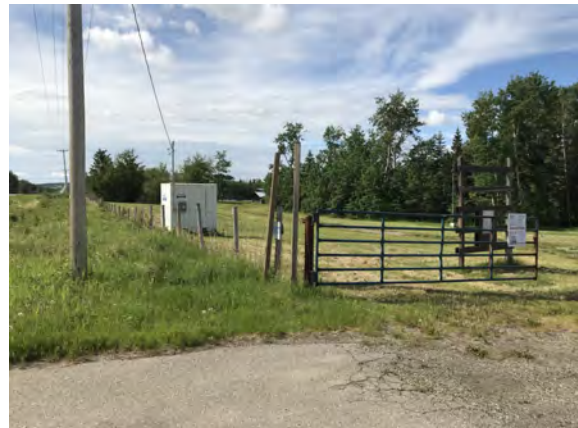
No major deficiencies were observed or reported during the assessment. The component has exceeded its expected useful life, although its remaining useful life has been extended to a later year due to the absence of significant observed or reported deficiencies.

<b>Recommendations #1 - Fencing and Gates - Wood Fence</b>	
Type	Life Cycle Replacement
Year	2025
Cost	\$146,372.80

Replace Fencing and Gates - Wood Fence

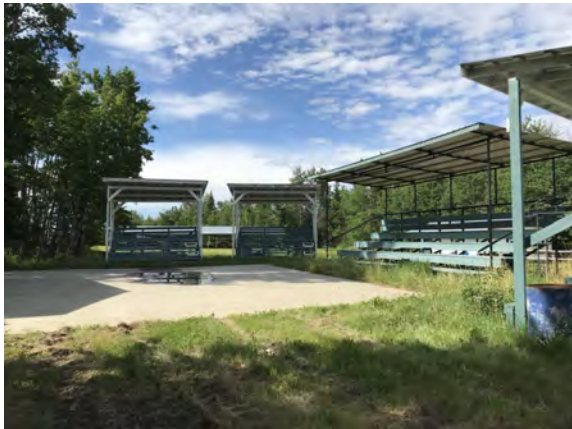
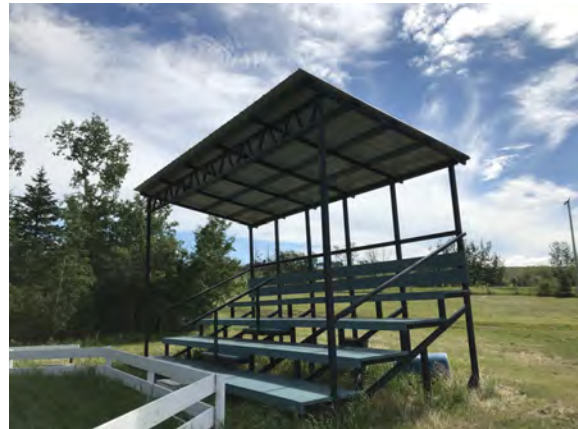
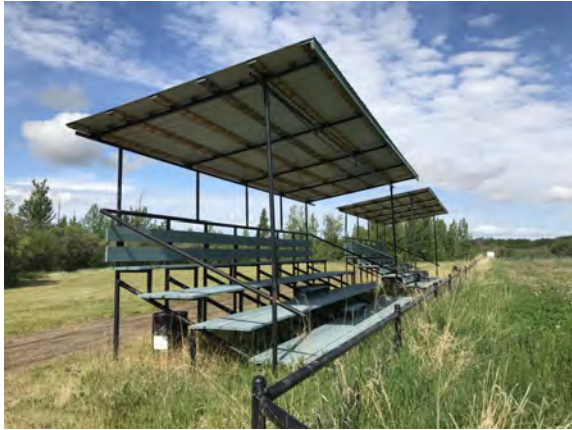
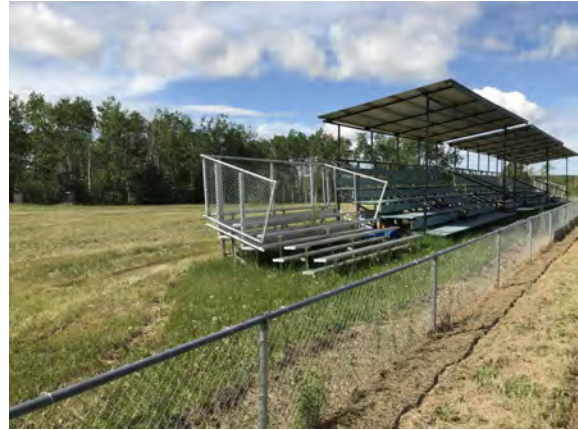
No major deficiencies were observed or reported during the assessment. The component has exceeded its expected useful life, although its remaining useful life has been extended to a later year due to the absence of significant observed or reported deficiencies.

<b>Recommendations #1 - Bleachers</b>	
Type	Life Cycle Replacement
Year	2027
Cost	\$364,438.40

Replace Bleachers

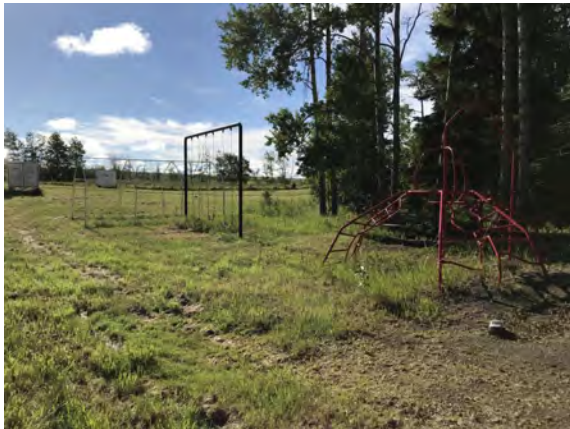
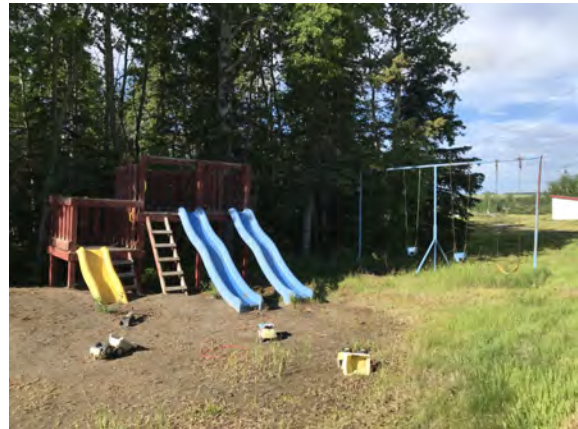
No major deficiencies were observed or reported during the assessment. Worn paint finishes were observed on the wood structure and metal swing sets. Repairs are recommended as part of regular maintenance activities.

<b>Recommendations #1 - Playground Equipment (Playscapes, slides, etc.)</b>	
Type	Life Cycle Replacement
Year	2026
Cost	\$48,168.60

Replace Playground Equipment (Playscapes, slides, etc.)

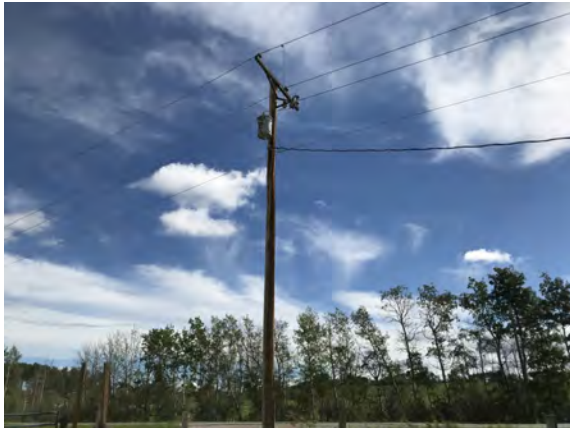
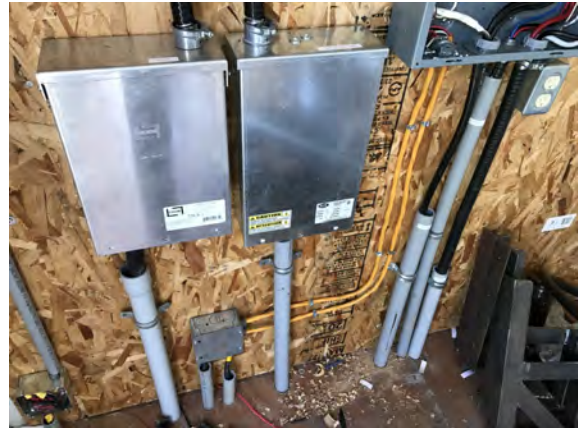
No major deficiencies were observed or reported during the assessment.

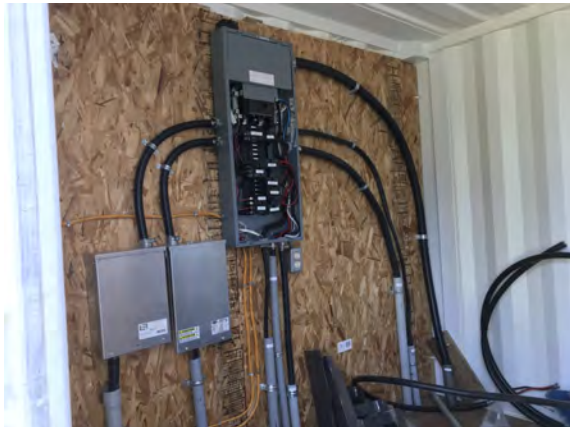
North Peace Fall Fair Grounds - Site - G401020

No major deficiencies were observed or reported during the assessment.

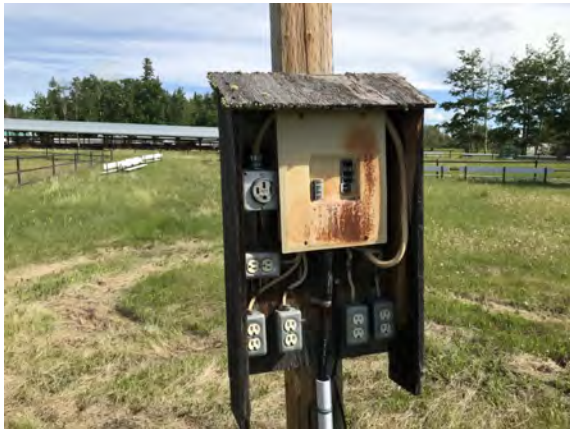
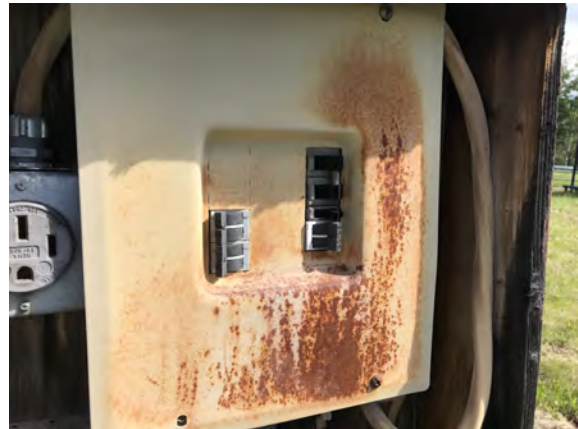
The panelboard has reached its end of its expected useful life and is exhibiting wear and tear that is consistent with the age of the materials. The panelboard is showing signs of corrosion. Lifecycle replacement is recommended within the short-term evaluation period. Difficulty factor has been adjusted to reflect the size of panelboard.

<b>Recommendations #1 - Site Panelboards</b>	
Type	Life Cycle Replacement
Year	2025
Cost	\$6,534.50

Replace Site Panelboards

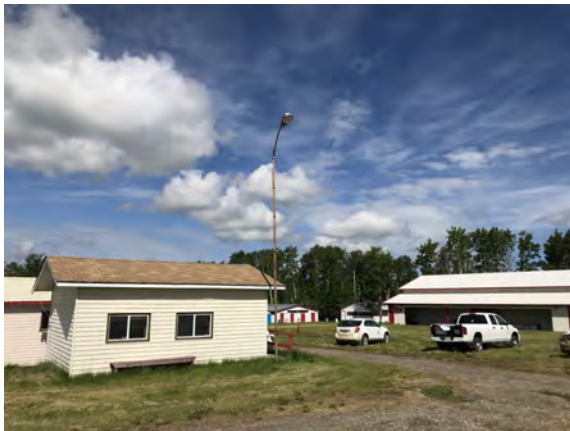
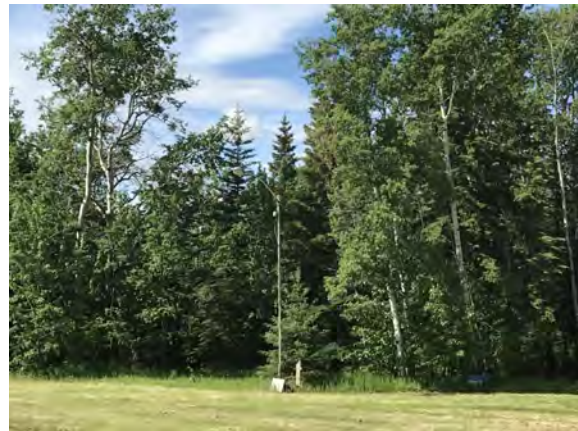
The posts have reached the end their expected useful life and is exhibiting wear and tear that is consistent with the age of the materials Lifecycle replacement is recommended within the short-term evaluation period.

<b>Recommendations #1 - Light Poles - 40' high</b>	
Type	Life Cycle Replacement
Year	2025
Cost	\$11,202.00

Replace Light Poles - 40' high

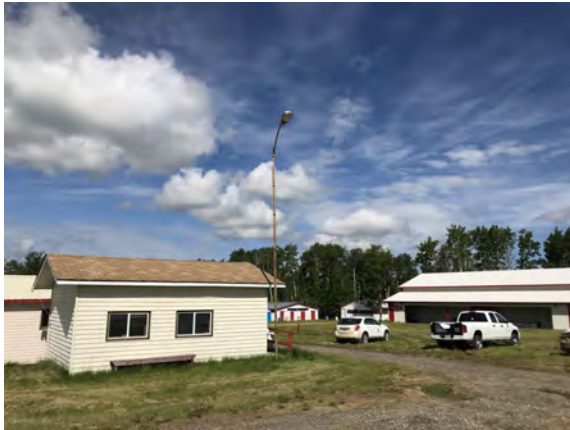
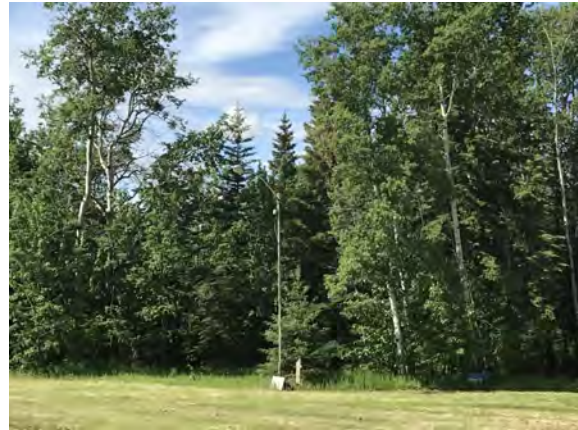
The light fixtures have reached the end their expected useful life and is exhibiting wear and tear that is consistent with the age of the materials Lifecycle replacement is recommended within the short-term evaluation period.

<b>Recommendations #1 - Pole Light Fixtures</b>	
Type	Life Cycle Replacement
Year	2025
Cost	\$5,601.00

Replace Pole Light Fixtures
