Peace River Regional District

**Facility Condition Assessment Report
Moberly Lake Community Hall**

November 16, 2021

Prepared by:
FCAPX a Division of Roth IAMS
Project No. 21075
www.fcapx.com

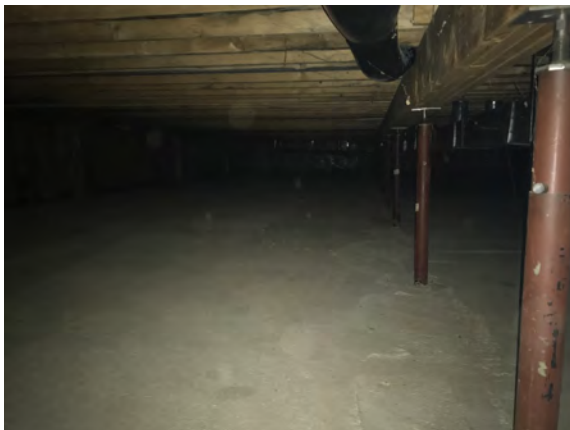
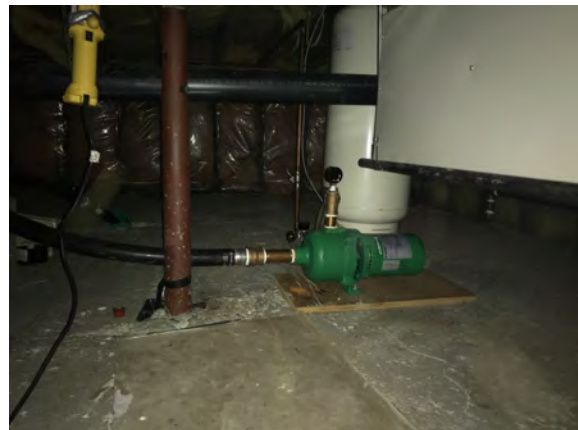
Moberly Lake Community Hall - A103001

No major deficiencies were observed or reported.

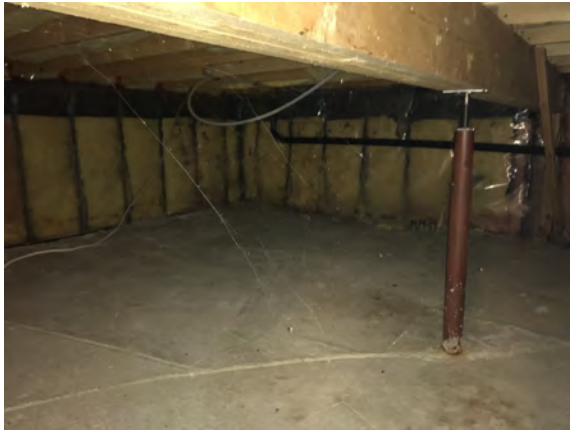
Moberly Lake Community Hall - A202001

No major deficiencies were observed or reported. It is understood that the original building structure, while constructed in 1991, was relocated to Moberly Lake in 2003. It is assumed that new foundations were installed at that time.

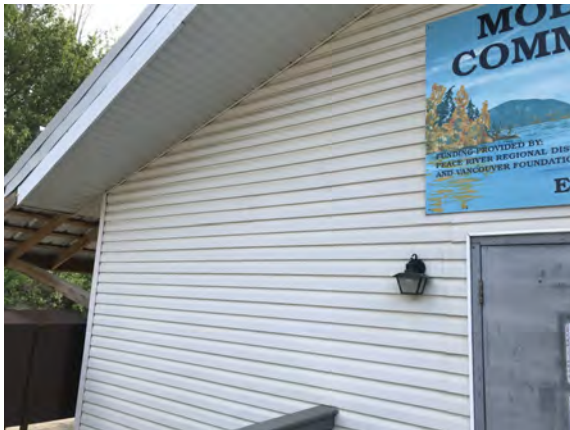
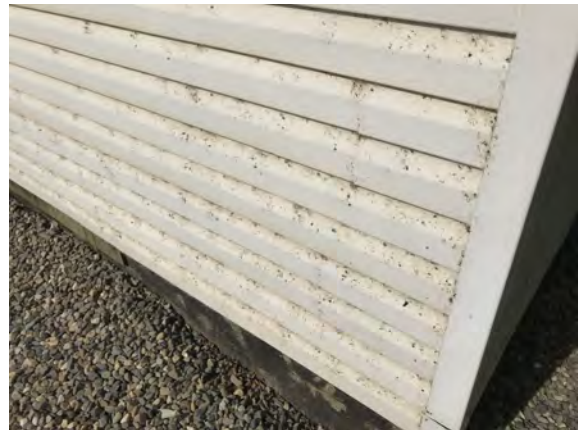
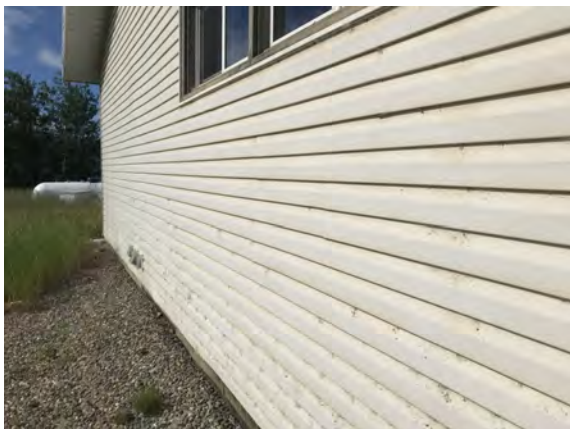
Moberly Lake Community Hall - B201025

No major deficiencies were observed or reported.

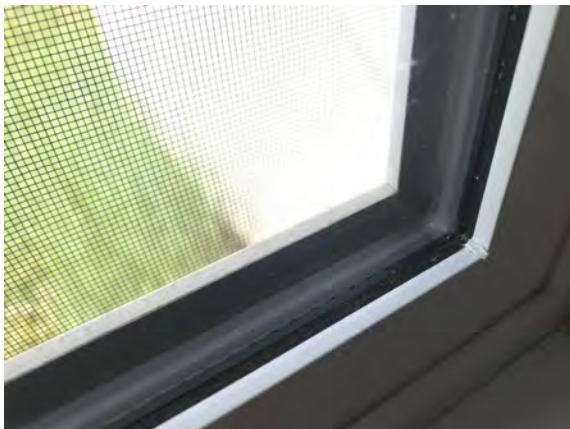
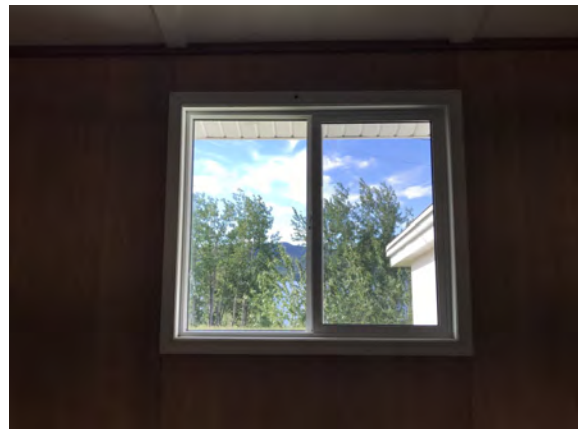
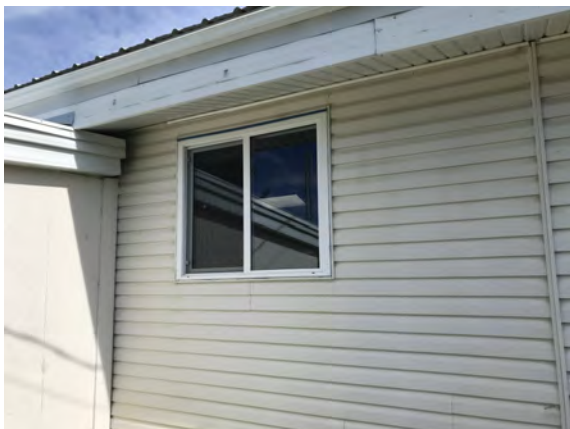
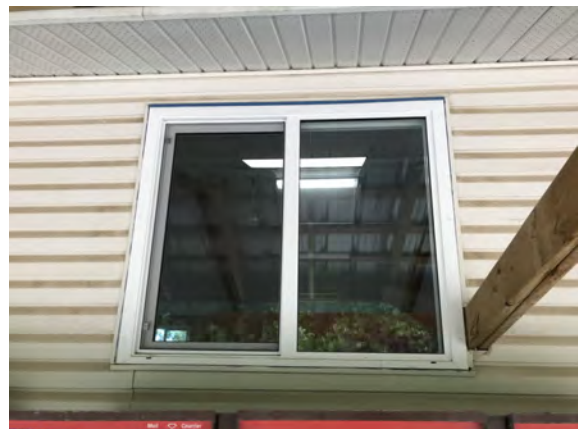
Moberly Lake Community Hall - B202001

No major deficiencies were observed or reported.

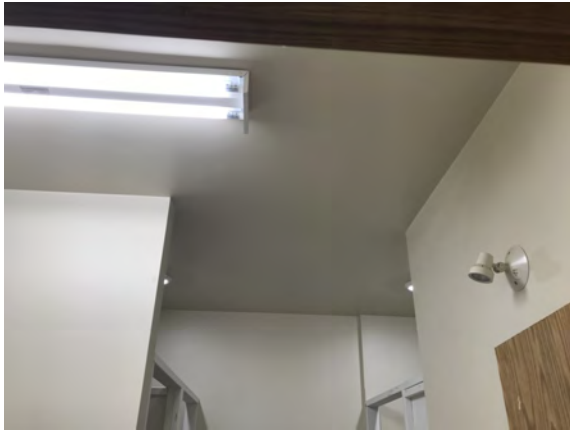
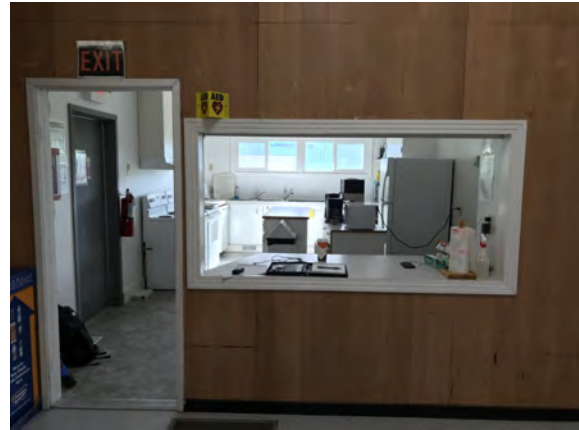
Moberly Lake Community Hall - C101001

No major deficiencies were observed or reported. The difficulty factor has been reduced to account for the limited number of interior fixed partitions.

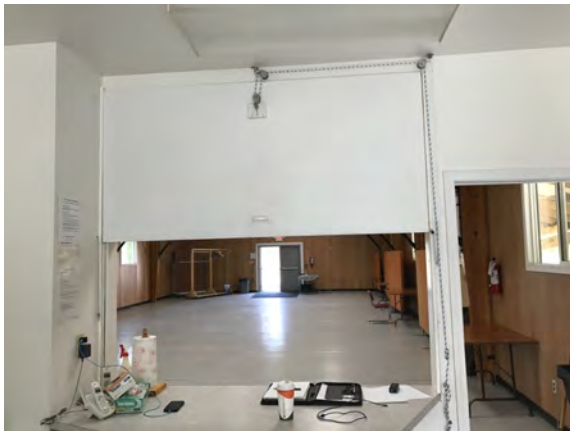
Moberly Lake Community Hall - C101027

No major deficiencies were observed or reported. The difficulty factor has been reduced to account for the construction type of the counter shutter.

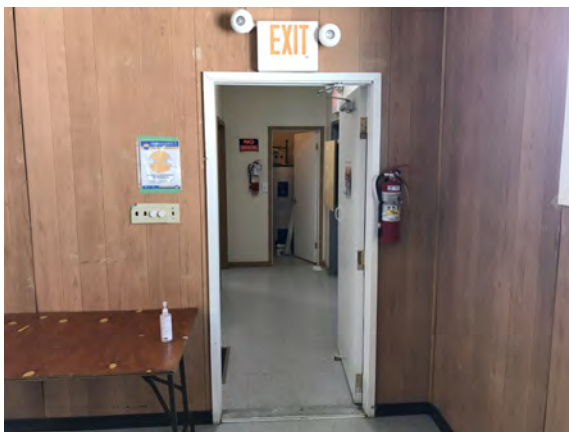
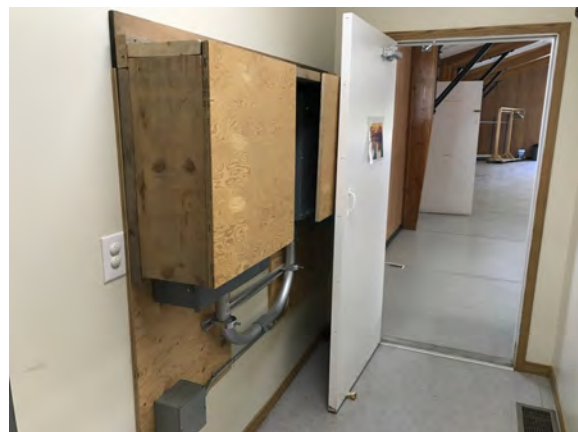
Moberly Lake Community Hall - C102022

No major deficiencies were observed or reported.

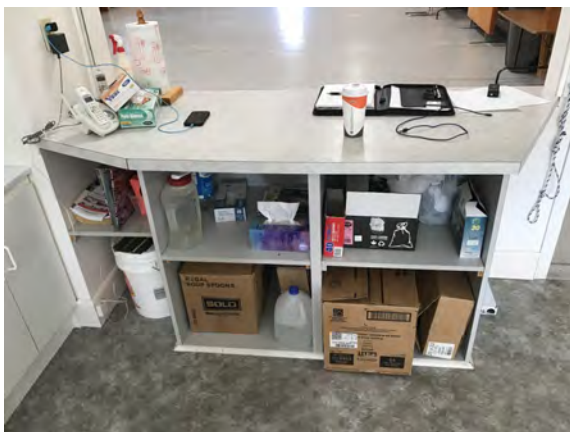
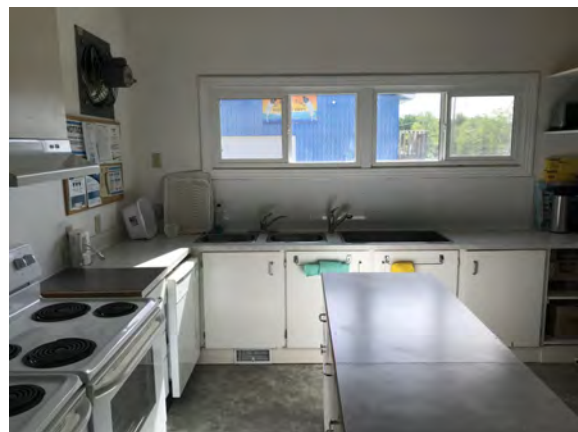
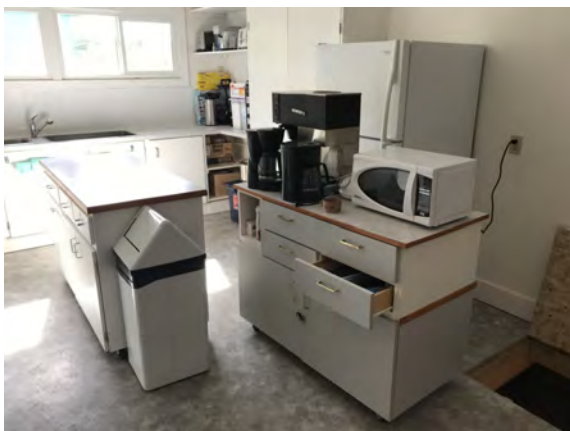
Moberly Lake Community Hall - C103009

No major deficiencies were observed or reported.

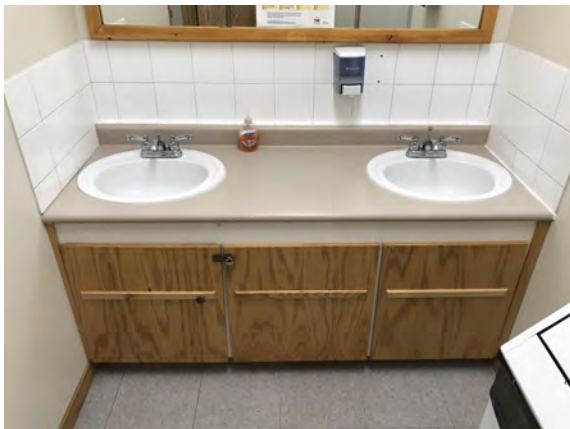
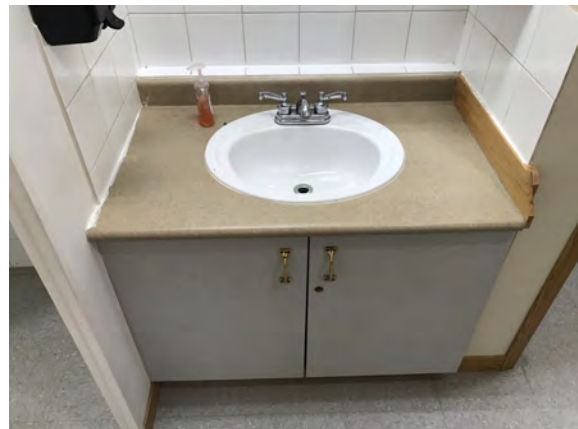
Moberly Lake Community Hall - C103010

No major deficiencies were observed or reported. The cost adjustment factor has been increased to account for the type of vanity construction.

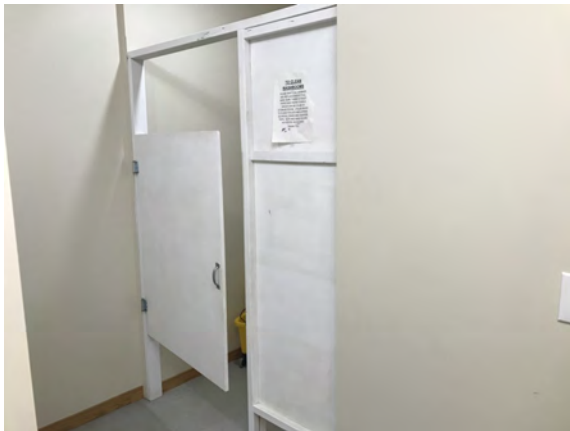
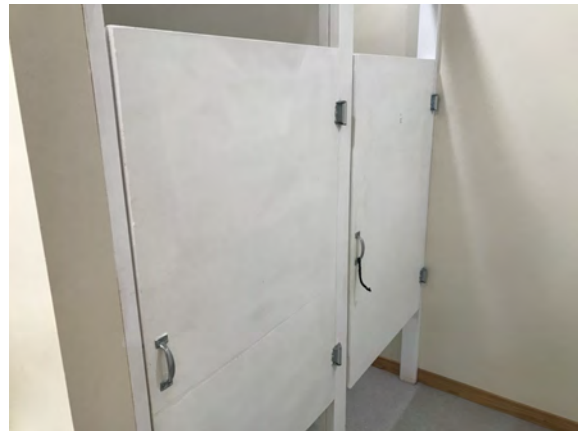
Moberly Lake Community Hall - C103028

No major deficiencies were observed or reported. The component will reach its expected useful life, however lifecycle replacement has been extended to a later year due to the absence of significant deficiencies. The cost adjustment factor has been reduced to account for the construction type.

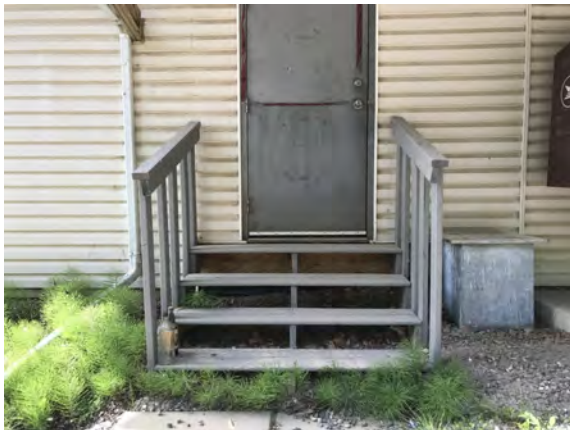
Moberly Lake Community Hall - C201002

No major deficiencies were observed or reported.

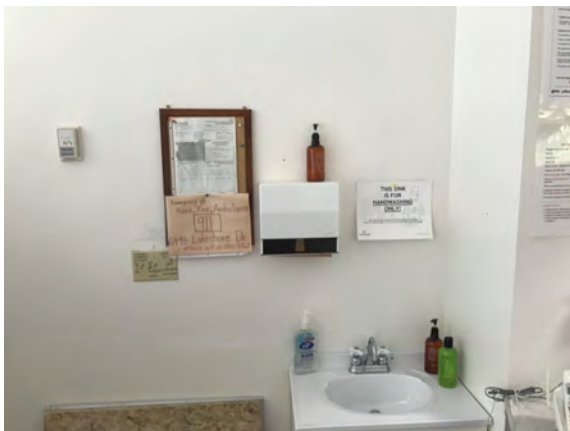
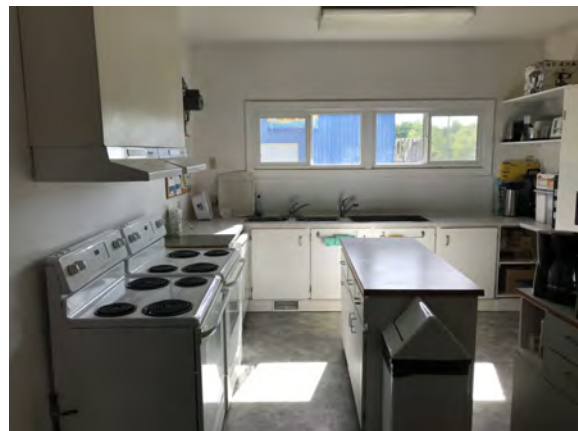
Moberly Lake Community Hall - C301005

No major deficiencies were observed or reported. The component will reach its expected useful life, however lifecycle replacement has been extended to a later year due to the absence of significant deficiencies.

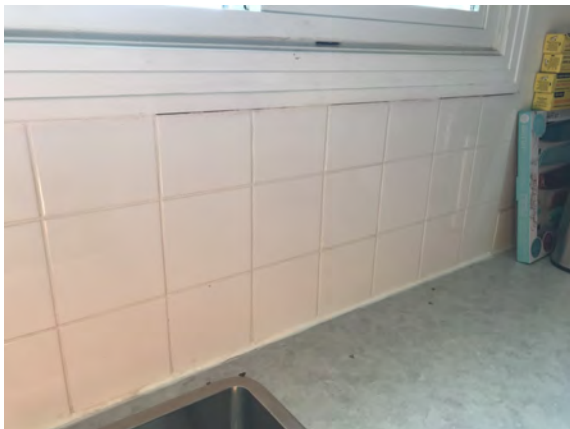
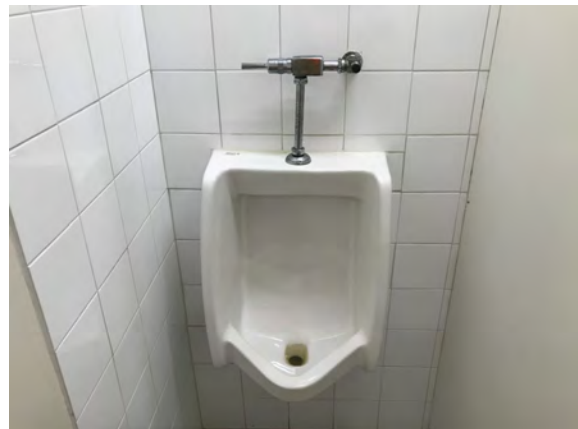
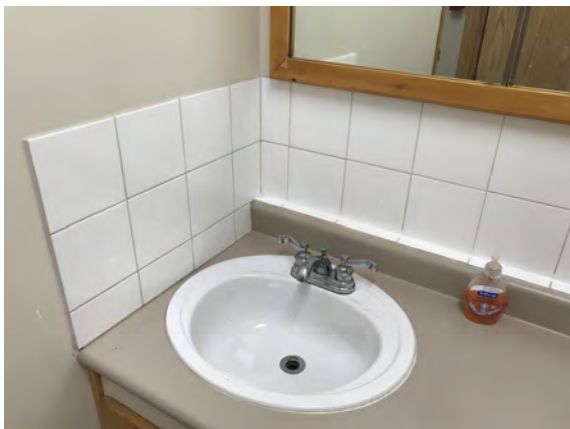
Moberly Lake Community Hall - C301023

No major deficiencies were observed or reported.

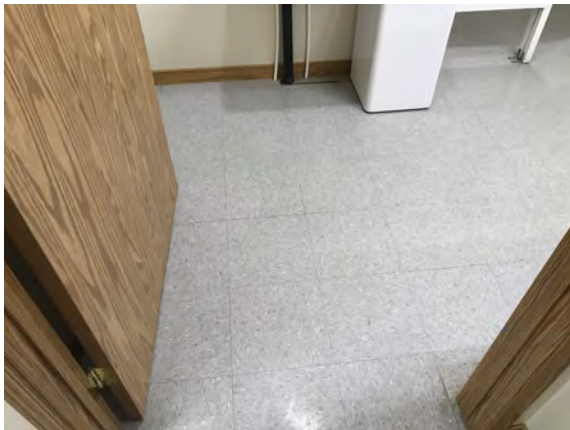
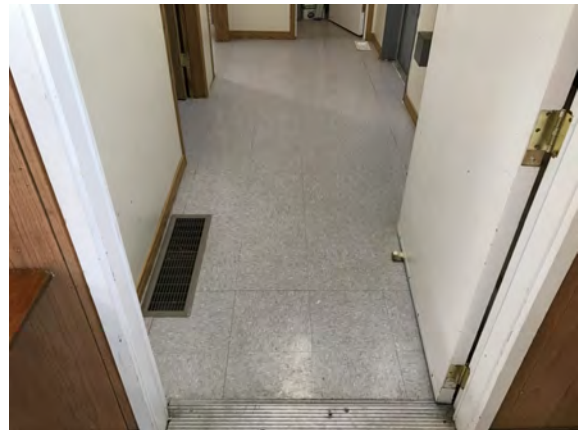
Moberly Lake Community Hall - C302022

No major deficiencies were observed or reported. The component has exceeded its expected useful life, however lifecycle replacement has been extended to a later year due to the absence of significant deficiencies.

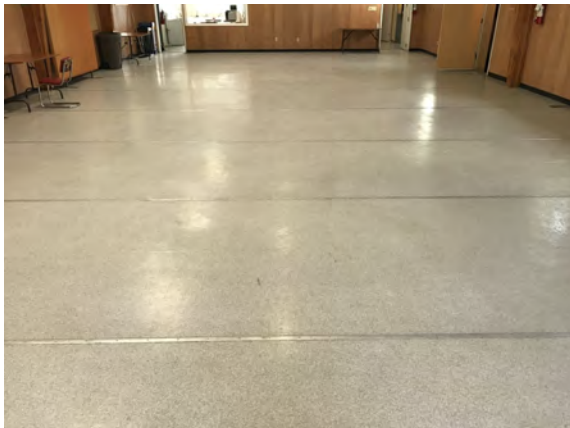
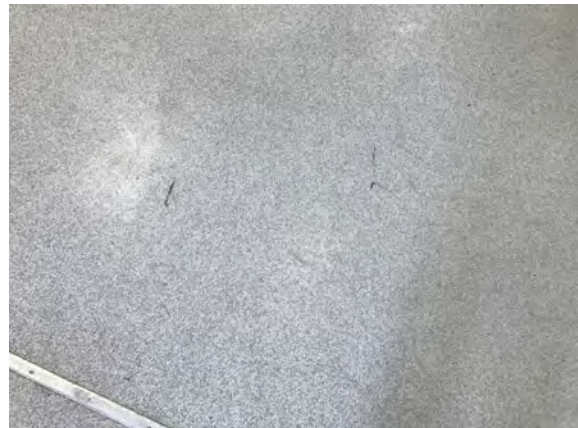
Moberly Lake Community Hall - C302023

The flooring has exceeded its expected useful life and is exhibiting wear and tear that is consistent with the age of the materials including a worn finish, gouges, and stains. Lifecycle replacement is recommended.

Recommendations #1 - Vinyl Sheet Floor	
Type	Life Cycle Replacement
Year	2022
Cost	\$34,502.16

Replace Vinyl Sheet Floor

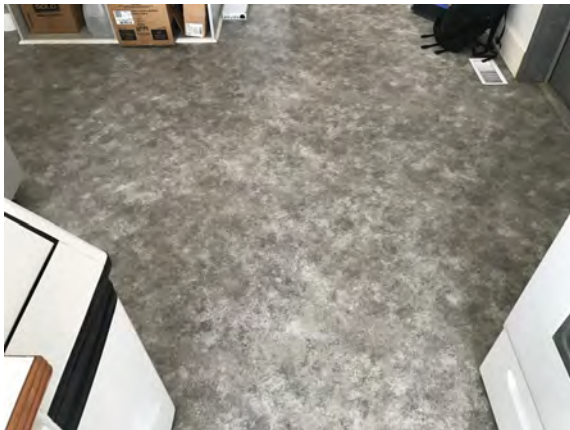
Moberly Lake Community Hall - C302023

Element Description	
Name	C302023 - Vinyl Sheet Floor - 2003
Installation Year	2003
Condition	2 - Good
Expected Useful Life	15 Years
Remaining Useful Life	6 Years
Renewal Year	2027
Quantity / Unit of Measure	23 / SM
Unit Cost	\$120.00
Difficulty / Regional / Soft Cost Factors	1.00 / 1.867 / 1
Replacement Cost	\$5,152.92

No major deficiencies were observed or reported. The component has exceeded its expected useful life, however lifecycle replacement has been extended to a later year due to the absence of significant deficiencies.

Recommendations #1 - Vinyl Sheet Floor	
Type	Life Cycle Replacement
Year	2027
Cost	\$5,152.92

Replace Vinyl Sheet Floor

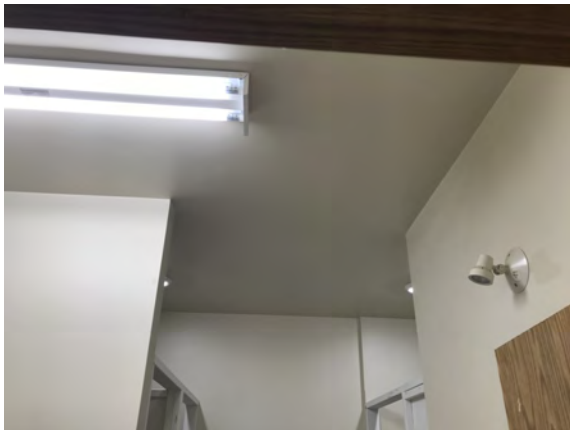
Moberly Lake Community Hall - C303006

Element Description	
Name	C303006 - Painted Ceiling Structures
Installation Year	2011
Condition	2 - Good
Expected Useful Life	15 Years
Remaining Useful Life	6 Years
Renewal Year	2027
Quantity / Unit of Measure	53 / SM
Unit Cost	\$30.00
Difficulty / Regional / Soft Cost Factors	1.00 / 1.867 / 1
Replacement Cost	\$2,968.53

No major deficiencies were observed or reported. The component will reach its expected useful life, however lifecycle replacement has been extended to a later year due to the absence of significant deficiencies.

Recommendations #1 - Painted Ceiling Structures	
Type	Life Cycle Replacement
Year	2027
Cost	\$2,968.53

Replace Painted Ceiling Structures

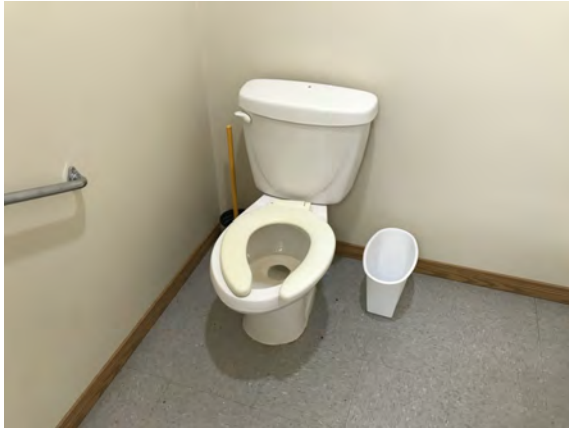
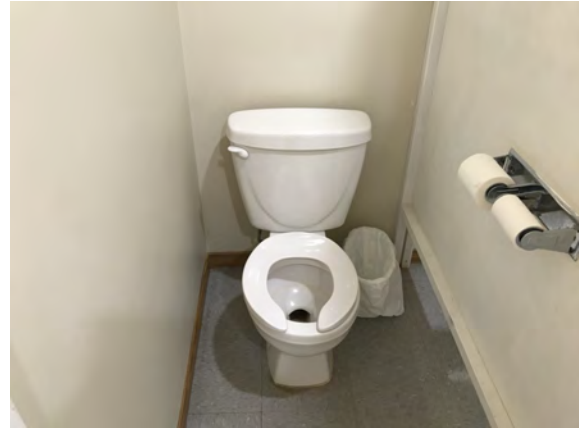
Moberly Lake Community Hall - D201001

Element Description	
Name	D201001 - Water Closets
Installation Year	2003
Condition	2 - Good
Expected Useful Life	35 Years
Remaining Useful Life	17 Years
Renewal Year	2038
Quantity / Unit of Measure	4 / Each
Unit Cost	\$1,000.00
Difficulty / Regional / Soft Cost Factors	1.00 / 1.867 / 1
Replacement Cost	\$7,468.00

No major deficiencies were observed or reported.

Recommendations #1 - Water Closets	
Type	Life Cycle Replacement
Year	2038
Cost	\$7,468.00

Replace Water Closets

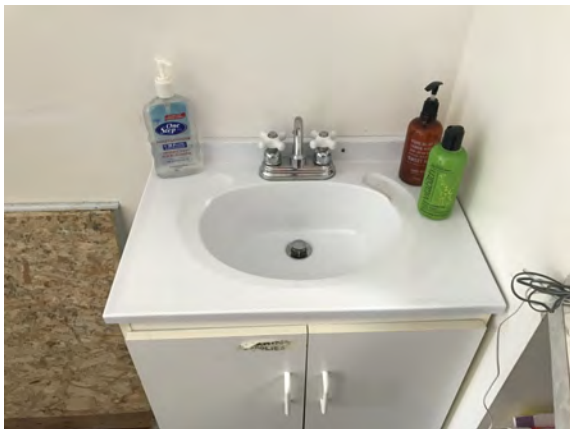
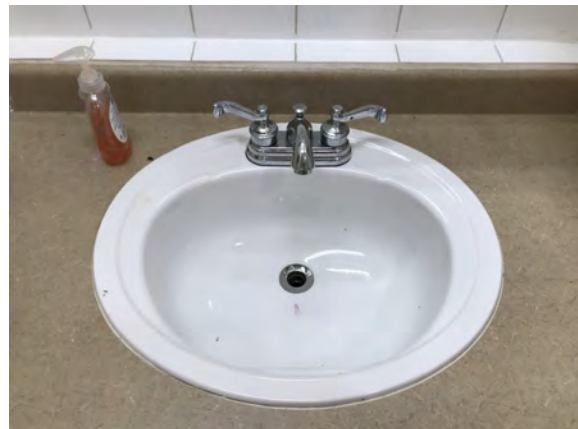
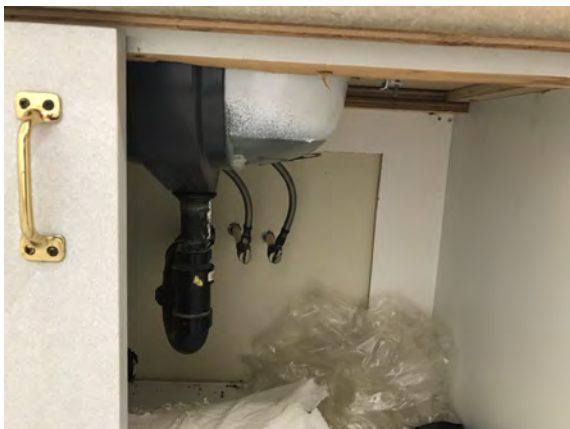
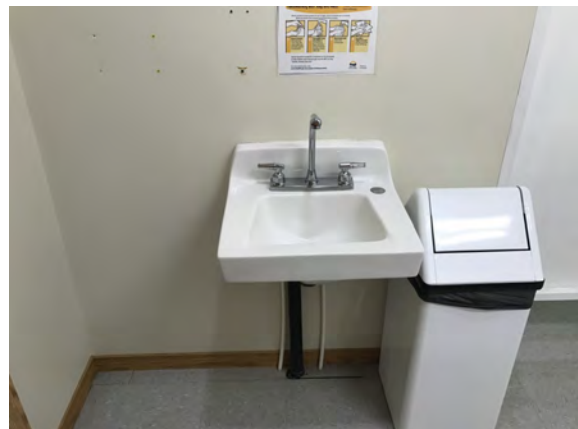
Moberly Lake Community Hall - D201003

Element Description	
Name	D201003 - Lavatories
Installation Year	2003
Condition	2 - Good
Expected Useful Life	35 Years
Remaining Useful Life	17 Years
Renewal Year	2038
Quantity / Unit of Measure	5 / Each
Unit Cost	\$1,000.00
Difficulty / Regional / Soft Cost Factors	1.00 / 1.867 / 1
Replacement Cost	\$9,335.00

No major deficiencies were observed or reported.

Recommendations #1 - Lavatories	
Type	Life Cycle Replacement
Year	2038
Cost	\$9,335.00

Replace Lavatories

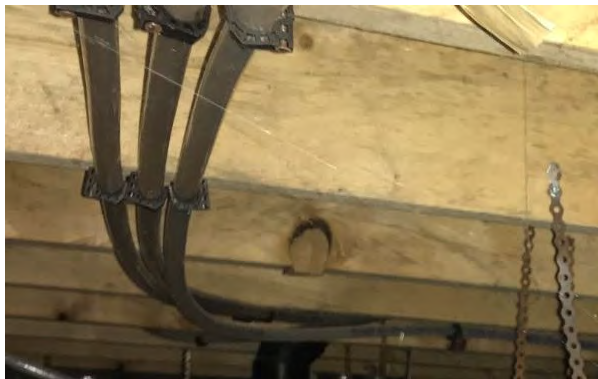
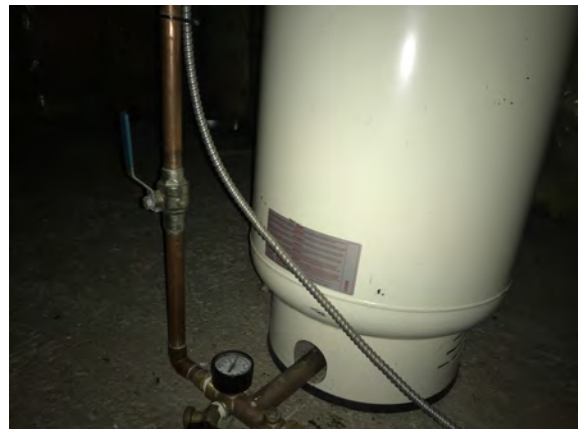
Moberly Lake Community Hall - D202001

Element Description	
Name	D202001 - Domestic Water Pipes and Fittings
Installation Year	2003
Condition	2 - Good
Expected Useful Life	40 Years
Remaining Useful Life	22 Years
Renewal Year	2043
Quantity / Unit of Measure	230 / SM Building
Unit Cost	\$40.00
Difficulty / Regional / Soft Cost Factors	1.00 / 1.867 / 1
Replacement Cost	\$17,176.40

No major deficiencies were observed or reported. The exterior buried domestic water tank is included under the Building Condition Report for the Moberly Fire Hall, as it is shared with, and maintained by the Fire Hall.

Recommendations #1 - Domestic Water Pipes and Fittings	
Type	Life Cycle Replacement
Year	2043
Cost	\$17,176.40

Replace Domestic Water Pipes and Fittings

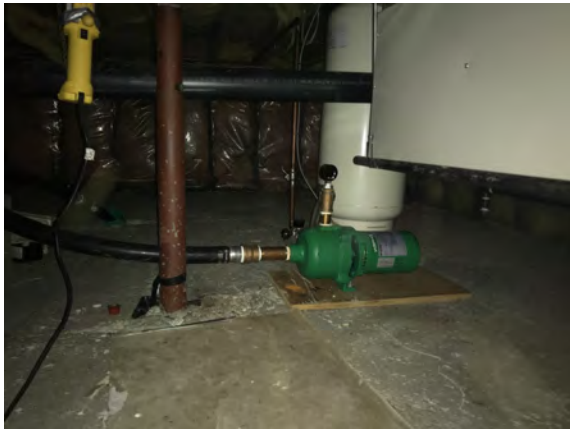
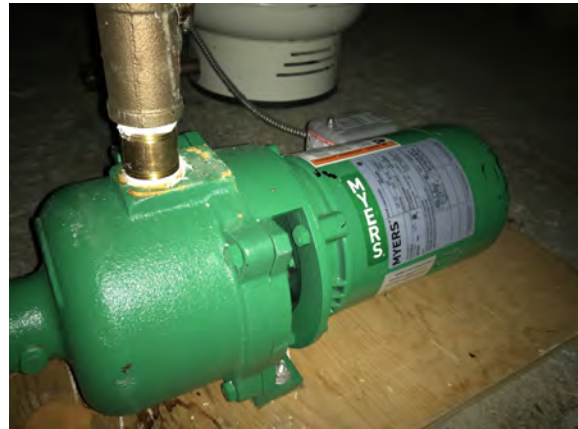
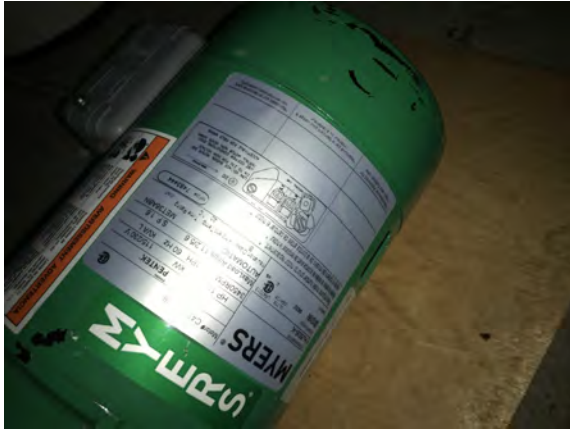
Moberly Lake Community Hall - D202006

Element Description	
Name	D202006 - Domestic Water Booster Systems/Pumps
Installation Year	2003
Condition	3 - Fair
Expected Useful Life	20 Years
Remaining Useful Life	4 Years
Renewal Year	2025
Quantity / Unit of Measure	1 / Each
Unit Cost	\$10,000.00
Difficulty / Regional / Soft Cost Factors	0.20 / 1.867 / 1
Replacement Cost	\$3,734.00

No major deficiencies were observed or reported. The component will reach its expected useful life, however lifecycle replacement has been extended to a later year due to the absence of significant deficiencies. The difficulty factor has been decreased to account for the size of the pump.

Recommendations #1 - Domestic Water Booster Systems/Pumps	
Type	Life Cycle Replacement
Year	2025
Cost	\$3,734.00

Replace Domestic Water Booster Systems/Pumps

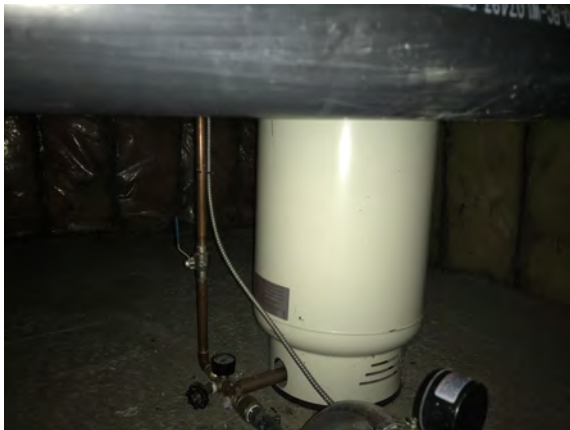
Moberly Lake Community Hall - D202008

Element Description	
Name	D202008 - Domestic Water Expansion Tanks/Pressure Tank
Installation Year	2003
Condition	2 - Good
Expected Useful Life	30 Years
Remaining Useful Life	12 Years
Renewal Year	2033
Quantity / Unit of Measure	1 / Each
Unit Cost	\$4,000.00
Difficulty / Regional / Soft Cost Factors	0.40 / 1.867 / 1
Replacement Cost	\$2,987.20

No major deficiencies were observed or reported. The difficulty factor has been decreased to account for the residential grade equipment.

Recommendations #1 - Domestic Water Expansion Tanks/Pressure Tank	
Type	Life Cycle Replacement
Year	2033
Cost	\$2,987.20

Replace Domestic Water Expansion Tanks/Pressure Tank

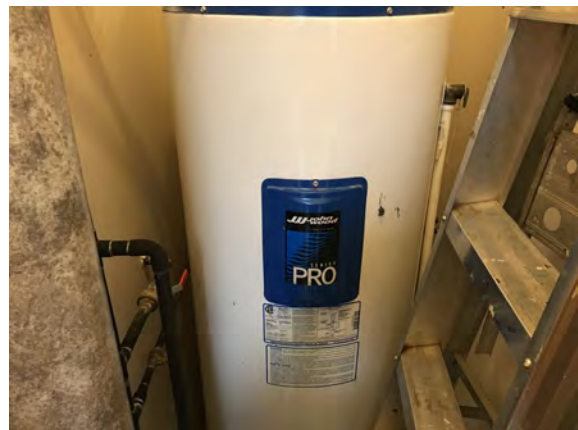
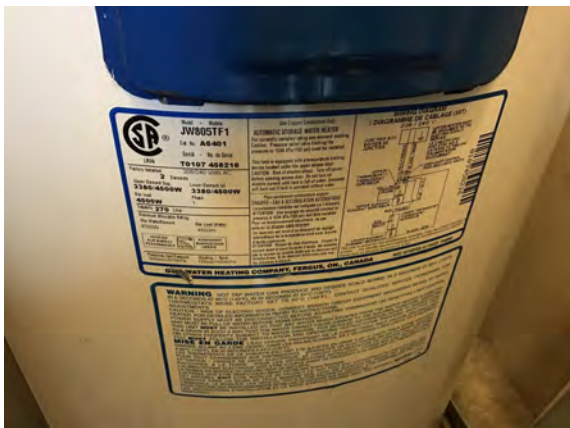
Moberly Lake Community Hall - D202035

Element Description	
Name	D202035 - Electric Domestic Water Heaters (Residential Tank Type)
Installation Year	2003
Condition	3 - Fair
Expected Useful Life	12 Years
Remaining Useful Life	3 Years
Renewal Year	2024
Quantity / Unit of Measure	270 / Liter
Unit Cost	\$25.00
Difficulty / Regional / Soft Cost Factors	1.00 / 1.867 / 1
Replacement Cost	\$12,602.25

No major deficiencies were observed or reported, however, based on the age of the unit, lifecycle replacement is recommended within the short-term evaluation period.

Recommendations #1 - Electric Domestic Water Heaters (Residential Tank Type)	
Type	Life Cycle Replacement
Year	2024
Cost	\$12,602.25

Replace Electric Domestic Water Heaters (Residential Tank Type)

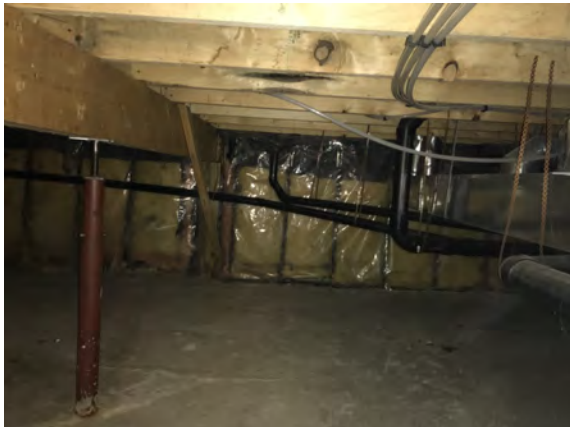
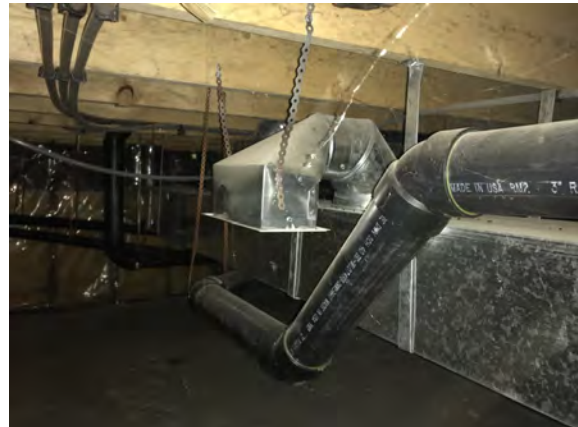
Moberly Lake Community Hall - D203001

Element Description	
Name	D203001 - Sanitary Waste and Vent Piping
Installation Year	2003
Condition	2 - Good
Expected Useful Life	50 Years
Remaining Useful Life	32 Years
Renewal Year	2053
Quantity / Unit of Measure	230 / SM Building
Unit Cost	\$45.00
Difficulty / Regional / Soft Cost Factors	1.00 / 1.867 / 1
Replacement Cost	\$19,323.45

No major deficiencies were observed or reported.

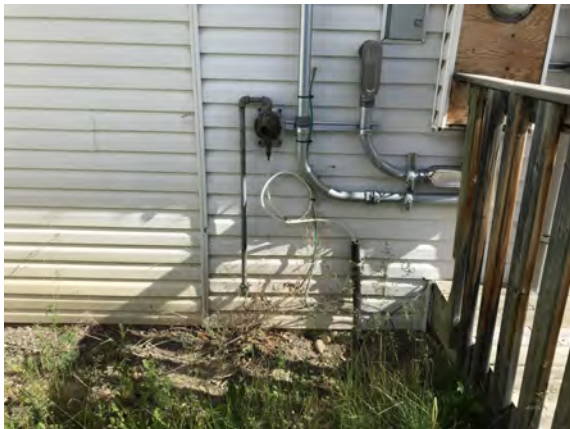
Moberly Lake Community Hall - D301002

Element Description	
Name	D301002 - Gas Supply Systems
Installation Year	2003
Condition	2 - Good
Expected Useful Life	40 Years
Remaining Useful Life	22 Years
Renewal Year	2043
Quantity / Unit of Measure	230 / SM
Unit Cost	\$20.00
Difficulty / Regional / Soft Cost Factors	1.30 / 1.867 / 1
Replacement Cost	\$11,164.66

No major deficiencies were observed or reported. The exterior propane tank is utility-owned and operated and is not included within this report. The cost adjustment factor has been increased to account for the small section of the buried propane line connecting to the utility-owned tank.

Recommendations #1 - Gas Supply Systems	
Type	Life Cycle Replacement
Year	2043
Cost	\$11,164.66

Replace Gas Supply Systems

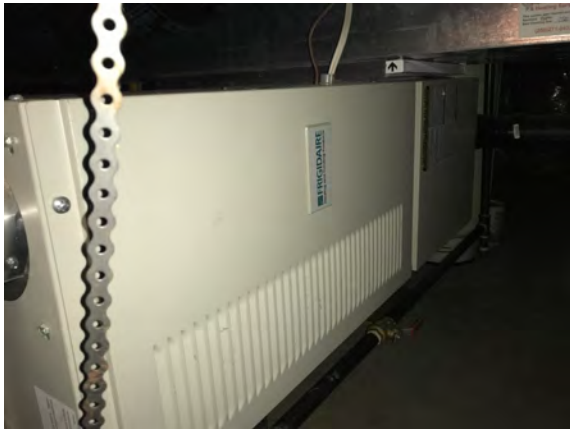
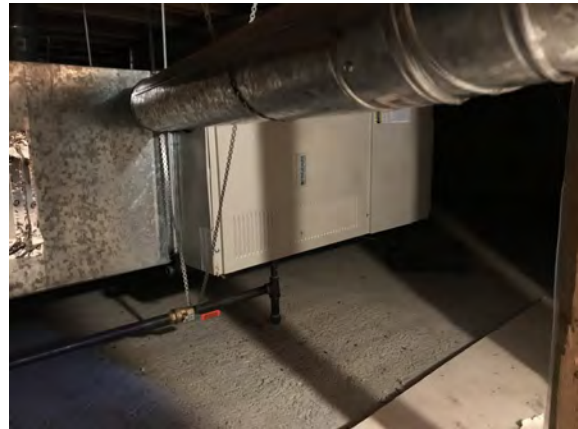
Moberly Lake Community Hall - D302003

Element Description	
Name	D302003 - Fuel Fired Forced Air Furnace
Installation Year	2003
Condition	2 - Good
Expected Useful Life	18 Years
Remaining Useful Life	3 Years
Renewal Year	2024
Quantity / Unit of Measure	200 / MBH
Unit Cost	\$40.00
Difficulty / Regional / Soft Cost Factors	1.00 / 1.867 / 1
Replacement Cost	\$14,936.00

No major deficiencies were observed or reported. The component has reach its expected useful life, however lifecycle replacement has been extended to a later year due to the absence of significant deficiencies.

Recommendations #1 - Fuel Fired Forced Air Furnace	
Type	Life Cycle Replacement
Year	2024
Cost	\$14,936.00

Replace Fuel Fired Forced Air Furnace

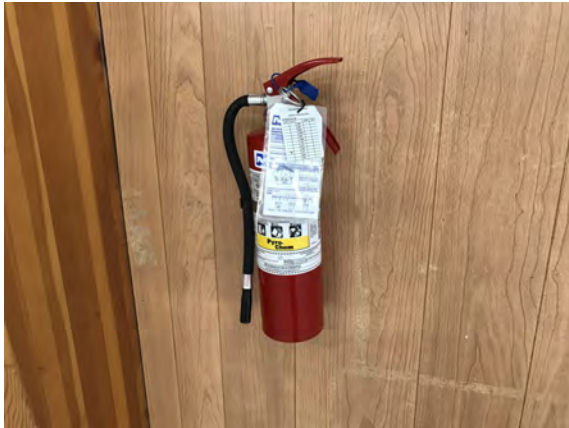
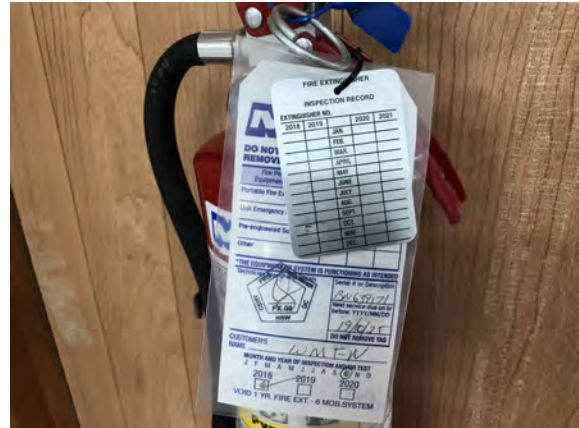
Moberly Lake Community Hall - D403002

The fire extinguishers were observed to have out-of-date annual inspection tags. Annual inspections should be completed on all fire extinguishers within the immediate term as a maintenance activity.

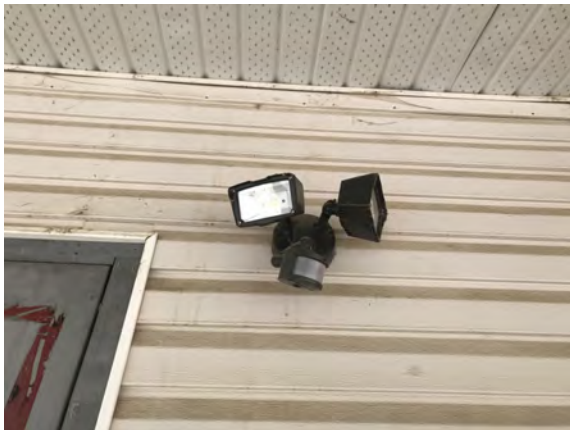
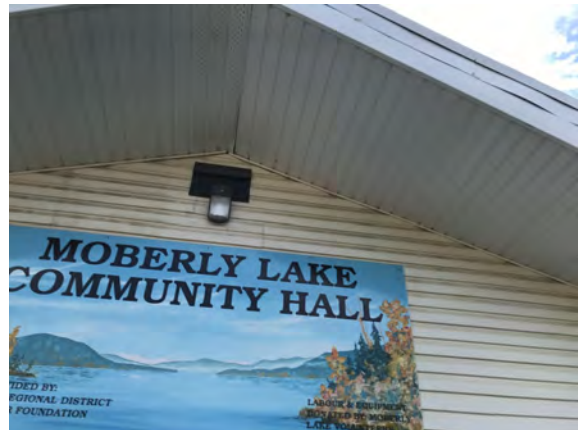
Moberly Lake Community Hall - D502041

No major deficiencies were observed or reported. The component will reach its expected useful life, however lifecycle replacement has been extended to a later year due to the absence of significant deficiencies.

Recommendations #1 - Exterior Lighting	
Type	Life Cycle Replacement
Year	2027
Cost	\$5,601.00

Replace Exterior Lighting

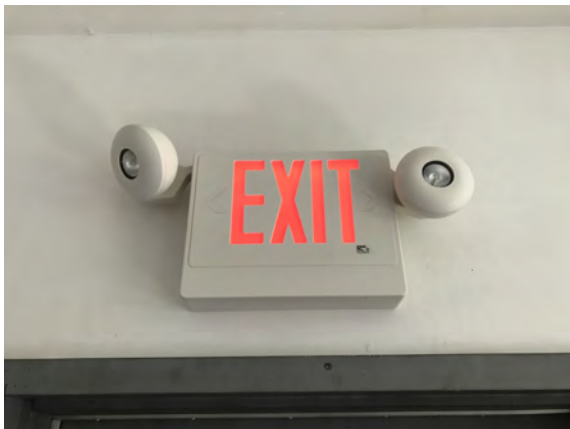
Moberly Lake Community Hall - D502053

No major deficiencies were observed or reported.

Recommendations #1 - Illuminated Combo Exit Signs	
Type	Life Cycle Replacement
Year	2038
Cost	\$3,360.60

Replace Illuminated Combo Exit Signs

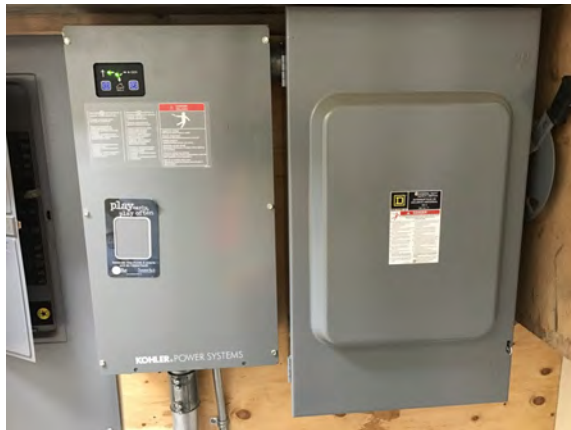
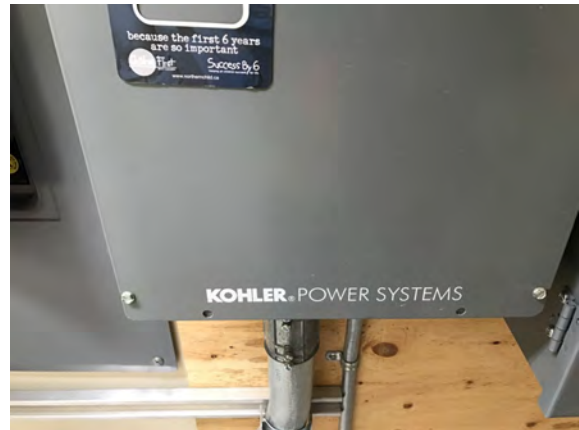
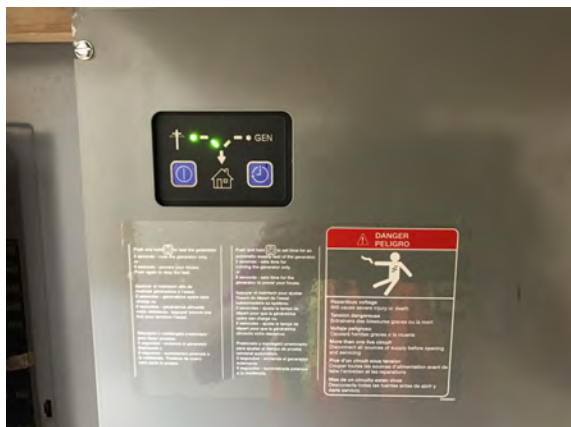
Moberly Lake Community Hall - D509031

No major deficiencies were observed or reported.

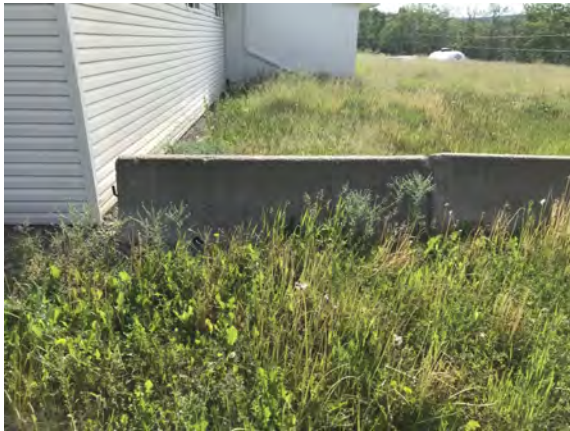
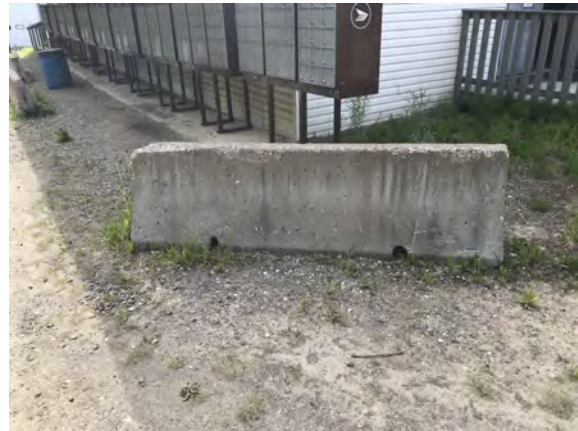
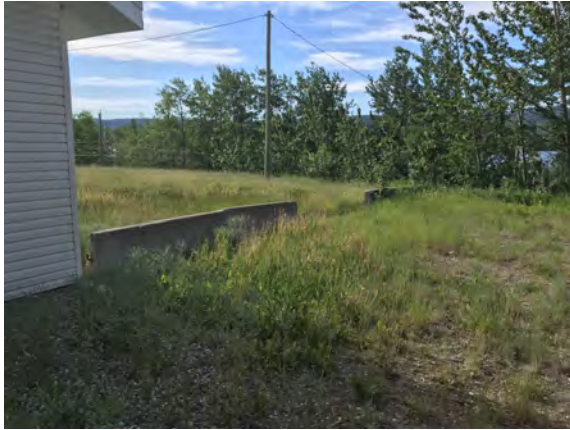
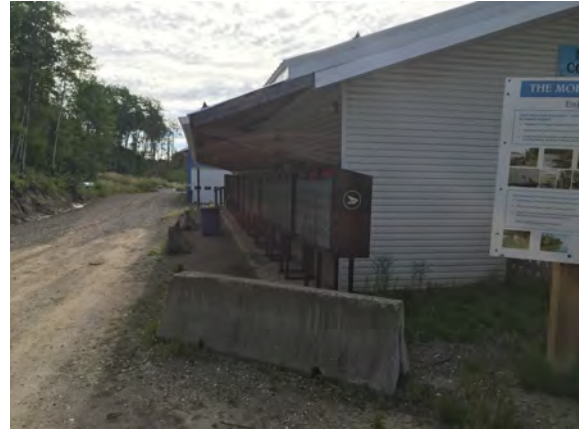
Moberly Lake Community Hall - G201005

No major deficiencies were observed or reported, however, there is some minor spalling and scaling on some sections. It is recommended to paint the barriers with exterior grade high visibility paint to help with visibility. The cost to paint the barriers is presumed to fall below the cost threshold for repair recommendations (\$5,000) and should be completed as a routine maintenance activity.

Recommendations #1 - Guardrails and Barriers	
Type	Life Cycle Replacement
Year	2033
Cost	\$17,923.20

Replace Guardrails and Barriers

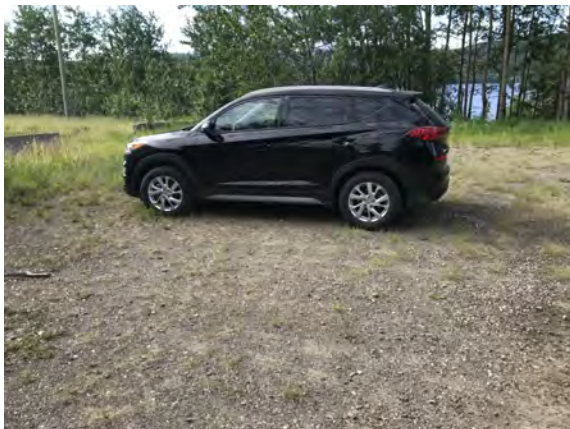
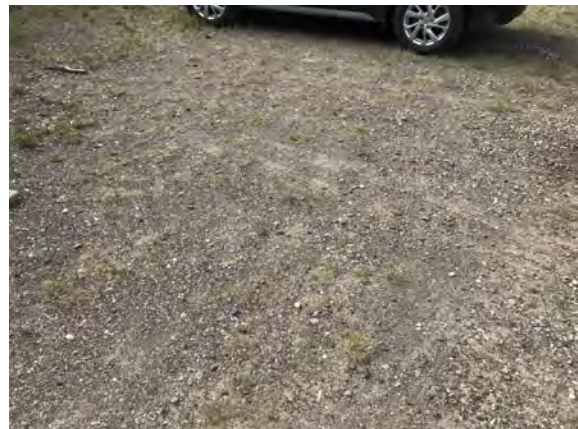
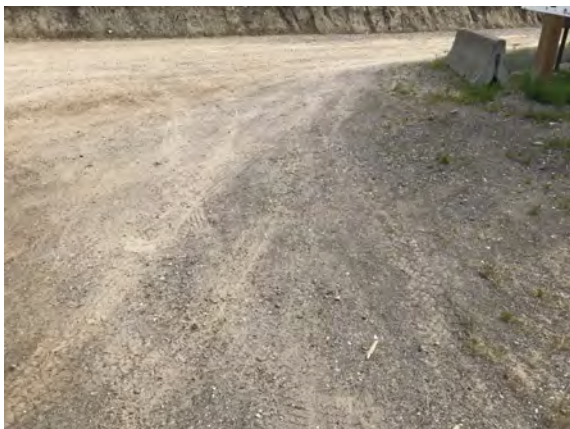
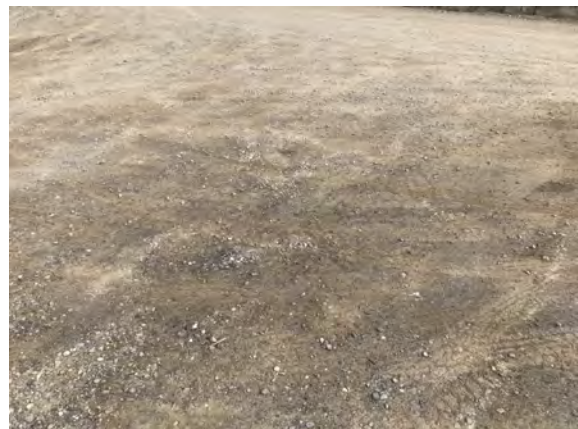
Moberly Lake Community Hall - G202024

No major deficiencies were observed or reported during the assessment. Lifecycle replacement has been deferred.

Recommendations #1 - Gravel Paved Surface - Parking Area	
Type	Life Cycle Replacement
Year	2025
Cost	\$17,503.13

Replace Gravel Paved Surface - Parking Area

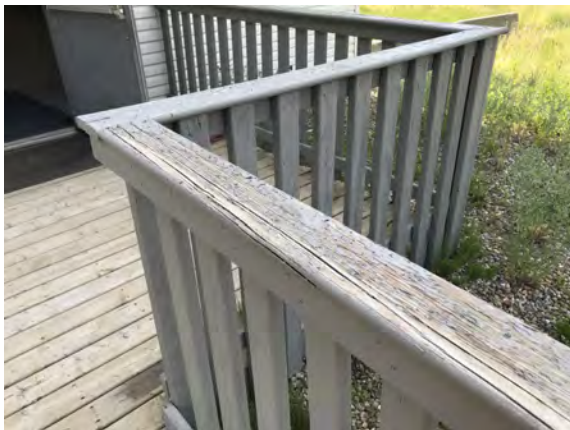
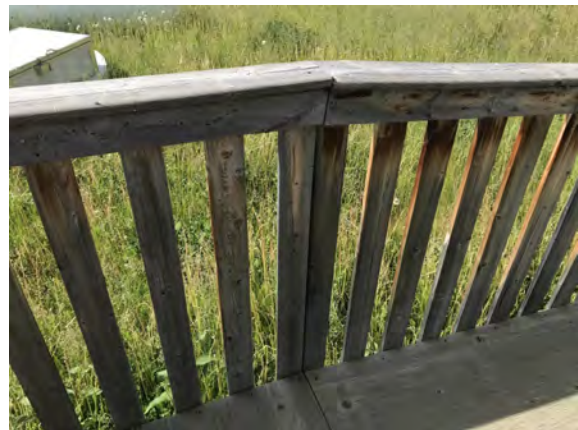
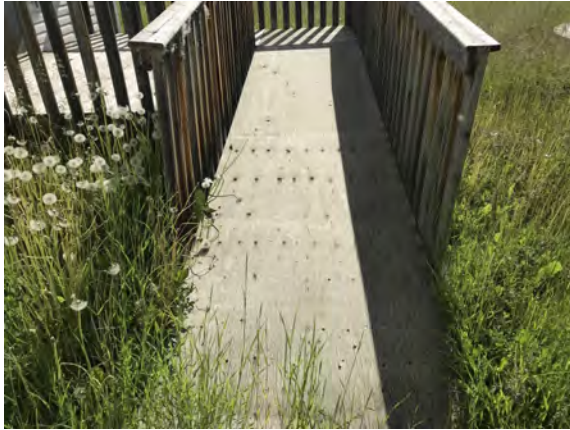
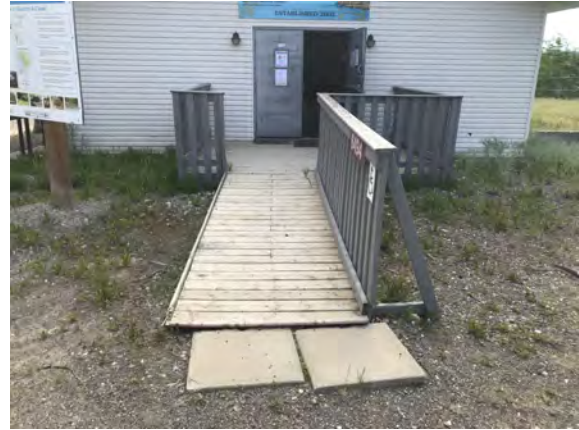
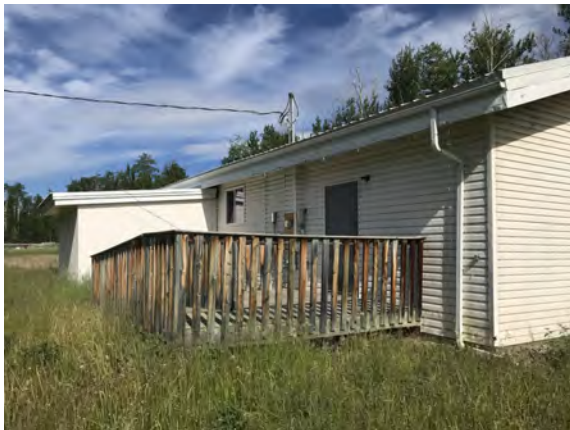
Moberly Lake Community Hall - G203029

The wood ramps and decking are nearing the end of their expected useful life and are exhibiting wear and tear that is consistent with age including a worn finish, localized deterioration of the wood, loose boards and railings, and some shifting. Lifecycle replacement is recommended. In the interim, it is recommended to check railing and decking and replace or repair any loose sections as needed. The cost to complete these repairs is presumed to fall below the cost threshold for repair recommendations (\$5,000) and should be completed as a routine maintenance activity. The cost adjustment factor has been increased to account for the wood-framed deck on the south elevation.

Recommendations #1 - Exterior Ramps - Wood	
Type	Life Cycle Replacement
Year	2023
Cost	\$30,338.75

Replace Exterior Ramps - Wood

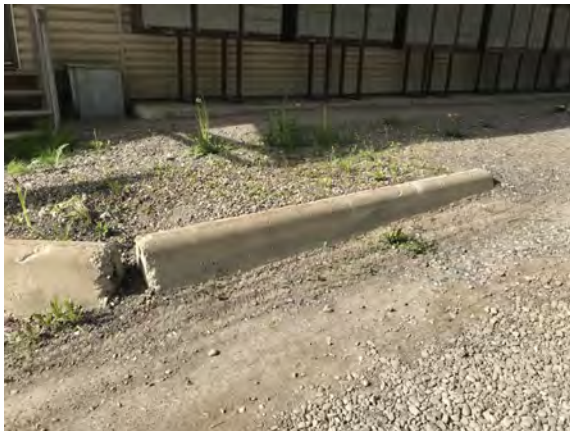
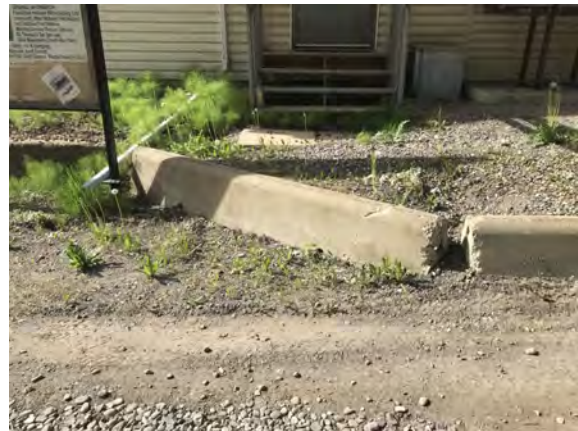
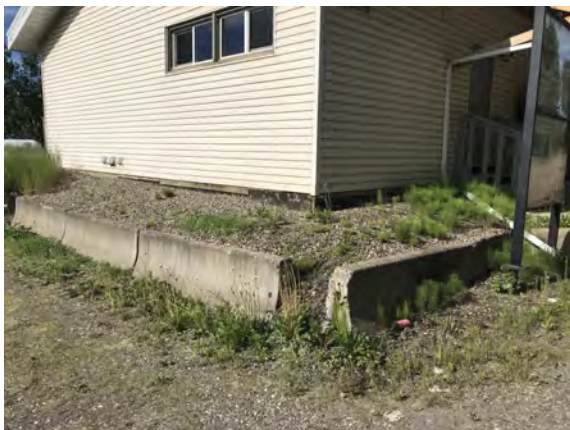
Moberly Lake Community Hall - G204033

No major deficiencies were observed or reported, apart from minor scaling and spalling on concrete surfaces.

Recommendations #1 - Retaining Walls - Precast Concrete Stone	
Type	Life Cycle Replacement
Year	2043
Cost	\$14,002.50

Replace Retaining Walls - Precast Concrete Stone
