Peace River Regional District

**Facility Condition Assessment Report
Moberly Lake Community Hall**

November 16, 2021

Prepared by:
FCAPX a Division of Roth IAMS
Project No. 21075
www.fcapx.com

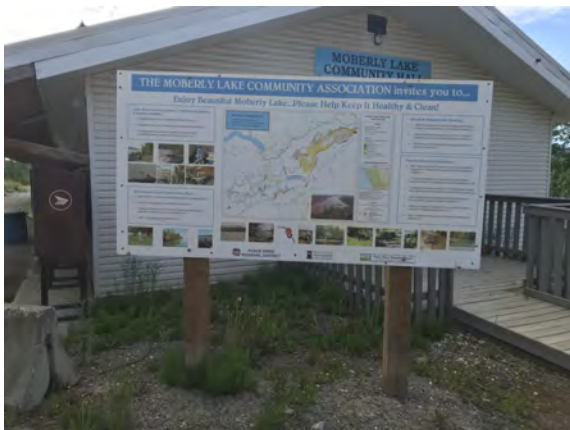
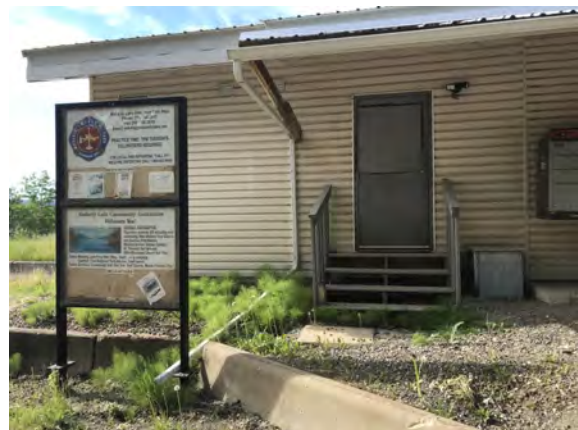
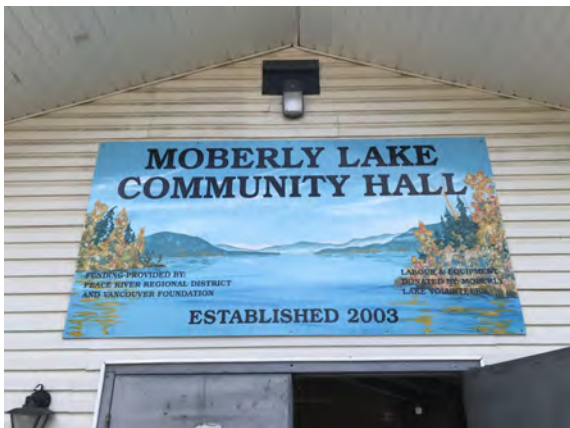
Moberly Lake Community Hall - G204080

No major deficiencies were observed or reported.

Recommendations #1 - Message Sign - Post-Mounted	
Type	Life Cycle Replacement
Year	2035
Cost	\$9,521.70

Replace Message Sign - Post-Mounted
