ROLLA WASTEWATER TREATMENT PLANT CONDITION ASSESSMENT

FINAL - 2020-10-26

PEACE RIVER REGIONAL DISTRICT
CONFIDENTIAL
PROJECT NO. 201-07251-00
AUGUST 2020

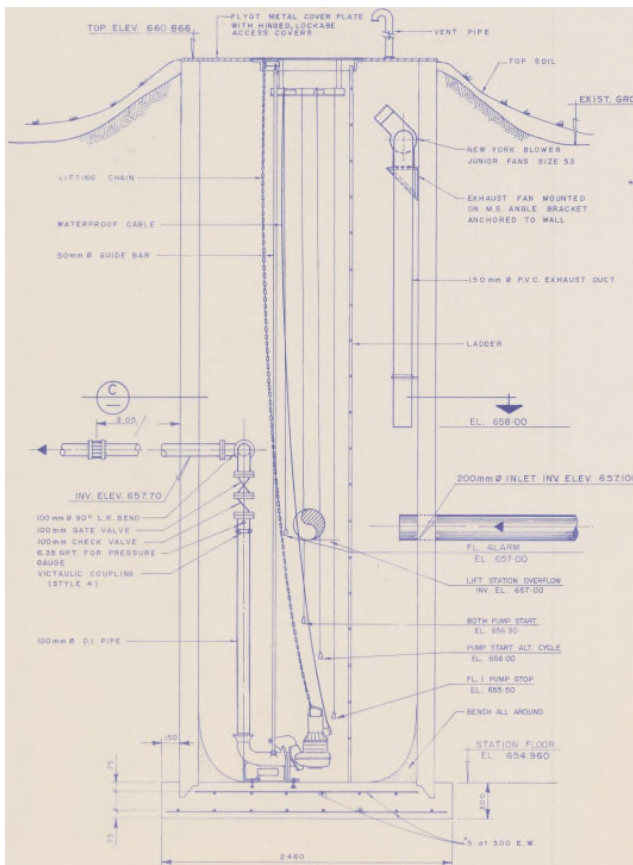
Figure 6: Lift Station Drawing (from Underwood McLellan Drawing Set)

Pumps are approximately 10 years old and are in good condition and pump sufficiently. There are 2 duty pumps and 1 spare on site. Based on their age, these are expected to need replacement in the next 3-10 years, however, pumps operating in severe conditions such as this can fail prematurely or unexpectedly.

It is currently not possible to enter the lift station without a portable man-rescue tripod system. In addition, several rungs are missing from the ladder which should be replaced, to facilitate entry, even with a man-rescue tripod system. The existing ladder rungs should be removed so that personnel are not tempted to use them. Portable ladders should be used.

Based on some water seepage marks on the inside of the lift station, it appears there is some groundwater infiltration. If groundwater becomes a concern, the joints between the concrete barrels could be grouted from the inside.

Lift Station	Repairs	Priority	Probable Cost
LS 1	Pump Operation	Replace pumps as required	3-10 years	\$ 40,000
LS 4	Ladder	Remove ladder rungs. Only use portable man-rescue system for entry with portable ladder.	<1 year	\$ 1,000
LS 5	Handrails & Safety Netting	Install hatch safety netting, handrails	<1 year	\$ 10,000
LS 6	Hatch Lock	Install latches and locks on hatches	<1 year	\$ 1,000
LS 8	Pressure gauge works	Install Pump Pressure Gauges	<1 year	\$ 1,000
LS 16	Lights & electrical	Install lights in lift station	1-3 years	\$ 1,000
LS 17	Drainage around Lift Station	Add concrete ring to raise lift station lid by 0.6m. Seal concrete ring joints with grout to 3m below grade.	1-3 years	\$ 15,000
				\$ 69,000

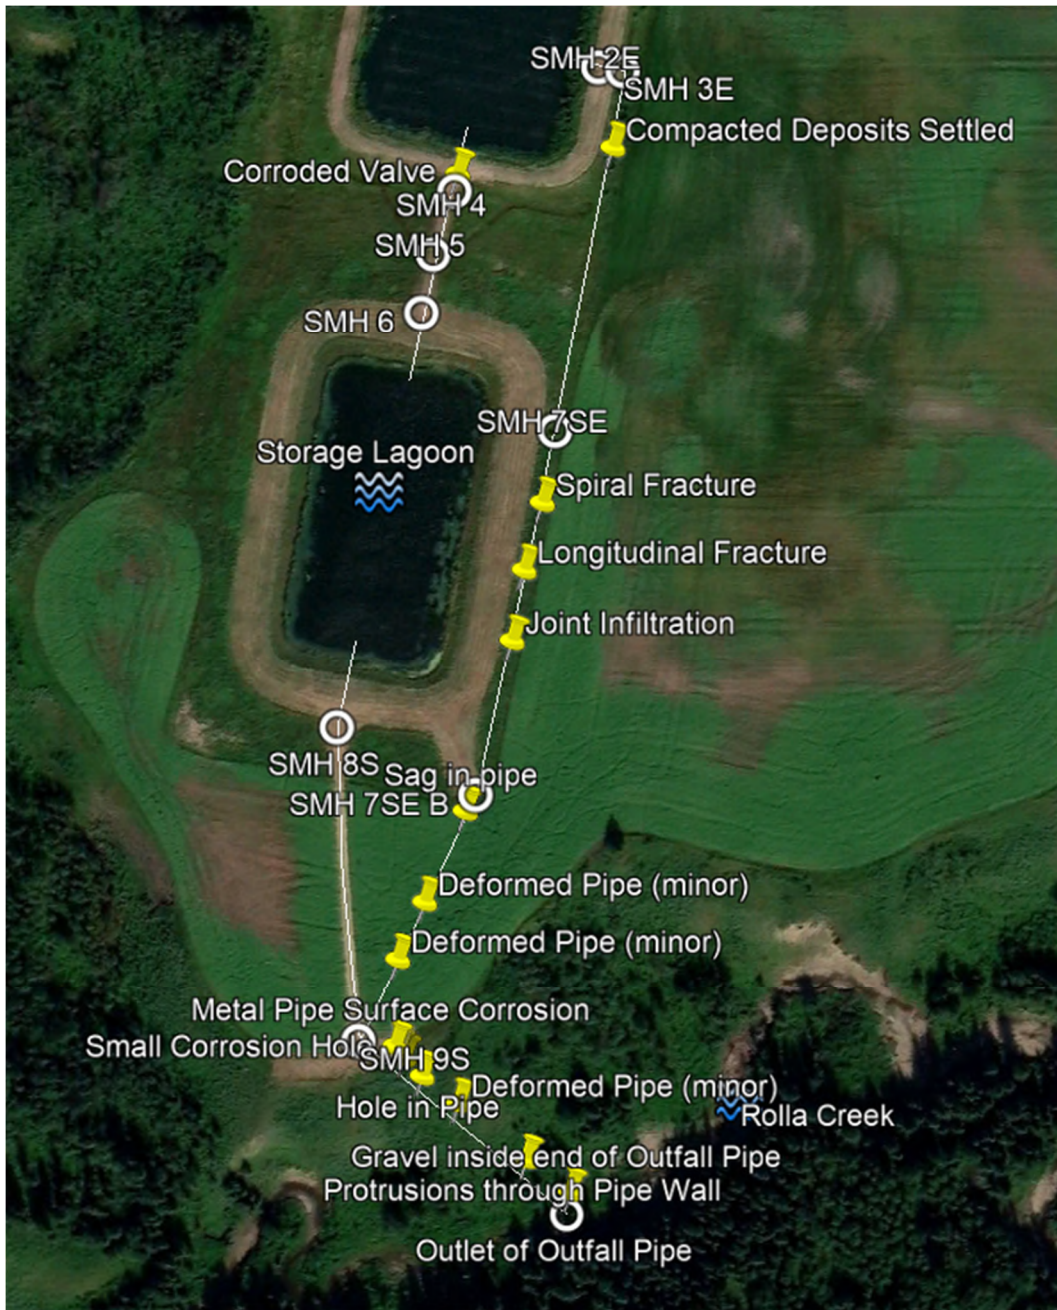
- Aerated Lagoon to Overflow
 - o Compacted deposits settled in first 65m of overflow pipe. Flushing did not remove the deposits.
 - o Structural spiral fracture – one pipe length affected – 30m south of SMH 7SE toward SMH 7SE B
 - o Structural longitudinal fracture - one pipe length affected – 51m south of SMH 7SE toward SMH 7SE B
 - o Evidence of joint infiltration – one joint - at 76m south of SMH 7 SE toward SMH 7SE B
 - o 8.5m long sag in pipe starting at SMH 7SE B toward SMH 9S
 - o Pipe Deformed (minor denting) 2 locations – 44m and 65m from SMH 7 SE B toward SMH 9S
- Aerated Lagoon to Storage Lagoon
 - o Corroded valve – at SMH Rolla 4
- Outfall Pipe
 - o Severe Metal Pipe Surface corrosion – entire length – SMH 9 to outlet

- Corrosion hole on side of pipe – 14m from SMH 9S toward outfall
- Stick stuck in pipe - 15m from SMH 9S toward Outlet
- Roots protruding at joint – 17.7m from SMH 9S toward outfall
- Hole in pipe at 26m from SMH 9S toward outfall
- Deformed (dented) pipe at 40m from SMH 9S toward outlet
- Protrusions through pipe wall at 70m from SMH 9S
- Gravel debris just inside outfall end

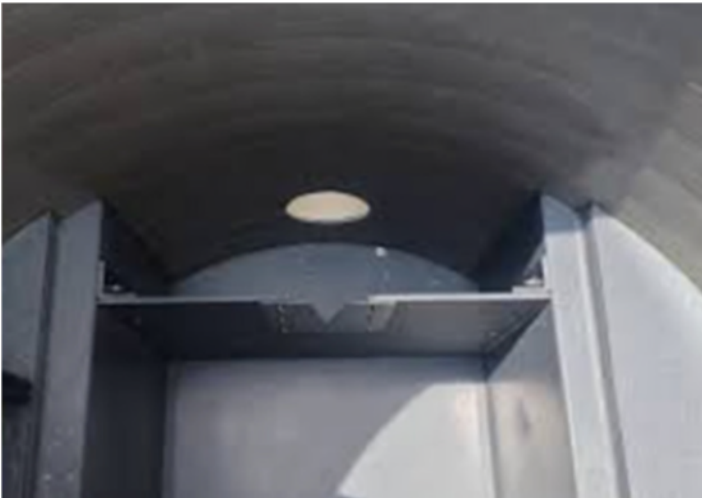
Figure 14 - Example of V-Notch Weir

The flow out of the storage lagoon can only be measured by observing the rate of level drop in the lagoon. Due to the difficulty in getting precise measurements of the lagoon level, this flow can only be estimated, but is sufficient for the batch discharge methodology that is being employed.

A more precise discharge flow measurement device could be installed. This could be a V-notch weir installed in a concrete chamber downstream of the lagoon discharge valve. The operator could watch the level in the weir and accurately turn the discharge valve to regulate the flow out of the lagoon, based on the flow in the creek.

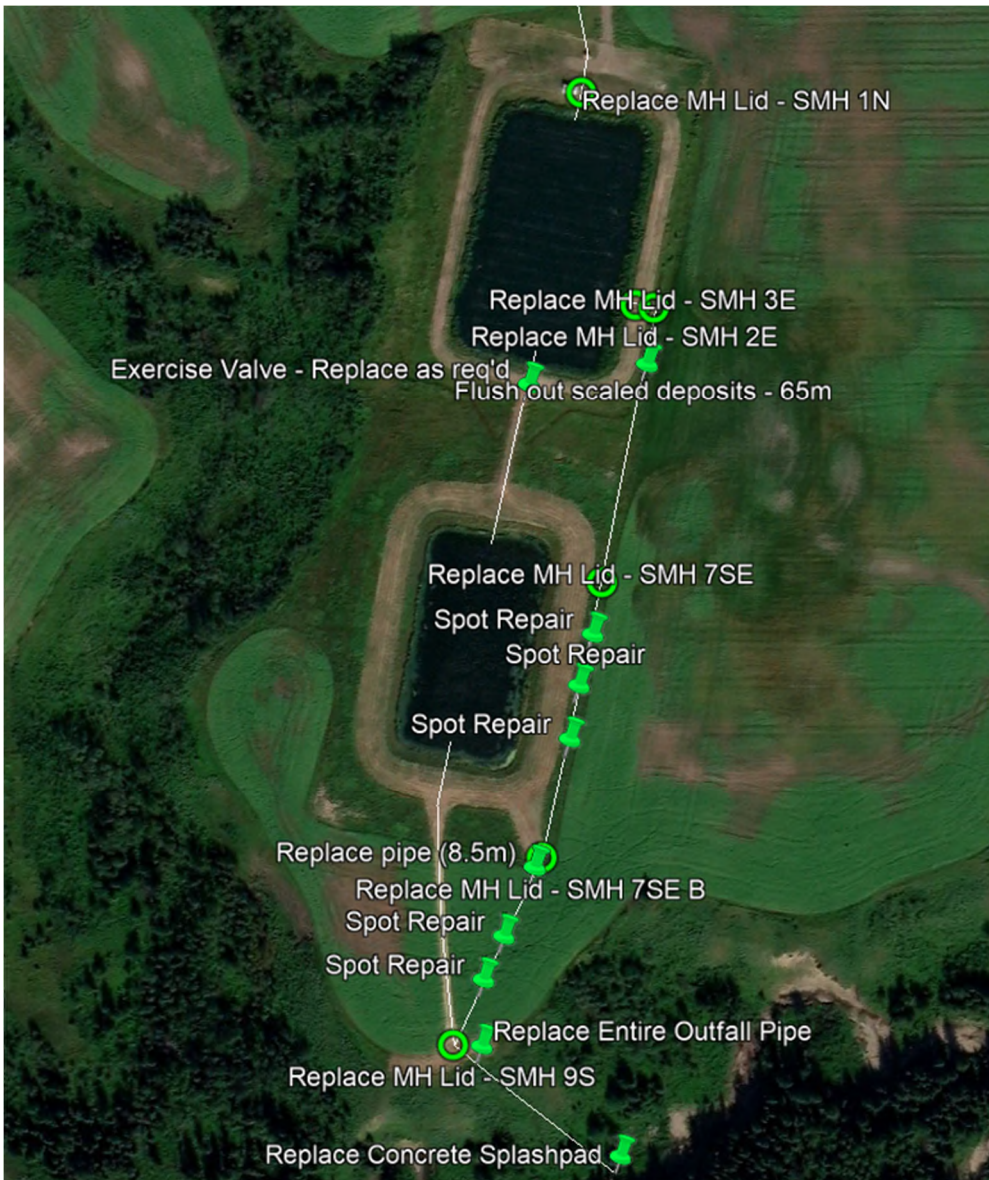
Figure 15 - Pipe Repairs

As can be seen from the CCTV reports, there are several deficiencies in the overflow piping. One section has a sag, there are several sections of “bent” pipe, and a couple structural failures in the PVC pipe.

The outfall pipe from the top of the hill by the storage lagoon to the creek is a corrugated steel pipe that is significantly deteriorated. The inside is severely corroded, there are leaks in a few locations, and there is a piece of metal protruding into the pipe in one location. There is a risk of the pipe joints separating, causing environmental damage during discharges.

The pipe will likely serve its purpose for many years however, it may suddenly collapse without anyone knowing it. It is important to repair the structural failures. We would recommend spot repairs instead of full pipe replacement.

This pipe should be replaced, however the constructability challenges with installing a new pipe down the steep bank make this a complex replacement.

The above costs for the overflow pipe repairs include spots repairs only. Since there are a number of them, the PRRD may consider replacing the entire pipe. At 330m long at approximately \$400 / m, replacement cost would be in the order of \$130,000.

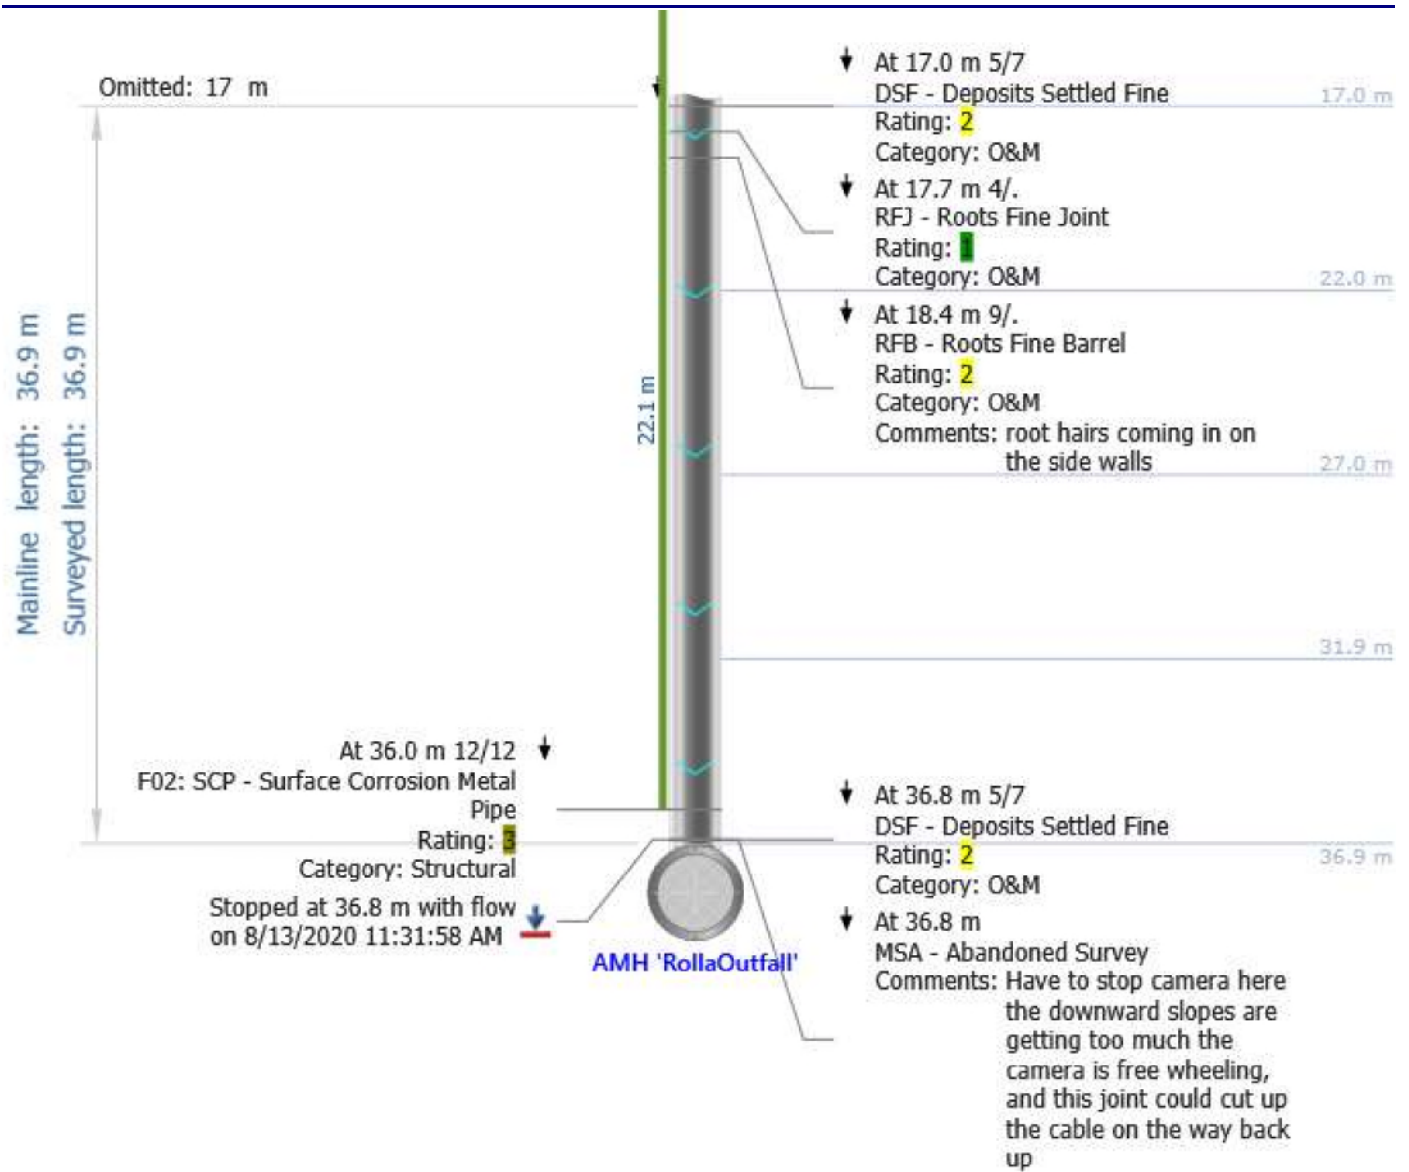
Main Inspections Pipe Run

Project name: RollaSaniLagoons,PRRD, WSP, Aug2020	Mainline ID: SMHRolla9S-RollaOutfall.	City: Rolla	Street: Far South end of the Lagoon going towards the Creek
Start date/time: 8/13/2020 11:40 AM	Direction: D	Weather:	Location code:
Shape: C	Material: CMP	Height: 200 mm	Width:

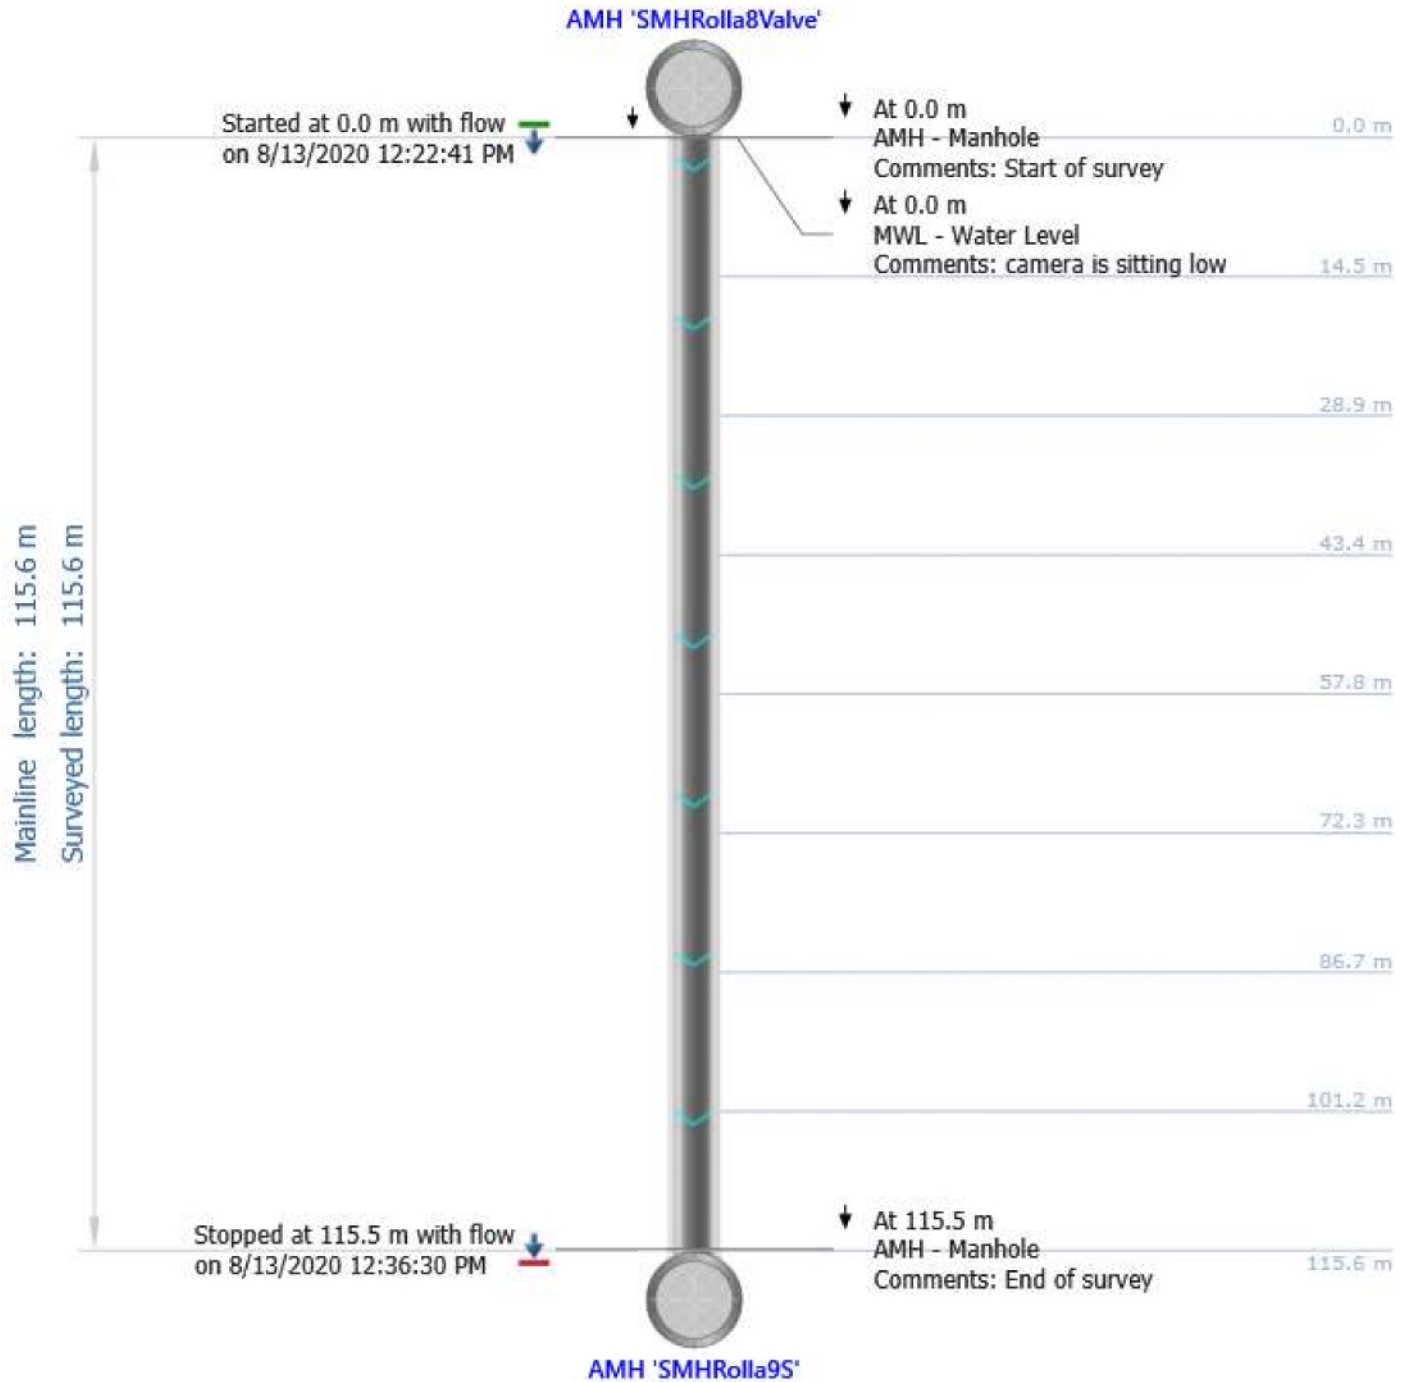
Main Inspections Pipe Run

Project name: RollaSaniLagoons,PRRD, WSP,Aug2020	Mainline ID: SMHRolla8Valv- SMHRolla9S	City: Rolla	Street: Coming out of Pond B South
Start date/time: 8/13/2020 12:22 PM	Direction: D	Weather:	Location code:
Shape: C	Material: PVC	Height: 300 mm	Width:

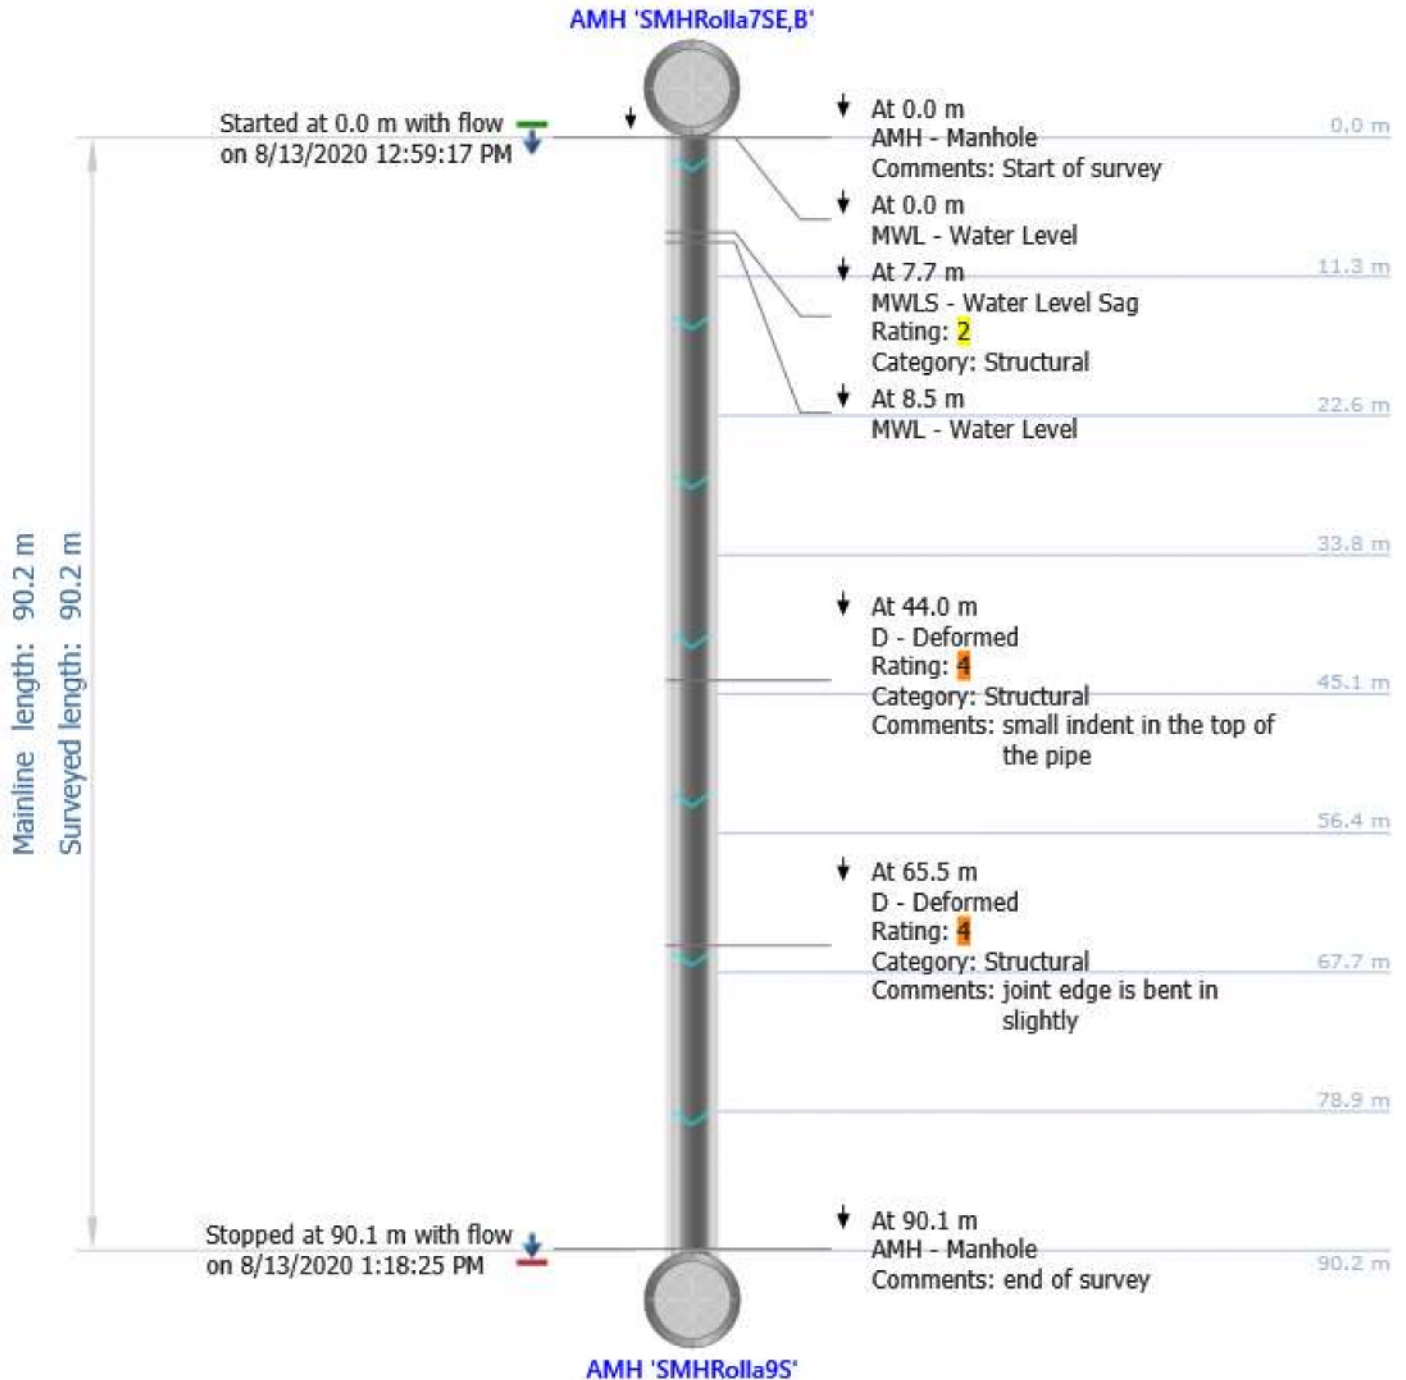
Main Inspections Pipe Run

Project name: RollaSaniLagoons,PRRD, WSP,Aug2020	Mainline ID: SMHRolla7SE, B-SMHRolla9S	City: Rolla	Street: Far South East corner along fence
Start date/time: 8/13/2020 12:59 PM	Direction: D	Weather:	Location code:
Shape: C	Material: PVC	Height: 200 mm	Width:

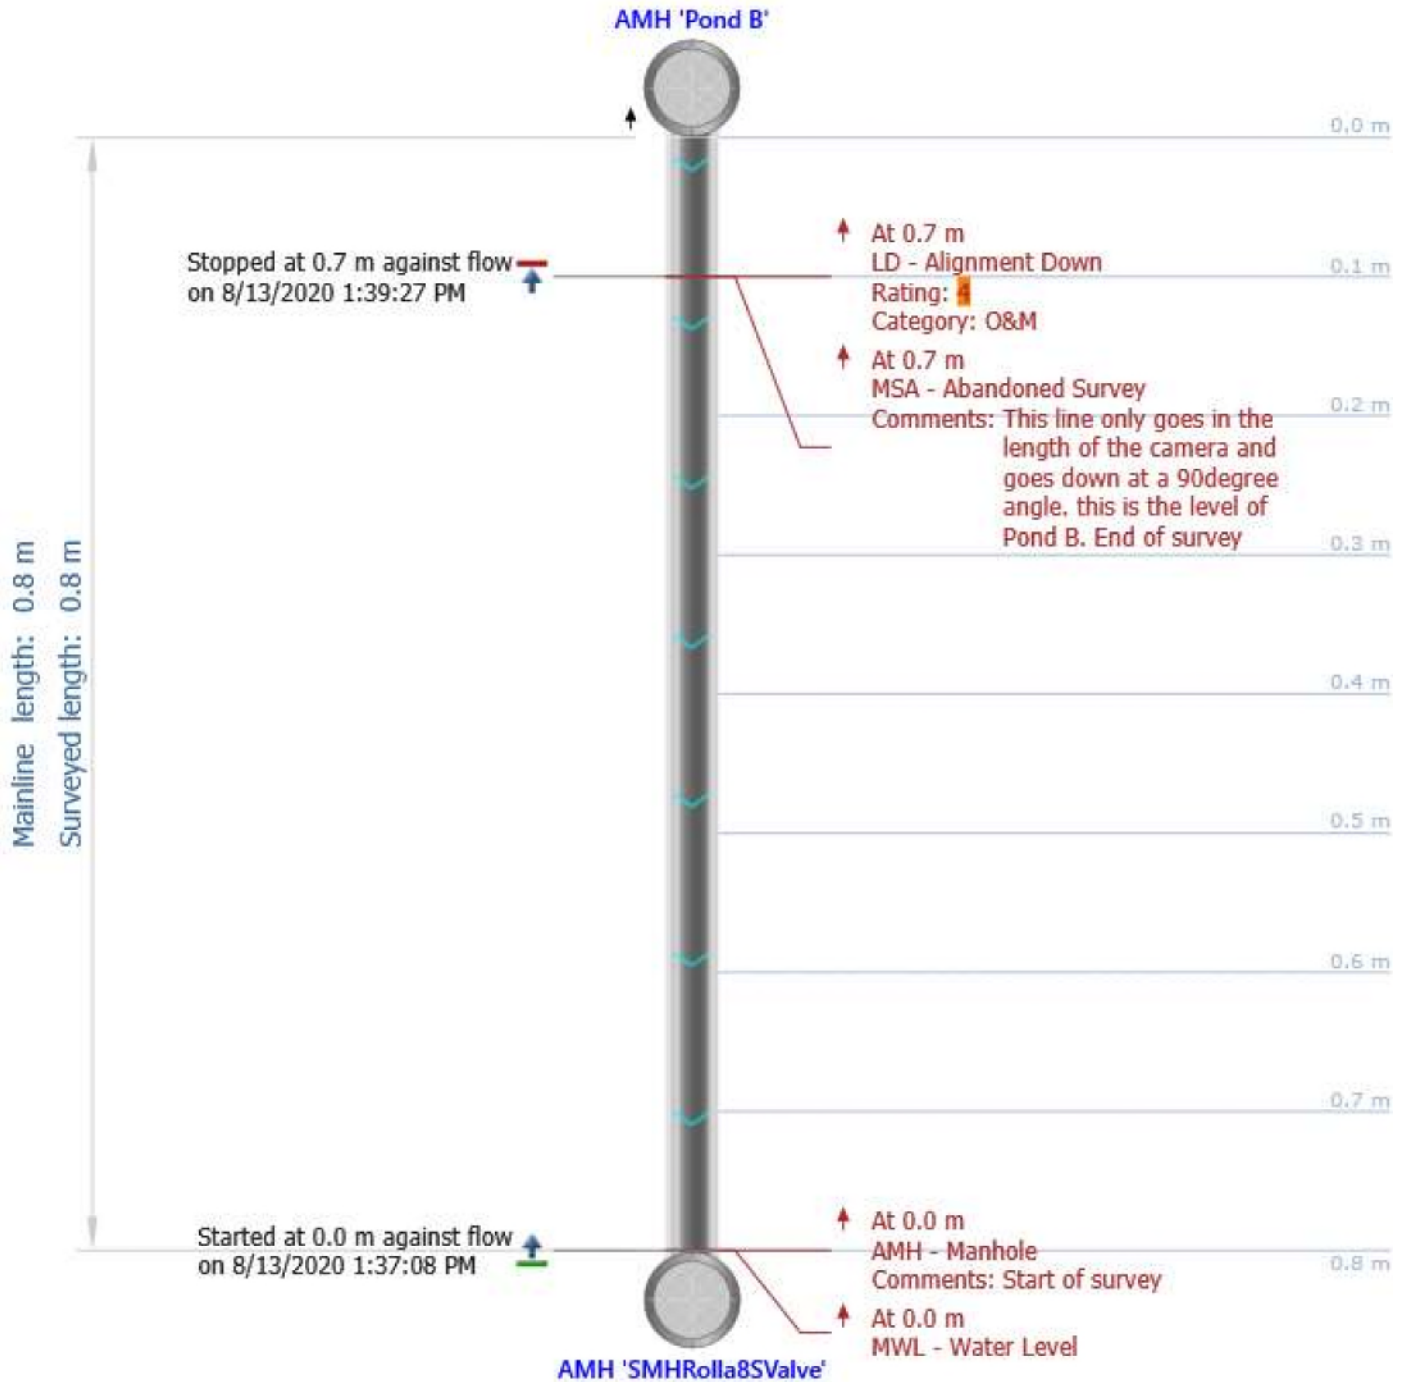
Main Inspections Pipe Run

Project name: RollaSaniLagoons,PRRD, WSP,Aug2020	Mainline ID: PondB-SMHRolla8SValve	City: Rolla	Street: Going into PondB
Start date/time: 8/13/2020 1:37 PM	Direction: U	Weather:	Location code:
Shape: C	Material: PVC	Height: 300 mm	Width:

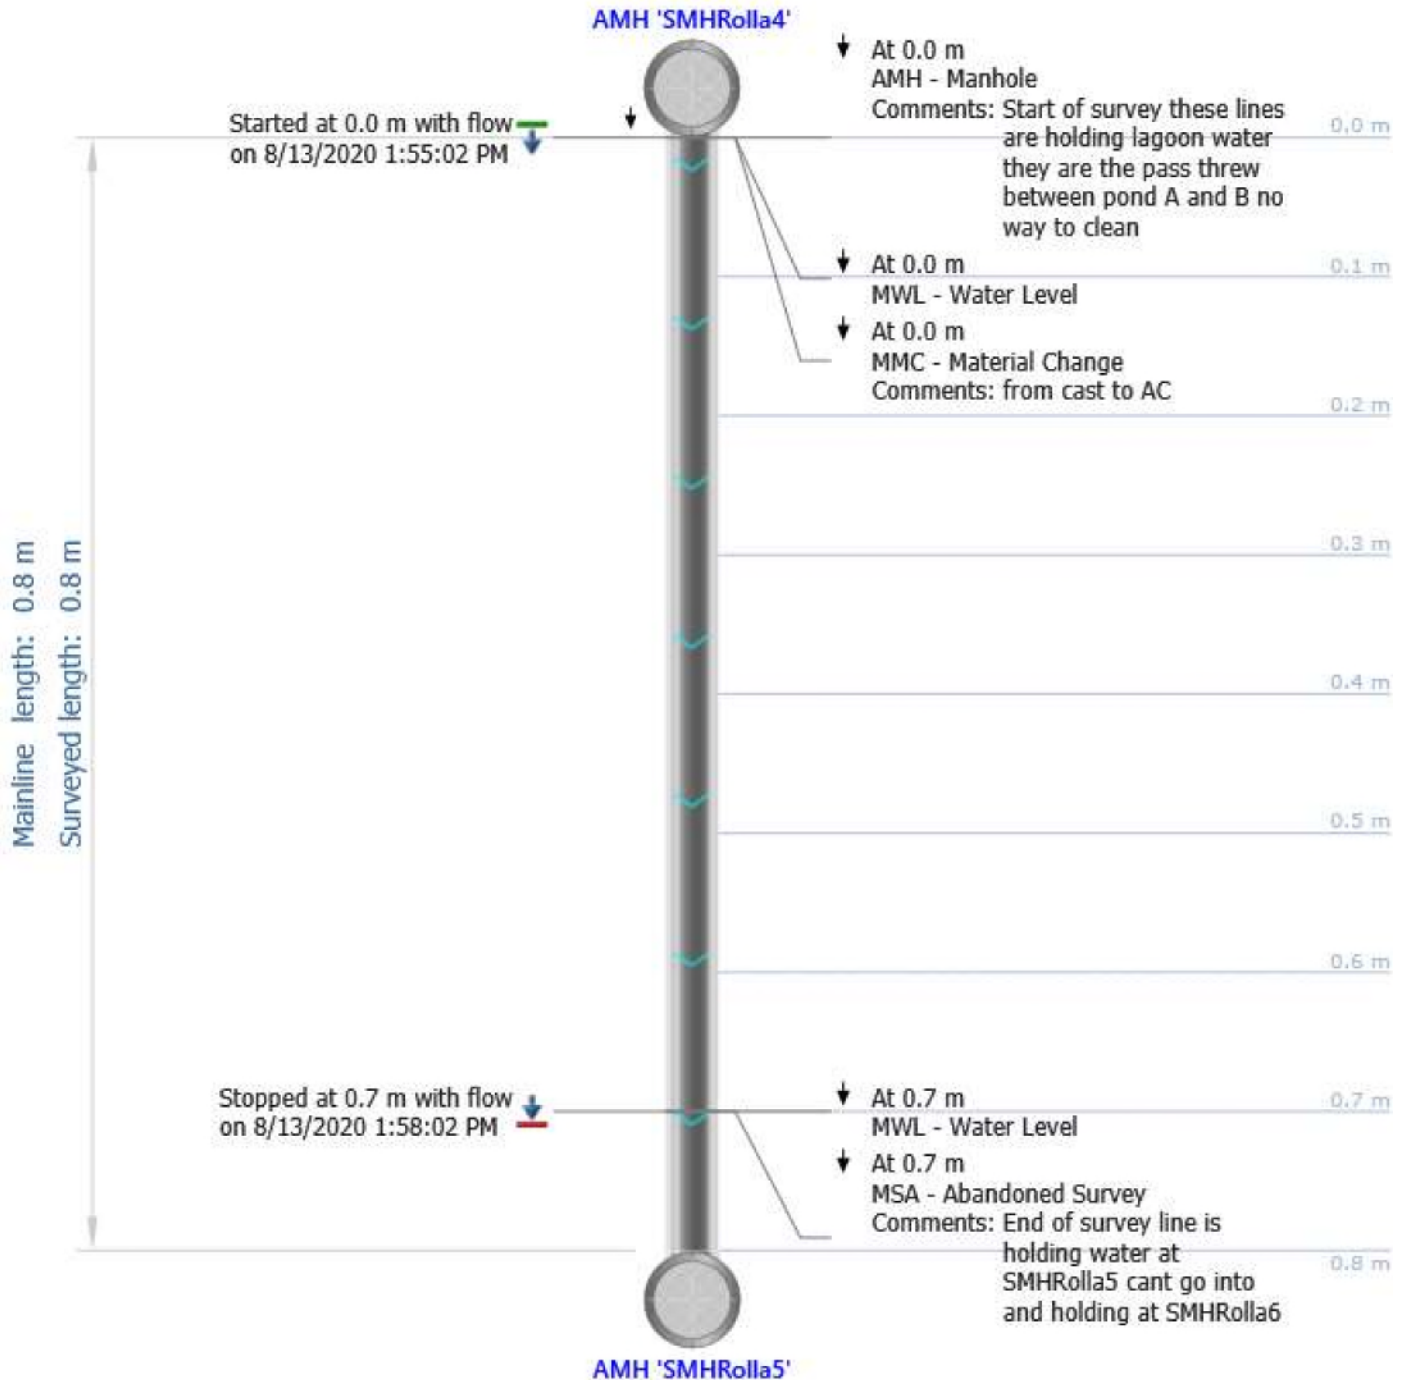
Main Inspections Pipe Run

Project name: RollaSaniLagoons,PRRD, WSP, Aug2020	Mainline ID: SMHRolla4-SMHRolla5	City: Rolla	Street: Middle between Pond A and B
Start date/time: 8/13/2020 1:55 PM	Direction: D	Weather:	Location code:
Shape: C	Material: CAS	Height: 200 mm	Width:

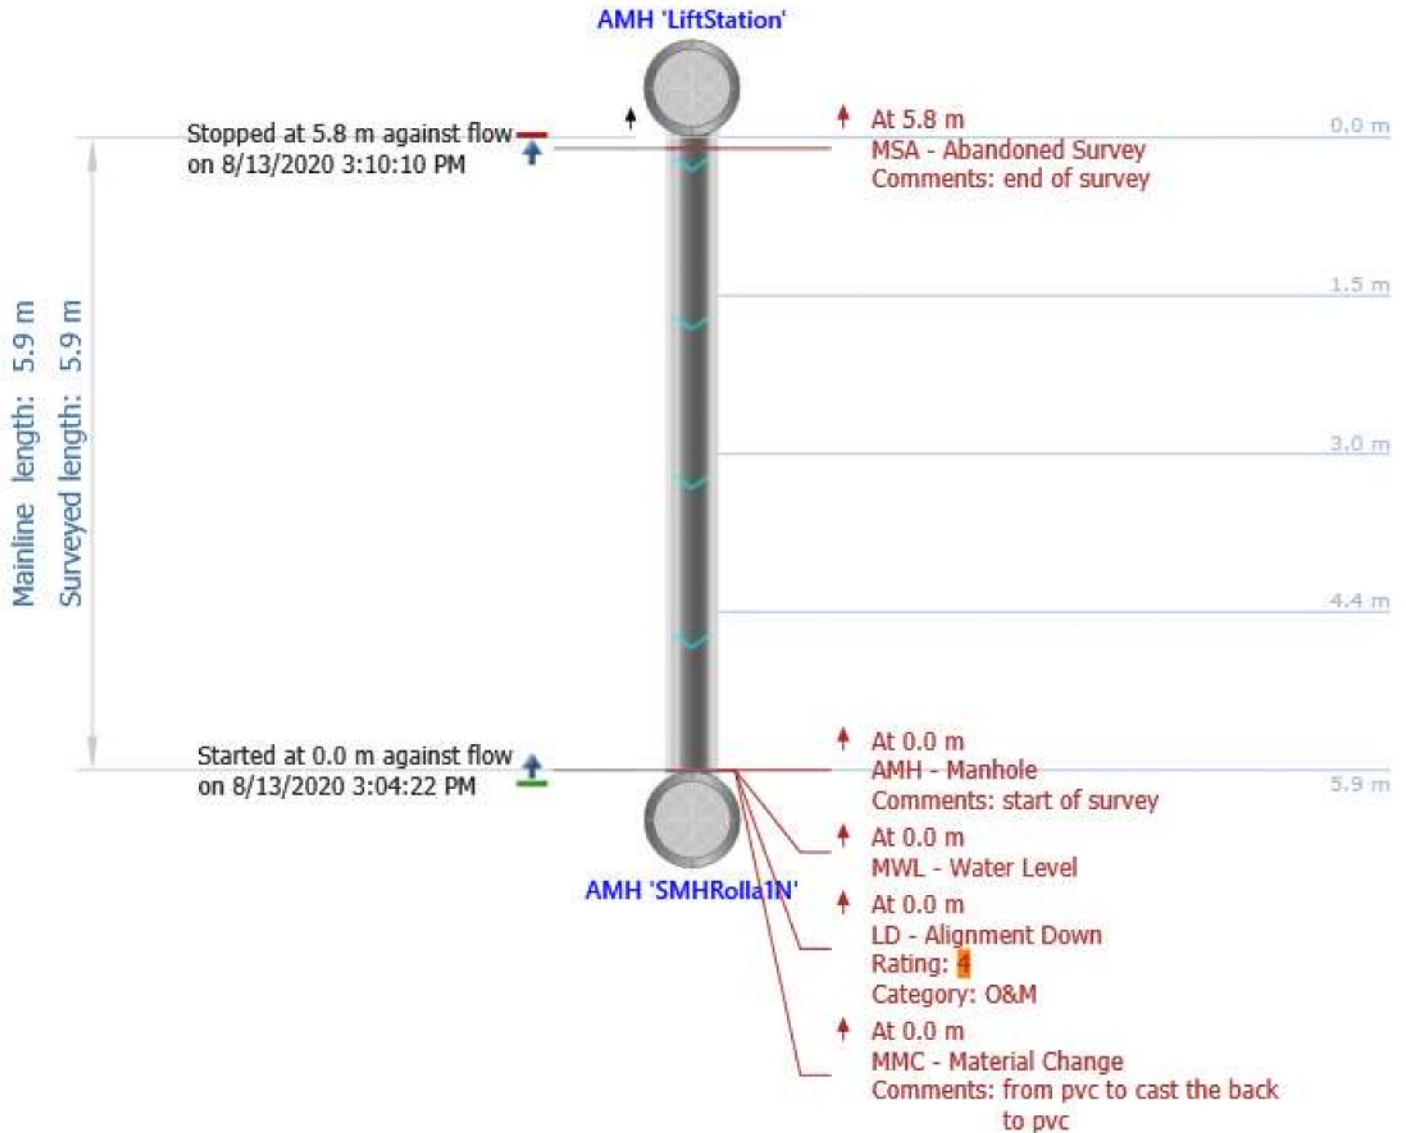
Main Inspections Pipe Run

Project name: RollaSaniLagoons,PRRD, WSP,Aug2020	Mainline ID: LiftStation-SMHRolla1N	City: Rolla	Street: Front entrance
Start date/time: 8/13/2020 3:04 PM	Direction: U	Weather:	Location code:
Shape: C	Material: CAS	Height: 100 mm	Width:

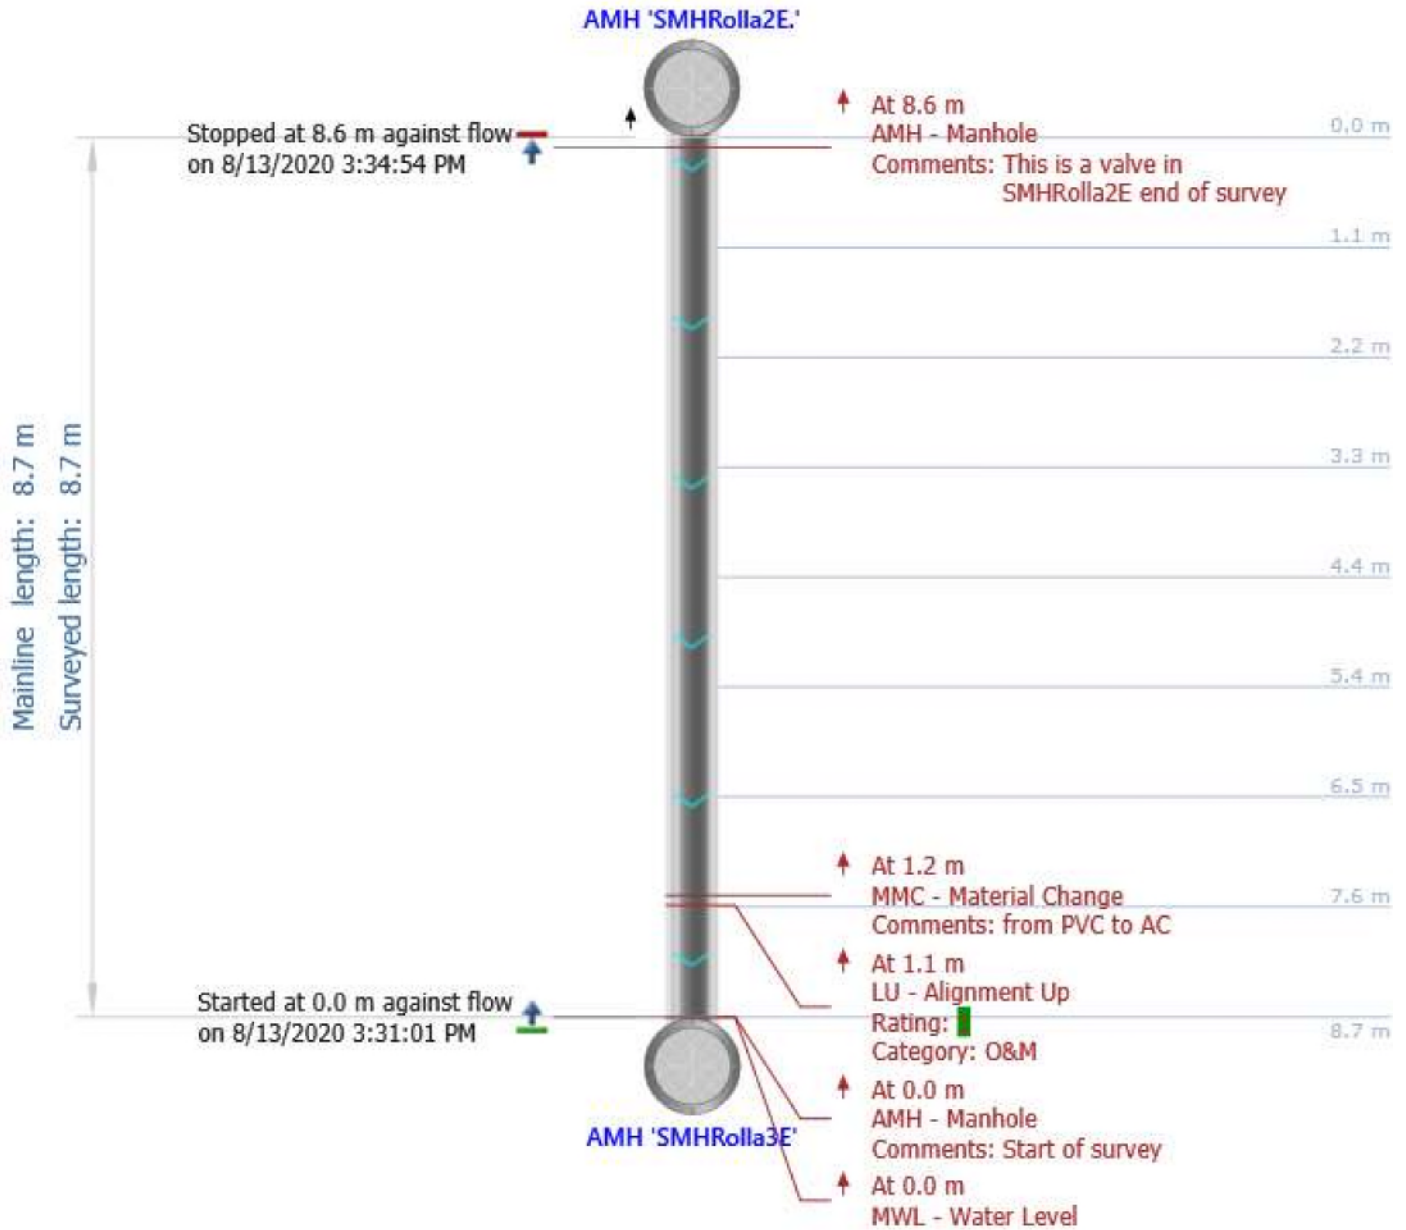
Main Inspections Pipe Run

Project name: RollaSaniLagoons,PRRD, WSP,Aug2020	Mainline ID: SMHRolla2E-SMHRolla3E	City: Rolla	Street: East side of Pond A
Start date/time: 8/13/2020 3:31 PM	Direction: U	Weather:	Location code:
Shape: C	Material: PVC	Height: 200 mm	Width:

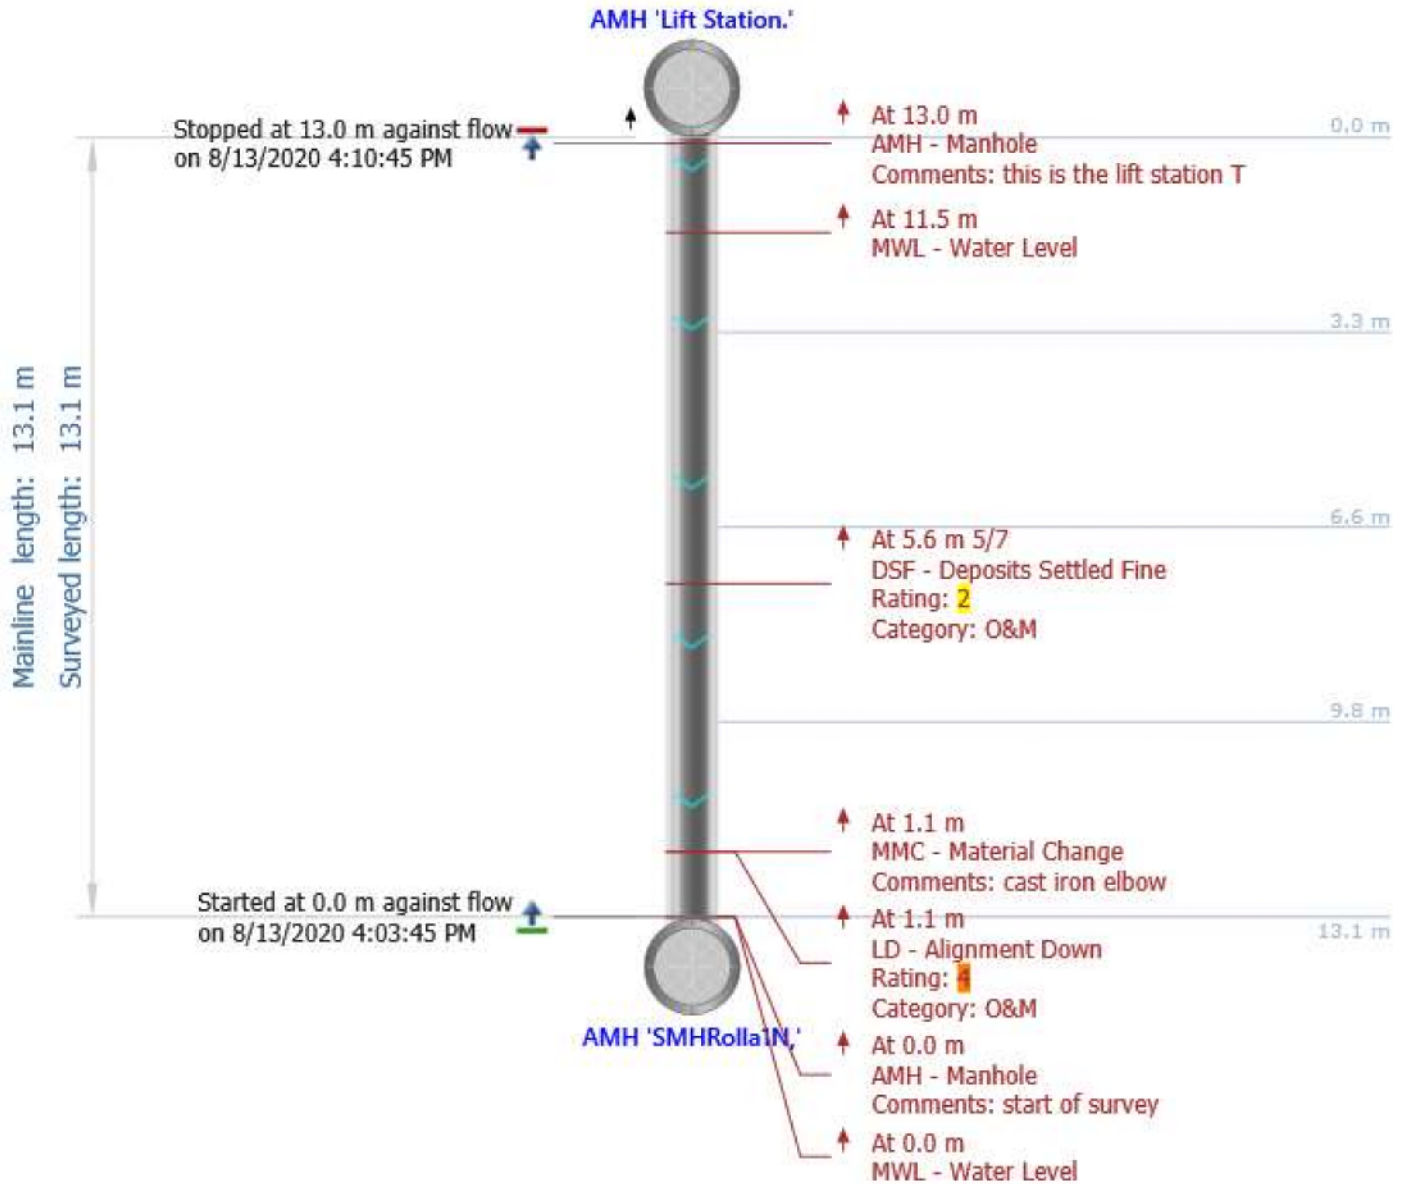
Main Inspections Pipe Run

Project name: RollaSaniLagoons,PRRD, WSP, Aug2020	Mainline ID: Lift Station-SMHRolla1N.	City: Rolla	Street: Front entrance to laggons
Start date/time: 8/13/2020 4:03 PM	Direction: U	Weather:	Location code:
Shape: C	Material: PVC	Height: 100 mm	Width:

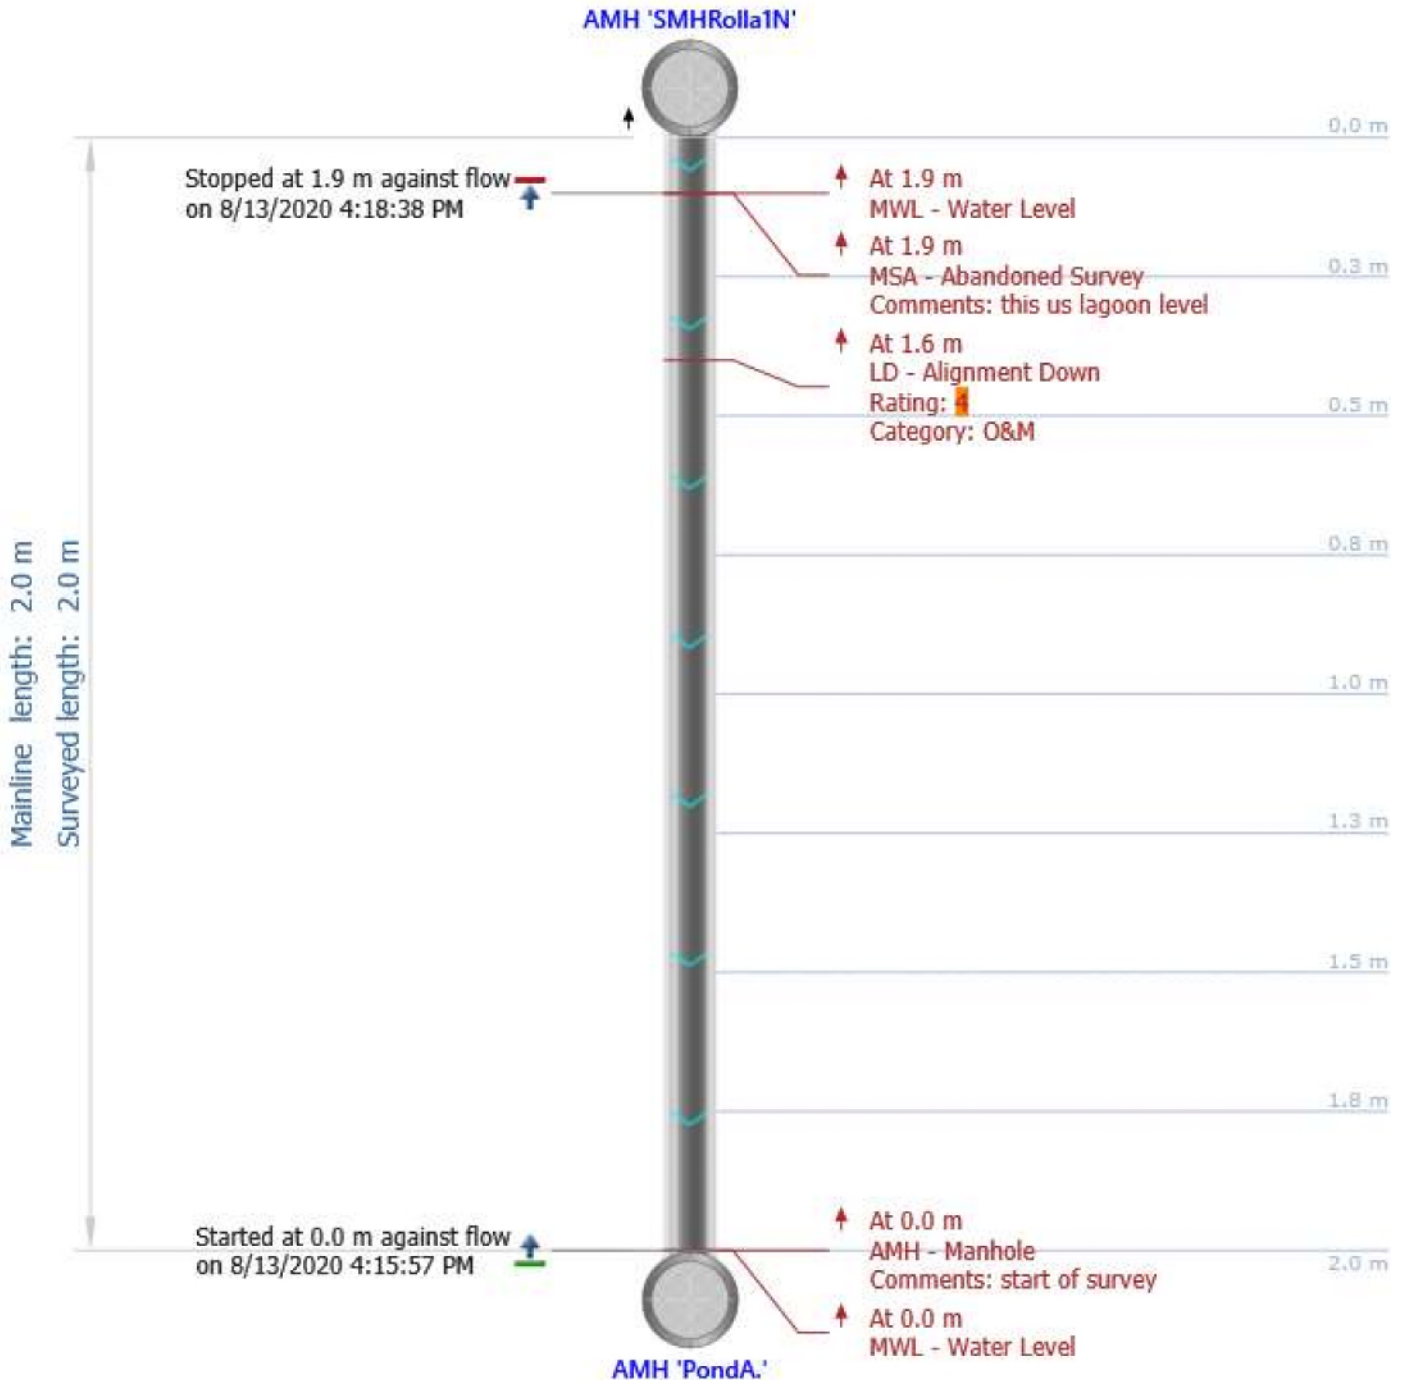
Main Inspections Pipe Run

Project name: RollaSaniLagoons,PRRD, WSP,Aug2020	Mainline ID: SMHRolla1N-PondA	City: Rolla	Street: Front entrance Pond A
Start date/time: 8/13/2020 4:15 PM	Direction: U	Weather:	Location code:
Shape: C	Material: PVC	Height: 150 mm	Width:
