Condition Assessment Report

YXJ Subdivision Water Network and Sewer Network

Draft Report Prepared for:
Peace River Regional District

By:
Pure Technologies, a Xylem Brand
November 27th, 2020

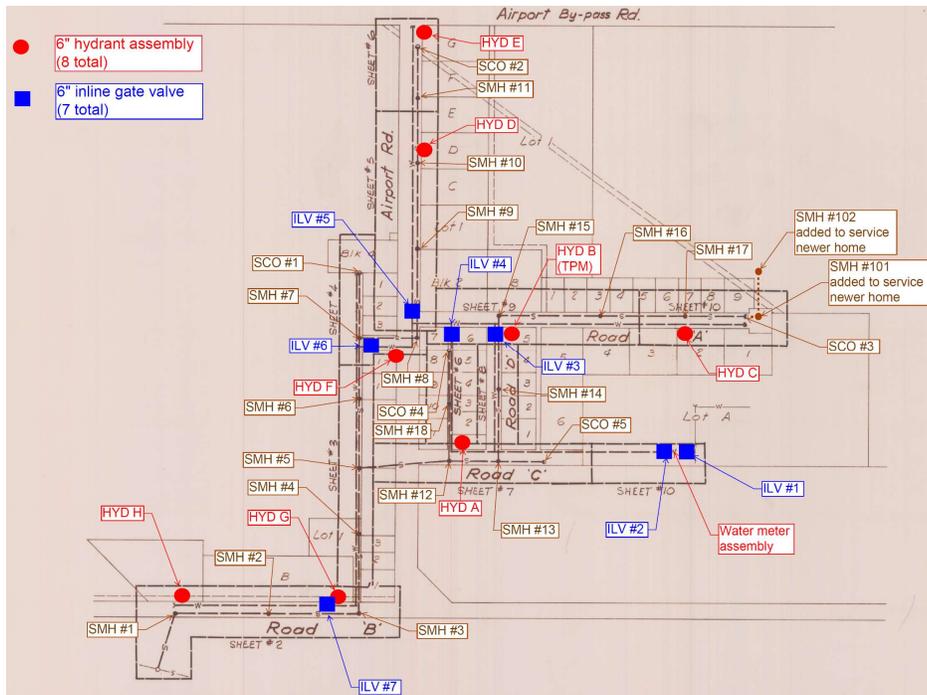
Figure 6.1: Location of Hydrants and Gate Valves in the 6-inch AC Water Mains

The Telog high speed pressure transducer was installed on the fire hydrant (HYD B) located at the southeast corner of Rowantree Ave. (Road A) and Lily St. (Road D). This location (see Figure 6.1) was selected because it is approximately in the middle of the YXJ Subdivision serviced by the 6-inch AC water main.

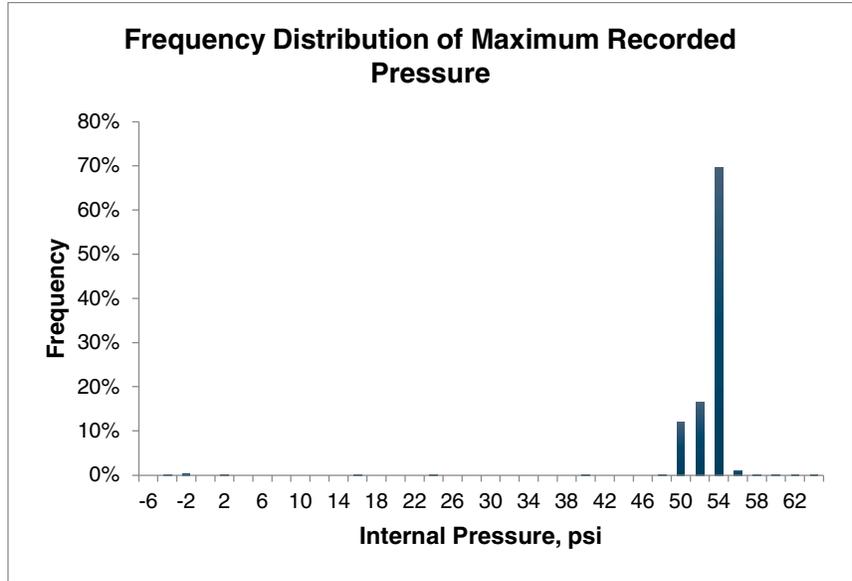
Figure 6.2: Frequency Distribution of Maximum Pressure

The frequency distribution of the 10,473 maximum pressure measurements can be seen in Figure 6.2 below. As expected from the graph in Appendix A, the majority of the maximum pressure measurements (applies to minimum and average too) falls into a very narrow band. In fact, 70% of all maximum pressures fall between 53 and 55 psi. This can also be observed in Figure 6.3 which shows the cumulative frequency distribution of this same data. More importantly, from a design perspective, 99.9% of all maximum pressures fall at 56 psi or below. The two maximum recorded pressures above 60 psi, which occurred at 9:00AM and 9:04AM on September 3, 2020, were probably due to some minor transient event in the system. The AWWA C401 design method incorporates a factor of safety of 4 on the working pressure to accommodate unexpected transients that may occur in a water distribution system. Consequently, for the AWWA C401 design check, a working pressure of 56 psi at the hydrant level was used. This represents the 99.9 percentile of all maximum pressure measurements in the YXJ subdivision.

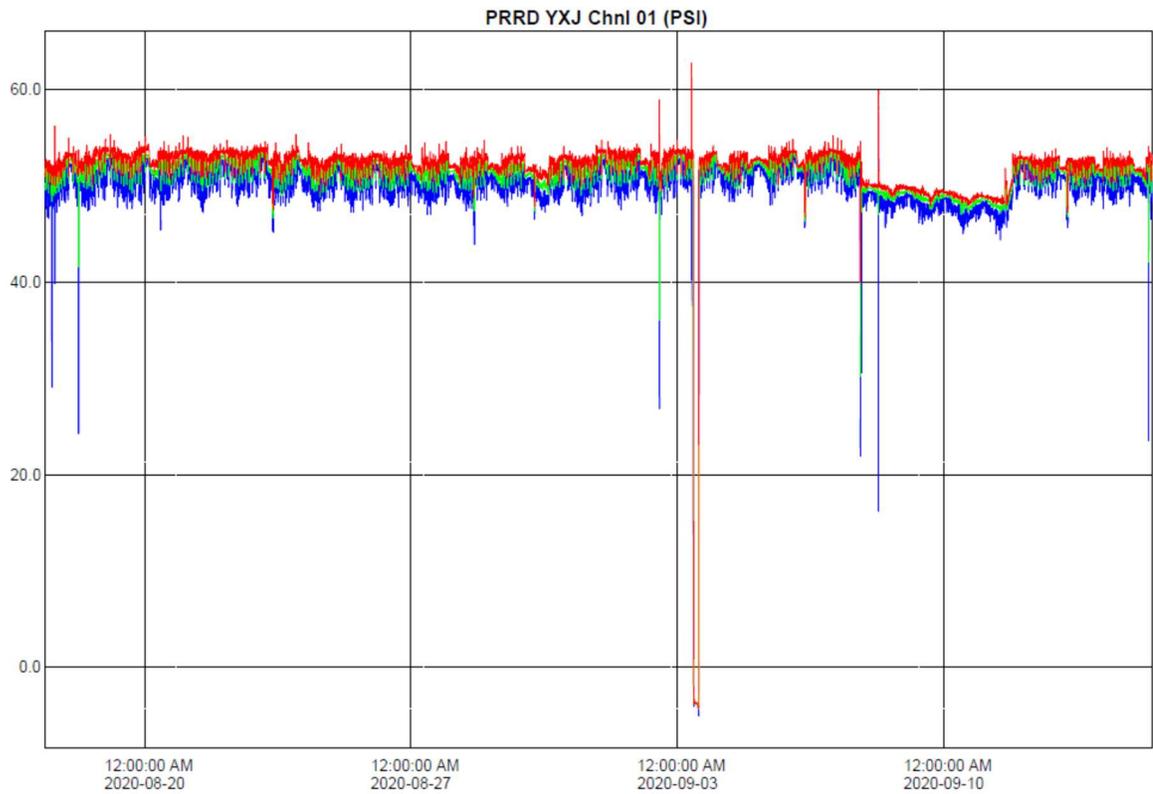
Figure A: Pressure Data over a 30-day monitoring period

On September 3, 2020 at 10:08 AM a minimum pressure of magnitude -5.08 psi was recorded. This negative pressure lasted a duration of 3-1/2 hours, until 1:36 PM. An hour preceding this registration of a negative pressure, the maximum pressure of 62.76 psi was recorded. This maximum pressure lasted approximately 8 minutes (2 recording cycles) before returning to a more normal level. It is suspected that the pressure to the subdivision was deactivated for that 3-1/2 hour period so maintenance or repair could be performed at some other location in the feeder system.
