Rural Budgets Administration Committee Meeting Revised Agenda

December 17, 2020, Immediately Following EADC 1981 Alaska Avenue, Dawson Creek, BC

Facility Condition Assessment Report Tate Creek Community Centre

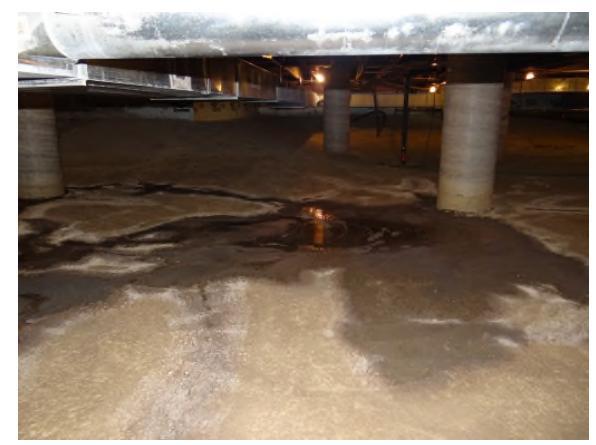
Tate Creek Community Centre - A1030

Recommendation #1 - Inspect excess moisture in crawlspace		
Туре	Engineering Study	
Year	2020	
Cost	\$10,000.00

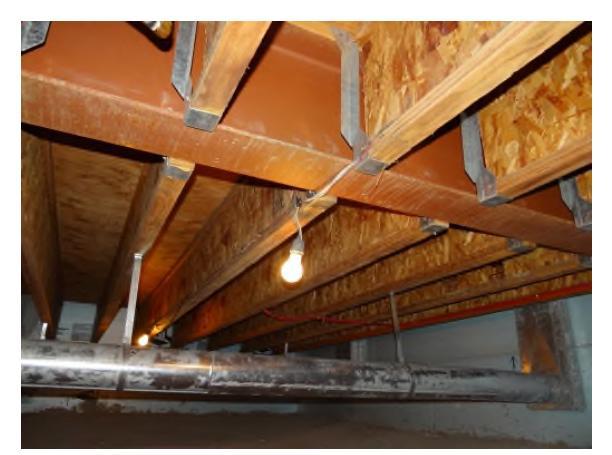
Tate Creek Community Centre - B1010

Item	Description
Uniformat Code	B1010 - Floor Construction
Installation Year	1975
Condition	1 - Good
Expected Useful Life	75 Years
Remaining Useful Life	31 Years
Quantity / Unit of Measure	522 / SM Building
Unit Cost	\$249.38
Difficulty / Regional / Soft Cost Factors	1.00 / 1.00 / 1.00
Element Renewal Cost	\$130,176.36

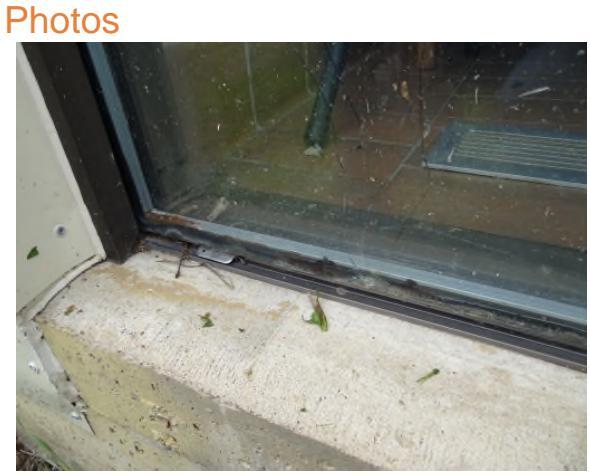
Tate Creek Community Centre - B202001

Deteriorated seals, mechanisms and caulking were observed.

Recommendation #1 - Windows	
Туре	Life Cycle Replacement
Year	2022
Cost	\$29,400.00

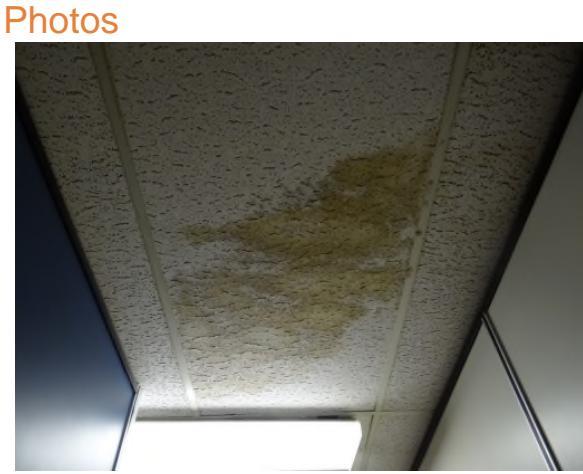
Tate Creek Community Centre - C303007

Staining was observed on some ceiling panels and should be replaced as part of maintenance.

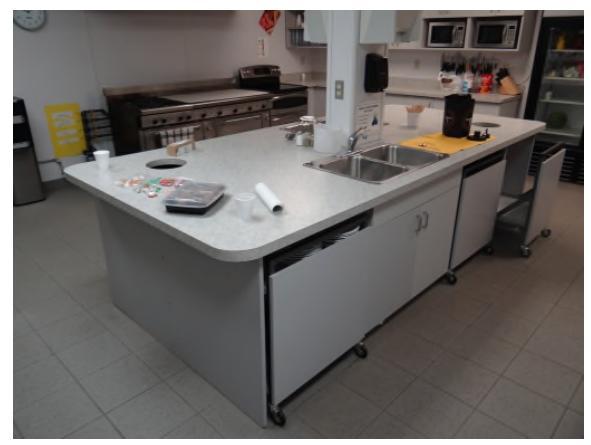
Tate Creek Community Centre - D201004

Item	Description
Uniformat Code	D201004 - Sinks
Installation Year	1975
Condition	3 - Poor
Expected Useful Life	35 Years
Remaining Useful Life	1 Year
Quantity / Unit of Measure	5 / Each
Unit Cost	\$1,000.00
Difficulty / Regional / Soft Cost Factors	1.00 / 1.00 / 1.00
Element Renewal Cost	\$5,000.00

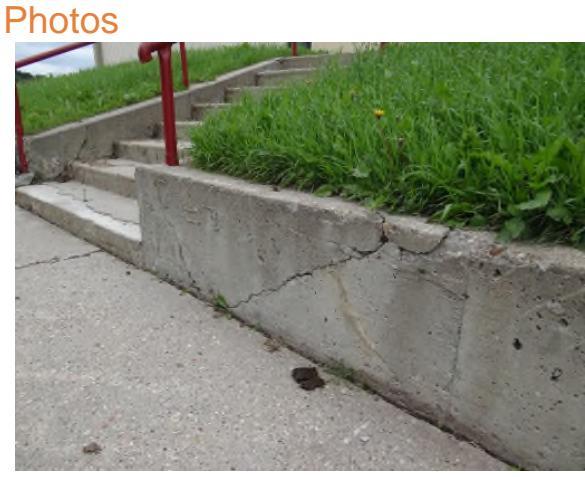
Tate Creek Community Centre - G204031

Cracks, displacement, and deterioration were observed.

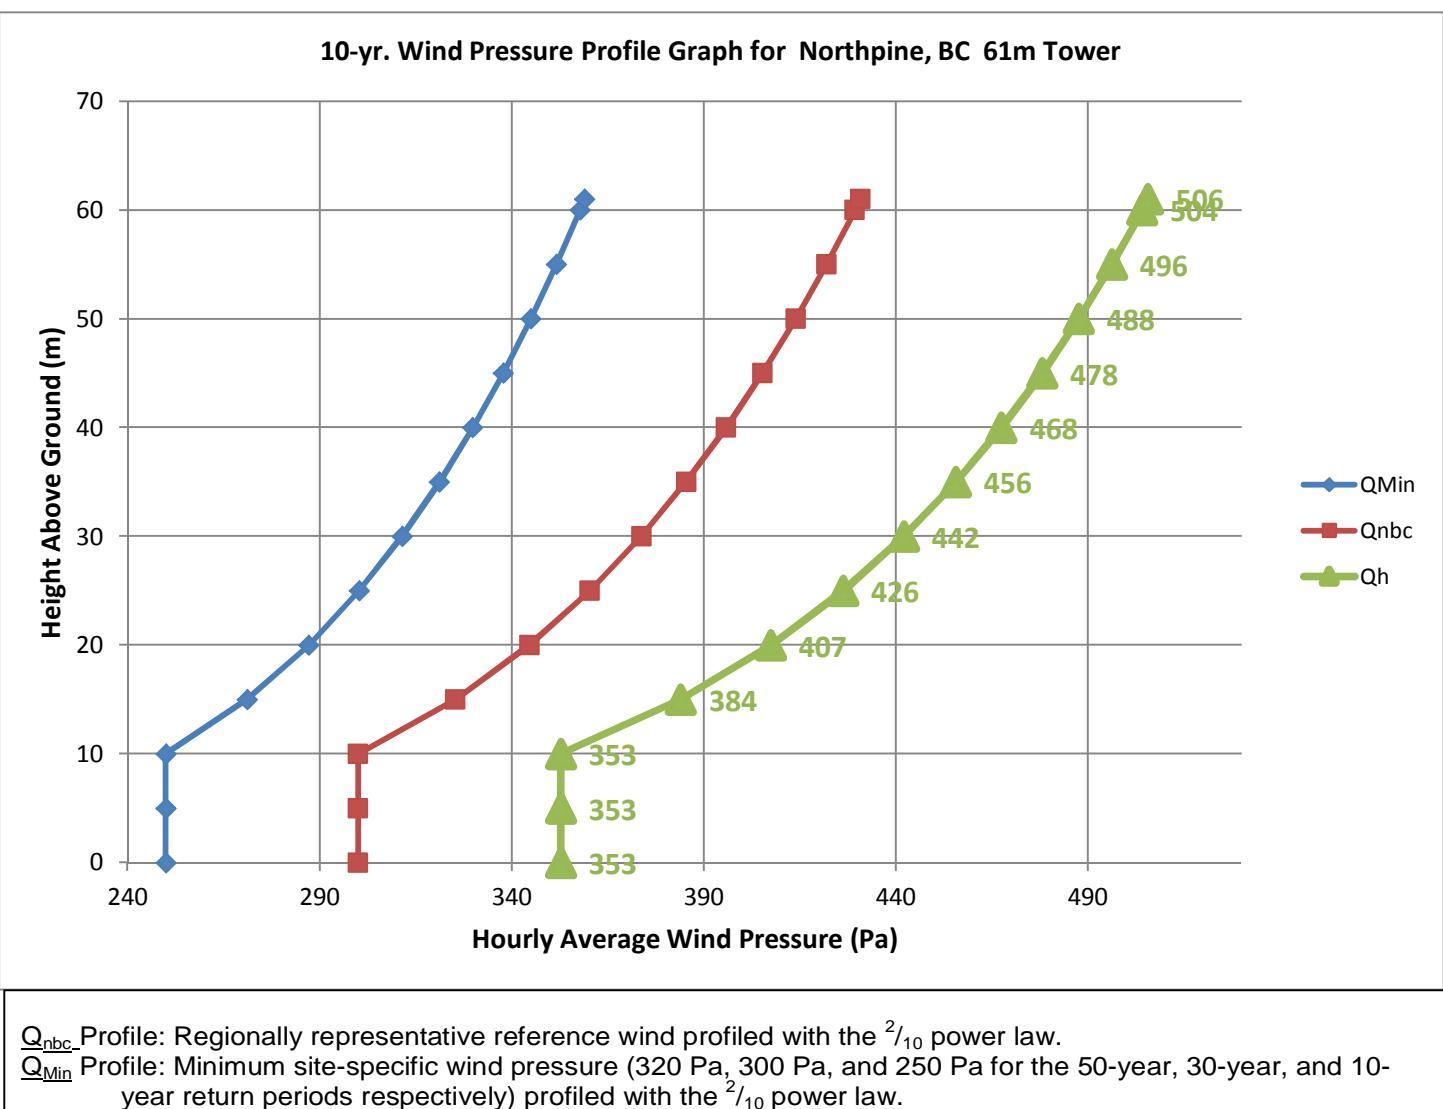
Northpine, BC 61m Tower

Q_h.Profile: The site-specific wind pressure profile directly from the Taylor and Lee (1984) simple guidelines.

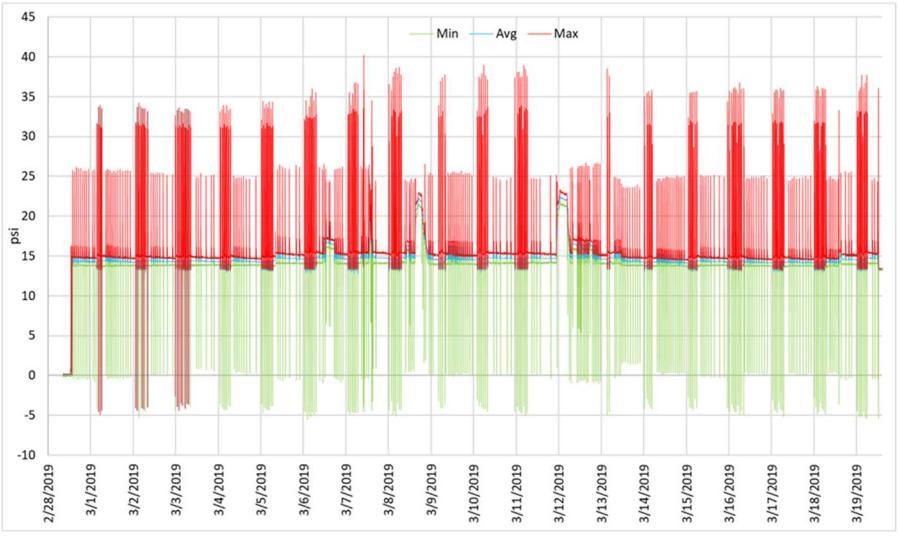
Hydraulic pressure transients occur in pipelines when the steady-state conditions of the system change due to pressure and/or flow disturbances (e.g., the rapid closure of a valve, pump startup/ shutdown, air pockets). Transient pressure monitoring (TPM) captured these pressure transients, as well as captured the working pressures of a pipeline. Figure 4.2 shows an example of transient pressure data gathered on a pipeline.

Figure 4.2: Example Transient Pressure Monitoring Data

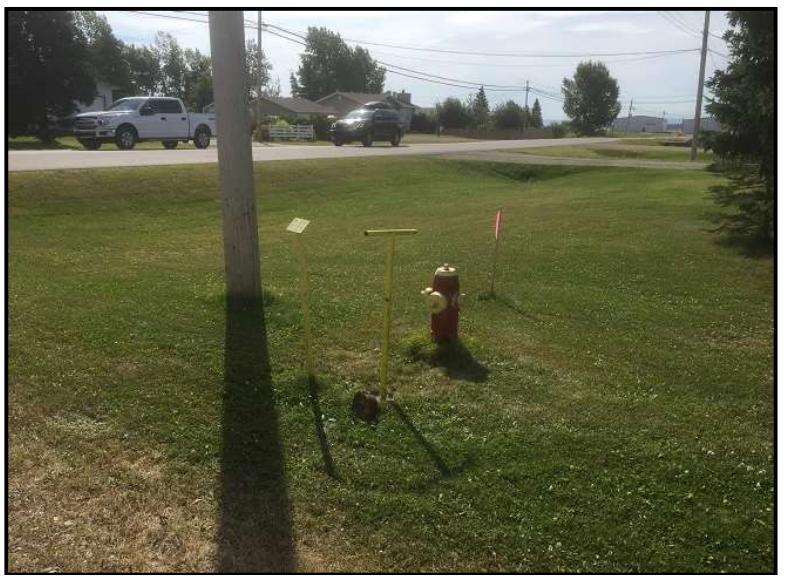
One leak was located during the survey. This was a leak on a hydrant lead on the hydrant located outside 10330 257 Rd. (Figure 5.1). Good leak noise was audible on the hydrant and on the secondary isolation valve. When the isolation valve was operated, the leak noise increased and water began to surface in the valve box. This indicated that the valve itself was the likely source of the leak and maintenance is required as soon as possible.

Figure 5.1: Leak on hydrant located outside 10330 257 Road

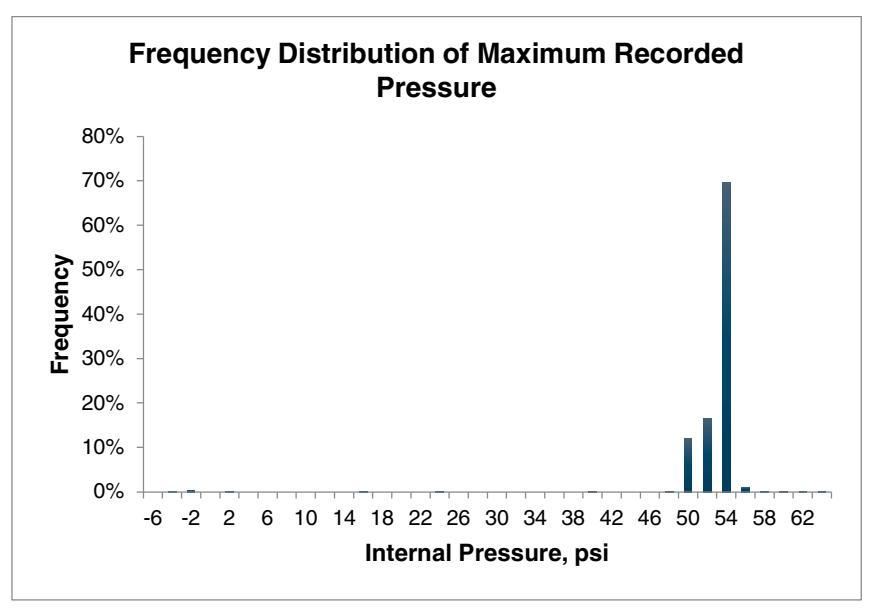
The frequency distribution of the 10,473 maximum pressure measurements can be seen in Figure 6.2 below. As expected from the graph in Appendix A, the majority of the maximum pressure measurements (applies to minimum and average too) falls into a very narrow band. In fact, 70% of all maximum pressures fall between 53 and 55 psi. This can also be observed in Figure 6.3 which shows the cumulative frequency distribution of this same data. More importantly, from a design perspective, 99.9% of all maximum pressures fall at 56 psi or below. The two maximum recorded pressures above 60 psi, which occurred at 9:00AM and 9:04AM on September 3, 2020, were probably due to some minor transient event in the system. The AWWA C401 design method incorporates a factor of safety of 4 on the working pressure to accommodate unexpected transients that may occur in a water distribution system. Consequently, for the AWWA C401 design check, a working pressure of 56 psi at the hydrant level was used. This represents the 99.9 percentile of all maximum pressure measurements in the YXJ subdivision.

Figure 6.2: Frequency Distribution of Maximum Pressure

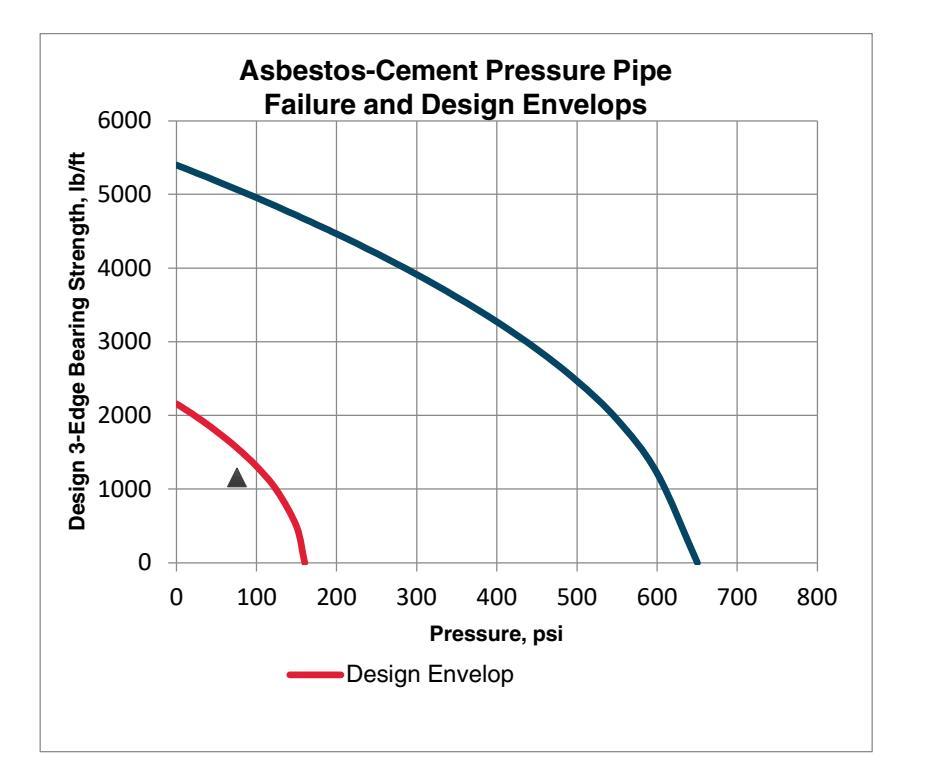
Figure 7.4: Design and Failure Envelop for 6-in Class 150 AC Water Pipe

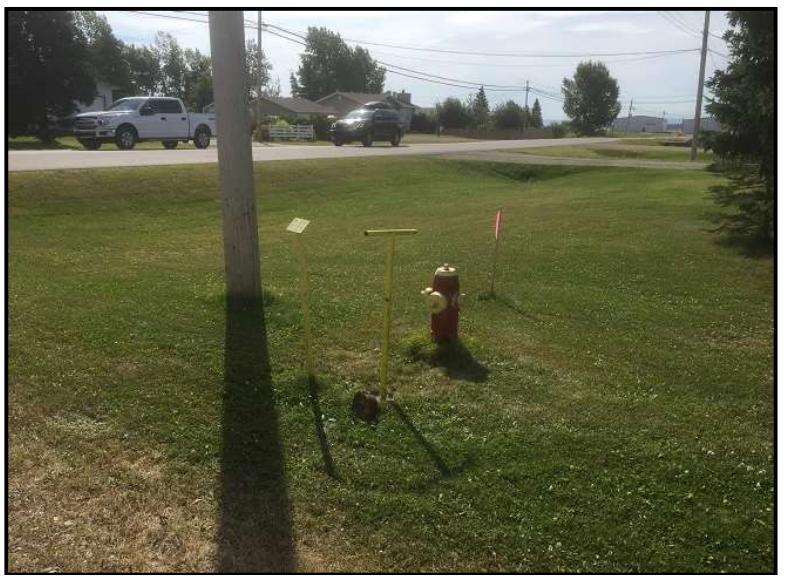
One leak was located during the survey. This was a leak on a hydrant lead on the hydrant located outside 10330 257 Rd. (Figure 5.1). Good leak noise was audible on the hydrant and on the secondary isolation valve. When the isolation valve was operated, the leak noise increased and water began to surface in the valve box. This indicated that the valve itself was the likely source of the leak and maintenance is required as soon as possible.

Figure 5.1: Leak on hydrant located outside 10330 257 Road

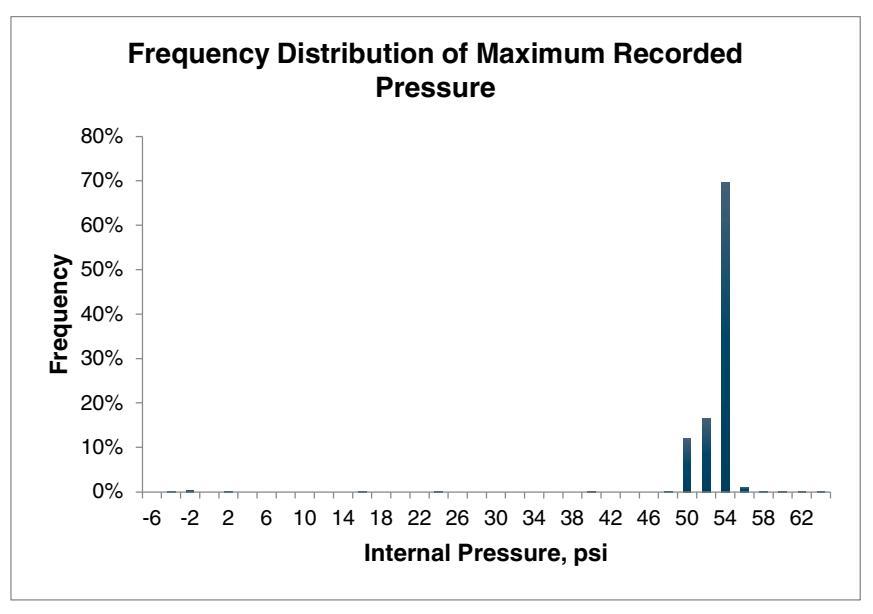
The frequency distribution of the 10,473 maximum pressure measurements can be seen in Figure 6.2 below. As expected from the graph in Appendix A, the majority of the maximum pressure measurements (applies to minimum and average too) falls into a very narrow band. In fact, 70% of all maximum pressures fall between 53 and 55 psi. This can also be observed in Figure 6.3 which shows the cumulative frequency distribution of this same data. More importantly, from a design perspective, 99.9% of all maximum pressures fall at 56 psi or below. The two maximum recorded pressures above 60 psi, which occurred at 9:00AM and 9:04AM on September 3, 2020, were probably due to some minor transient event in the system. The AWWA C401 design method incorporates a factor of safety of 4 on the working pressure to accommodate unexpected transients that may occur in a water distribution system. Consequently, for the AWWA C401 design check, a working pressure of 56 psi at the hydrant level was used. This represents the 99.9 percentile of all maximum pressure measurements in the YXJ subdivision.

Figure 6.2: Frequency Distribution of Maximum Pressure

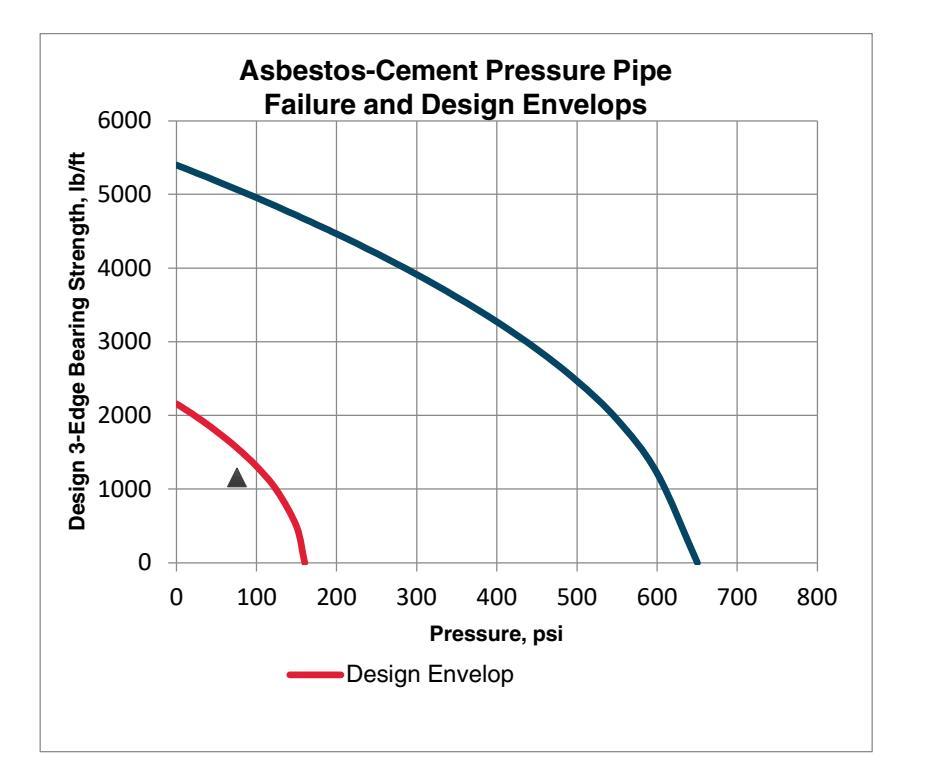
Figure 7.4: Design and Failure Envelop for 6-in Class 150 AC Water Pipe
