## HAMLET OF ROLLA SEWER COLLECTION SYSTEM CONDITION ASSESSMENT

## HAMLET OF ROLLA SEWER COLLECTION SYSTEM CONDITION ASSESSMENT NOVEMBER 2021 FINAL REPORT

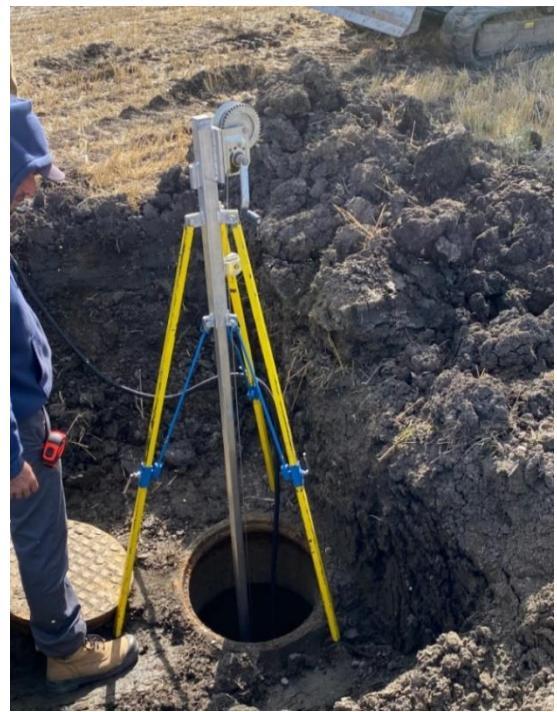
Figure 1:Manhole inspection in Rolla Hamlet

Our crew employed a high-resolution Zoom Camera to check the pipes, valves, shut-offs, and cleanouts for wall structural integrity and sewage leaks.

Following the inspection of the pipes and manholes, PACP/MACP certified viewers reviewed and graded the inspection videos. This report and appendices include listings of defects encountered during inspections, according to PACP/MACP terminology.
